Historic Building Recording
Former Lomond Hotel
Kinnesswood
PERTH & KINROSS

KR10

**HISTORIC BUILDING RECORDING
FORMER LOMOND HOTEL
KINNESSWOOD**

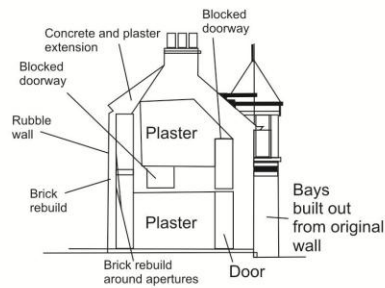
Southwest

The SW elevation featured the ghost of the demolished extension as a gable outline, with exposed bare plaster and a yellow sandstone core, and modern brick rebuild/reinforcement around ground floor entrances inserted at the NW and SE ends of the elevation. The NW entrance had a counterpart immediately above on the first floor, while the SE entrance had a blocked, plastered former doorway above. The SE entrance featured a modern plywood door, but both upper and lower NW entrances were simply empty frames, probably truncated corridors rather than doorways per se. The SE doorway measured 0.70m wide, 2.05m high, from a tiled threshold to a concrete lintel, with both side casings also tiled. The doorway accessed the ground floor staff cloakroom. The NW entrance, which led directly into the ladies' toilets, measured 0.63m wide and 2.68m high, from a wooden threshold to bare ceiling joists, with the sides formed from plasterboard. Above and to the right (SE), the base of a blocked doorway was visible, protruding below the exposed plaster, on the same level as the example immediately above the SE door. The wallhead above this partially visible door appeared to have been built out to the NW to expand the width of the building, permitting the insertion of the extant open corridor at first floor level; the original building must therefore have been narrower by approximately 1.00m at the SW end.

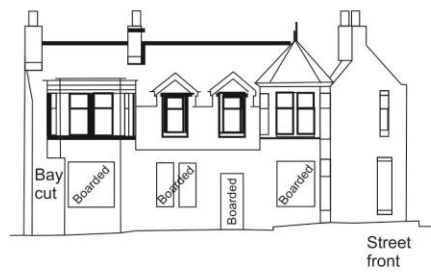
Southeast

The SE elevation faced onto the former car park entrance from the street. It featured bay windows at either end on both ground and first floors within spire-topped tower projections. The ground floor featured a central double window between the bays, with a single doorway immediately to the NE. The double windows were each 0.70m wide, within a combined frame measuring 1.54m wide and 1.75m high (internal). A veranda roof projected 1.25m from the first floor above these windows, joining the two bay towers. All ground floor apertures were boarded up. The first floor featured two evenly-spaced single windows in dormer turrets above the ground floor double window- the dormers were possibly earlier features set into the original roof, but the fixed windows with hoppers were modern. All the visible (not boarded) windows in this and the NE elevation featured white upvc frames. Only one of the bay window frames was accessible and measured 0.70m wide and 1.80m high.

The SW side of the SW end ground floor bay window had been cut and re-built with brick, exposing a flat stone wall face behind, indicating that the bays had been built onto the original flat-fronted building. Both bay towers were 3.00m across and projected 1.10m from the flat wall.

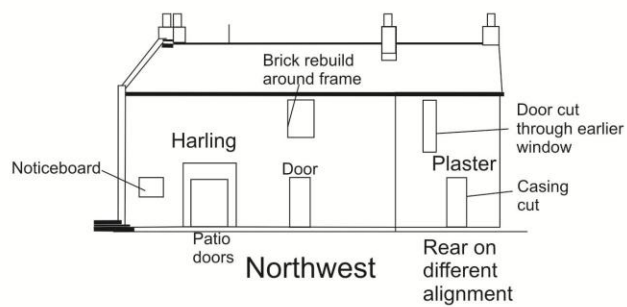
Northwest

The NW elevation was harled across approximately two-thirds of its wall surface area, with the rear third (SW end, away from the street) featuring plaster (suggesting perhaps an internal surface), all being white-painted. A doorway in the SW end accessed the ladies' toilets and measured 0.82m wide, 2.05m high to the stone lintel from a carpeted threshold on a brick built-up ledge or step projecting 0.20m outwards from the wall base, 0.38m above the exterior ground surface. The stone lintel might have suggested an original feature, but the evidence from the SW elevation that the building had been widened indicated otherwise. Indeed, the exposed stone rubble of the casing to the SW appeared cut-off, as though by an insertion. A door was positioned above and to the NE at first floor level; this was a modern insert cut through an earlier window, the sides subsequently built up with bricks, accessing the now-demolished extension. This feature confirmed that the plastered rear third of the elevation had been interior to the extended hotel. The rear third was also on a slightly different alignment to the remainder of the elevation, being orientated more N-S, and appeared to be not fully keyed-in, adjoining the main building at a dogleg where the latter jutted out by 0.40m. It therefore seemed that the Victorian hotel had been approximately 1.40m wider at the street front than at the rear, which may have featured a small attached utility block (perhaps containing the kitchen), the latter built onto an originally rectangular single block. This is borne out by the OS Second Edition map, which shows a rectangular building with a small rectangular projection at the rear (NB, "Lomond Hotel" is indicated, but the label is misleadingly placed nearer a neighbouring building- the hotel is actually in its correct, current plot).

3.30m NE of the dogleg, a modern plywood door with reinforced glass windows measured 0.77m wide and 2.20m high from a carpeted threshold on a step 0.40m above the exterior ground surface to the top of the wooden frame, paint obscuring the lintel. The sides of the doorway appeared to be concrete rebuilding. What was probably a cellar hatch back-filled with demolition rubble and debris was positioned immediately to the NE of the door in the exterior ground surface. The first floor featured a window above the doorway, set within a black-painted moulded frame, the sides re-built with brick indicating either modern reconfiguration of an existing feature or an entirely modern insertion.

2.75m from a concrete block street front wall at the NE end of the elevation were glazed double patio doors, in an entrance 1.40m wide and 1.98m high from a wooden threshold to the top of the doorframe and within a moulded flat-topped arch.
