Historic Building Record
Blairfindy Castle
Glenlivet
MORAY
GN02

**HISTORIC BUILDING RECORD
BLAIRFINDY CASTLE
GLENLIVET**

GN02

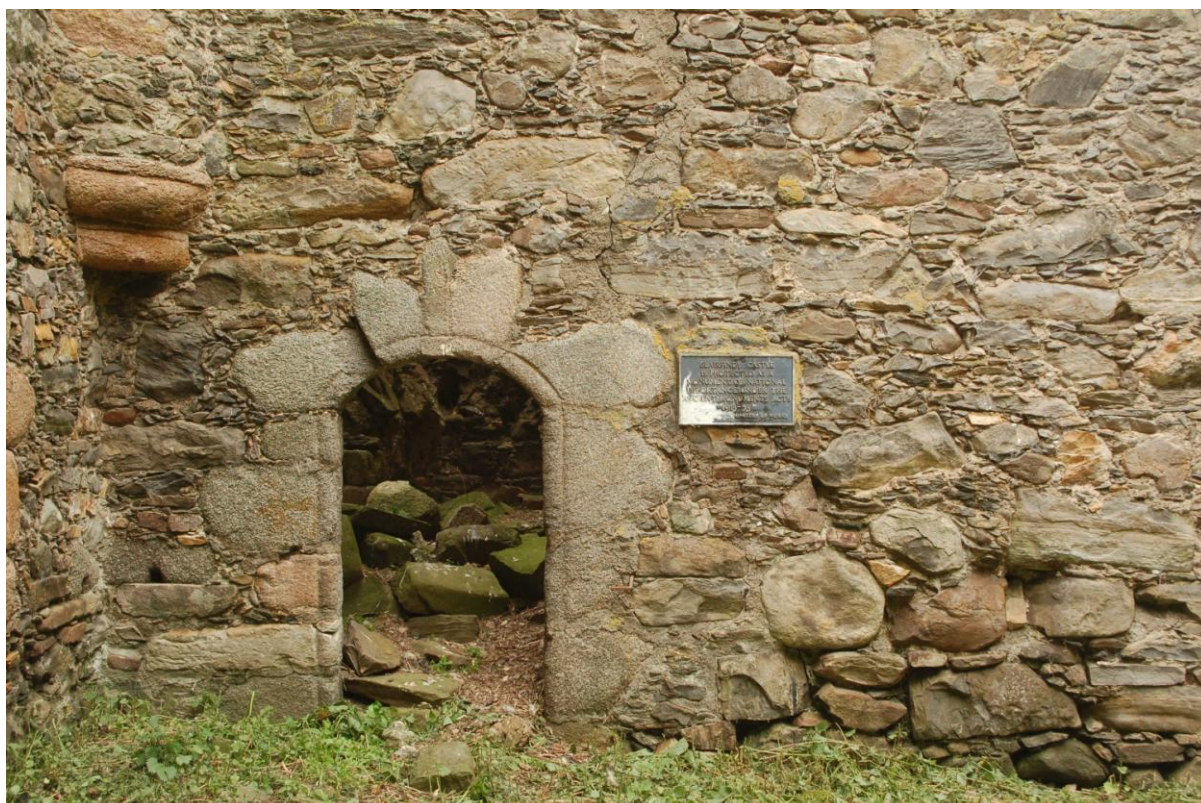
The arched doorway, the only entrance to the building, was set into the N wall of the wing, to the E of the centre line. It measured 0.84m wide and, at the time of the survey, 1.49m from the present ground surface to the apex of the arch, which featured a large capstone- of irregular ellipsoid shape suggesting a shaped boulder rather than cut masonry. This formed part of a splayed setting of similar boulders or slabs vaguely resembling a fleur-de-lis or crown (whether or not this was the intention, there was clearly an aesthetic quality to the arrangement as well as the practical result of forming the top of the arch). The threshold was obscured, probably by a build-up of silt and perhaps rubble, which had raised the interior floor level of the wing a considerable height (possibly as much as 1.00m in places) above the external ground surface. Meanwhile, evidence of subsidence raised the possibility that the castle as a whole may have sunk into the subsoil, leading to a reduction in the height of the doorway. Slots in the left of the moulded granite jamb, including a possible latch slot, and a corroded iron hinge opposite indicated the position of the door and that it was hinged on the right (facing from outside). The corroded hinge may have been a later insertion. The wall around the entrance was 0.60m thick, including 0.16m of jamb.

Image 3: The entrance doorway, shothole visible to left

A shothole in the exterior elevation to the left (E) of the doorway appeared to correspond to a gun-port opening within the wall to the rear of the E jamb; however, this aperture was irregular in form and appeared damaged. Moreover, to utilise the gun port, a defender would be obliged to lie sideways within the doorway with head and shoulders within the aperture, unable to take aim and almost certainly deafened and blinded (if not concussed!) by exploding powder. This therefore appeared extremely puzzling and the shothole seemed to be an unusable affectation, until the true gun-port was discovered behind a large “plug” of masonry in the interior, at the junction of the wing with the main building. The semi-circular plug, measuring 1.20m long x 0.55m wide and up to 0.50m thick, consisted of lime-bonded rough-dressed boulders and had been positioned to create a curve in the entrance to the cellar, which it also restricted; patches of mortar on the wall behind suggested it had been attached to the main wall but not keyed-in. It had subsequently pulled away from the wall and collapsed onto the ground. Behind it was found a V-shaped gun-port, through which a defender could fire through the shothole beside the entrance. The plug had either been created to form a (rather treacherous) roof extension above the port or, more likely, to block it off entirely, presumably in more recent times when active defence of the castle was less likely to be needed. The hole accessing the port from behind the door jamb appeared to result from damage or the removal of masonry, rather than being part of the designed defences.

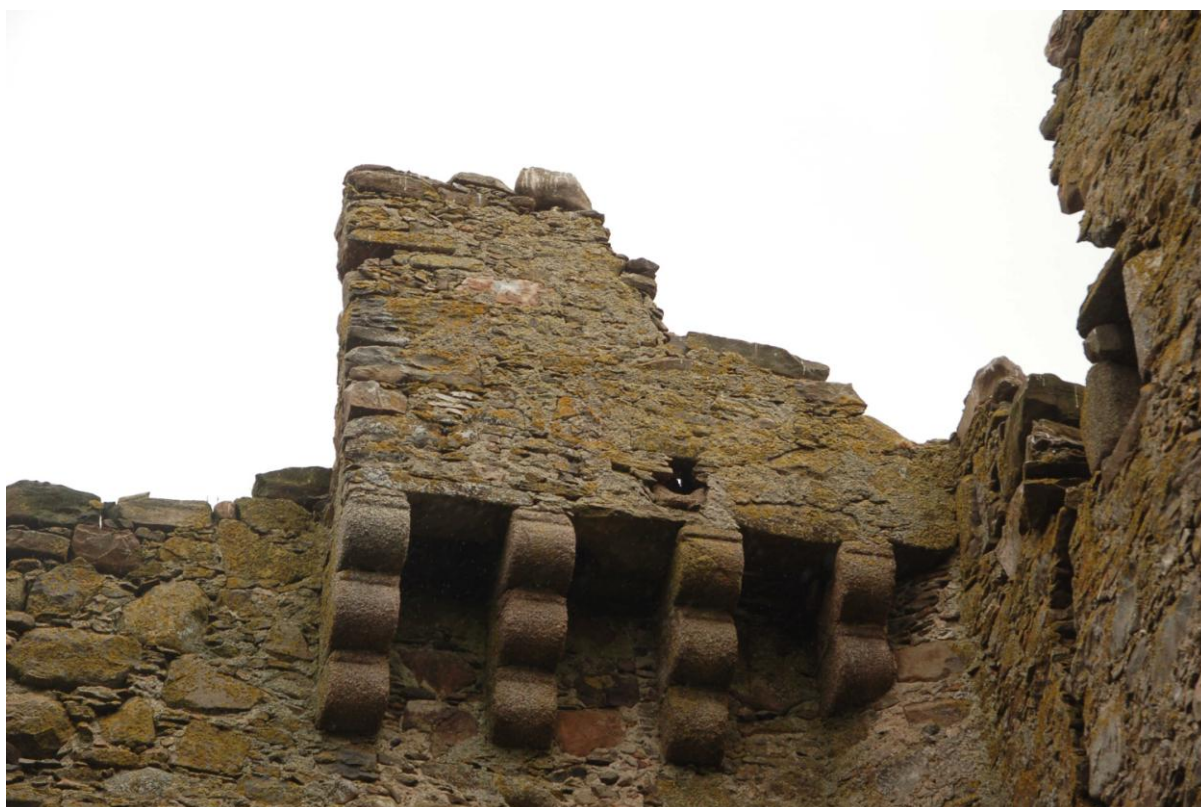
The most prominent feature of the exterior W elevation of the main building was a box bretèche positioned at the wallhead close to the junction with the wing. The junction itself had been buttressed from 1.80m above ground to wallhead level, partly to reinforce keying and perhaps also due to the former presence of a second bretèche directly above the entrance or alternatively a caphouse turret above the internal stairwell (see above). The surviving bretèche appeared to be positioned too far from the doorway to guard it effectively, but in tandem with another would perhaps have been more formidable. Machicolation (holes permitting the dropping of stones, darts or fluid) was visible in the base of the bretèche, which was supported in its projection from the wall by base corbels that also formed the sides of the apertures. Defences of this kind were archaic by the sixteenth century and it may be that, in addition to providing practical defence, the bretèches were intended to convey an appearance of antiquity and longevity on what was in fact a new construction, perhaps in rivalry with the older castle a short distance away at Drumin. The effect would also have been to give Blairfindy the appearance of a castle “proper”, rather than the fortified house it was in reality.

Image 4: The bretèche

Damage was apparent on the outer face of the bretèche, with a sub-circular hole close to the base and the absence of a section of wallhead. Meanwhile, the central of the three machicolated apertures had been blocked by a slab, perhaps to permit a defender to stand within the bretèche itself rather than behind it on the main wall, or to reduce the possibility of an attacker succeeding in firing upwards through the apertures

(alternatively, the blocking may have been the accidental result of the partial collapse of the structure).

Bretèche: three large, unshaped boulders (up to 0.38m diameter) were positioned on the wallhead behind the machicolation of the bretèche, with no bonding material. Although they may well have been relics of decayed wall fabric, it is just possible that they represented a stock of defensive missiles placed in readiness and never removed. Removal of silt and vegetation in and around the bretèche had revealed a deposit of lime mortar and a slab floor walkway along the wallhead, accessing the machicolation.

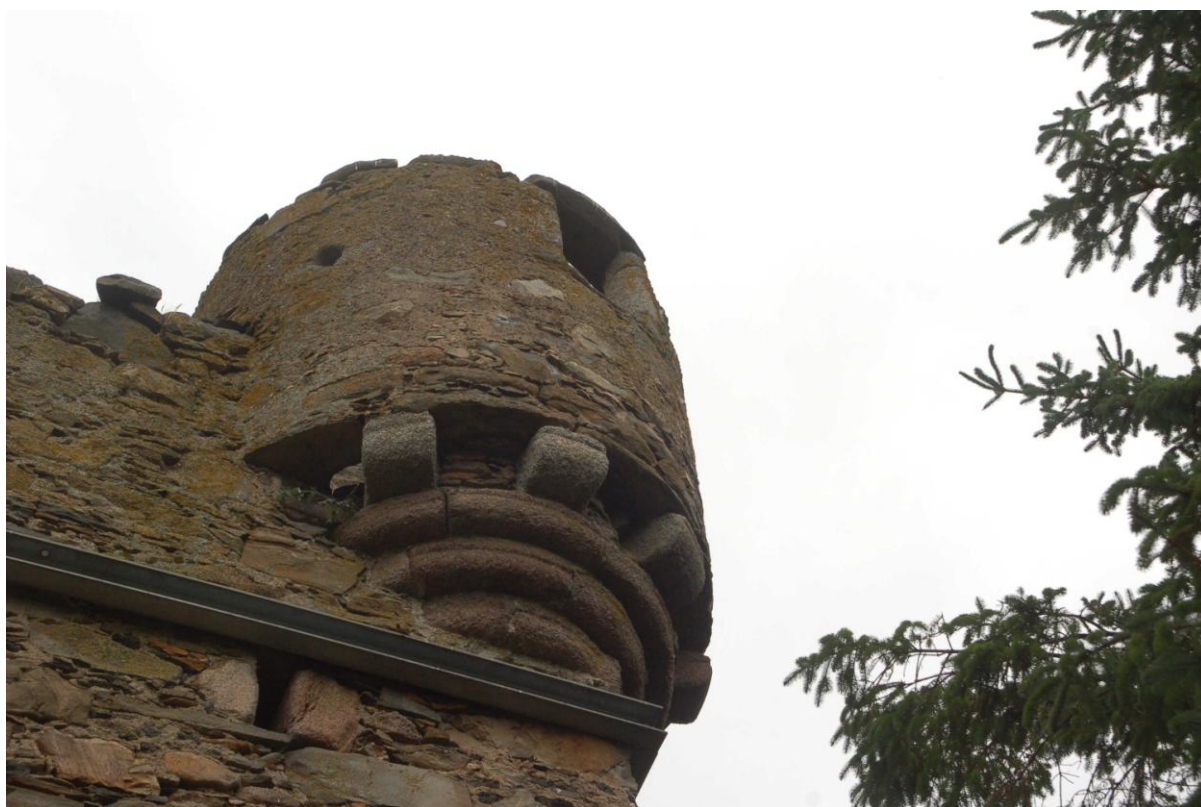
The exterior N elevation featured a 2.00m tall circular bartizan turret at the NE corner, 10.775m above the ground, where it was supported by five dressed corbels projecting from 2.00m below the wallhead, where they were in turn supported by three concentric rings of moulded granite. Currently roofless, the turret featured a central rectangular window with stone lintel in the NE quadrant of the circle where it served both to permit a defender to traverse the N and E approaches to the castle and to illuminate the interior of what almost certainly had been a structure with a conical roof. To either side of the window, shotholes allowed fire to be directed along the N and E wall faces of the building without exposing a sentry at the window to counter-fire from the sides.

Image 5: The bartizan

Bartizan: the intramural passage below the turret was found to measure 0.88m wide.

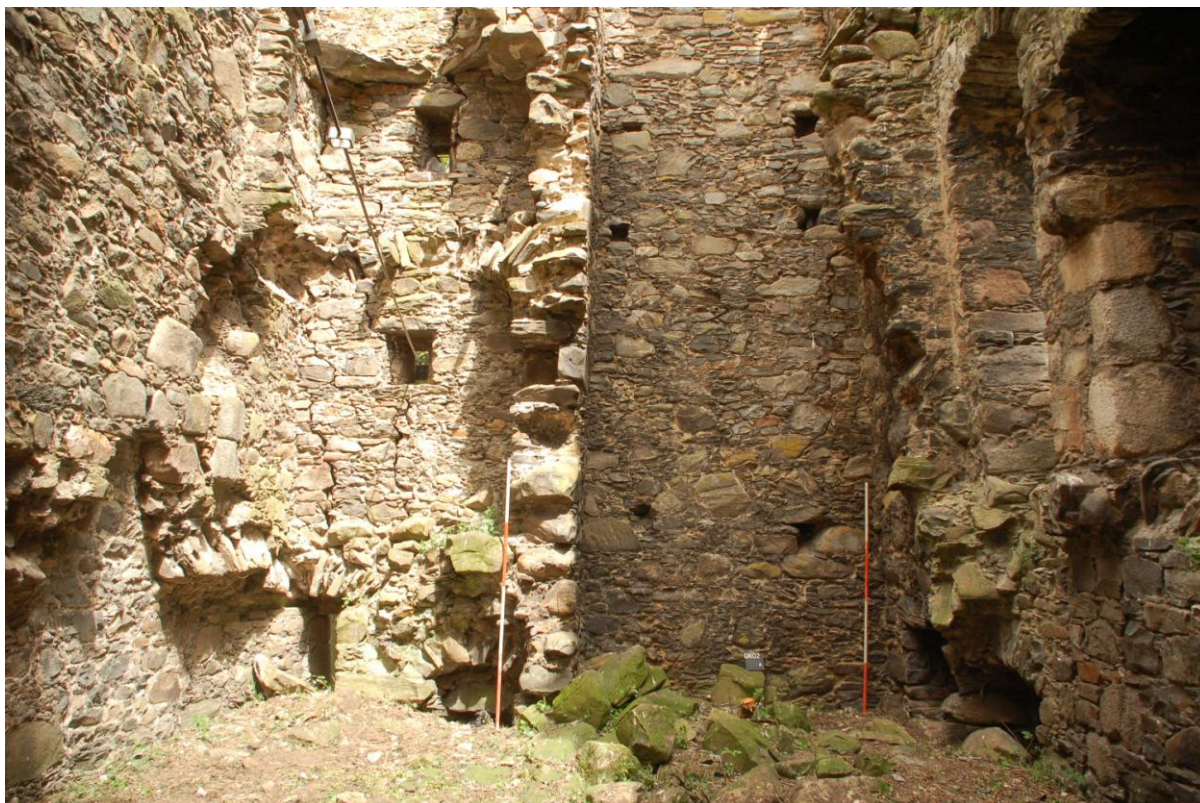
The N elevation was dominated by a large chimney flue extending from the cellar floor upwards. 3.15m wide at its base (internally) and 1.00m deep, the flue gradually narrowed to meet the 2.10m wide chimney stack, which stood 13.818m tall. Rubble deposits across the base of the flue may have derived from partial collapse of the inner wall of the chimney, which had largely disintegrated, the flue standing open from the ground to the base of the attic level. Within the flue, six subrectangular beam slots had been built into the outer wall, two at the level of the cellar ceiling, two at approximately the level of the first floor ceiling and two level with the second floor window at the W end of the elevation (see below). These may have been intended to tie in the surrounding wooden floors, but were noticeably uneven, not quite level with the floor beam slots in the W elevation and in the outer rather than inner wall of the flue, so may in fact have been putlog slots deriving from construction scaffolding. A single slot was also visible in the outer wall within the flue at attic level, where the inner wall was intact. It is presumed that the main kitchen fireplace was located at the base of this chimney, but the collapse of the inner wall, coupled with the build-up of silt and rubble, meant that no direct evidence of such a structure could be discerned. McGibbon & Ross depict a circular structure on the W side of the flue, probably an oven, at cellar level, but again, no trace of this remained, beyond a small, vaulted recess now blocked with rubble to the E of the ground floor slit window. At the base of the E wall of the flue was an alcove measuring 0.80m high x 0.55m wide, with a slab lintel. This was probably a small side oven within the main fireplace. To the S of the alcove, on the other side of the flue wall, was the blocked window and drain described above (see *Exterior*).

Image 6: Base of N elevation, interior of main building, with “oratory” to left of flue

The W side of the elevation appeared to be divided into compartments, the front wall of which was represented by protruding vertical stubs in the N end of the W elevation, beginning on the first floor, with their base on the projecting edge of the cellar ceiling. The base of this column of stubs was formed by two moulded stones representing the lower part of a door jamb, located in the W elevation 1.40m from the junction with the N wall. There thus appeared to be an entrance from the Great Hall to a small room in the NW corner of the building, with a slit window in the N elevation providing limited illumination. Above the door jamb (after an area of damaged wall fabric that may have resulted from the removal of stair treads or vaulting) the column of stubs continued at the same distance just below attic level the width of the rooms decreased to 1.20m. In places, projecting slabs probably represented floor levels, but these were out of sequence with the main building floors. Altogether, a vertical set of chambers appeared to be represented, that may well have been landings in a stairwell, each with a vertical slit window to permit defence of the N elevation. The failure of the small chambers to align with the levels of the larger rooms without also suggested landings, rather than simple room extensions or storage space etc. In fact, the lower (first floor) and uppermost (attic) chambers were on the main floor levels, but the two intervening chambers were not (the attic chamber was mostly represented on the N elevation, only slabs reflecting its floor position just below the wallhead were visible on the W elevation). Interestingly, the attic chamber and the chamber immediately below were alongside a subsidiary flue which ran off the main chimney and was visible on the N elevation, its inner wall collapsed and along with it any trace of fireplaces. The chamber below the attic also featured a rectangular alcove in the W elevation; it may be that as well as landings, the chambers were intended as guard posts, which benefited from heat transferred from the side flue, albeit that this was accessed from the apartment rooms to the S.

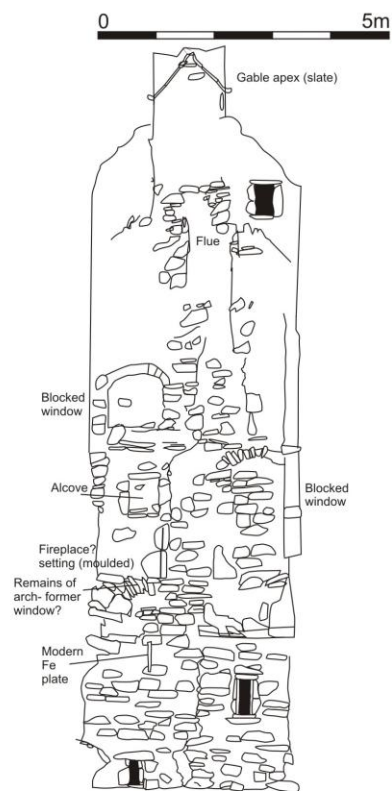
Illus 14

Interior West elevation, wing
