Historic Building Record  
Broadfold Farm  
Auchterarder  
PERTH & KINROSS  
AA15

**BROADFOLD FARM  
HISTORIC BUILDING RECORD  
AUCHTERARDER  
PERTH & KINROSS**

**AA15**

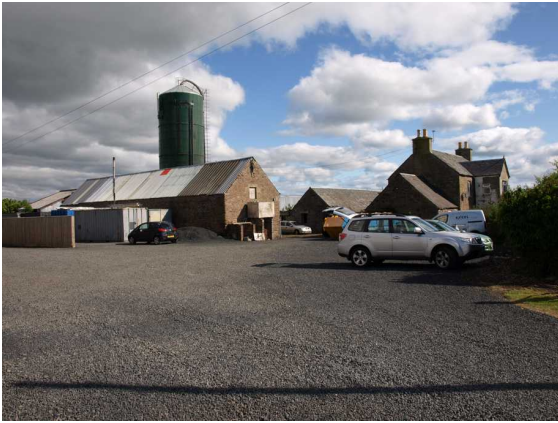
Illustration 6: General view, N. W Range, Farmhouse, Grain Silo and S Range beyond.

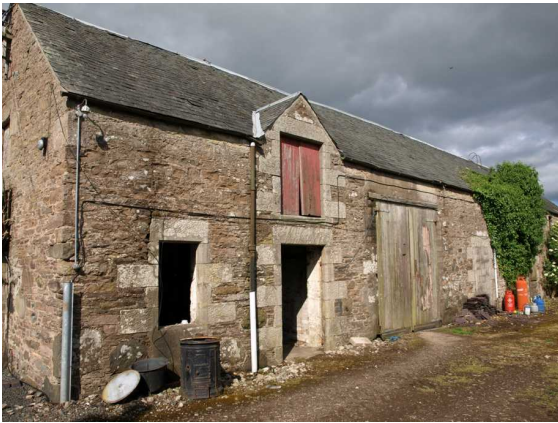
This building is tall, long and narrow, aligned N – S with a steep pitched roof. The east slope of the roof is slated in diminishing courses. On the W slope the slates have been replaced with profiled metal sheeting. It was originally built with a ground floor and loft, but in places the loft floor has been cut away. There are a number of blocked altered or inserted doors and windows. At the south end there is a windowed room with a loft above, perhaps a stable and hayloft. There are two curious hatches in the loft floor above, perhaps for bringing down feed and bedding into the stable. At the N end of the building there are arched cart doors, one now blocked, facing out to the E.

Illustration 7: W Range, S end.

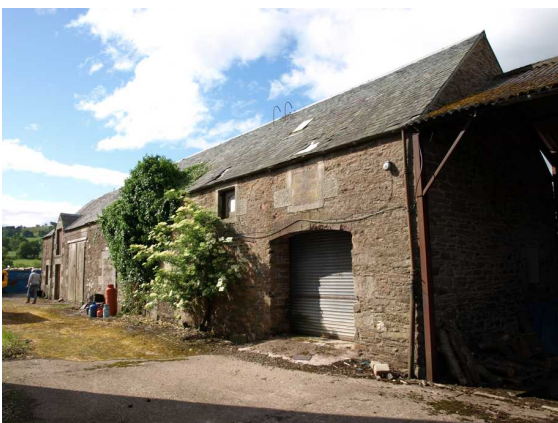
Illustration 8: W Range, N end. Cart doors.

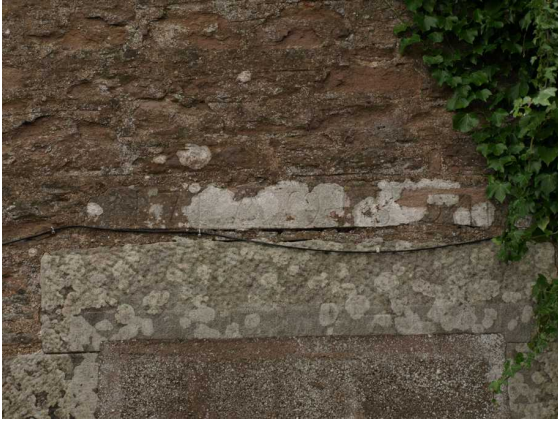
To the N of the workshop door, above the lintel of a now blocked doorway, is a much smaller, thinner lintel, with the inscription **17 IA** [heart] **IB 54**. This is obviously an 18<sup>th</sup>-century marriage lintel, dated 1754 and commemorating the marriage of two persons with the initials IA and IB. The lintel is not structural in its present position above a much more substantial lintel, and obviously out of place on a clearly agricultural building. It does seem to have been built into its present position rather than inserted later. It was perhaps brought here from a town house in nearby Auchterarder, or from an earlier farm house at Broadfold, and incorporated in the present building to preserve it, either as an antiquarian curiosity, or because of a family connection with the previous building.

Illustration 9: W Range, detail of re-used marriage lintel.

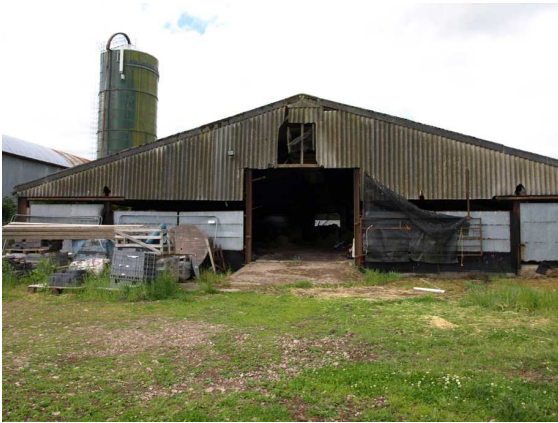
This is the largest and probably the latest structure, apart from the telecoms cabin. It is a wide, low cattle shed, oriented E – W, with a steel portal frame, and asbestos cement sheeting. There is a concrete entrance ramp at the E end, grooved for drainage and traction, leading to a central concrete aisle. The cattle holding areas on either side are of precast concrete slatted design, to allow machine cleaning from below with minimal cattle movement. This building is probably of mid to late 20<sup>th</sup>-century vintage.

Illustration 10: The N Byre, E end.

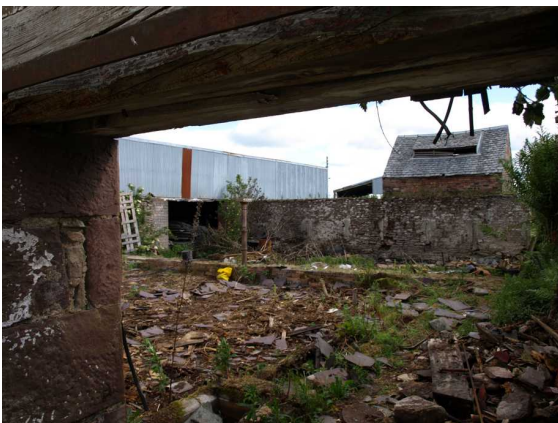
The Courtyard is bounded to the S by the S Range, and to the E, W and N by sandstone rubble walls, with wide doorways for the movement of cattle. The E wall is now freestanding, but is marked by vertical ventilation slits of the sort normally provided in

cattle sheds, showing that this wall was once part of an enclosed building. The slits are now blocked, and are visible only on the W side.

Illustration 11: The Courtyard. Ventilation slits in E wall.

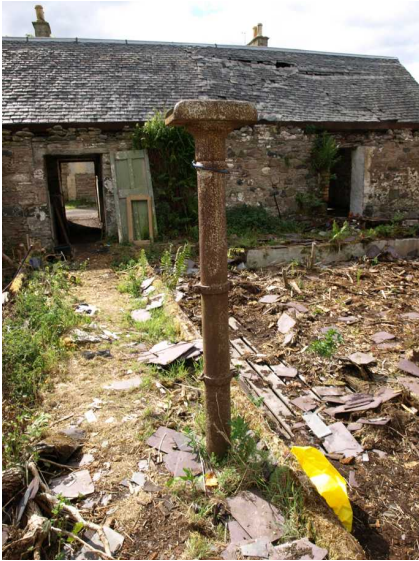
Illustration 12: Detail, cast iron column in Courtyard.

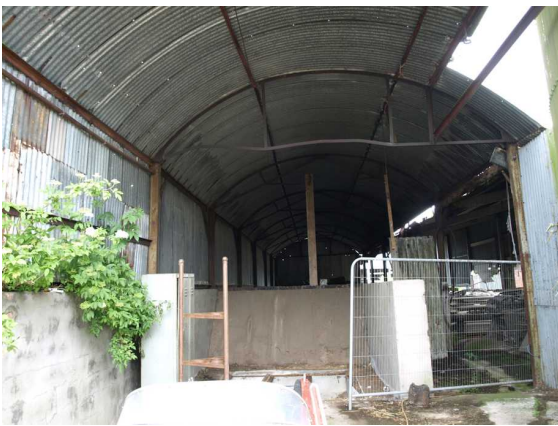
The N range is aligned E – W, and consists of two lightly built steel framed buildings with corrugated iron sheeting and mainly open ends. The S part of the N Range incorporates the sandstone rubble wall on the N side of the courtyard. It has a monopitch roof sloping down to the N, ie away from the Courtyard. The N part of the N Range directly abuts the S Range, and has an arched steel roof, with light and rather elegant steel roof trusses. The SW corner of this building has been partly removed to accommodate the Grain Silo.

Illustration 13: N Range interior.

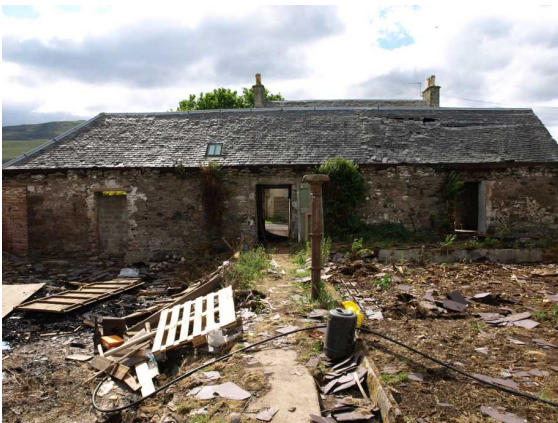
Illustration 14: S Range, N elevation.

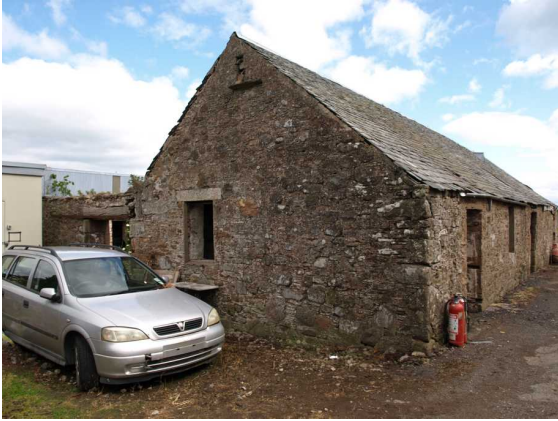
At the W end there are three cattle stalls against the gable wall, while in the E end wall there is a small ventilation slit, now blocked. There are also two triangular zinc vents in the roof above the E end. In the W gable wall, just below the apex and slightly to the S, there is a small, narrow slit, now blocked, with a small, projecting sandstone table projecting externally, perhaps for the benefit of small visiting birds.

Illustration 15: S Range, W gable end with 'Bird Table' at apex.

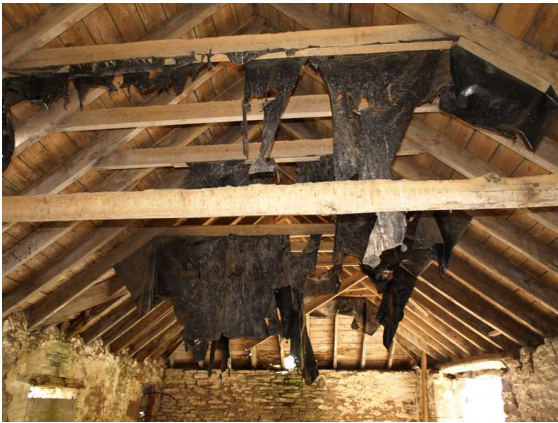
Illustration 16: S Range, interior. Roof timbers at E end.

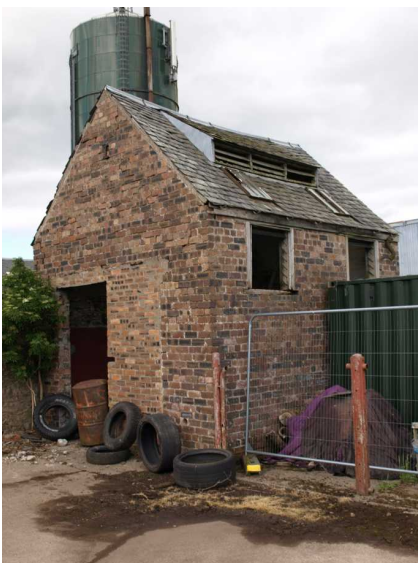
The Dairy is a tall, compact, rectangular brick building, just outside the SE corner of the Courtyard. Its W wall rests on top of the Courtyard wall. It has a ridged, slated roof, aligned N – S. It has no roof trusses or rafters. Instead, the sarking boards are supported on a ridge beam and N – S purlins running between the N and S gable walls. On either side of the roof are louvered vents built like catslide dormers.

Illustration 17: The Dairy, S gable end with reduced doorway.

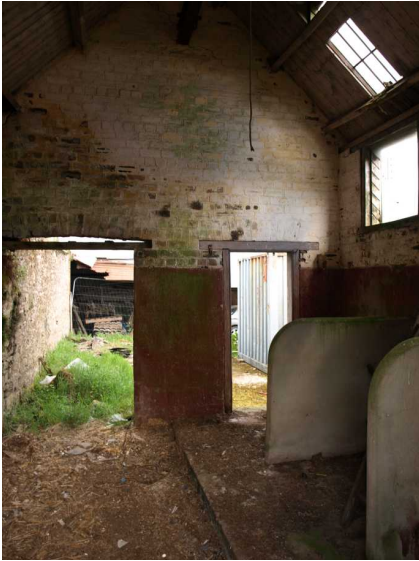
Internally there is rolled steel beam running N – S just below the ridge, inserted into the gable ends. This does not support the roof in any way, and was perhaps intended to support milking machinery or similar equipment. There are three cattle stalls built against the E wall. At the N end there are two doorways with timber lintels and brick arches above. At the S end there is a double doorway, spanned by a rolled steel lintel, subsequently reduced in brick to a single doorway.

Illustration 18: The Dairy, interior. N gable end with double doorways. Stalls in E wall.

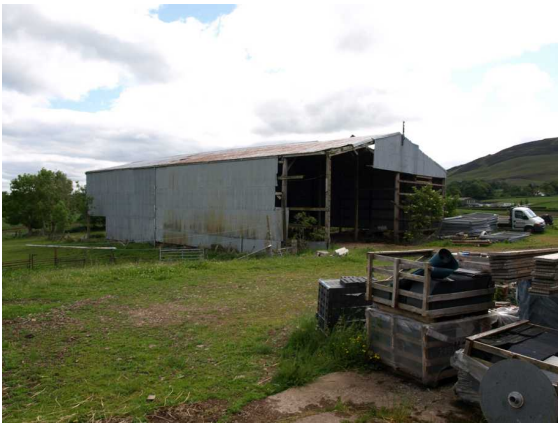
The E Barn stands a little apart by itself. It is a large, tall and curious structure built of re-used softwood timbers and corrugated iron sheeting, with mostly open ends, and an earth floor. It is supported on the centre line and at the sides by very large, earthfast posts, spanned by heavy timber rafters and a ridge beam, and lighter purlins, with a system of sawn plank wind braces, all apparently nailed together. The larger timbers shows various signs of re-use, with non-functional notches and grooves. The posts are similar to telegraph or power transmission posts, but much larger, with horizontal grooves like those on traditional telegraph poles to support the cross-members which carried the wires. It is possible that these posts might have been salvaged at a time when the National Electricity Grid was being created in the mid 20th-century, and timber transmission posts were being replaced by 330 KV lines on steel pylons.

Illustration 19: The E Barn.

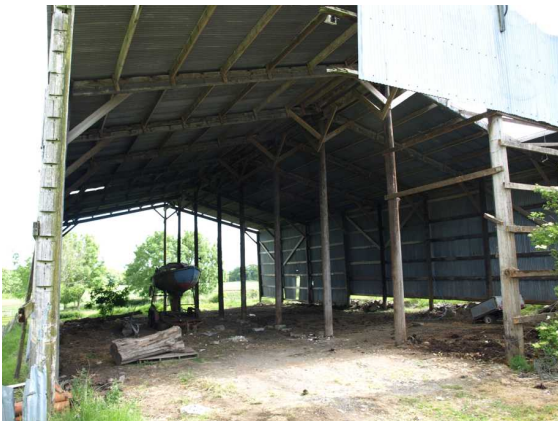
The E Barn appears to be an ingeniously improvised, hand-built structure, and would have been suitable for storing bulky, low-value materials requiring ample ventilation, such as straw and hay bales. The propensity of hay to spontaneous combustion might be a motive for its location away from the steading.

Illustration 20: The E Barn, internal structure.

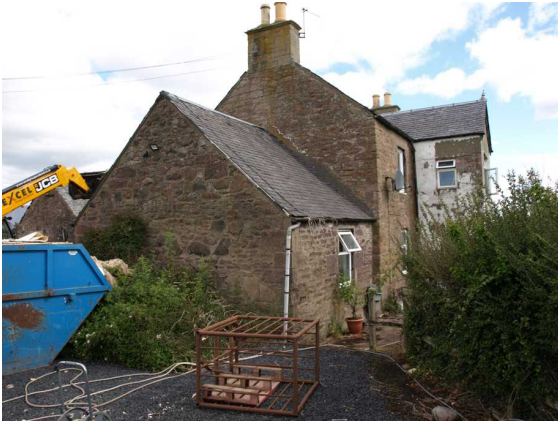
The W extension was of similar construction to the main house, single-storey with a pitched, slated roof, added on to the W gable end, probably of mid 19th-century date. The back entrance door to the house was in the N wall of this extension.

Illustration 21: The Farm House. W gable end and W extension.

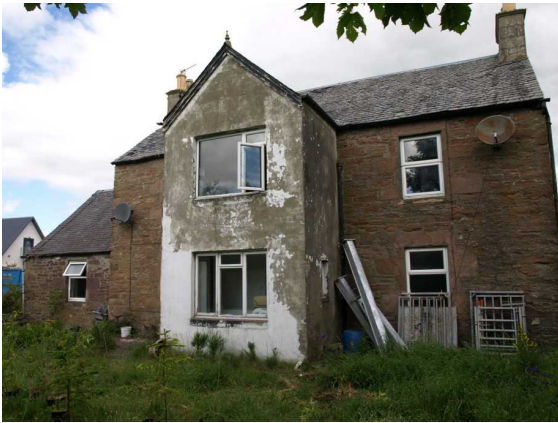
The S extension created a new front door and entrance lobby on the ground floor, and a small additional S room on the first floor, with a pitched slated roof above. In the N there were two extensions. In the centre of the N wall was a ground floor cellar or boiler room, with a small room above, off the stair landing (mezzanine or entresol seems too grand a term), and a lean-to roof. To the N was a small, single-storey toilet and entrance lobby with lean-to felt roof. The three S and N extensions were all of cement-rendered brick, of mid 20th-century date.

Illustration 22: The Farm House. S elevation and S extension.

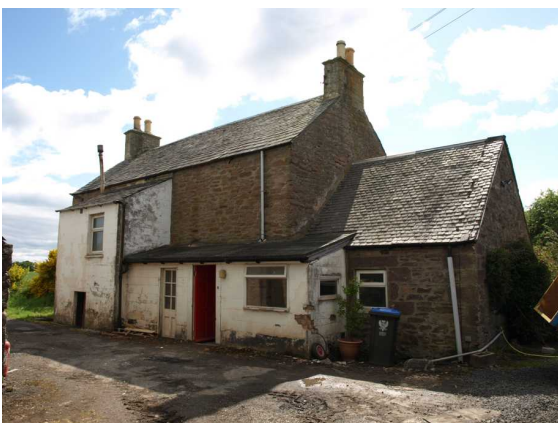
Illustration 23: The Farm House. N and W elevations with extensions.

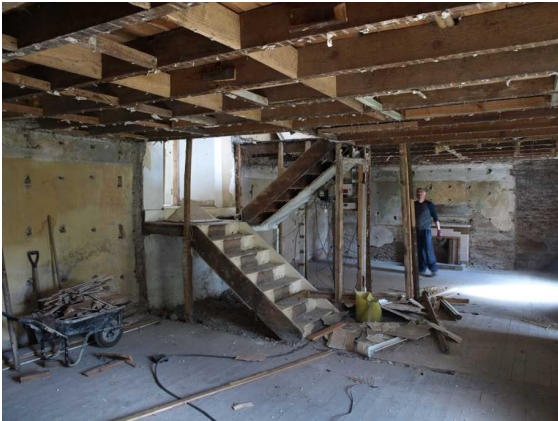
Illustration 24: The Farm House. Ground floor interior with central stair.

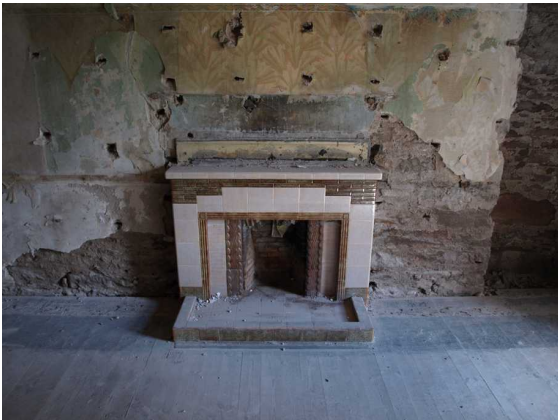
The internal faces of the outside walls were originally plastered on the hard. This must have been miserably cold, and was pierced with holes for wooden dooks to support a later internal plaster lining, no doubt to improve insulation. The fireplaces had been altered to insert firebrick linings, mid – late 19th-century cast iron surrounds, and Art Deco tile surrounds.

Illustration 25: The Farm House. Ground floor interior with Art Deco fire surround in E gable wall.

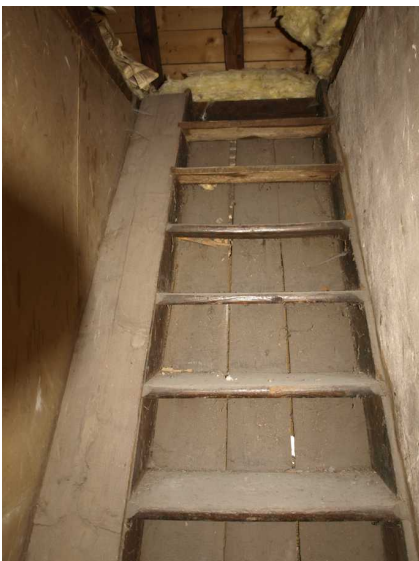
Access to the loft was by a steep, narrow and very worm-eaten plank-and-slat stair or ladder, obviously unsafe. The loft was only very locally floored, and the position of the roughly trimmed joists (forming the base of the roof trusses) was concealed by a double layer of glass fibre insulation. For these reasons the loft was not entered, but only photographed by holding up a camera through the access hatch.

Illustration 26: The Farm House. Access stair / ladder to loft.

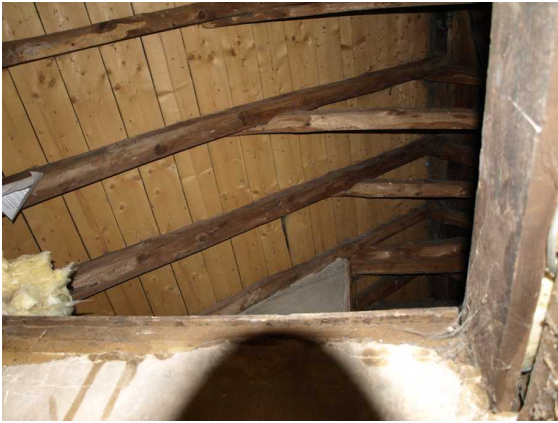
Illustration 27: The Farm House. Roof timbers in loft.
