Historic Building Record  
4 Atholl Crescent  
Perth  
PE68

**HISTORIC BUILDING RECORD**  
**4 ATHOLL CRESCENT**  
**PERTH**  
**PE68**

*Alder Archaeology produced a historic building record (site code PE68) of 4 Atholl Crescent, Perth, for Blazon Investments Ltd, in advance of internal alterations to return the building to residential use. The recording was undertaken on 05<sup>th</sup> and 07<sup>th</sup> August 2020.*

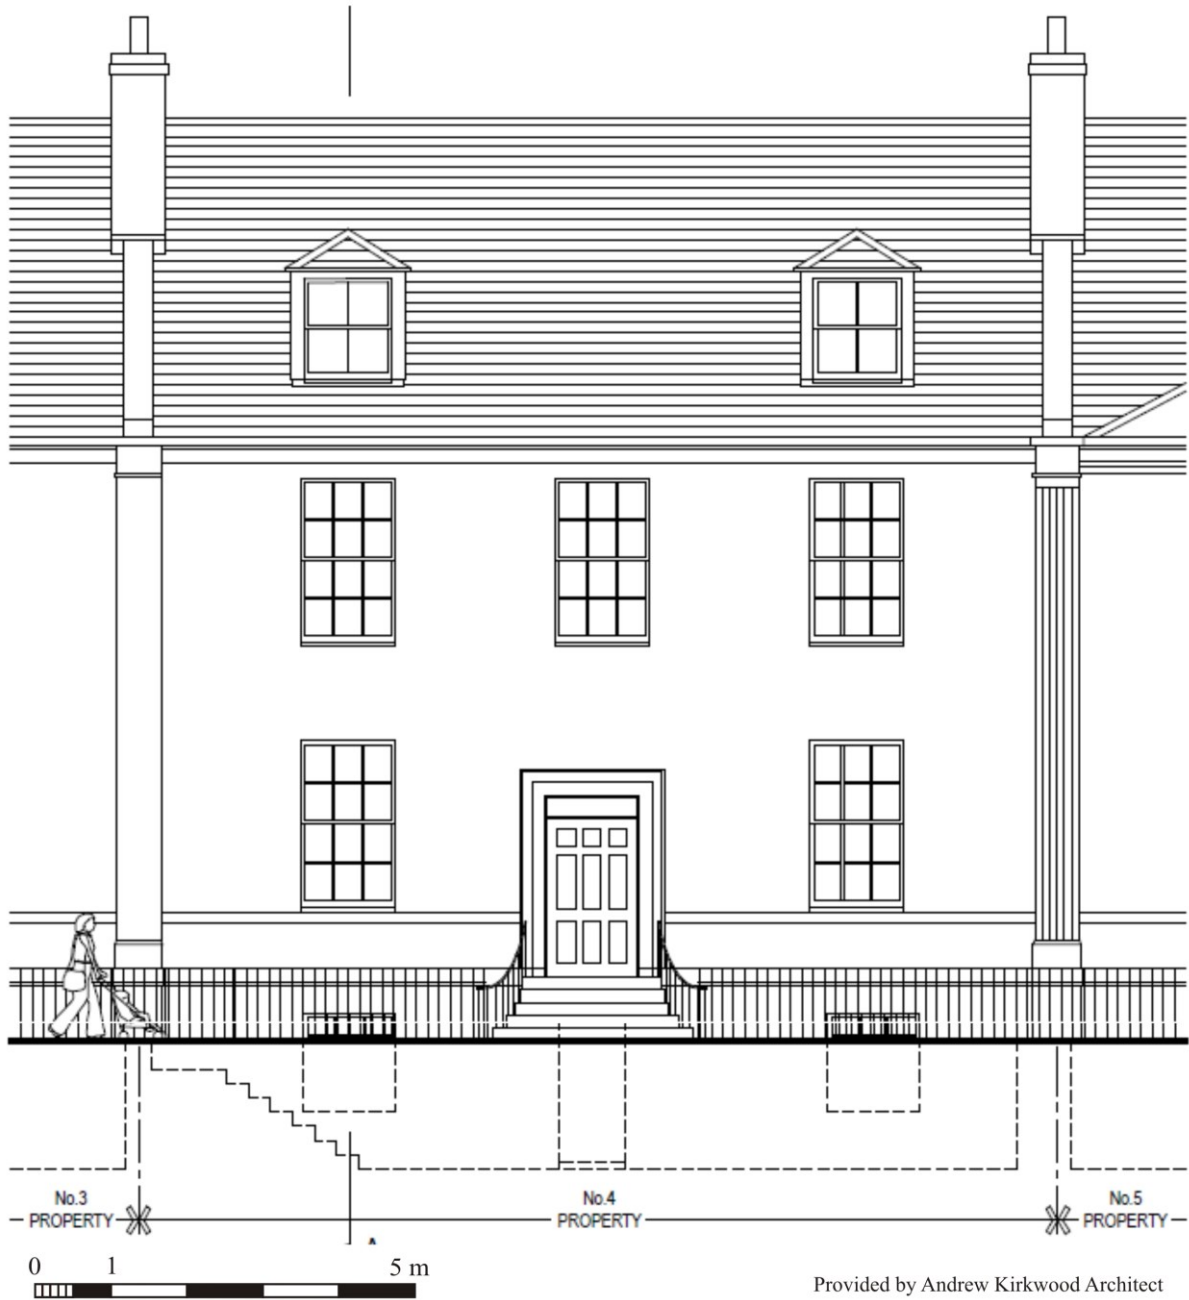
Illus 7

4 Atholl Crescent, Perth: North Elevation

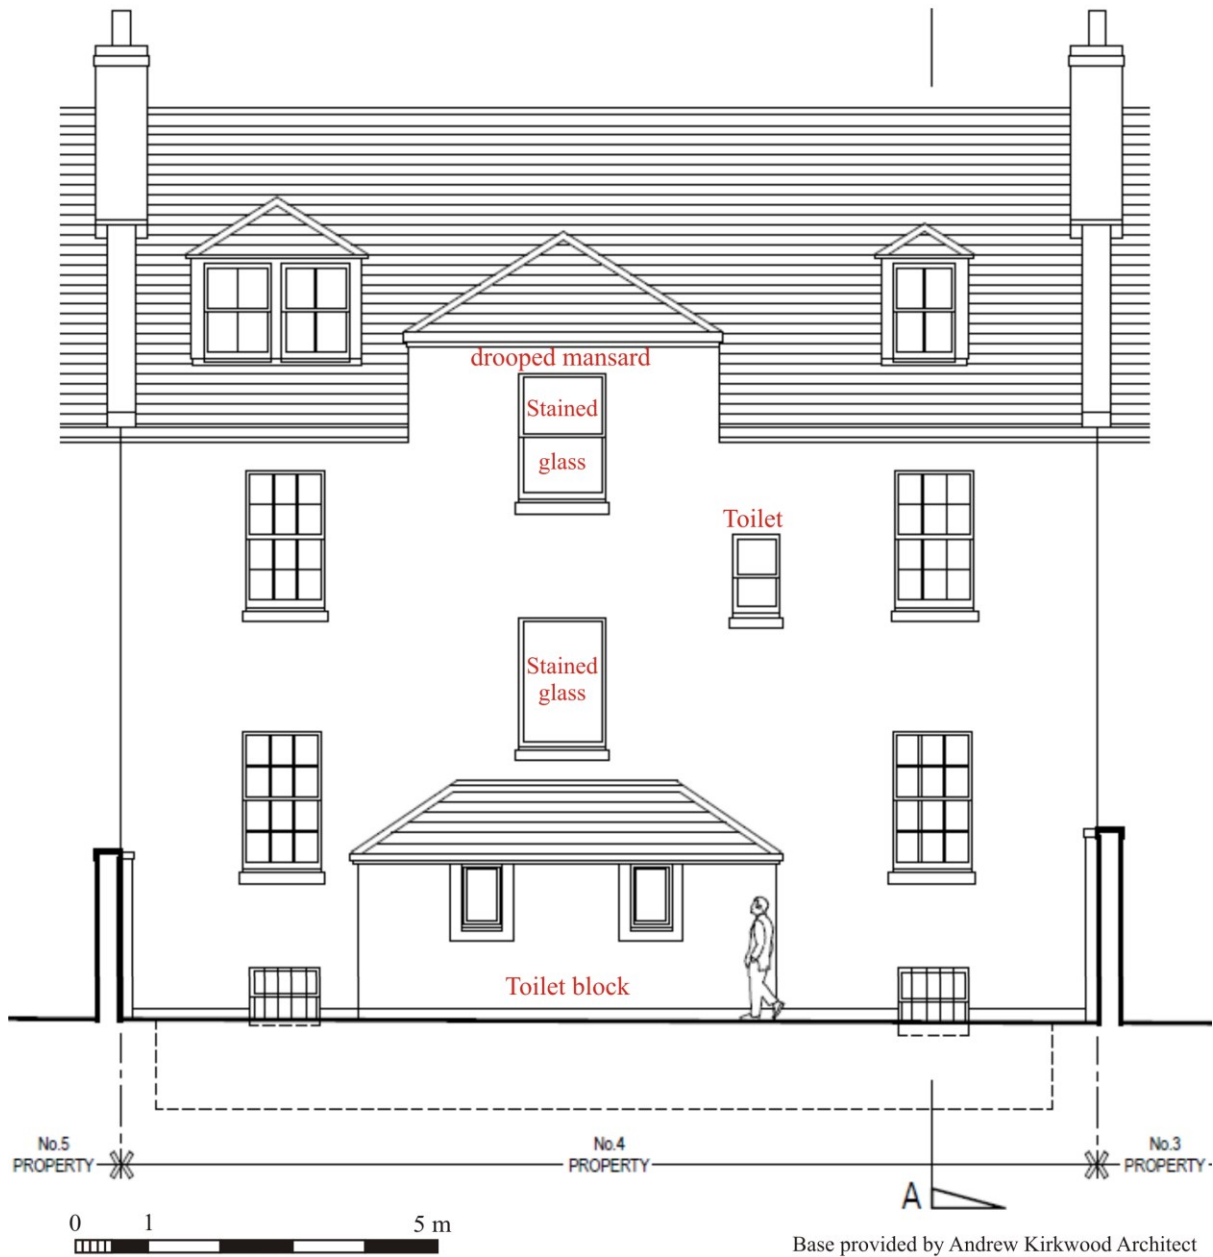
Illus 8

4 Atholl Crescent, Perth: South Elevation

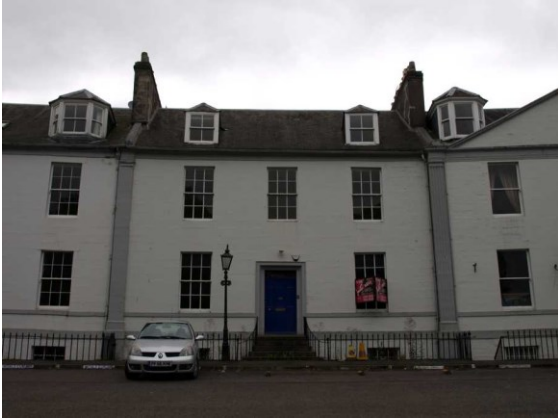
Illustration 11: Atholl Crescent facade. Lamp post to L of entrance.

In the outside 'Area' in front of the basement, there is a black cast iron switch box decorated with the Perth City crest, which controls the electricity supply to a black cast iron lamp post on the pavement just to the E of the entrance. This is the only lamp post in Atholl Crescent, curiously placed here, rather than in the centre of the crescent outside No 5 (the Masons' Hall) as might have been expected. There was a custom in Perth (and other Scottish towns) of placing a lamp post, often highly decorated, outside the Provost's house, as a mark of respect. When this custom was discontinued these lamp posts seem to have been left where they stood, and a number can be seen in Perth in various places. It may be that this is a slightly less ornate example of the practice, marking the former residence of a Provost or other dignitary at No 4.

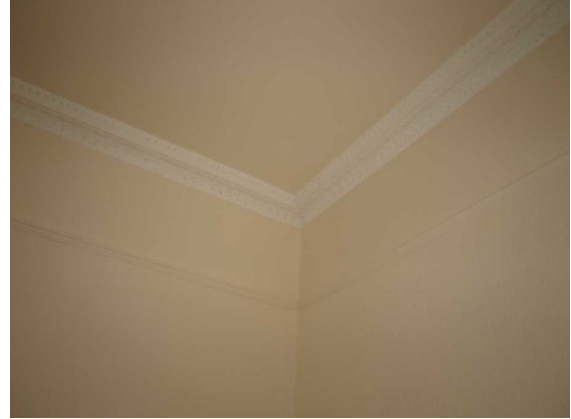
Illustration 14: Ground Floor, NE Room. Moulded plaster cornice.

It is notable that deepest and most complex profiles are confined to the main rooms, and the elaborate moulded designs are found only in the NE room on the ground floor, and the NW room and N central bay on the first floor, clearly the most important public rooms in the building. Moulded plaster corbels are also found in two places, at the foot of the main stair on the ground floor, and in the N central bay on the first floor.

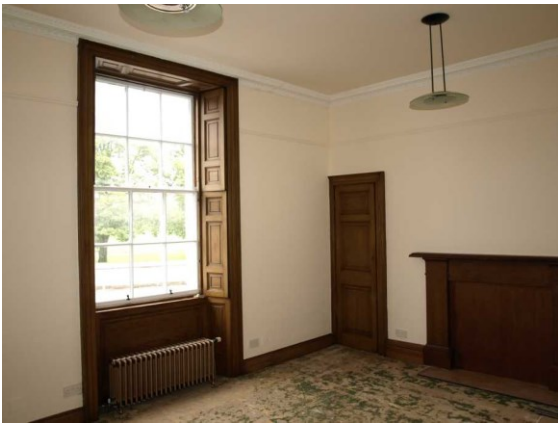
Illustration 12: Ground Floor, NE Room. Window shutters. Oak finish fire surround. Moulded plaster cornice.

The doors, architraves and window surrounds are generally of stained and varnished softwood. On the ground floor, the shutters in the NE room and the mantelpiece in the NW room have been very skilfully decorated with deft brush and sponge work to simulate oak, a traditional technique known as scumbling, and quite popular in Scotland in the 19<sup>th</sup> and early 20<sup>th</sup> centuries, though not always so well done as here.

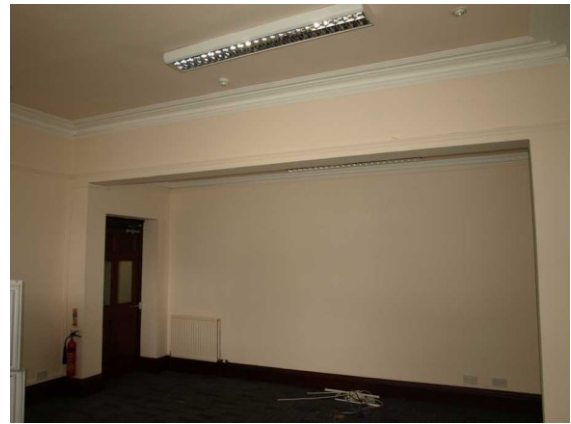
Illustration 15: Ground Floor, NW Room. Modern glazed entrance door. Long alcove in S wall. Deep beam overhead, reduced ceiling. Corniche and picture rail follow main high ceiling. Simpler cornice in alcove.

The partition which forms the back wall of the NW front room on the ground floor does not line up with the stone wall in the basement below, or with the partition wall on the first floor above. Instead, the overhead partition seems to be supported (with a slight offset) by a beam in the ceiling of the ground floor room, forming a long alcove with a lowered ceiling in the N end of the ground floor room. The same happens in reverse between the NE and SE rooms, forming an alcove in the SE room. This can be seen in plan and section. This seems quite an adventurous piece of structural design for the late 18<sup>th</sup>-century, but the plaster cornices in all the affected rooms respect it, and show no obvious signs of disturbance or alteration. If this was a later insertion to enlarge the front room at the expense of the back room and vice versa, its purpose is not obvious, and it must have been very well and carefully done to restore all the different cornices in each room to their proper form.

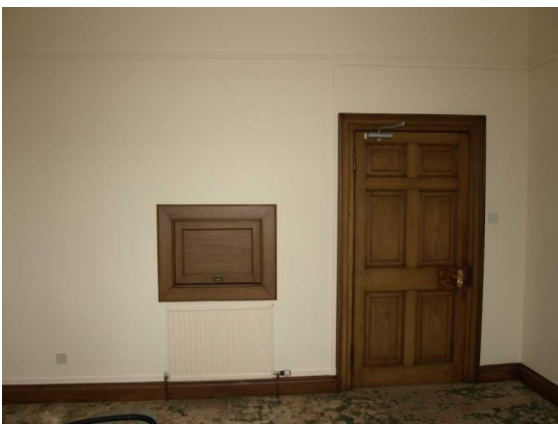
Illustration 13: Ground Floor, NE Room. Serving hatch and wide door.

There is a serving hatch in the partition wall between the front and back rooms on the E side of the ground floor. This perhaps indicates the position of the dining room (front) and kitchen (back) when this was a private residence, though in theory it could have served for handling cash in its early days as an accountant's office, when cash was an important part of business.

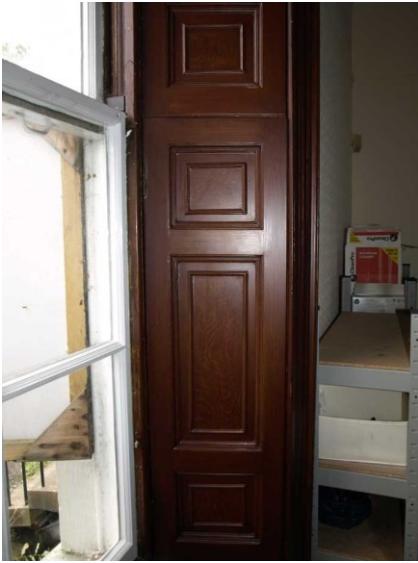
Illustration 16: Ground Floor, NW Room. Shutter with oak woodgrain effect.

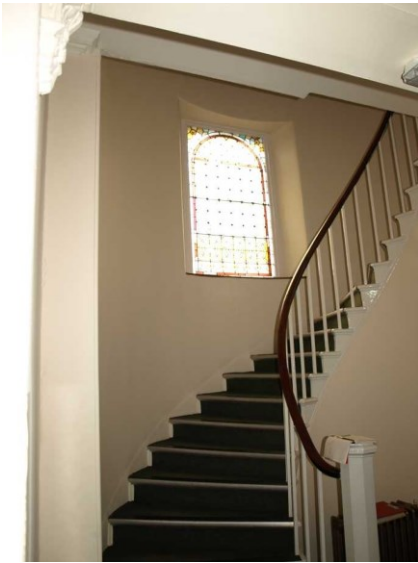
Illustration 17: Spiral stair. Cantilever stone treads. Wrought iron banister with mahogany handrail. Stained glass window.

The main stair is a very impressive feature, with its cantilever stone treads, wrought iron and mahogany banister, and the two decorated stained glass windows with hand-painted roundels depicting strawberries, daisies, flowers and birds, possibly a bullfinch and a robin. The machine-made moulded glass suggests a 19<sup>th</sup> or early 20<sup>th</sup>-century date, and there is some evidence of later repairs. At first floor level the banister on the hall or landing still has wooden sockets for safety gates of the type traditionally fitted to protect small children. The stairs are rather steep, and even adults might have benefitted from a barrier on the descending stair, but there is a similar fitting on the stair up to the attic, clearly intended to contain over-confident toddlers rather than protect absent-minded adults. This seems to be an interesting relic of a previous period when the house was in use by a family with small children.

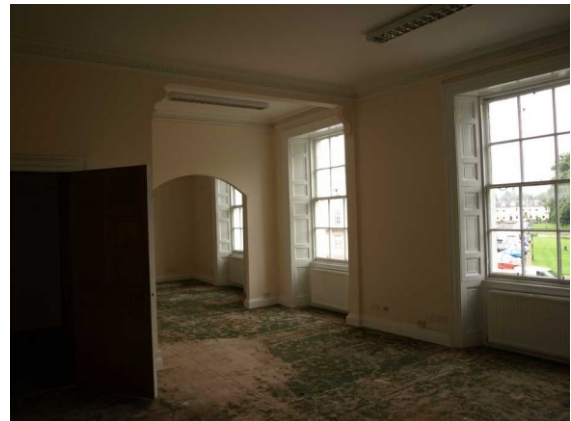
Illustration 19: First Floor, N Rooms. Moulded plaster cornice and corbels. Arched partition leads to NW room.

This large space had been further enlarged in modern times by cutting a wide, round-topped opening into the adjacent NW room, clearly not part of the original layout, with its much simpler cornice and its own separate entrance from the hallway. This opening showed that the partition wall was surprisingly thin, nearer 4" (10 cm) than the 6" (15 cm) of more modern partitions. Similar thin partitions were exposed by an opening

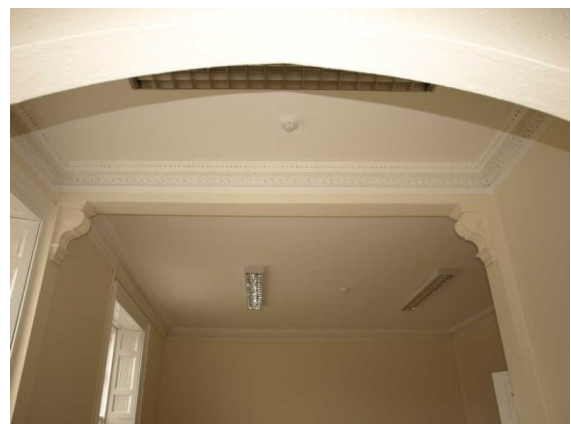
Illustration 20: Central bay, with moulded plaster cornice and corbels. Arched partition overhead.

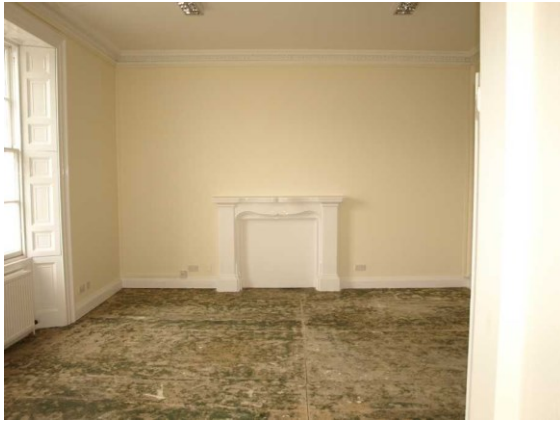
Illustration 21: Ornate fireplace in E party wall.

It was clear that the most important public room, with its grand fireplace, moulded cornices, and a large window overlooking the North Inch, was the NE room on the first floor. This opened up into a central bay over the front door, with a similar cornice and window, and plaster corbels over the junction of the spaces. The primacy of the first floor or *piano nobile* is a long-established architectural tradition, and no surprise in a building with such obvious classical ambitions as Atholl Crescent.

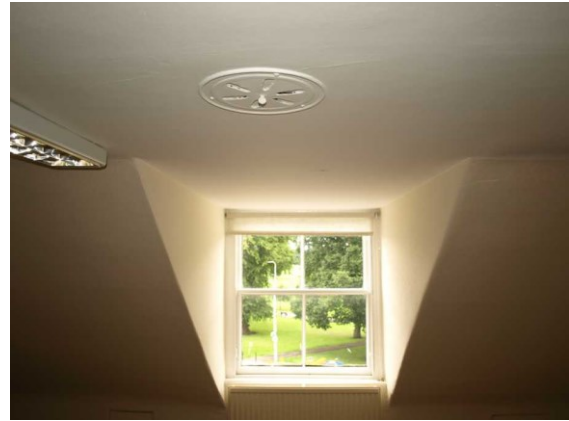
Illustration 24: NE dormer. View to North Inch. Vent overhead.

The NE front room has a curious round pressed-steel ventilator opening into the loft above.

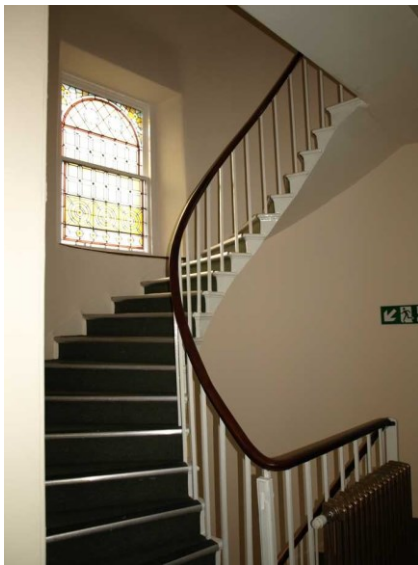
Illustration 22: Spiral stair to attic. Stained glass window in S wall.

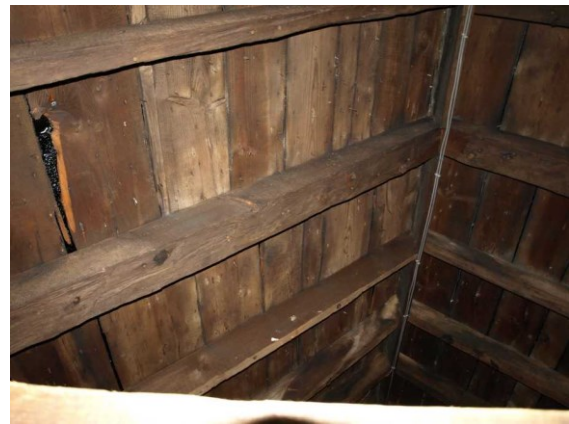
Illustration 25: Rafters and sarking boards. Double thickness rafter overhead, with interrupted ridge beam.

The opportunity was taken to open up one of the loft hatches and photograph the internal roof structure. The rafters are apparently sawn, relatively light and shallow in section, and in places tapering out to sapwood towards the apex, as also seen in late 18<sup>th</sup>-century timbers at 199 - 205 High Street in Perth. They clasp a ridge beam (also quite light) rather than overlapping each other. There is a discontinuity in the ridge beam near the middle of the building, where one pair of rafters meet end-to-end, and are of double thickness (not depth). This may reflect a practical difficulty in obtaining timbers long (and straight) enough to span the full width of the building, but may also reflect the difficulty of roofing a trapezoidal building in a crescent, with presumably asymmetric roof trusses spanning between a straight back wall and a curved front wall. The ridge may not actually be absolutely straight, though this is not obvious from the ground or from Google Earth. The E party wall seems to be of grey sandstone rubble.

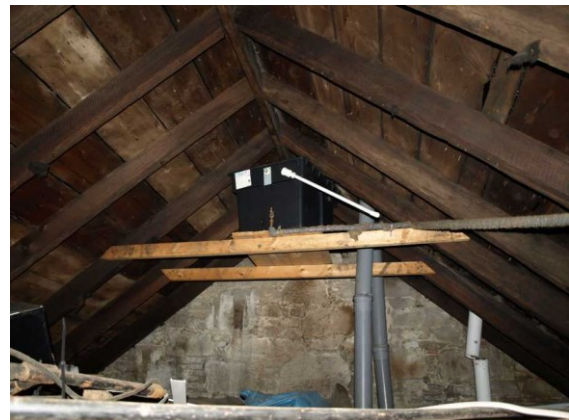
Illustration 26: Rafters, sarking boards and E party wall.

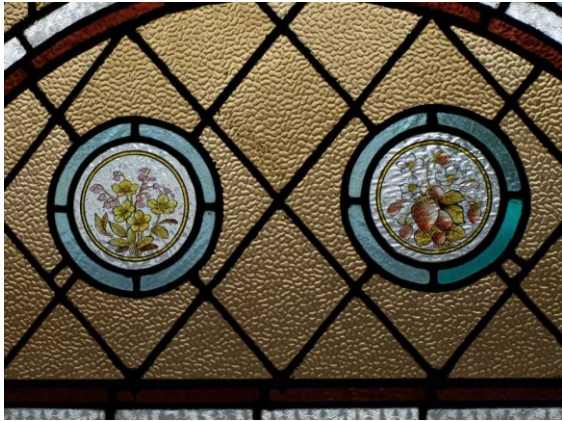
Illustration 27: Window roundels. Flowers and strawberries.

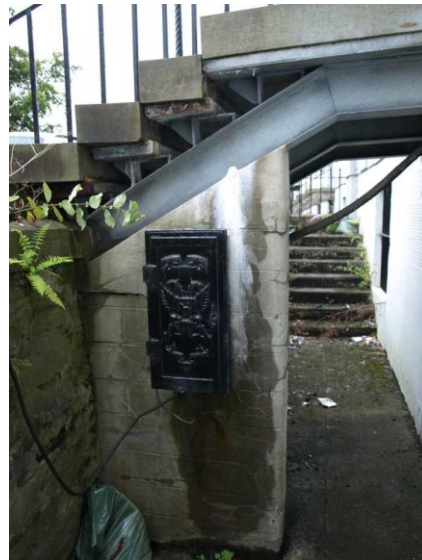
Illustration 30: Front Area. Steel sub-frame and cast iron switch box.

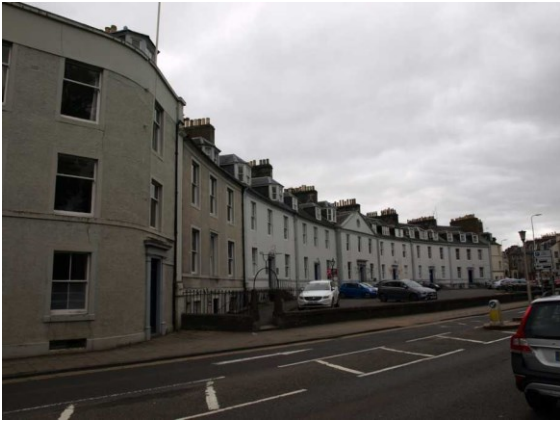
Illustration 31: Atholl Crescent with pediment at No 5. Lamp post only at No 4.

applied to the full height of the facade to separate each house from its neighbours. The central house of the crescent (No 5), now the Mason's Hall, has a large classical pediment occupying the whole width of the attic storey, with a central oculus, which naturally emphasises the formal symmetry of the design. The pilasters of No 5 are decorated with fluting, to further emphasise the importance of this central location. The arrangement of Carpenter Street and Blackfriars Street to the S give No 5 the largest space to the rear, now occupied by a large extension to accommodate the Mason's Hall, while the space diminishes progressively to E and W. No 4, directly to the E of No 5, is thus on a prominent and extensive site within the crescent.

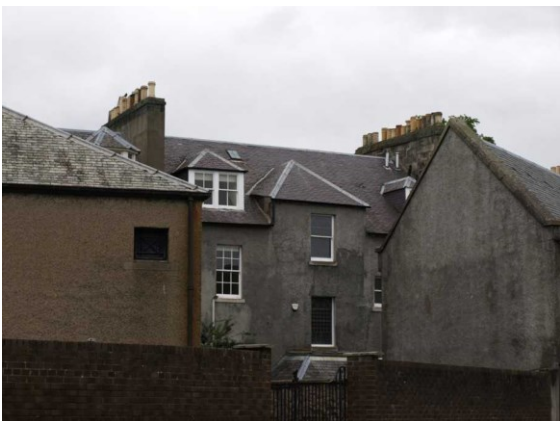
Illustration 33: Rear elevation with drooped mansard over main stair.

The roof over the main stair is in effect an enlarged dormer with a pitched mansard roof, but the whole dormer droops to the S, so that neither the ridge nor the eaves are horizontal, though the eaves droop more obviously. This works perfectly well in providing maximum headroom where needed as the spiral stair reaches the attic floor, and explains the complex shape of the attic ceiling at this point. Each house in Atholl Crescent seems to have its main stair in the same position in the back wall, but solves

the problem of roofing the stair in a slightly different way. The drooped mansard dormer seems to be unique to No 4.
