Historic Building Recording
14 Upper Craigs
STIRLING
ST32

HISTORIC BUILDING RECORDING
14 UPPER CRAIGS
STIRLING

ST32

Westerlea Properties commissioned Alder Archaeology to undertake a Level 2 Historic Building Recording of former light industrial units behind Upper Craigs, Stirling, in advance of conversion into flats. The proposed development area is an entirely enclosed space subdivided into multiple units, centred on NGR NS 79691 93173. The work (site code ST32) was undertaken on 8th October 2020 in bright weather conditions.

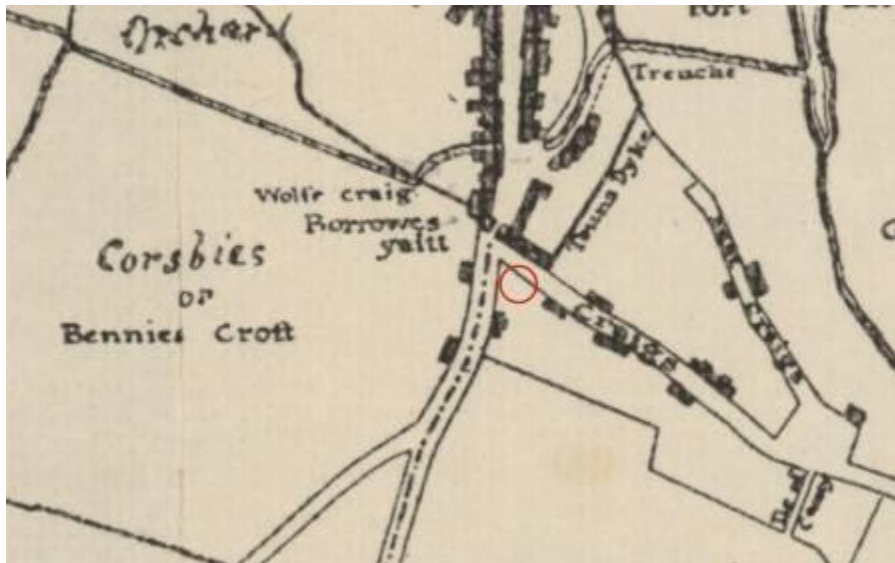
A.B. Macdonald, “Plan of the Royal Burgh of Stirling” (site circled)

This shows open ground at the corner of what are now Port Street and Upper Craigs. However, by the time of an 1820 survey by John Wood, the corner had been built upon:

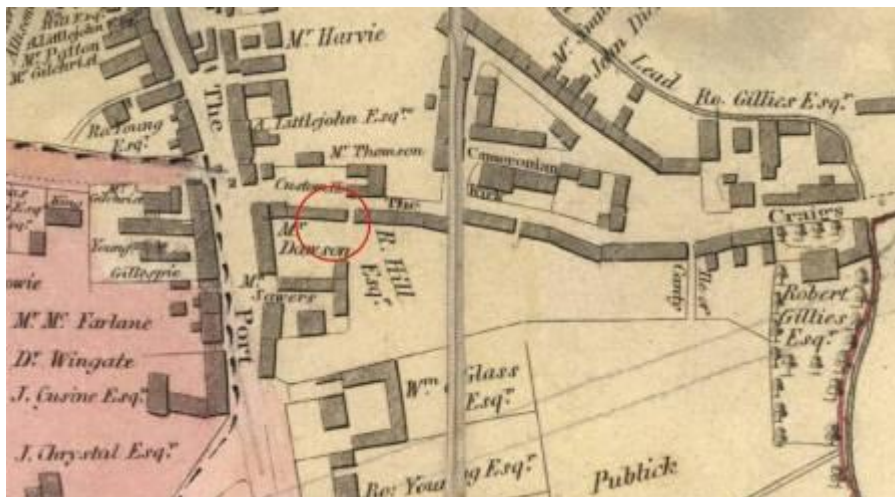
J. Wood, “Plan of the town of Stirling from actual survey”

The corner buildings were formed around a yard owned by a Mr Dawson, with the S side of the yard possibly belonging to the Mr Sawers shown as owning an entry from Port Street. N of this arm was a gap where the buildings that form the subject of this

report would later stand- therefore, while some of the surrounding properties may be of Georgian origin, it appears those within the development site must be later. The situation was unchanged twelve years later at the time of the 1832 Great Reform Act:

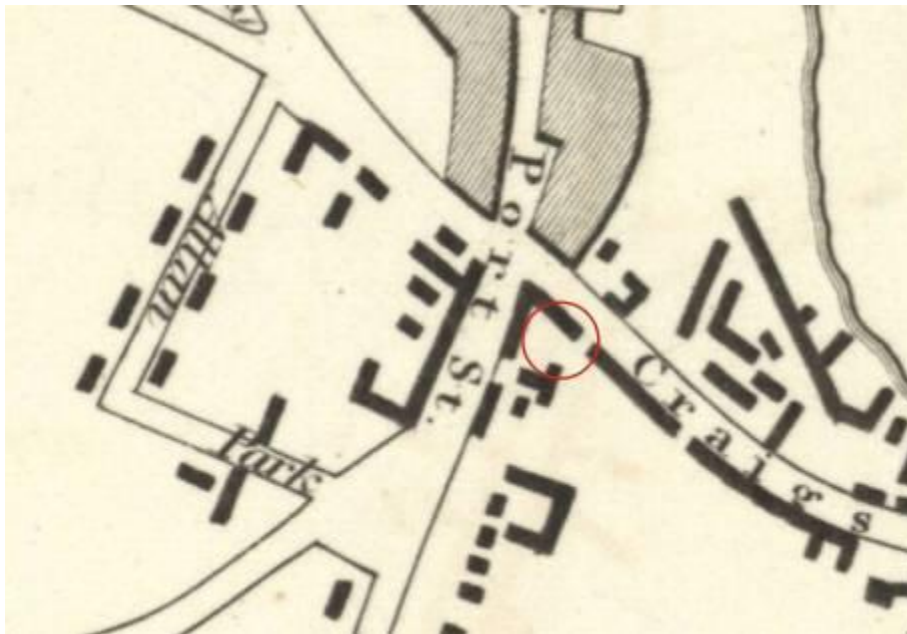
Great Reform Act, Plans and Reports

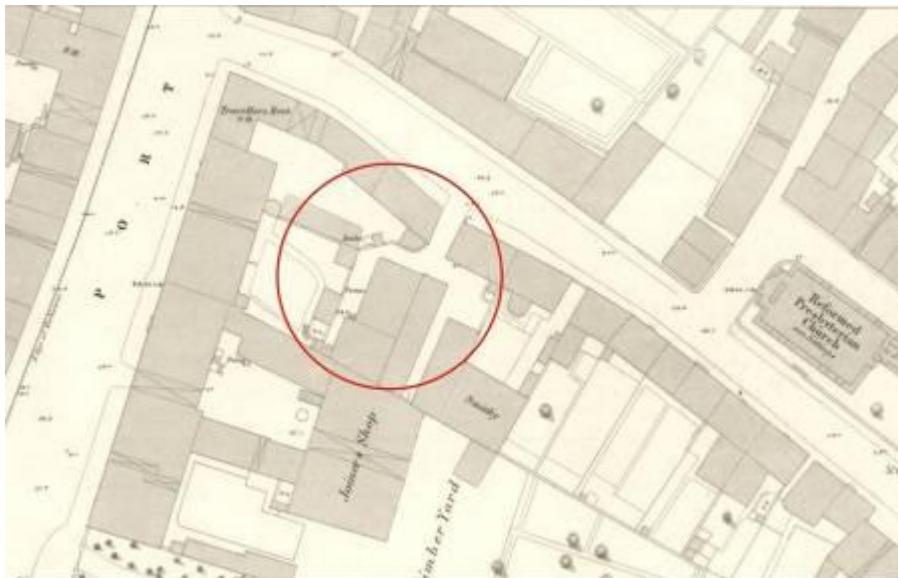
Ordnance Survey, Stirling 1858

By now, the main building, containing rooms 6 and 7 (see below) and the long, narrow block at the SE side containing the ground floor office and first floor rooms 8, 9 and 10 (see below) have both appeared. The pend to the SE of the alley is not yet present, but the curved entrance and roofless yard (see below) are essentially finished, albeit minus

the entrance gate and partition around the entrance passage and the SW wall of the yard. A boiler (perhaps serving the pub on the corner) is depicted in place of the NE wall of the yard and a (water) pump is indicated- no trace of either feature was noted during the survey. The NW side of the site is largely an open space. Thus, the core of the site appears to be of mid-nineteenth century construction. The first edition six inches to a mile map of 1860 shows the same general plan. As well as a public house, neighbouring structures include a joiner's shop, timber yard and smithy.

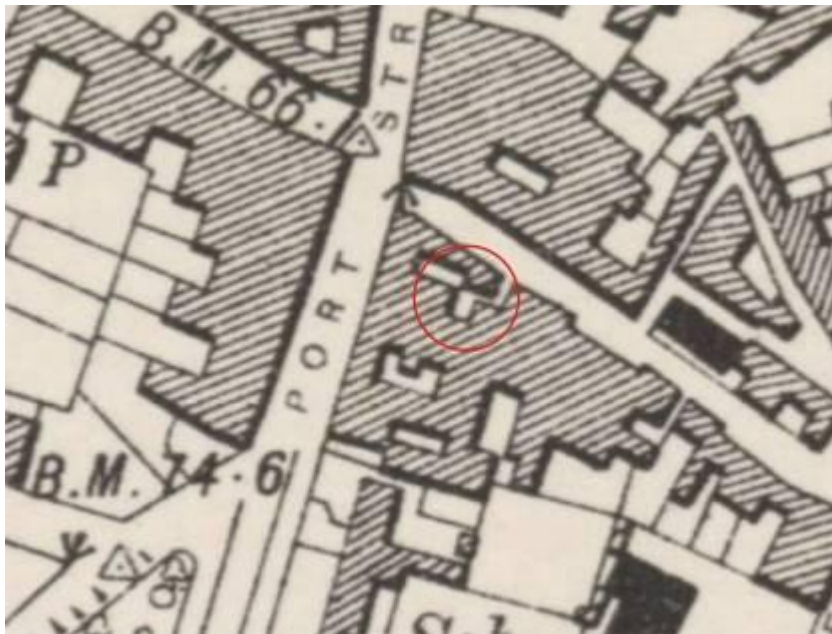
Ordnance Survey, six inches to a mile (second edition)

However, the level of definition is not sufficient to determine whether this in-filling is in the same configuration as the present site. The evidence of the building fabric itself suggests the construction of a brick wall across the ground floor SW boundary of the property was a filling in of the space between iron pillars supporting the first floor; meanwhile, a blocked window “between floors” indicates that the building to the SW did not have an upper storey initially.
