Archaeological Monitoring
Binn Eco Park Wind Farm
Glenfarg
Perth and Kinross
GF05
Amended 27/11/2020

**ARCHAEOLOGICAL MONITORING
BINN ECO PARK WIND FARM
GLENFARG
PERTH AND KINROSS
GF05
AMENDED 27/11/2020**

GF05

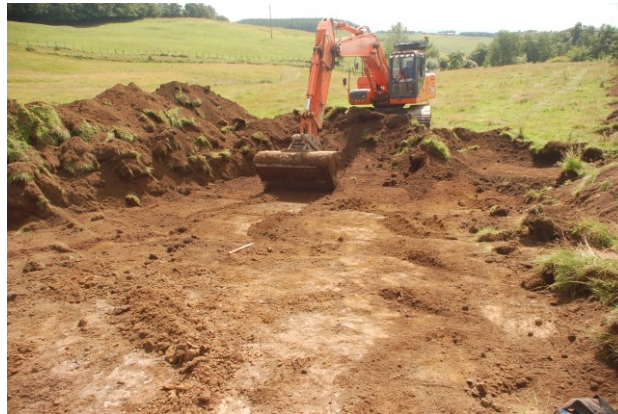
GF05: general excavation at turbine 03, for SSE compound, view SW

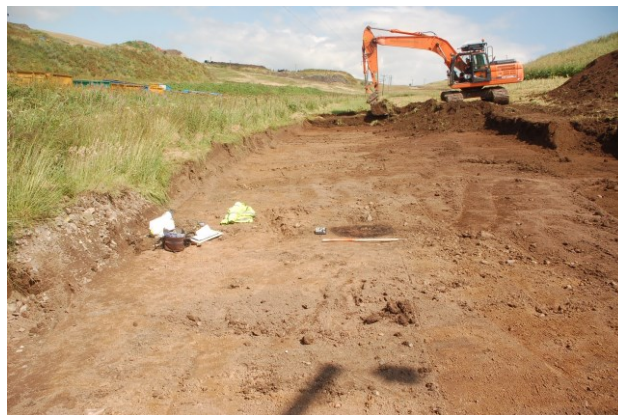
GF05: Location of 'fire pit' Ctx 326, View N

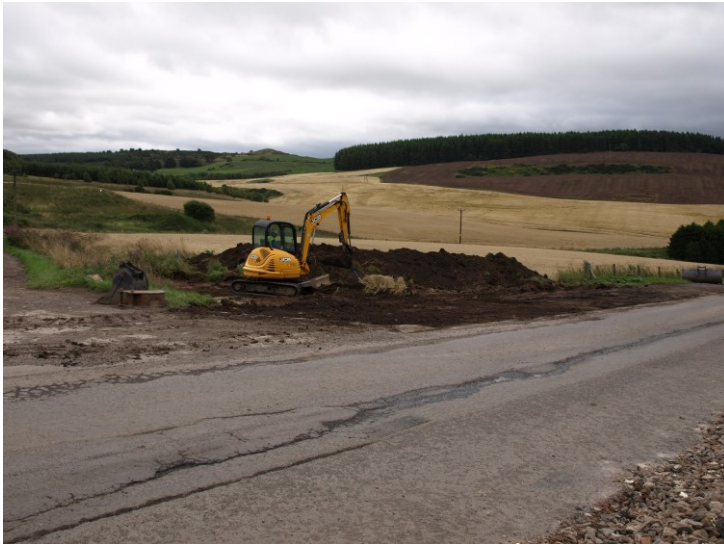
Illus 3: Forming site entrance, view SE

Groundworks at this location required the formation of a new site entrance from the existing tarmac road. A BT cable in disturbed ground was re-positioned, which revealed topsoil containing some modern rubbish and rubble over light brown sandy silt subsoil. Scraping and general topsoiling onto subsoil revealed nothing of archaeological significance.

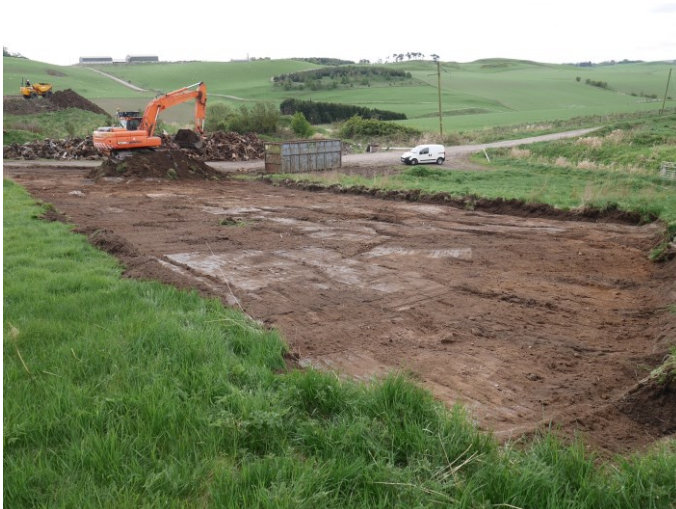
Illus 4: Forming site compound and access, view SW

The watching brief here observed the machine stripping of a Green Cat Renewables Ltd works compound required for the windfarm work along with an associated access track and a track to a spoilheap. It was carried out by one person, weather conditions were cold and overcast.

Turf and brown topsoil (0100) was stripped to a depth of 0.40m, generally this overlay a mixed orange brown silty clay and yellow sand with frequent stone (0101). At the southern end of the stripped area natural bedrock (0102) was revealed at a depth of 0.10m. At formation level a linear feature (0103) was identified running from E to W across the stripped area, this was filled with yellow sand and brown silty clay (104) and was not excavated. Nothing of archaeological interest was located and the only finds were a small group of animal bone which had been buried in a plastic bag in soil layer 101. The bone was recorded photographically but not retrieved.

This track was 3.9m wide and 26m long and lead up to a previously existing spoilheap. Turf and brown topsoil (0200) was stripped to a depth of 0.20m. A compacted layer of demolition material with occasional brick was exposed (0201), there were no finds.

This new 5m wide roadway was machine dug from the South East of the works compound to provide access to the proposed site of a crane pad and turbine base. At its southern most end it was dug through a cultivated field, it then ran across an existing fence line and down the slope to the works compound. In the cultivated field 0.40m of brown plough soil (0300) was excavated off a brown silty clay subsoil (0301) and natural bedrock (0302). A single large fairly flat stone (0304) was found at formation level and left in situ. Beyond the fence line and down the slope 0.40m of turf and topsoil (303) was excavated off a brown silty clay (0301) and natural bed rock (0302). Nothing of archaeological interest was located.

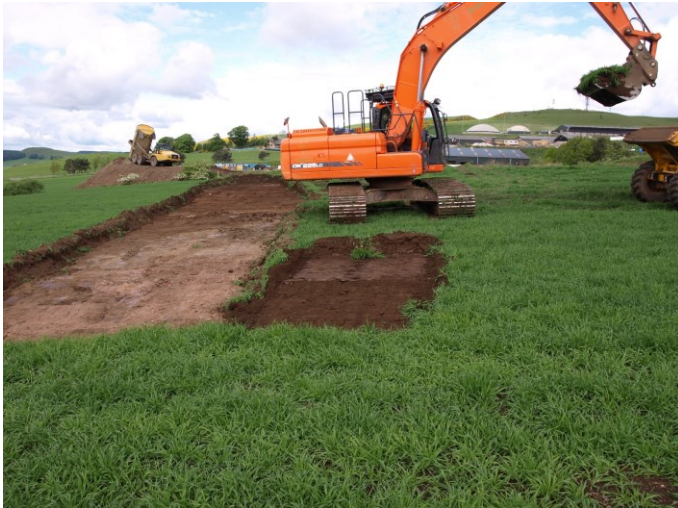
Illus 5: Stripping topsoil for turbine base 01, view NW

At the site of the turbine base centred on NGR NO 1757 1311 stripped topsoil in an arable field comprised a dark reddish-brown silty loam with the shoots of a cereal crop. Here the topsoil was 0.1 m deep and contained occasional fragments of C19th pottery. The total depth of topsoil was about 0.25 – 0.3 m. Below topsoil was a pink-grey silt subsoil (102) with abundant stone fragments. The subsoil changed to yellow brown silt (104) with stone. Occasional modern plough marks (105), aligned E – W could be seen in the subsoil. An outcrop of weathered bedrock (103) in the middle of the first stripped area re-appeared at the NW end of the trench in the second and subsequent strips. A test excavation in SE corner of area revealed dark brown silty loam topsoil (108), 0.3 m deep, over a subsoil (109) of brown-yellow silt with stones. The subsoil under (108) became redder to the N, with rocky outcrops appearing. Nothing of archaeological significance was found at the site of turbine base 01.

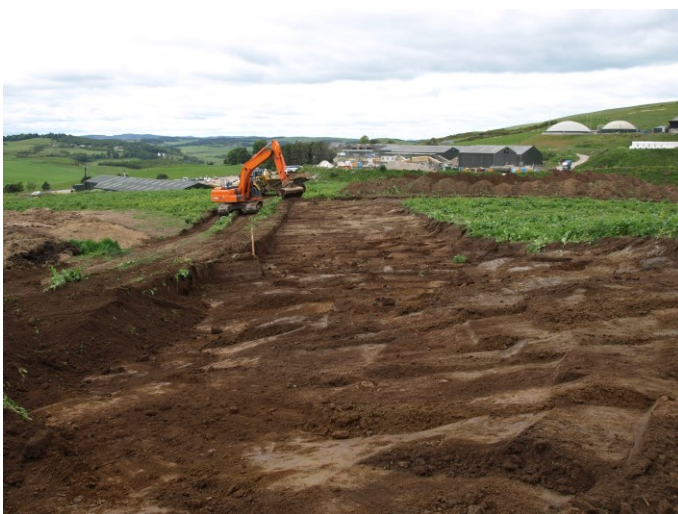
Illus 6: Turbine base 02, S end boundary strip complete, view W

The turbine base was centred on NGR NO 1763 1339. At W edge of the laydown pad topsoil (208) contained Brussels sprouts or turnip shoots. Below topsoil was a tan silt in the SE area which reverted to rock in the SE corner. A major outcrop of rock occurred in the centre of the turbine base which had to be reduced for a level surface. No features of archaeological significance were encountered.

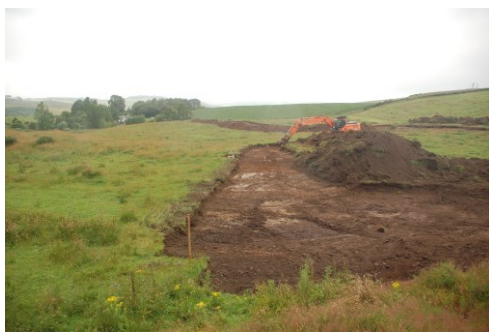
Illus 7: General stripping base 03, view W

Turbine base 03 was centred on NGR NO 1811 1350. It was located in an area of rough pasture in sloping undulating terrain. Post and wire fencing (305-306) forming a pen or compound was removed on the north western part of the site. Topsoil (301) mainly comprised brown silty loam 0.40-0.60m in depth over a subsoil of brown stony clayey silt over rock. There was a rock outcrop on the site E side. Five rubble field drains mainly aligned SSE-SSW were recorded (307), (309), (310), (312) and (314). General stripping, for SSE (Scottish and Southern Electricity) compound on W side of turbine base was also carried out. Topsoil here was 0.45-0.80m thick over silty clay subsoil with natural rock showing through at the base and with very occasional small boulders revealed at E edge. Apart from field drains no features of archaeological significance were found on the site of turbine base 03 and the SSE compound.

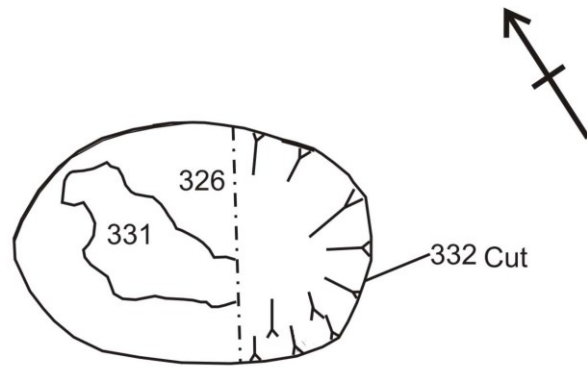
Illus 9 'Fire Pit' plan and section

Close to the S end of the cable track at NGR NO 17493 13334 an ovoid feature was revealed 0.90m in length and 0.60m wide cut into the subsoil. This feature appeared to be a 'fire pit' containing a fill (326) of black silt or burnt material with a lens of orange burning. The feature was considered to be potentially prehistoric and was half sectioned and sampled. The cut for fire pit (332) had a maximum depth of 0.08m with moderately sloping sides with a flattish bottom. No finds were recovered from the excavated fill. Alder recommends that the sample from the 'fire pit' should be processed and that any suitable material recovered should be submitted for C14 dating. A further black deposit, context (329), elongated in shape but less defined than fill (326) was located c 7m NE of fire pit (326). This deposit was not excavated.

'Fire Pit' half sectioned

SE Facing Section

The ground works for this development are now concluded and no further archaeological work is required for this development. However, Alder recommends that the sample from the 'fire pit' should be processed and that any suitable material recovered should be submitted for C14 dating. The final decision regarding any further work ultimately rest with Perth and Kinross Heritage Trust.

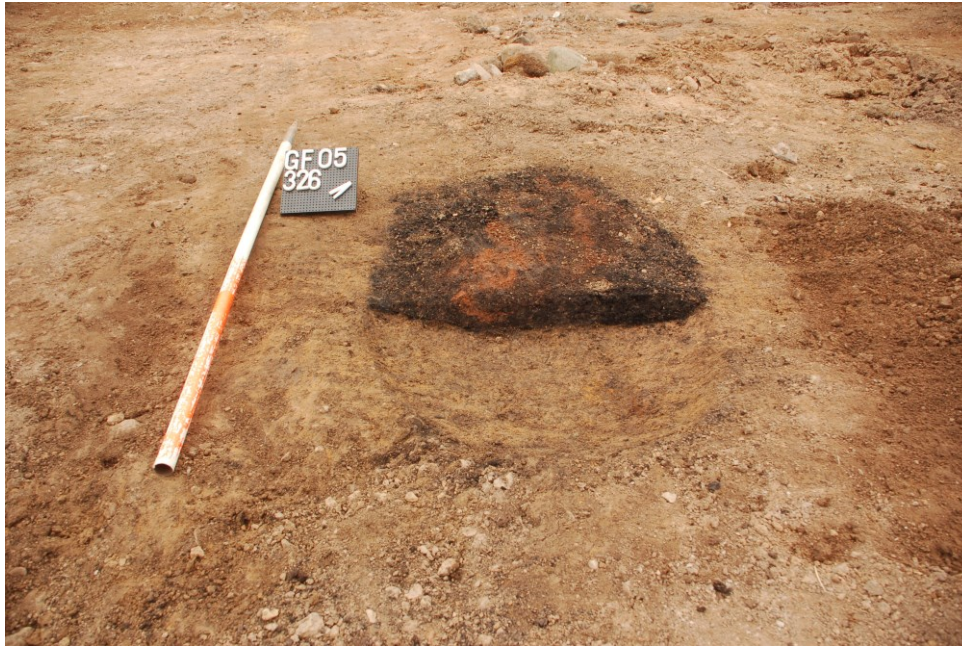
Illus 12: 'Fire pit' post excavation, view NNW

wide cut into the subsoil. This feature appeared to be a 'fire pit' containing a fill (326) of black silt or burnt material with a lens of orange burning. The 'fire pit' feature was considered to be potentially prehistoric and was half sectioned and a sample collected for processing and hopefully to obtain a C14 date. No other significant archaeological features were found during the monitoring.

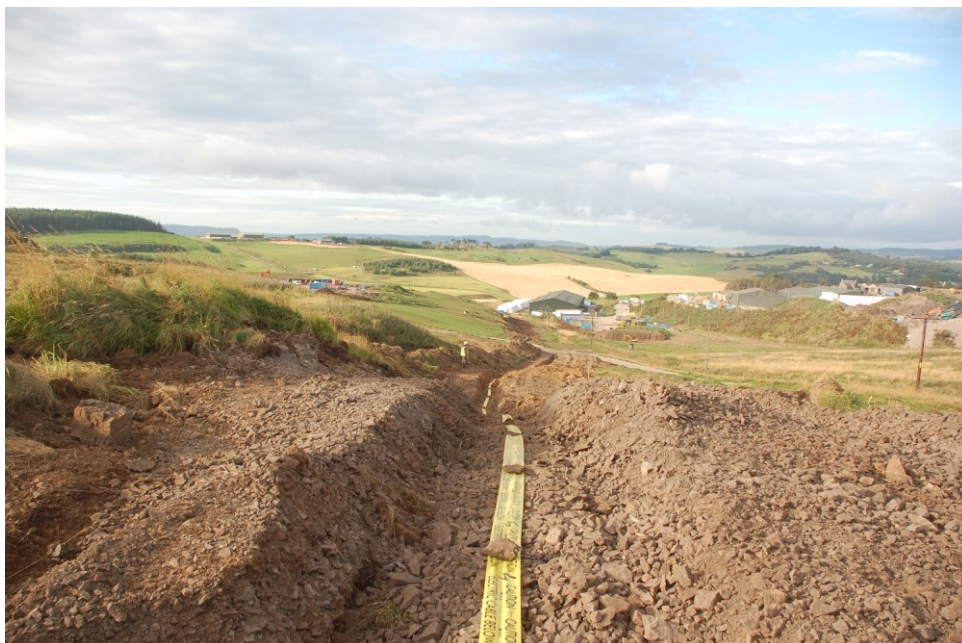
Illus 13: Narrow cable track view SW

A narrow cable trench 1m wide had been dug on the E side of the wide cable track. This narrow track ran uphill from NGR NO 17509 13352 to approximately NGR NO 17750 13750 beyond the site of turbine base 04. It had been partially backfilled with a depth of 0.60m that was unfilled which revealed the subsoil. Nothing of archaeological significance was identified in this cable trench.

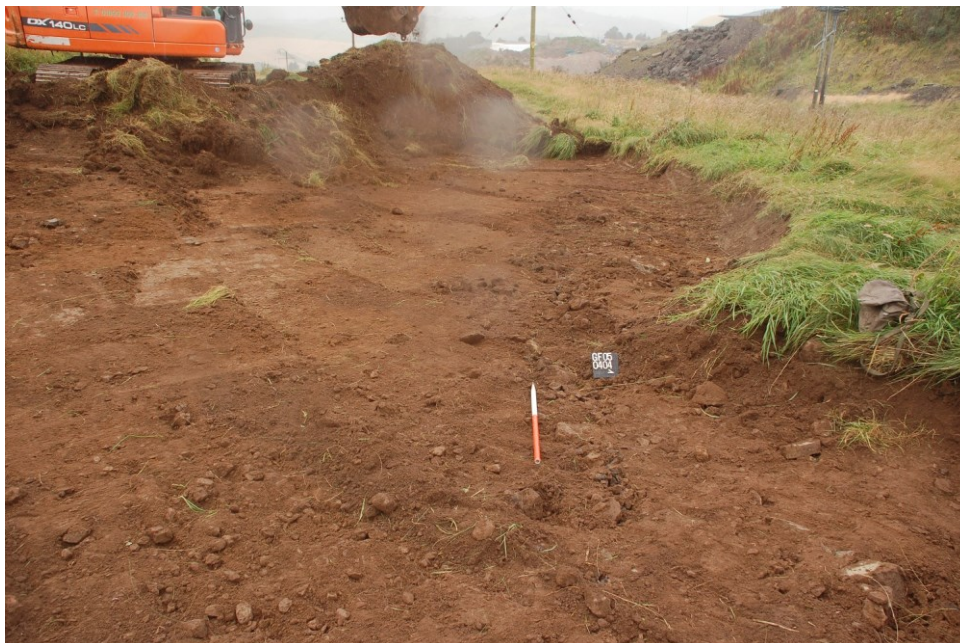
Illus 14: General stripping turbine base 04, showing field drain 0404, view SW

Turbine base 04 was centred on NGR NO 17725 13731 within a grassy area on a moderate south-west down slope. A NE-SW aligned post and wire fence ran through the centre of the site. Topsoil (0402) was generally 0.30-0.60m in depth over stony brown silt subsoil (0403) with natural rock showing below subsoil especially in the NE part of the site. A rubble field drain (0404) 0.40m wide was recorded within the NE corner of the site running down slope in a NE-SW direction. A modern black poly pipe foul water drain buried in the sub soil ran through the centre of the site on an NE-SW alignment. Nothing of archaeological significance was identified on the site of turbine base 04.
