Historic Building Recording
Wester Croftintygan
Kenmore
PERTH & KINROSS

**HISTORIC BUILDING RECORDING
WESTER CROFTINTYGAN
PERTH & KINROSS**

KZ06

A disused steading was recorded prior to conversion to a dwelling house. The building comprised a stables or cowshed, garage and storerooms and was two-storey. It was solidly constructed of lime-bonded stone rubble with slate roof and had been well maintained and in use until recently. Map evidence suggested it was no older than the last quarter of the 19th Century and this was corroborated by its appearance and fabric. The survey was conducted on 15th February, 2021.

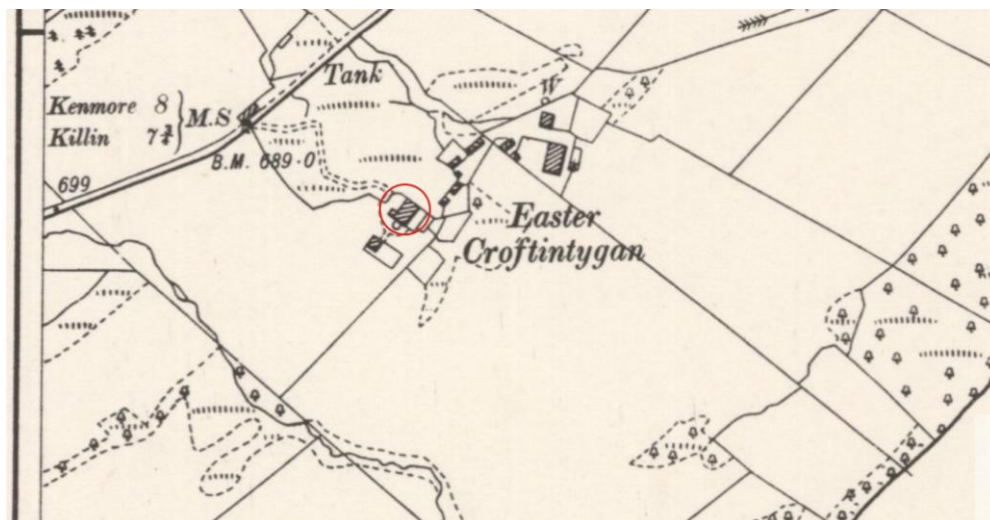
side of Loch Tay. The modern farm stands amid twenty-seven buildings, many now ruined, six enclosures and the site of a limekiln. The First Edition Ordnance Survey map of the area (1867) shows no steading at Wester Croftintygan, but this has appeared by the time of the Second Edition (1900) and is depicted in its present configuration. The subject of the HBR is therefore of later 19th Century origin.

OS 2nd Edition (1900), the steading in its current configuration

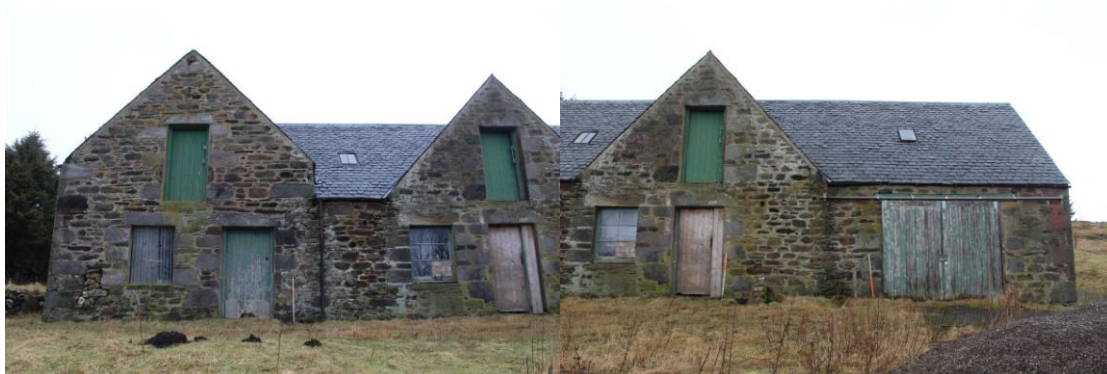
SW end of SE elevation

NE end

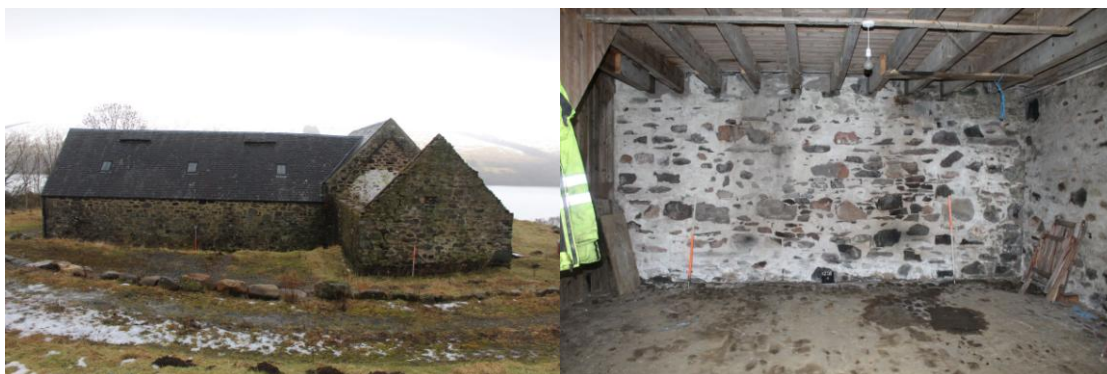
NW elevation

Garage/vehicle shed

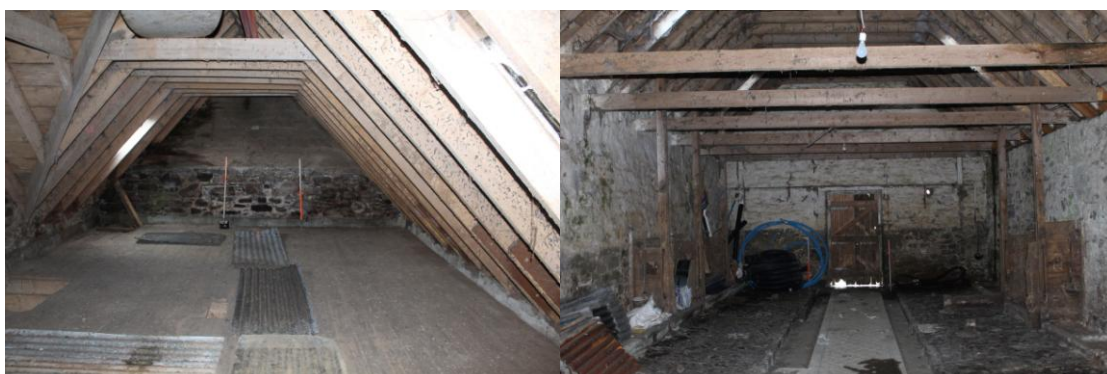
Central room, first floor

“Sheep shed”
