Archaeological Standing Building Survey
Ury Walled Garden
Stonehaven
ABERDEENSHIRE

SZ02

**ARCHAEOLOGICAL STANDING
BUILDING SURVEY
URY WALLED GARDEN
ABERDEENSHIRE**

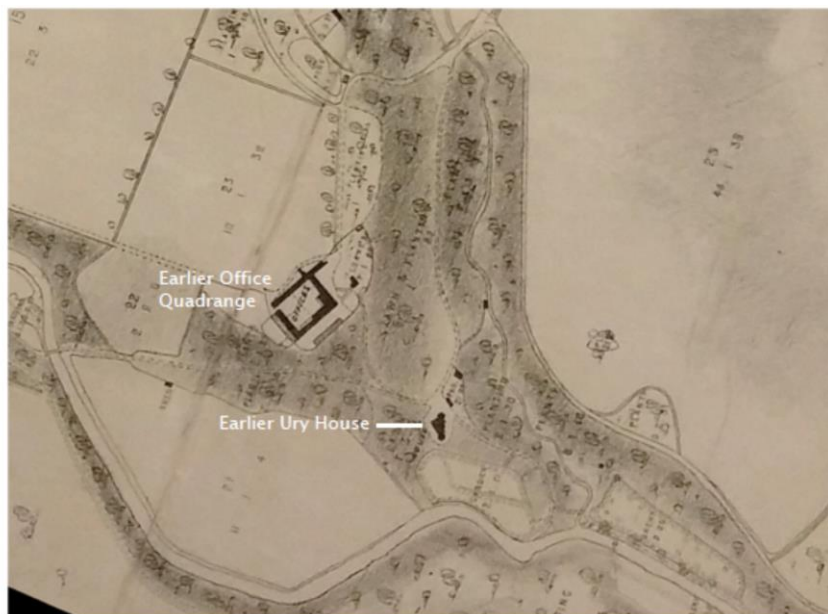
Beattie, 1847, notation by Tom Morton of Arc Architects Ltd

The area of the walled garden first appears on the estate plan of 1847, surveyed by James Beattie, showing a quadrangle of buildings:

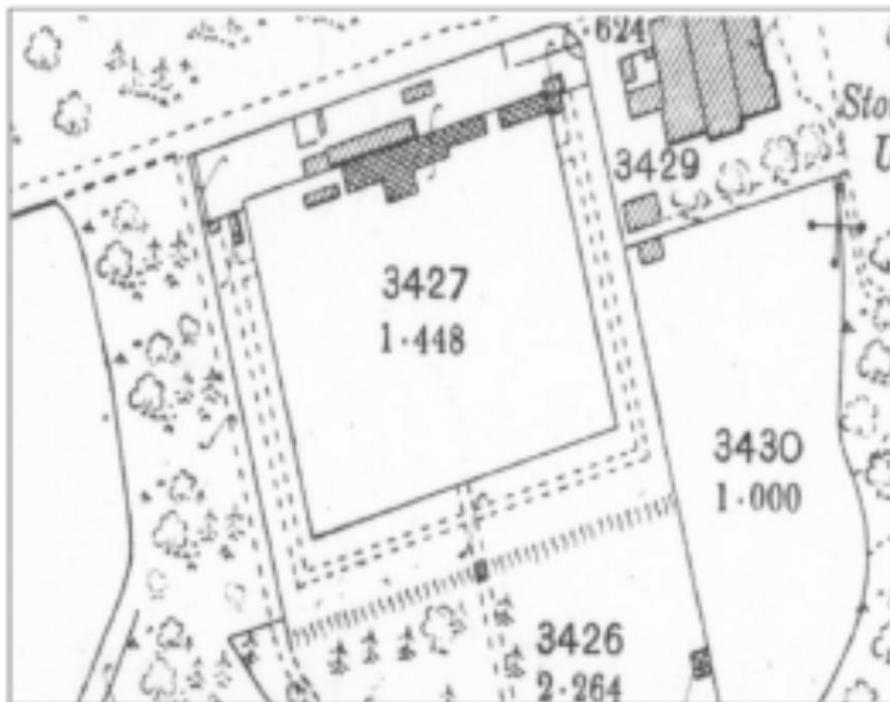
OS Second Edition 1902. The buildings around the screening wall in the NW corner have since disappeared, along with the NE corner enclosure.

At this stage, none of the buildings along the NNW elevation are yet present, but by the OS Second Edition (1902) these structures have been added, while the S terrace wall and fountain have disappeared:

The OS Third Edition (1923) shows very little change, beyond the felling of some of the woodland to the S of the garden. By this stage, then, the garden was essentially complete. In its earlier phase, the interior appears to have been laid out as a formal pleasure garden, but the later removal of paths and fountain and addition of working buildings suggest a later focus on horticultural production.

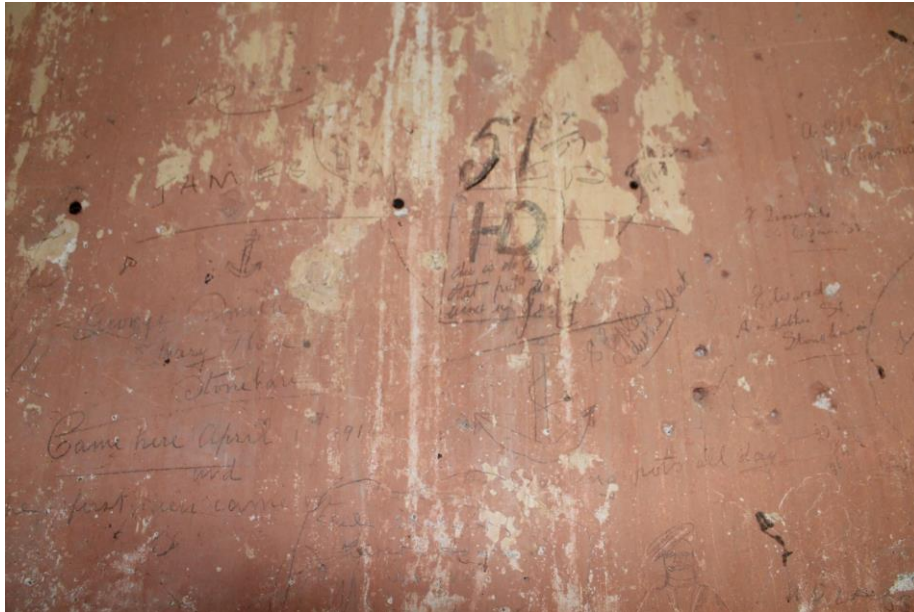
The central section of the lean-to is taken up by a two room bothy, which does not directly communicate with the boiler cellar, instead accessed via a separate doorway opening into a small entrance hall. At the WSW is a room with plasterboard walls, measuring 3.66m NNW-SSE x 2.55m transverse, with a window in the NNW elevation and a short extension that may have contained a washroom and presently houses a plastic cistern. This may have been a bedroom (a sprung iron bedstead was noted elsewhere on the site) and also featured a small cupboard. The larger room, c.3.60m square, to the ENE, contains a fireplace against the SSE elevation, with a moulded mantelpiece 1.29m tall x 1.43m wide with brick backing below. Perhaps the most interesting feature of the bothy is the presence of graffiti scrawled on the painted plaster walls of the living room, the earliest noted being from 1913 and other examples written by serving members of the 51st Highland Division.

Evidently, the garden was for a time a local attraction open to the public of Stonehaven and environs, although some entries may have been made by gardeners living on the site. The NNW elevation features a stone-cased window of the same dimensions (1.16m wide x 1.78m tall) as in the bedroom). The ENE room of the lean-to is a former workshop, not directly communicating with the bothy but accessed by a doorway noticeably wider than those into the bothy and cellar (1.66m as opposed to 1.06m), perhaps to facilitate the movement of trolleys and wheelbarrows. Unlike the bothy, which features floorboards, the workshop is floored with poured concrete, quite badly eroded. A hatch in the WSW elevation accesses attic space above the bothy, but this could not be reached during the survey. The workshop directly access the greenhouses in the garden interior via a 0.92m wide doorway, damaged on its WSW side.
