**HISTORIC BUILDING RECORD
TALBOT HALL, TRADES LANE,
COUPAR ANGUS
CG13**

Alder Archaeology produced a historic building record (site code CG13) of Talbot Hall, Trades Lane, Coupar Angus, for Mr Josh Everett, in advance of conversion to residential use. The recording was undertaken on 20th March 2021.

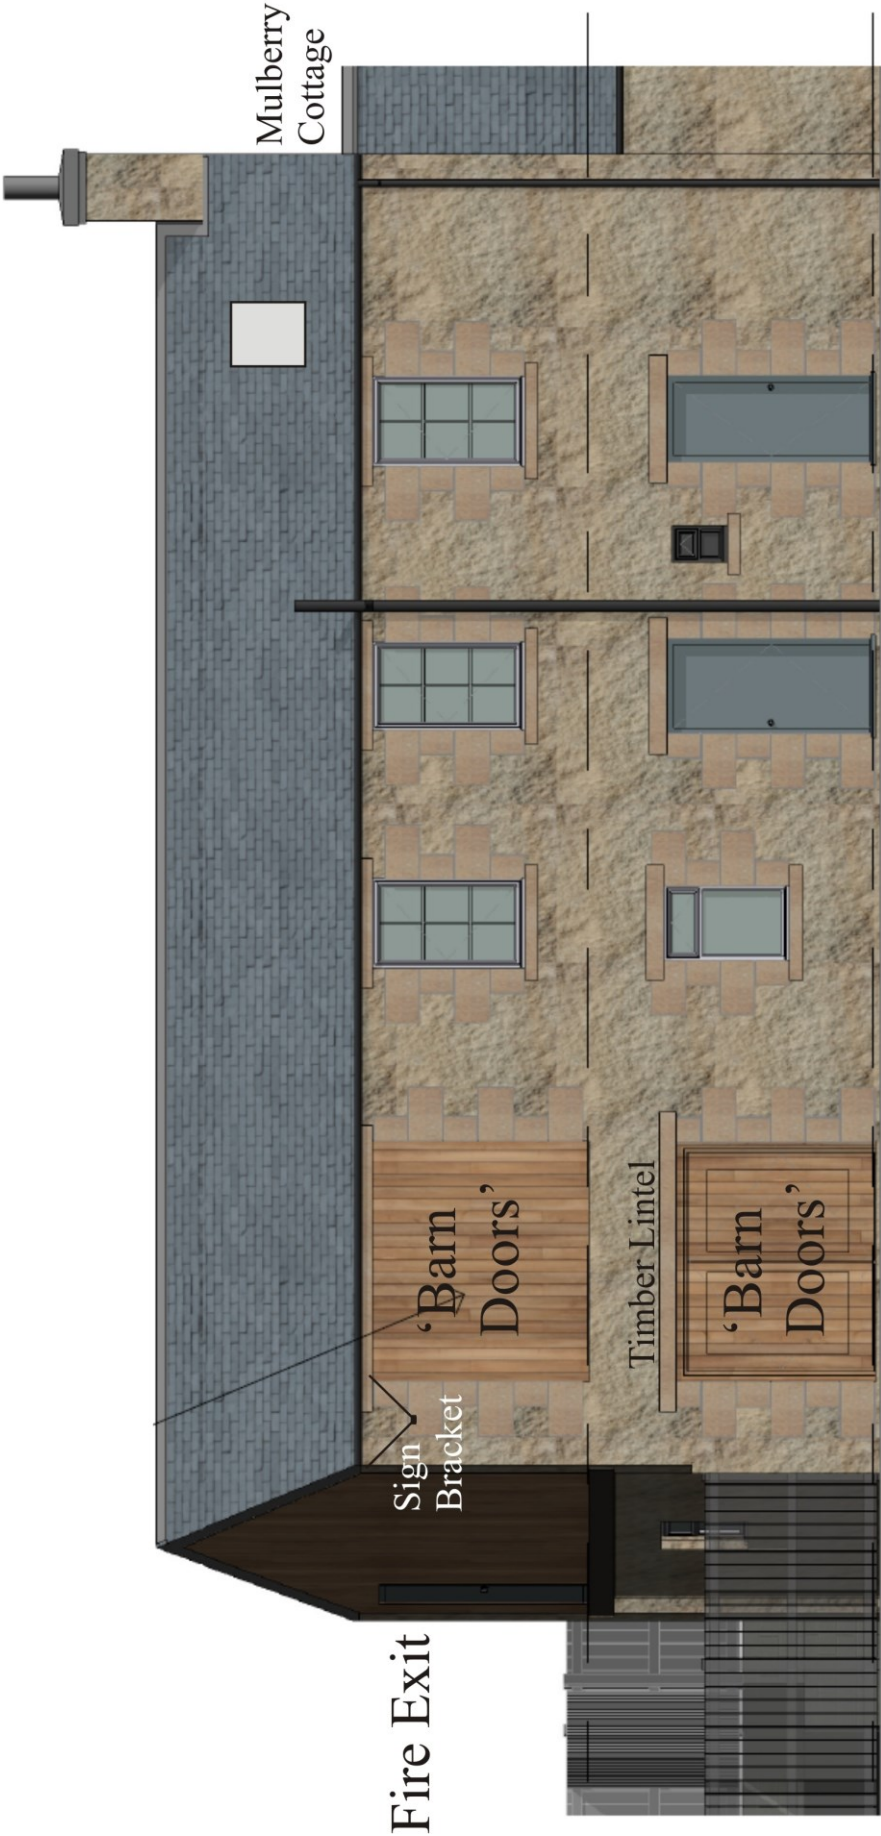
Illus 5 Talbot Hall, Trades Lane, Coupar Angus. South Elevation

The S elevation stands directly on the Trades Lane frontage. On the ground floor, it contains three doors and two windows. At the W end there is very large double doorway, spanned by an original timber lintel, but closed by almost new 'barn doors', with vertical wooden planks. Near the middle of the elevation is a small window, with late 20th-century glazing detail, and a modern floral motif painted on the inside of the glass. E of this is an ordinary 20th-century plywood door giving access to the main ground floor room, a very small toilet window with late 20th-century glazing, and near the E end another 20th-century plywood door giving access to a small lobby and the foot of the internal stairs. All the door and window openings appear to be original.

On the first floor, at the W end there is another double doorway exactly like the one below, spanned with a timber lintel, and closed with 20th-century horizontal wooden planks. E of this are three similar, evenly-spaced windows, each containing twelve-pane fixed glazing in a wooden frame. The joinery is modern, with modern float glass, but in imitation of early 19th-century industrial style.
