Historic Building Record  
Talbot Hall, Trades Lane  
Coupar Angus  
CG13

**HISTORIC BUILDING RECORD  
TALBOT HALL, TRADES LANE,  
COUPAR ANGUS  
CG13**

*Alder Archaeology produced a historic building record (site code CG13) of Talbot Hall, Trades Lane, Coupar Angus, for Mr Josh Everett, in advance of conversion to residential use. The recording was undertaken on 20<sup>th</sup> March 2021.*

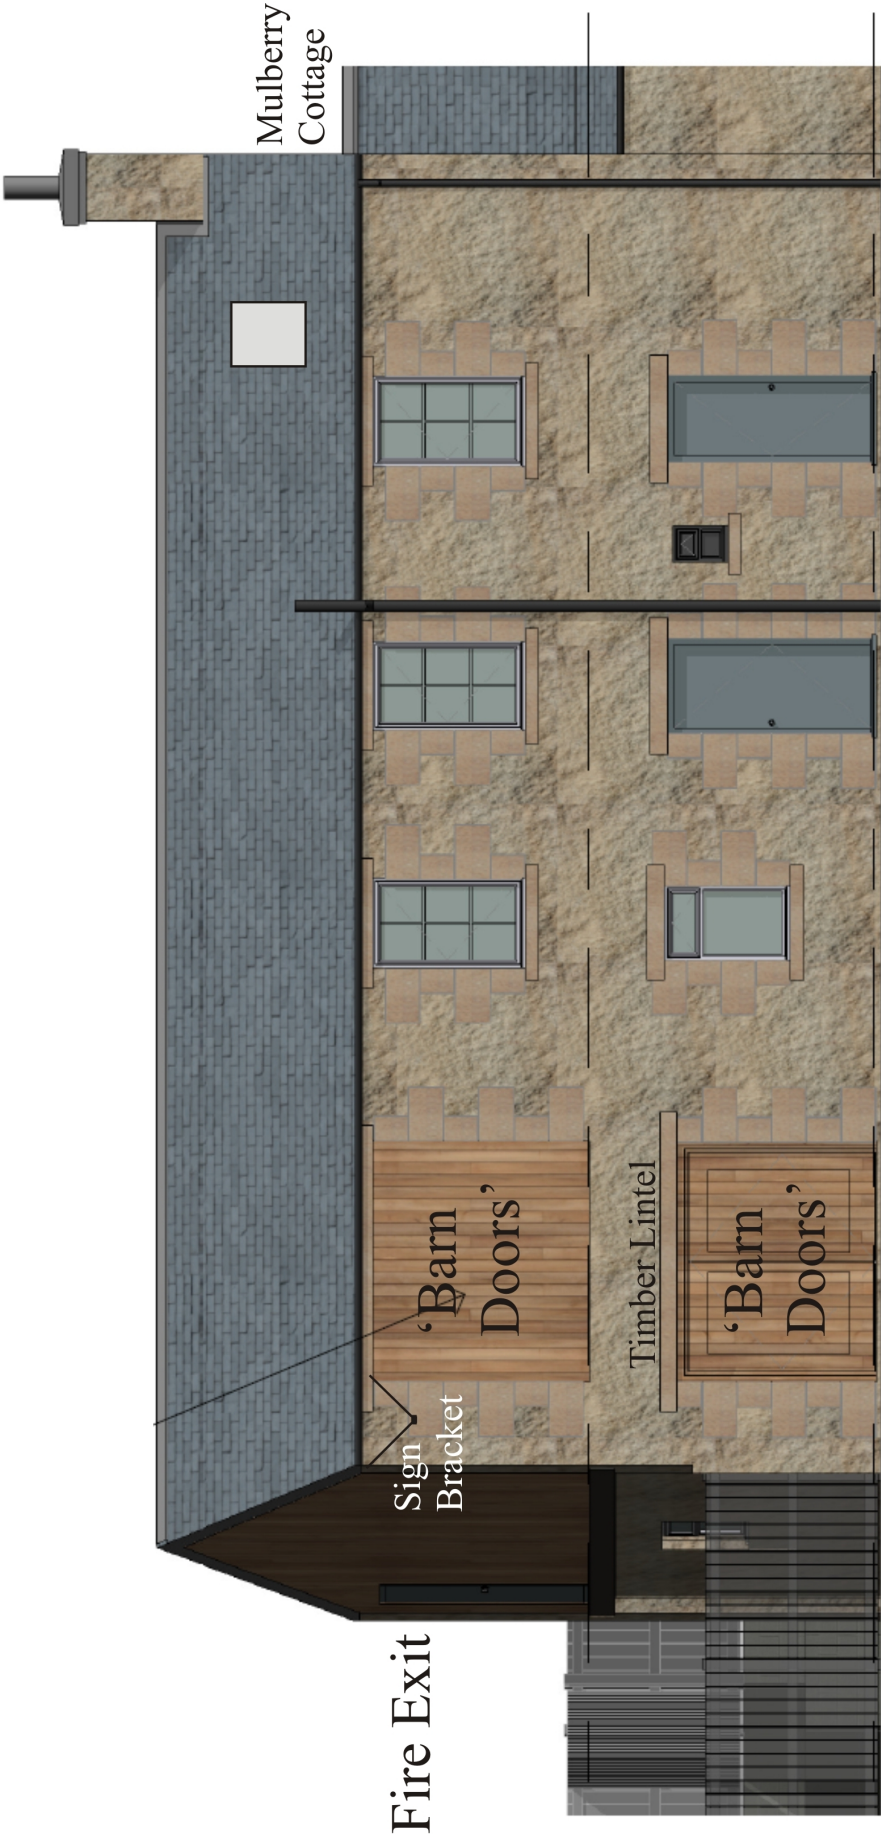
Illus 5 Talbot Hall, Trades Lane, Coupar Angus. South Elevation

Mulberry Cottage

Fire Exit

Sign Bracket

'Barn Doors'

Timber Lintel

The S elevation stands directly on the Trades Lane frontage. On the ground floor, it contains three doors and two windows. At the W end there is very large double doorway, spanned by an original timber lintel, but closed by almost new 'barn doors', with vertical wooden planks. Near the middle of the elevation is a small window, with late 20<sup>th</sup>-century glazing detail, and a modern floral motif painted on the inside of the glass. E of this is an ordinary 20<sup>th</sup>-century plywood door giving access to the main ground floor room, a very small toilet window with late 20<sup>th</sup>-century glazing, and near the E end another 20<sup>th</sup>-century plywood door giving access to a small lobby and the foot of the internal stairs. All the door and window openings appear to be original.

On the first floor, at the W end there is another double doorway exactly like the one below, spanned with a timber lintel, and closed with 20<sup>th</sup>-century horizontal wooden planks. E of this are three similar, evenly-spaced windows, each containing twelve-pane fixed glazing in a wooden frame. The joinery is modern, with modern float glass, but in imitation of early 19<sup>th</sup>-century industrial style.

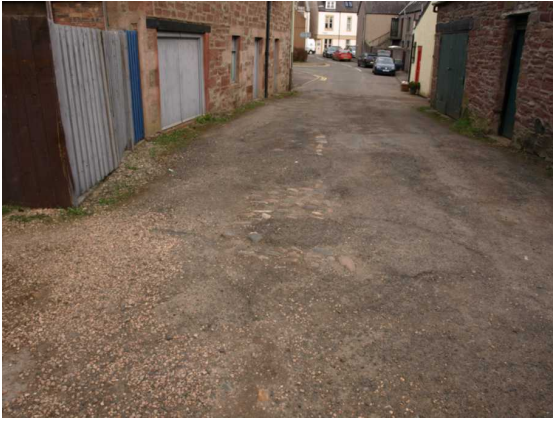
Illus 9 Cobble surface of Trades Lane, E

Hall fits very well into this pattern. The Lane itself is paved with rough asphalt, worn away in places to reveal an earlier surface of rough cobbles, ie natural rounded stones, not squared whinstone setts.

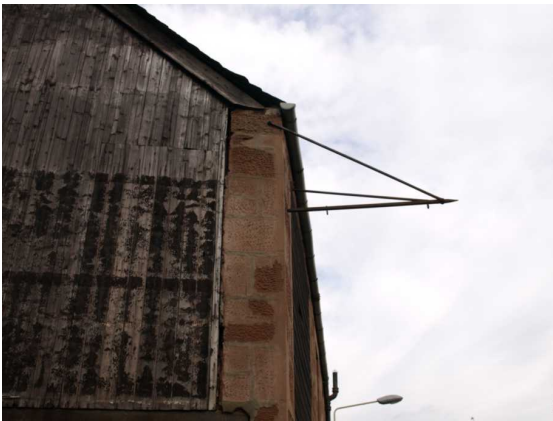
Illus 10 West gable with sign bracket

At the SW corner, just below the wall head, is a wrought iron bracket projecting out over the Lane as if to support a hanging sign board, in the manner of a traditional pub sign. At the NW corner, the W end of the N wall is much better built than on the ground floor, and slightly thinner.

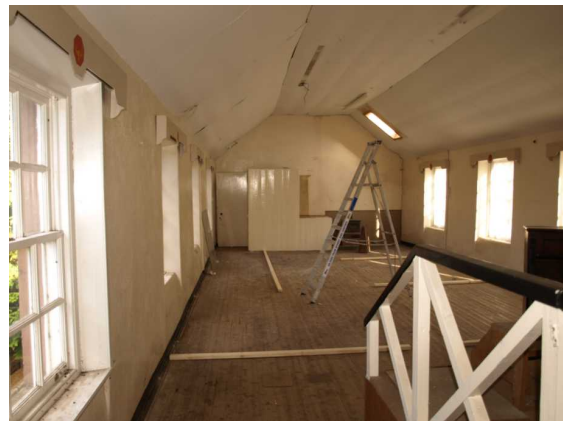
Illus 16 Stair to Upper Hall

At the E end is a steep and narrow timber stair, built against the gable wall and boxed in with painted planks, leading to the first floor. In the NE corner is a kitchen area, modernised in the late 20<sup>th</sup> century. This was partially separated from the main room by a partition of green-painted timber and plywood, later covered and extended with plasterboard.
