Historic Building Record
Westwood Cottage
Balthayock
Perth and Kinross

PE70

**HISTORIC BUILDING RECORD
WESTWOOD COTTAGE, BALTHAYOCK,
PERTH AND KINROSS
PE70**

Alder Archaeology produced a historic building record (site code PE70) of Westwood Cottage, Balthayock, Perth and Kinross, in advance of its demolition and replacement by single house. The recording was undertaken on 14th April 2021.

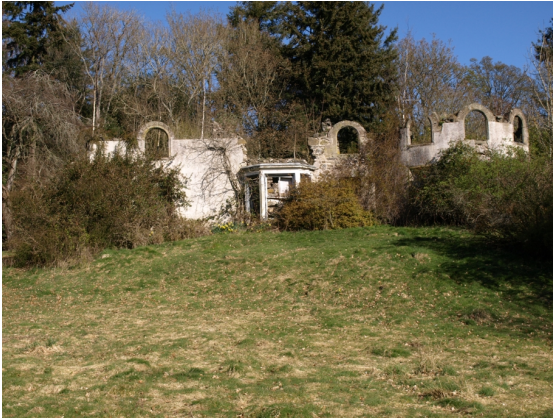
This is clearly the principal elevation of the house, and designed to make the best of the sunlight and the view, with its central bay window, large ground-floor windows and numerous round-arched dormers above. The round-arched dormers, although generally similar, show interesting differences of detail. The arch on the W side has seven voussoirs, with pecked faces and drafted edges. The arch on the E side has five voussoirs, with faces tooled in a radial pattern.

Illus 6 S elevation.

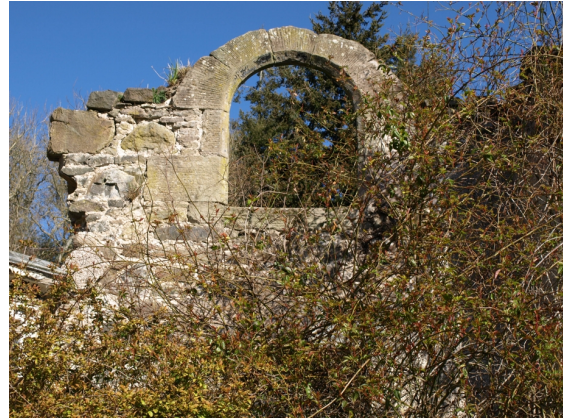
036 - 7	E end of S elevation. White cement harling on sandstone rubble wall. Round-headed dormer above. Five dressed sandstone voussoirs with tooled face and dressed inner	N

edges. Different from W dormer. Ground-floor doorway below, hidden by vegetation. Apsidal S end of E range to R.	
038	Detail, internal partition wall above central bay window. Small angular rubble.	NNW
039	Apsidal S end of E range. Three round headed-dormers. Three windows on ground floor, obscured by vegetation.	N
040	Apsidal end hidden by vegetation. Ground falls away to L.	N
041	Ground falls away to L. Rocky outcrop.	NNE
042 - 3	Round-headed dormers in apsidal end. E dormer also five voussoirs. Dressed edge, pecked face. Arches curve in two axes, because of apsidal end.	NNW
044	As 042. Collapsed harling shows rubble masonry of outside wall.	NW
045	As 042. Angle shows two-axis curve of arches.	WNW
046	As 043	NW
047	As 043	NNW
048	As 044. Apsidal end meets E wall of E range. Cement harling on lime-bonded whinstone rubble.	NW
049 - 51	As 048. Detail of rubble.	NW
052 - 3	Detail, wire mesh arch in shrubbery. Steps down to Fuel Store.	NE

Illus 9 E end of S elevation. Round-headed dormer.

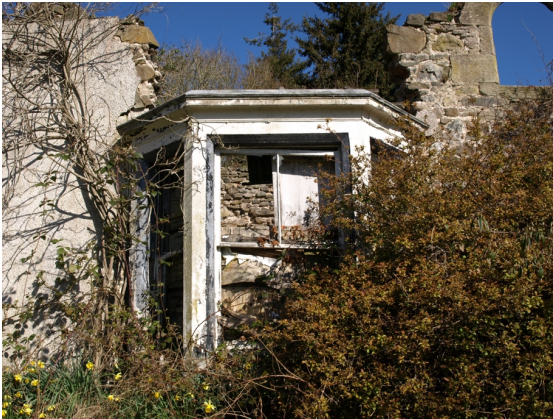
The architect's drawing shows a round arched dormer over the central bay window, but this has since collapsed. It also shows an entrance door to the E, and three large windows on the ground floor of the apse, but these are now obscured by vegetation.

Illus 7 Central bay window.

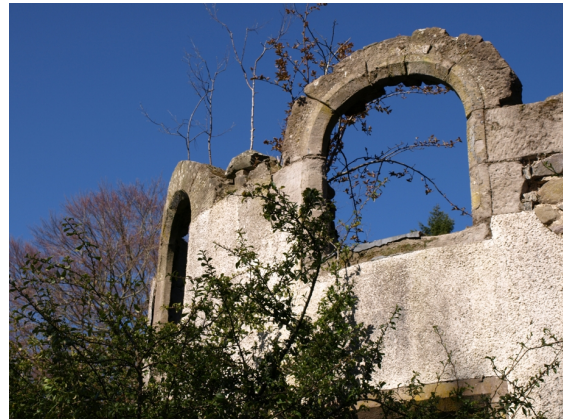
On the apsidal bay at the E end, the central arch again has five voussoirs, with faces tooled in a radial pattern. The arch immediately to the E of this has five voussoirs with pecked faces and a drafted edge. The arch immediately to the W of centre is partly missing, but also has voussoirs with pecked faces and a drafted edge, probably five in number. This is compatible with the HES report, based on photographic evidence, that two of the windows here are part of the 1850s alterations to the building.

In either form, the three arched dormers over the apsidal bay are curved in two axes, to form the round arches and to follow the cylindrical curve of the apse. Making voussoirs and sills of this form would require a very high level of craft skills.

Illus 10 Dormers in apsidal end.

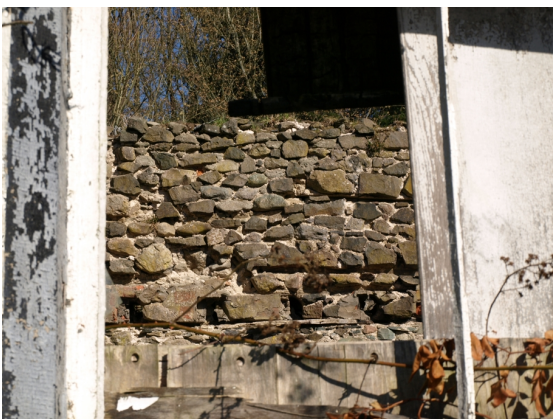
Looking in through the windows, it can be seen that the internal partition walls and also the high gable wall are generally of very small angular whinstone rubble, set in a matrix of thick lime mortar. Rubble masonry in Scotland is often more like a drystone dyke, complete with pinnings, with a small amount of lime mortar added for extra stability. This maximises the use of cheap rubble, and minimises the use of expensive lime. It also has the effect that the wall is still stable as the mortar decays, being supported by direct stone on stone contact. In the present case, this has been completely abandoned, the wall is completely dependent on the lime mortar, and as this weathers out, the walls have become completely unstable. It can also be seen that the walls are indented with horizontal rebates to support horizontal battens, on which vertical studs would have been nailed to support lath and plaster or panelled lining, now lost.

Illus 8 Detail, internal partition.

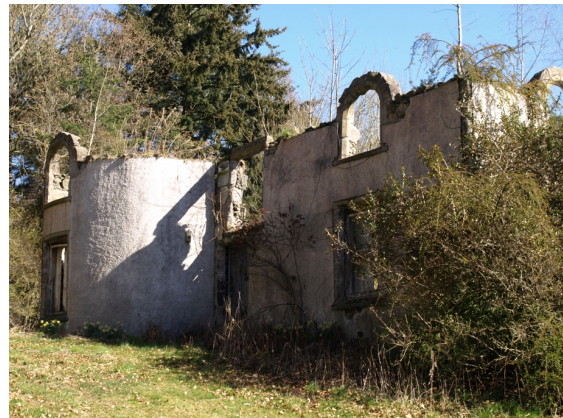
The W elevation partly mirrors the S elevation, terminating in an apsidal projection. At the S end, there is a large sash and case window on the ground floor, complete with internal shutters. Above is a round-arched dormer, with seven voussoirs with pecked faces and drafted edges. Near the middle of the elevation is what may have been the main entrance door. Above it is a large rectangular window, one of only two examples on the upper storey, and now about to fall backwards into the house. The location of the main door, tucked into the re-entrant angle beside the projecting apse or drum at the NW corner, is reminiscent of a tower-house door, perhaps intentionally.

Illus 11 SW corner and W elevation.

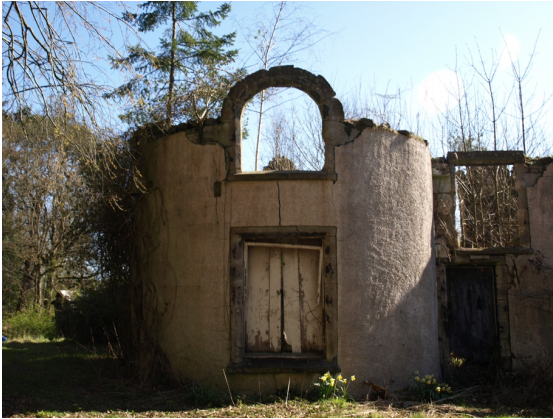
In the centre of the apse is a single large ground floor window, with a single round-arched dormer above. The sill, lintel and joinery of the sash and case window all follow the cylindrical curve of the apse, and so originally, would the glass. The arched dormer above is of the seven-voussoir type, with pecked faces and drafted edges, again compatible with the 1850s enlargement identified in the HES report. This arch also is curved in two axes, as it follows the curve of the apse. The arch has sagged very slightly as the apse below splits and bursts open under its own weight, allowing daylight to be seen in between the voussoirs.

The partial subsidence of the NW apse suggests that it may be founded on softer, made ground, extending beyond the rocky outcrop on which most of the cottage stands.

Illus 12 W elevation, with apsidal NW corner.

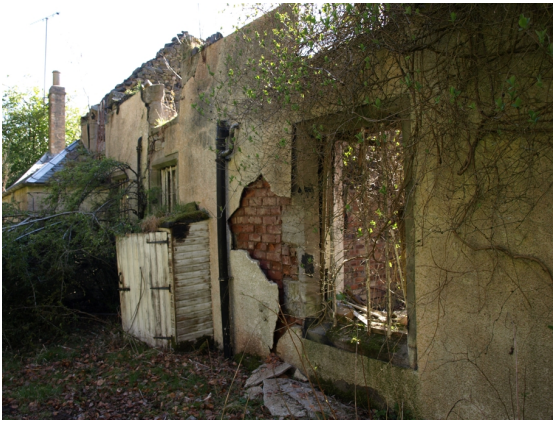
This is the most easily accessible elevation of the building, but very obviously the back entrance. It is overshadowed by the building, and hemmed in by trees and rising ground. The walls in this area are of red brick in header bond, rather than stone, visible where the harling has fallen off. The use of brick on the north wall is curious, because there might be very little cost saving compared with locally sourced whinstone rubble, and very little aesthetic difference once the wall has been harled over. It does not quite fit with any chronological scheme either. Having lived in a whinstone rubble building myself, the present author can testify that they can be desperately cold and damp inside. Perhaps brick was used on the dark and shady N side in the hope of making this part of the building slightly more heatable and habitable.

Illus 13 N wall. .

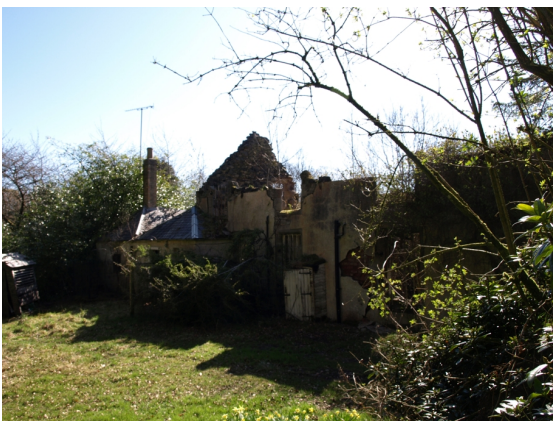
Rising behind the boiler room and back door area is a tall whinstone rubble gable wall, perhaps the E gable end of the W block added in the 1850s. There appears to be a rectangular window in this gable, looking E over the boiler-house roof. Where it is possible to look in through the windows, the internal walls are mostly of whinstone rubble with sandstone dressings, but some, adjoining the boiler room and back door, are of red brick.

Illus 14 N Elevation and internal gable.
