Standing Building Survey
Commercial Street
Newtyle
ANGUS
NW03

**ARCHAEOLOGICAL STANDING
BUILDING SURVEY
COMMERCIAL STREET
NEWTYLE**

NW03

A Level 2 survey was carried out of a B-listed disused former railway goods shed, in advance of conversion to housing. The shed formed part of the Old Station of Newtyle (opened 1831), but was probably somewhat later than the station as a whole, most likely originating in the 1860s. In the later 19th C, an adjoining shed was demolished and replaced with smaller structures, while a partially brick-built extension housing waiting rooms and a toilet was built onto the NW corner. The Old Station was replaced by a newer complex for passengers, but remained in use as a goods depot, until closing to regular traffic in 1955. The main building was constructed of stone rubble, with regular, stugged quoins, with a replacement asbestos roof. Although the listing details included the stone pier of a goods crane, no trace of this now remained. The survey was conducted on 27th April, 2021.

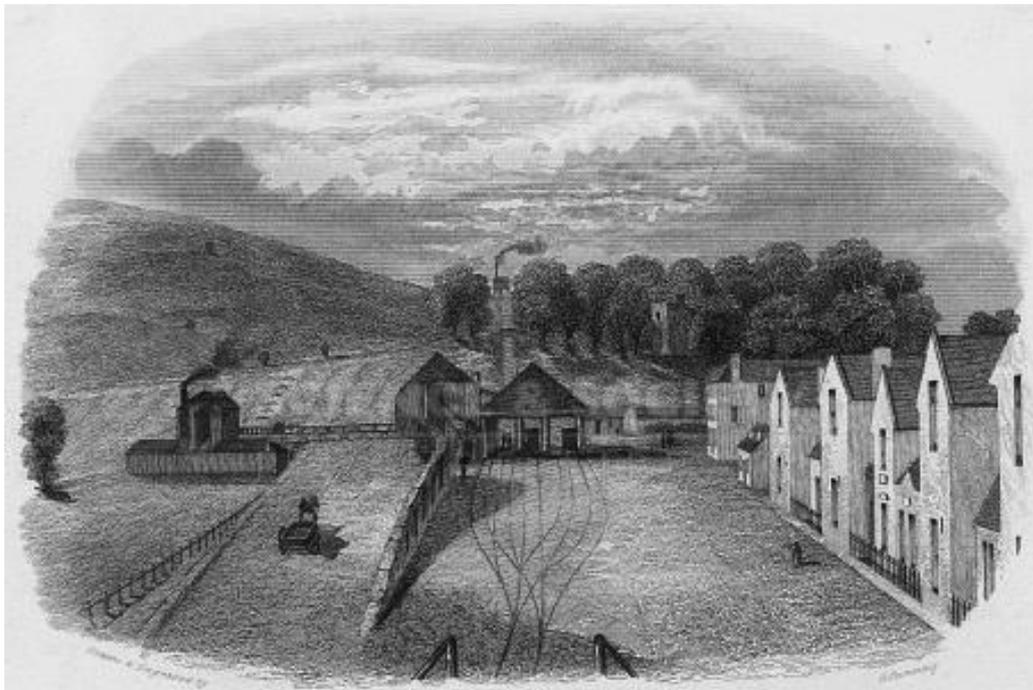
The original station, Hatton Hill to left (Science Society, from www.theatreorgans.com)

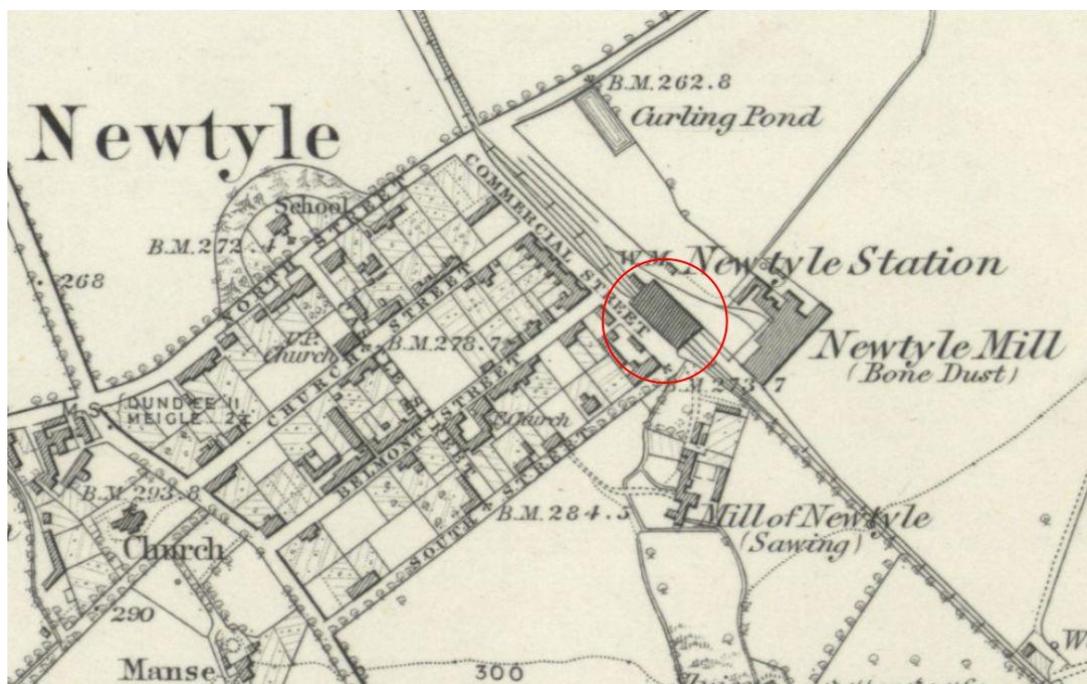
OS First Edition (6 inch, published 1865). The shed is wider than at present and has a small NW extension further N than the brick structure noted in the survey

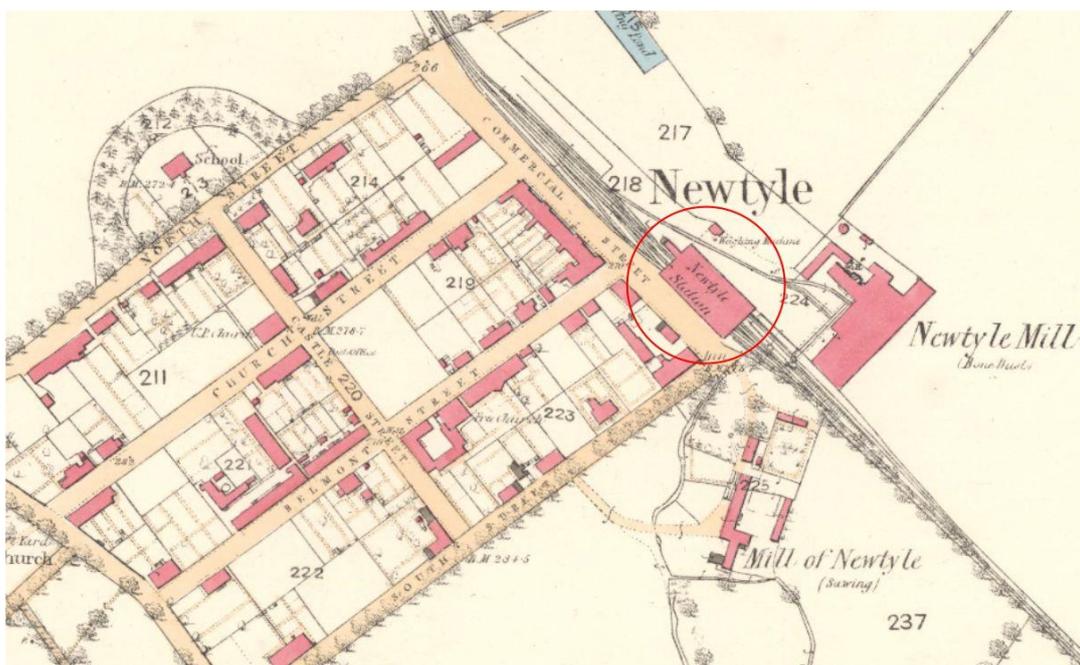
OS First Edition (25 inch, published 1863), the shed is clearly labelled as the station

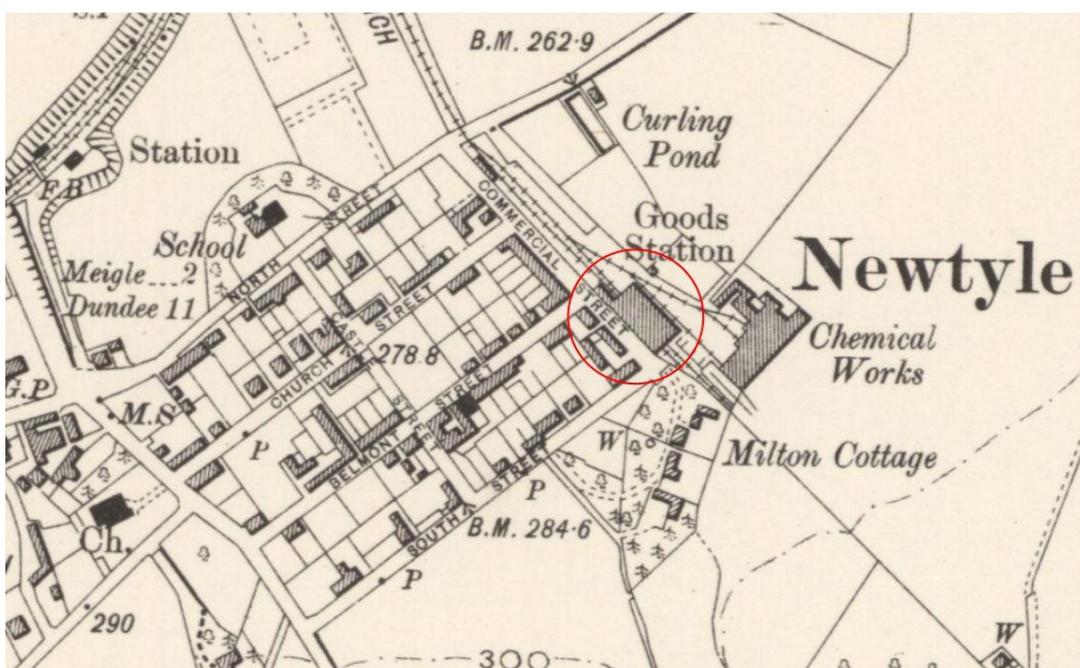
OS Second Edition (6 inch, published 1903). The shed now has its NW extension in the present location, while the station is now a “Goods Station” (note the “Station” top left)

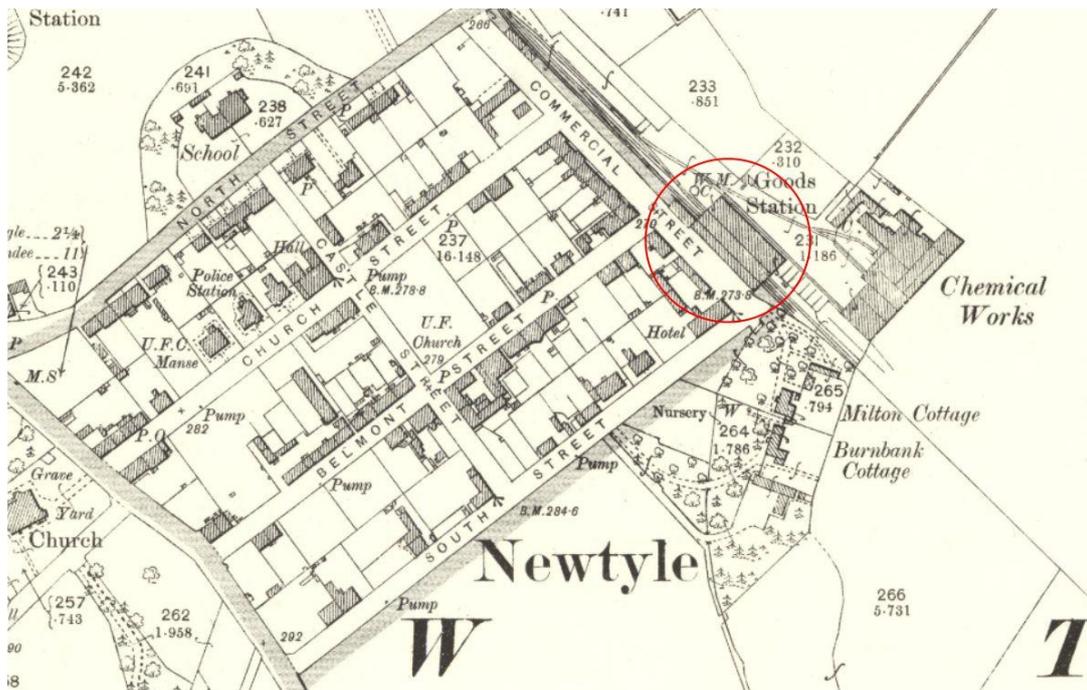
OS Second Edition (25 inch, published 1901), the division of the shed into the still-extant pitched-roof building and a since demolished rectangular block to the NE is clearly indicated

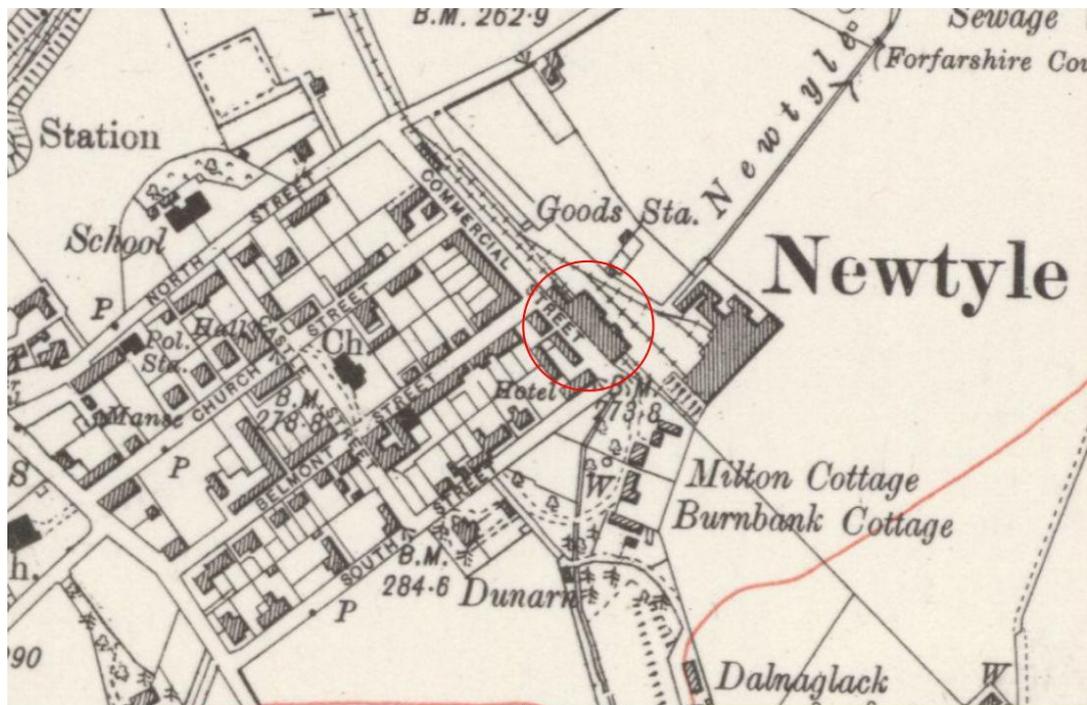
OS Third Edition (6 inch, published 1926). The shed is reduced in width (further from the track to NE) and two ancillary structures are shown against the NE side

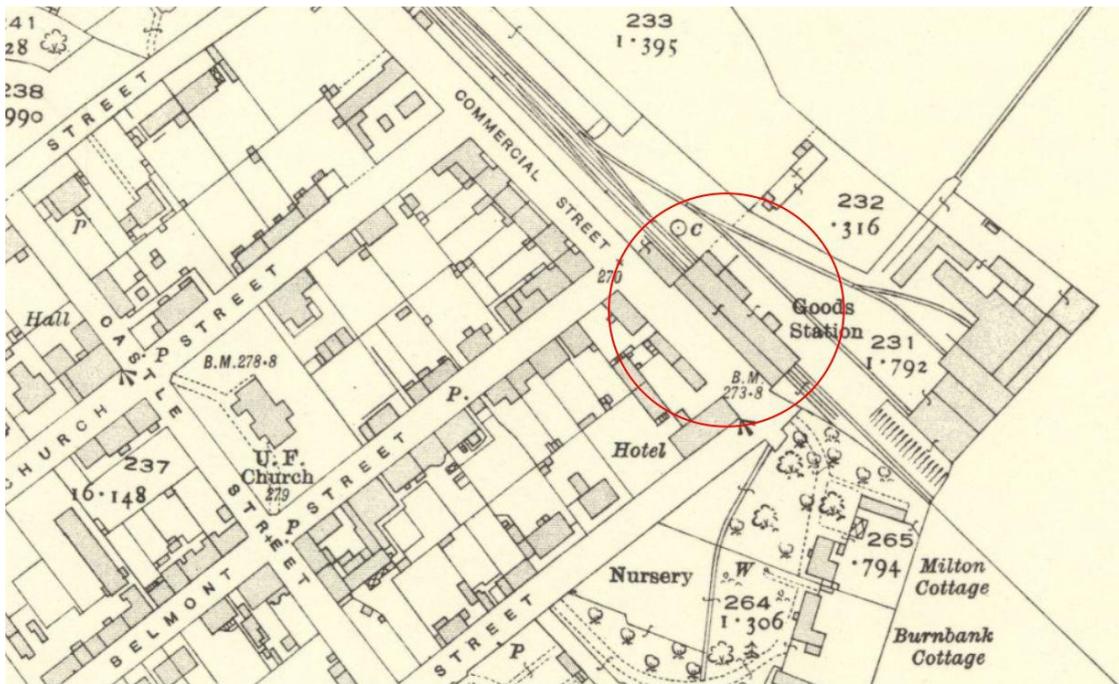
OS Third Edition (25 inch, published 1922), the ancillary structures are shown as a small lean-to to the SE and a subdivided block to the NW, as borne out by the survey (see Results, below)

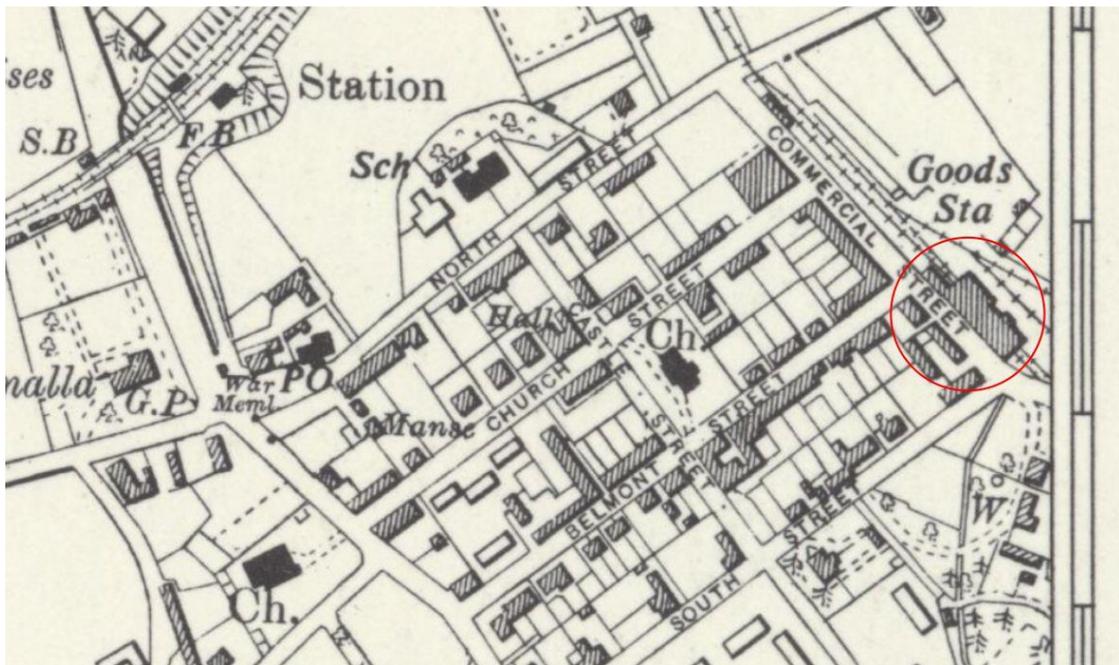
OS National Grid Map NO24SE- A (published 1959) shows the same configuration following closure of the station in 1955

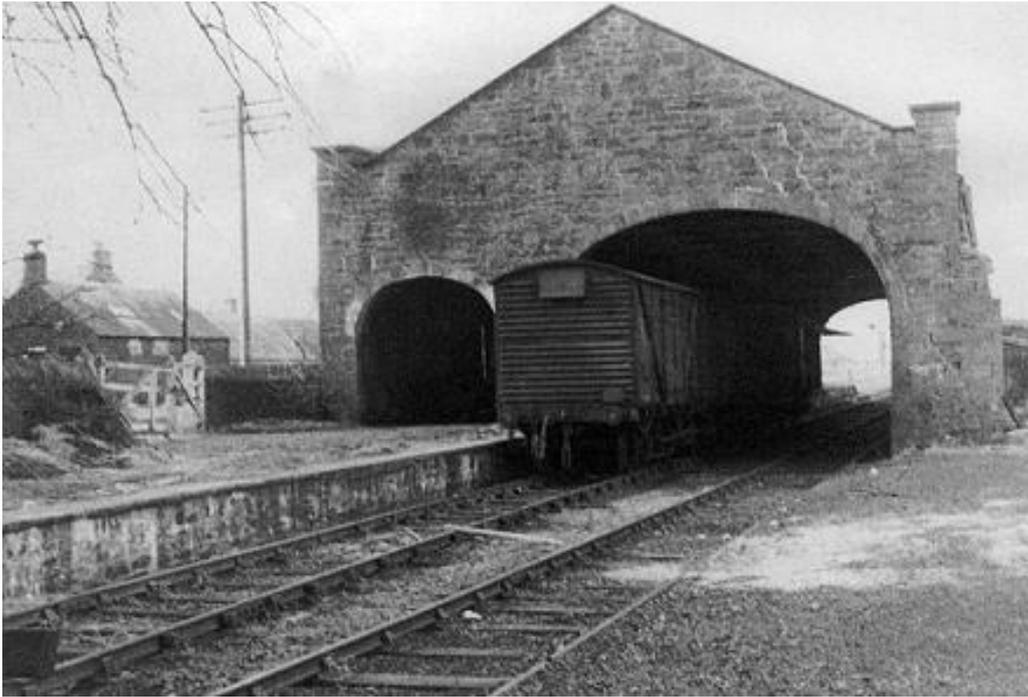
February 1960, view from S of shed (prior to construction of Knox Close) (photo by Norrie Forres, www.theatreorgans.com).

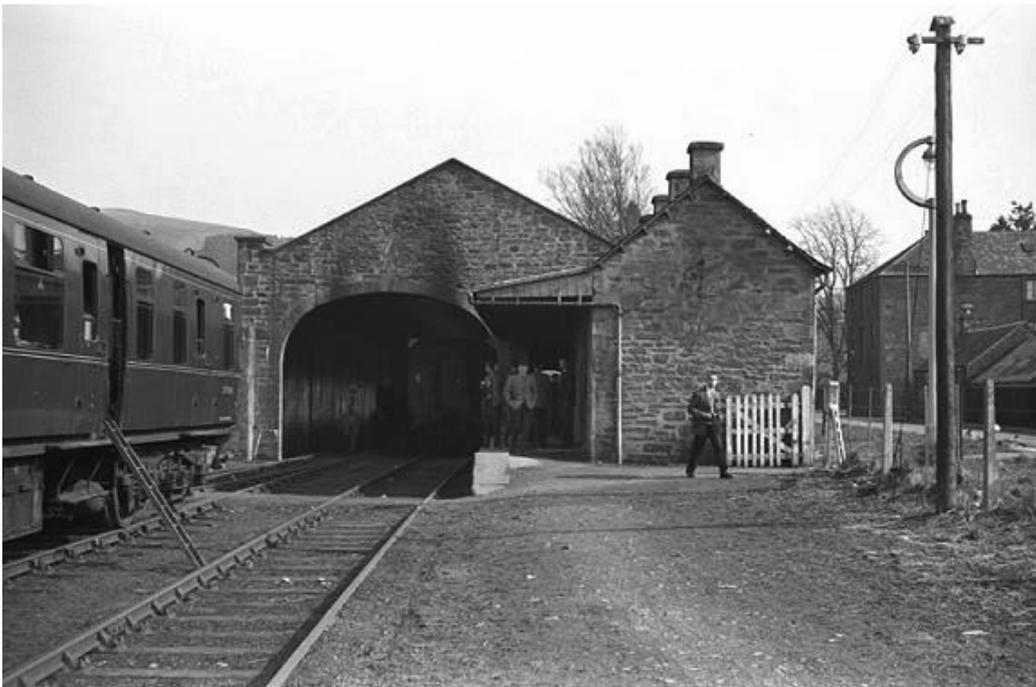
April 1962, view from N of shed, the extension shown to be a small platform with waiting rooms and veranda roof (prior to construction of neighbouring house to N on Commercial Street) (author unknown, from www.theatreorgans.com).

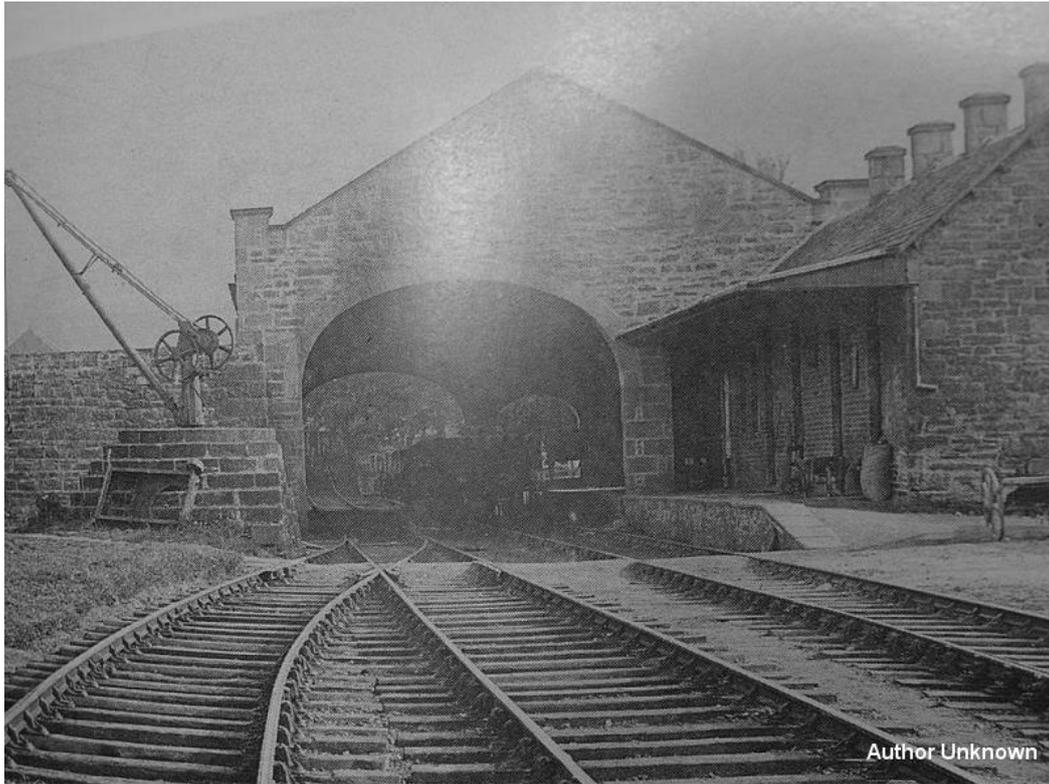
Similar view, unknown date, a crane stands against the roofless ruin NE of the main building. The rise in the track to the S is visible. It should be noted that, although the listing details for the station include the crane plinth and pivot, no trace of these now exist (photo from www.theatreorgans.com).

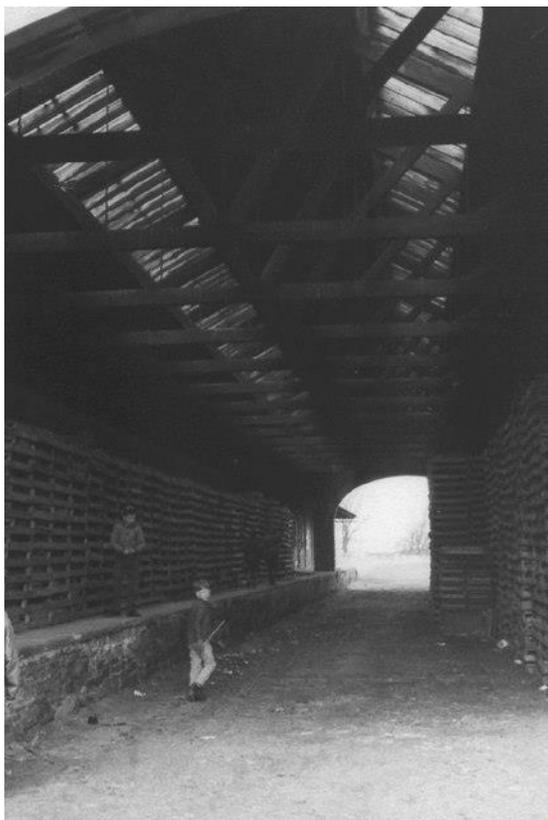
1966, the shed interior in use as a potato store. Note the raised walkway (now absent) alongside the former track bed and the corrugated roof supported by wooden A-frames (photo by Elliot Simpson, www.theatreorgans.com).

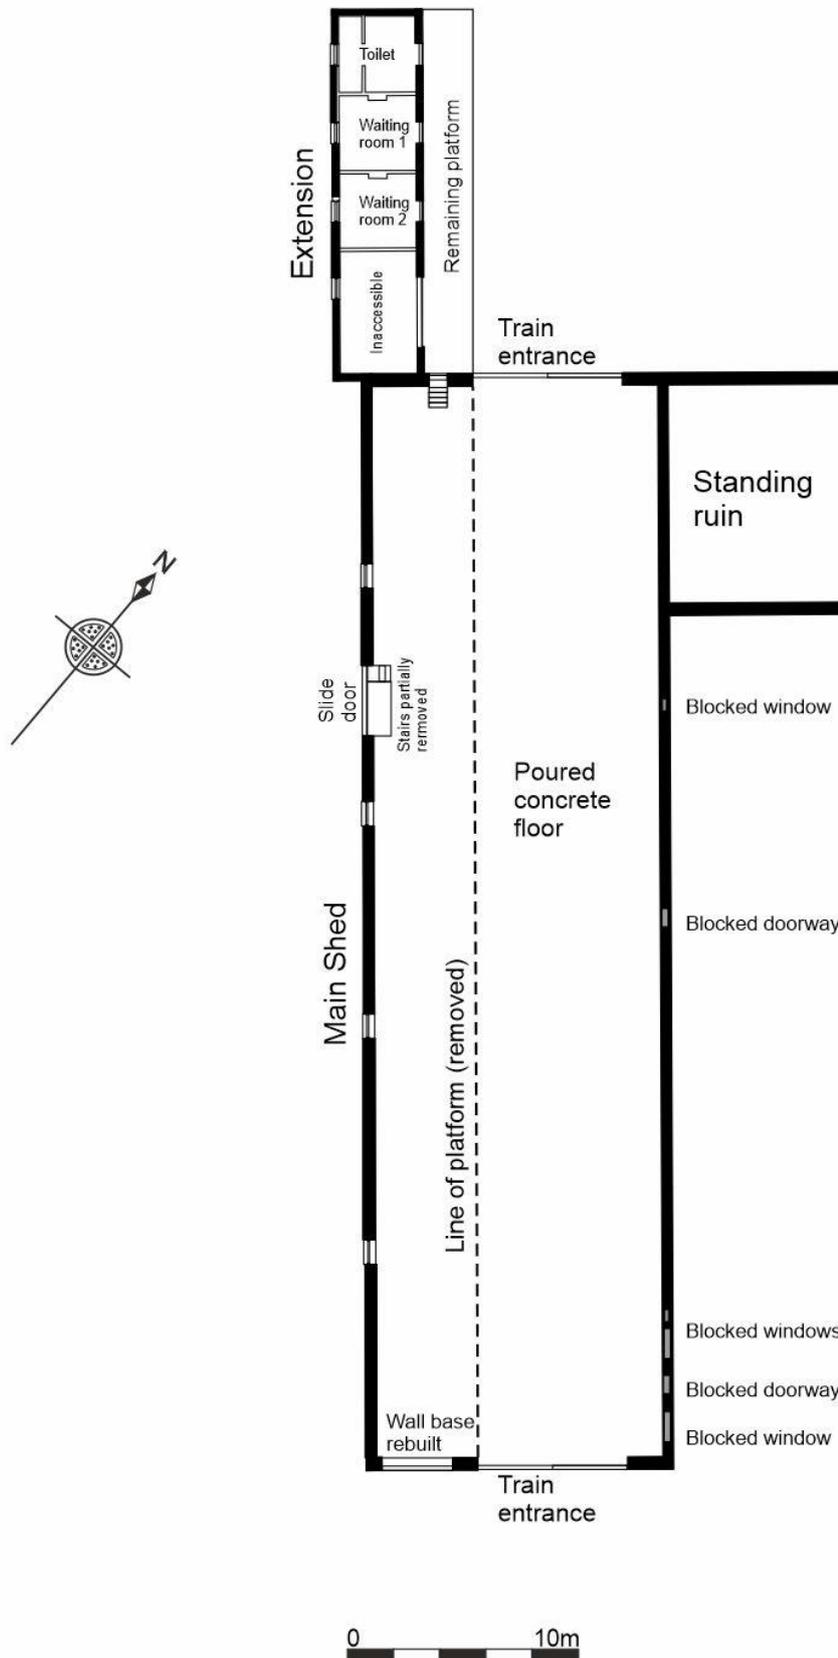
Illus 2

Floor plan

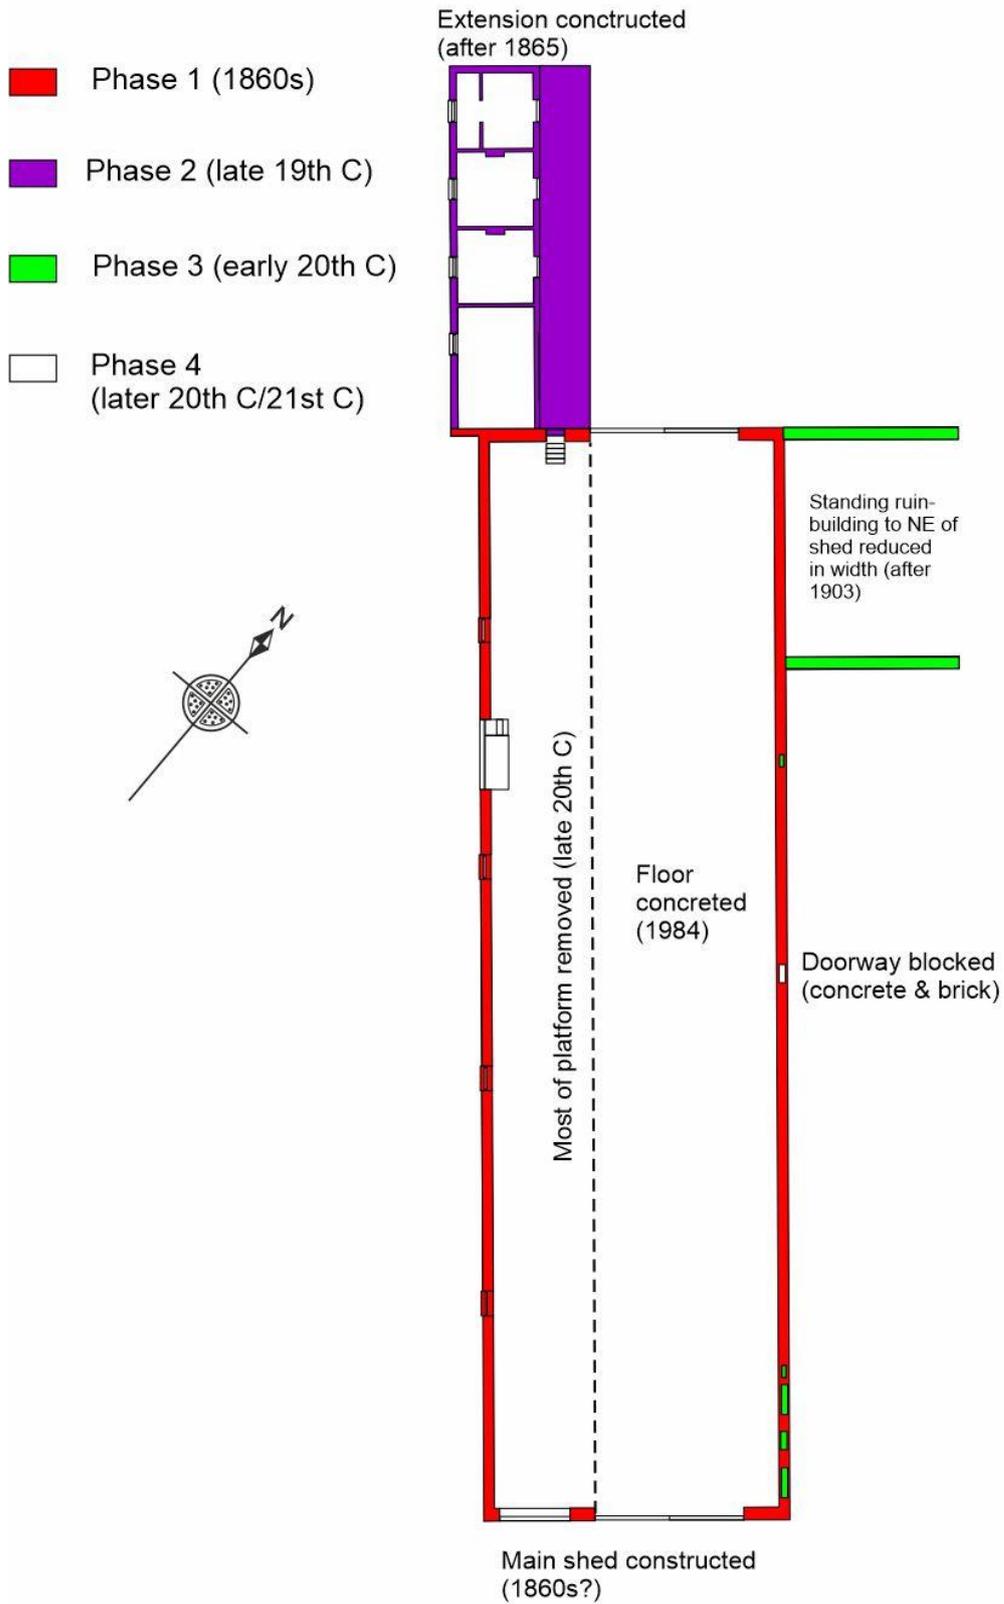
Illus 3

The general style and construction of the main shed was certainly in keeping with a mid-nineteenth century origin. The NW extension was probably constructed in the later 19th C, with the demolition of the shed to the NE of the main building and its replacement with a smaller, narrower building and lean-tos following in the early twentieth century, at which time, most probably, the original (probably slate) roof was replaced with corrugated asbestos. All of this sequence is commensurate with the available map and photographic evidence. Following the disuse of the station, further alteration within the shed included the removal of the platform and track and the concreting of the floor, this last element probably being completed in the 1980s.

Phase plan

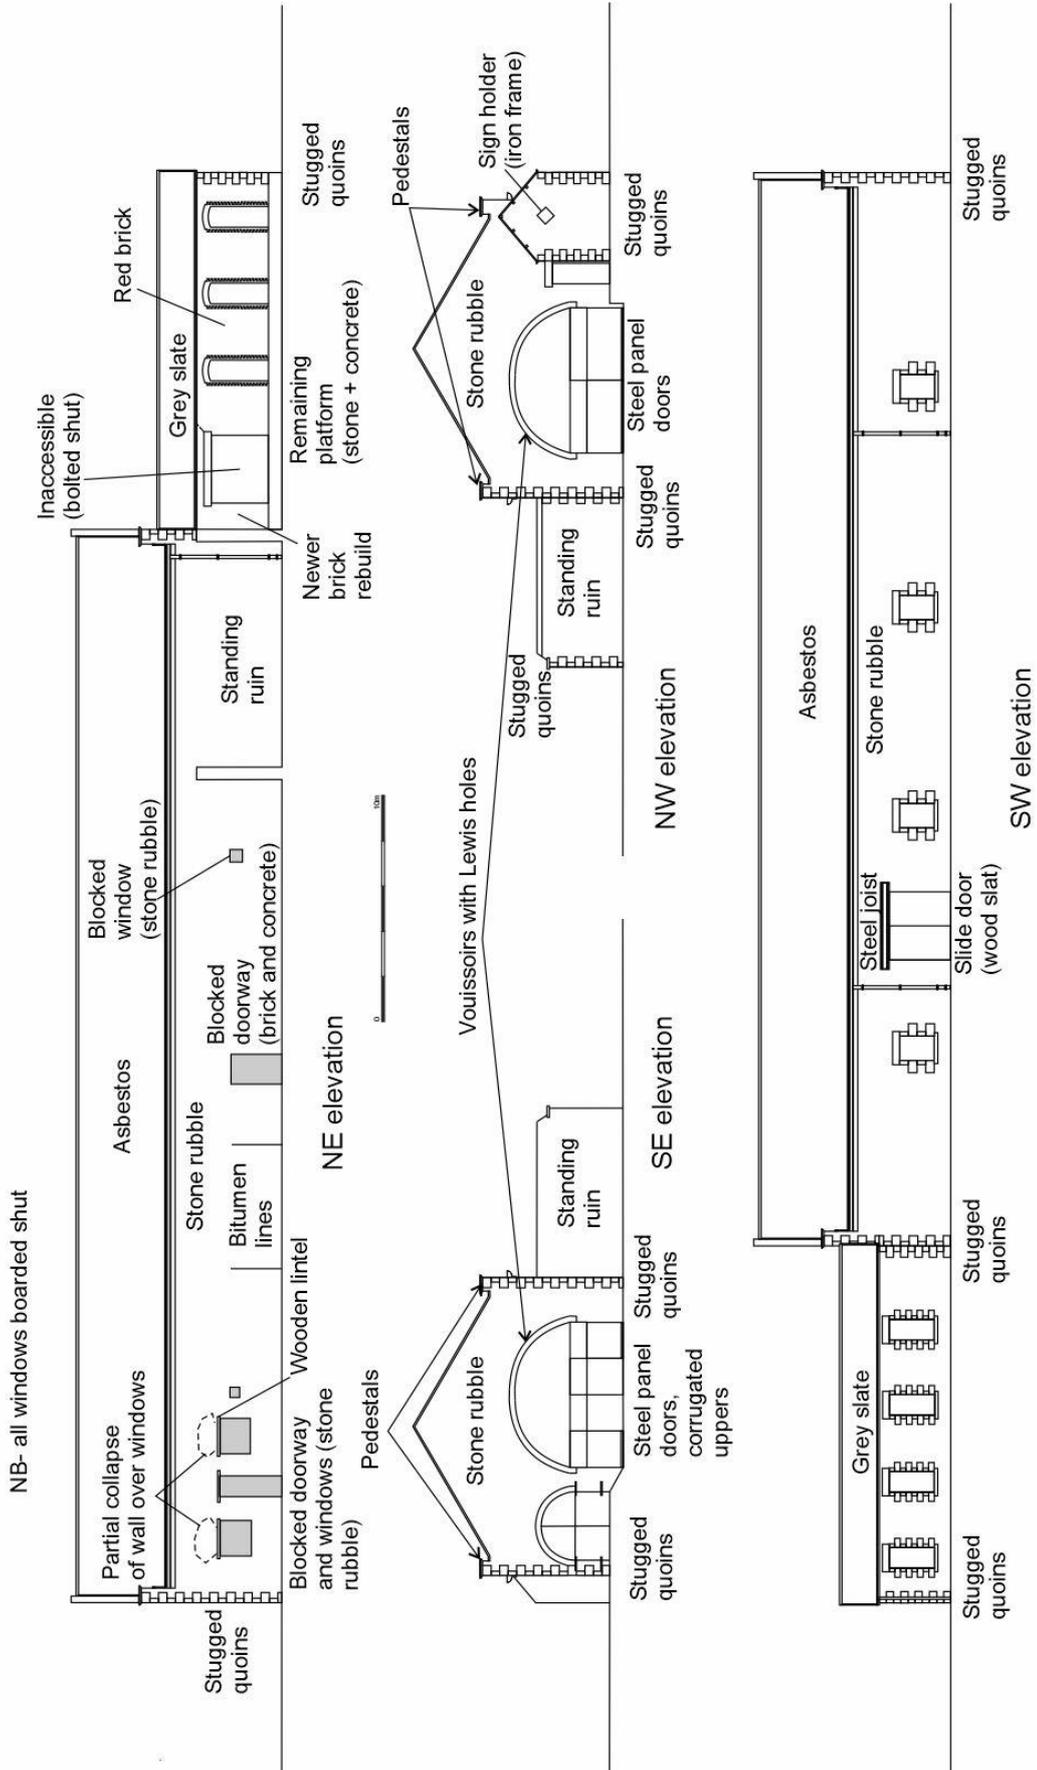
Illus 4

Main external elevations

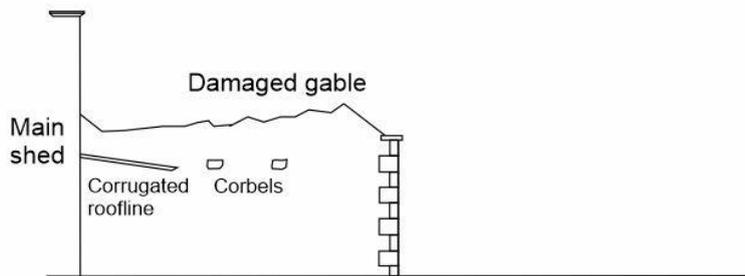
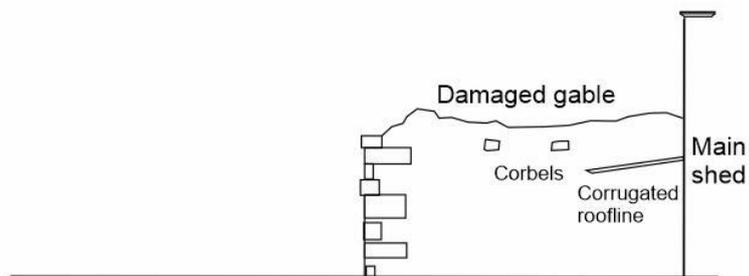
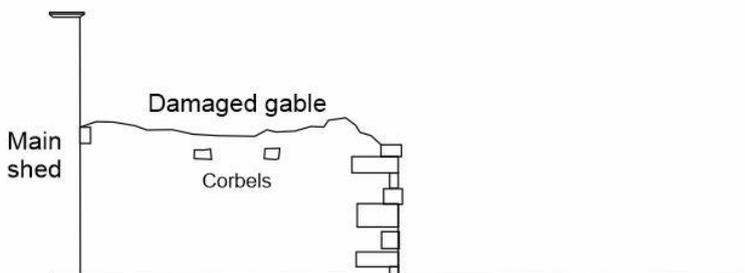
Illus 5

This was keyed to the NW end of the NE elevation of the main shed (see above). It consisted of two projecting walls, each 7.50m long and standing 4.80m tall from the present ground surface, 9.95m apart. Projecting from the interior faces of both walls were two stone corbels just below the wallhead, indicating the former presence of an upper floor, whether a fully accessible room or merely loft space. The remains of corrugated asbestos as sloping lines below these corbels marked a newer, lower roofline, but the vestiges of gables were clear, if damaged, on both wallheads and suggested the original building had been significantly taller than in this later phase. Corbels also projected from the SE face of the SE wall, indicating a continuation of the building. This almost certainly was as marked on the OS Third Edition maps; no clear traces were apparent of the much larger building shown on the First and Second Editions (see Desk-Based Research, above). Within the ruin, the floor of which was thickly overgrown, were the corroded remains of what appeared to be a small track trolley or trailer, perhaps evidence of the storage function of the building when in use.

Elevations of standing ruin

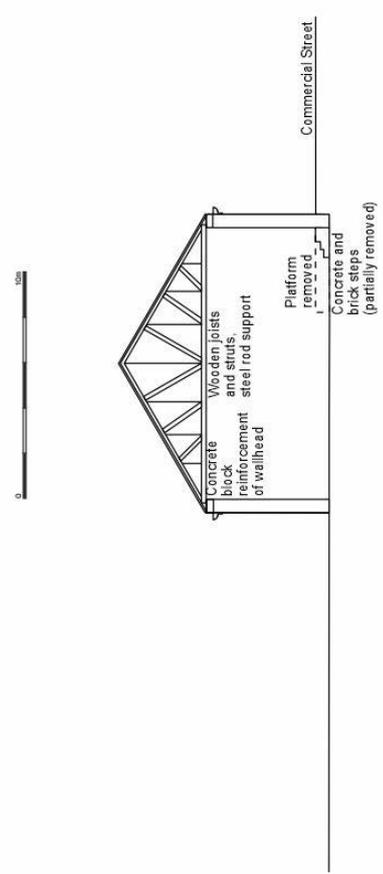
Illus 6

The shed interior was a single, mostly bare, rectangular room with a poured concrete floor, with wooden A-frames supporting the corrugated asbestos roof. It measured 46.60m NW-SE and 12.30m NE-SW. No trace remained of either the former track and track bed or the platform that formerly ran along the SW side of the building (see *Photographic and Map Evidence*, above). Near the SE end of the building, at the base of the SW elevation, was a date inscribed in concrete: “30.3.84” (presumably 1984, dating the modern floor, rather than 1884!). The wallheads of both long elevations had been reinforced with concrete joists, probably to take the modern roof; given that this same roof is visible in the 1966 photograph (see above), the wall reinforcement must have occurred prior to this date. The platform/walkway is also visible in the same photograph, making its removal later- this may well have been done just before the concrete floor was laid in 1984. Building materials in various forms were currently being stored by the present owners, but the building was essentially disused.

Mid-section of main building

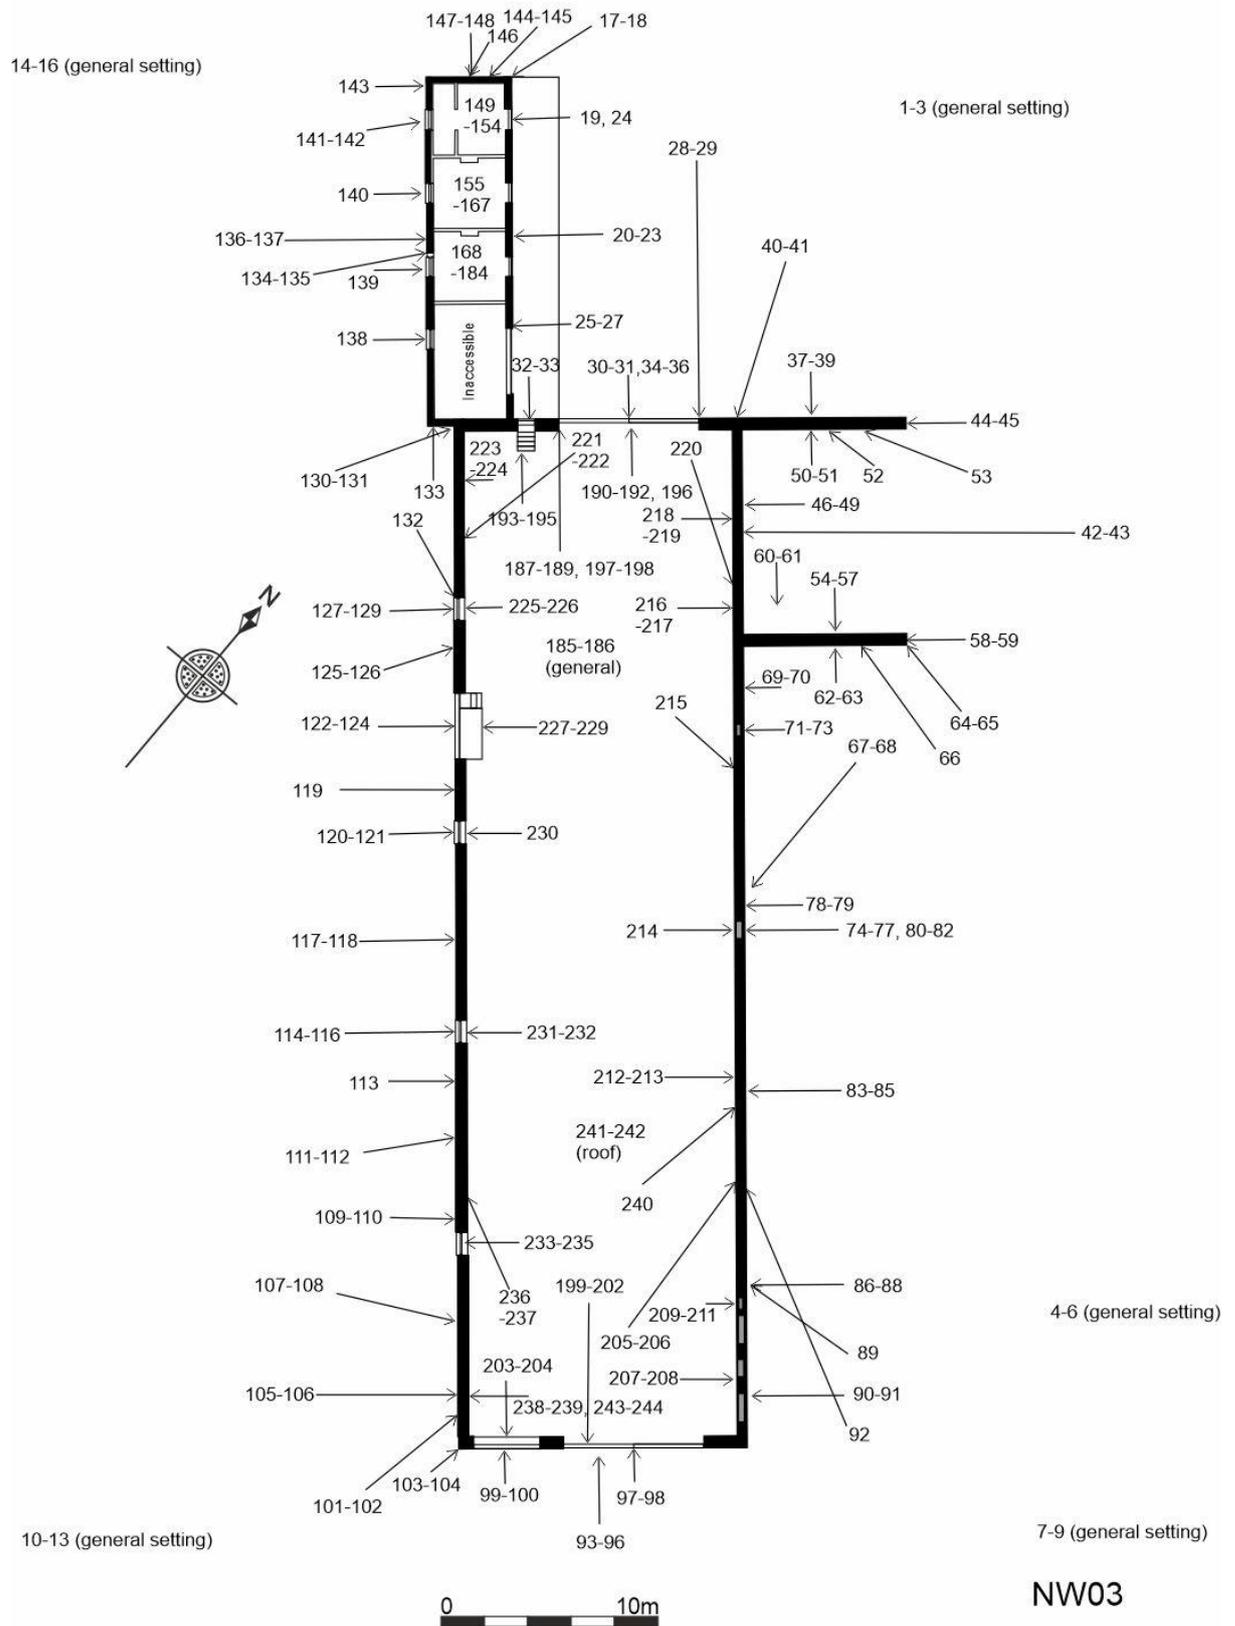
Illus 7

Photographic plan
