Historic Building Record  
Old Stables  
Tullibole Castle  
Crook of Devon  
Kinross

**HISTORIC BUILDING RECORD  
OLD STABLES, TULLIBOLE CASTLE,  
CROOK OF DEVON,  
KINROSS  
KR11**

*Alder Archaeology produced a historic building record (site code KR11) of the stables, Tullibole Castle, Crook of Devon, Perth and Kinross, in advance of conversion to residential use. The recording was undertaken on 16<sup>th</sup> April 2021.*

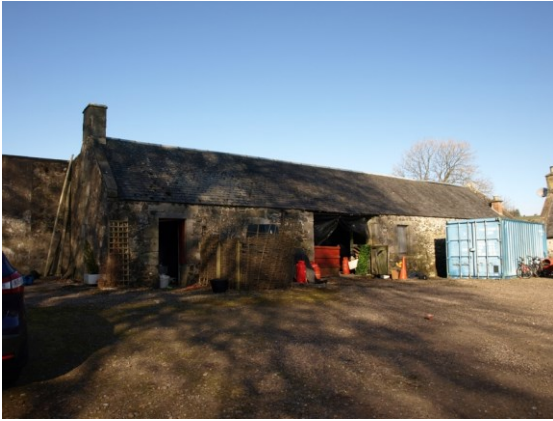
Illus 5 S and E elevations.

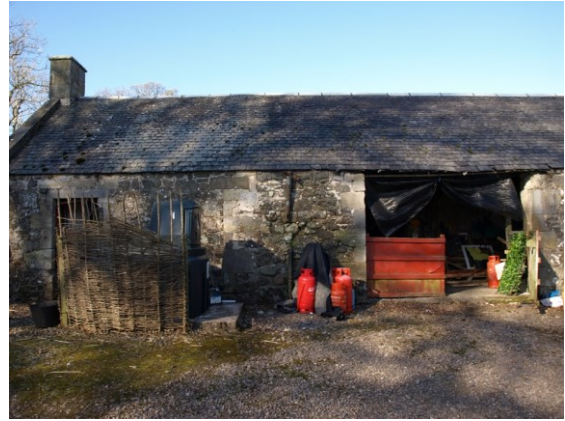
Illus 8 E elevation. Quoins show addition of S end.

The central and largest part of the building is the stable proper. This is also of whin and sandstone rubble with sandstone quoins. Where the tack room abuts the S end of the stable, it appears from the detail of the quoins that the stable came first, with the tack room built onto it. It also appears from the quoins that the wall head was raised, perhaps to allow the extra height required to build a loft over the tack room.

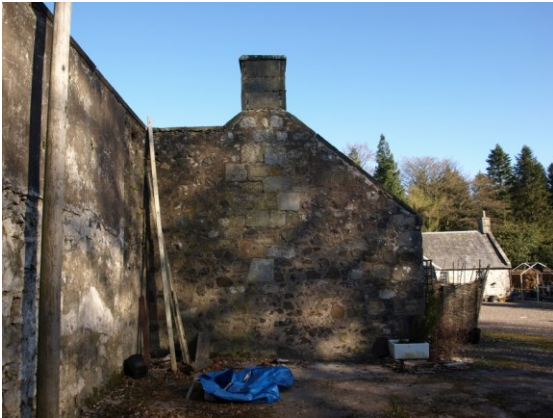
Illus 6 S gable wall.

The S gable wall of the stable block is mostly of whin and sandstone rubble, with sandstone quoins and coping on the skewes, and sandstone skewputs. There is a central chimney stack built of ashlar blocks, surmounted by a flat sandstone coping with bevelled edges. There is no visible chimney can. The coping has been partly removed on the W side, where the gable has been partly built over by the Courtyard Wall (see above). The gable stands to ground floor and loft height, with a visible change of build about 1.2 m off the ground. Above this level the exterior of the chimney is largely formed by ashlar blocks, probably re-used.

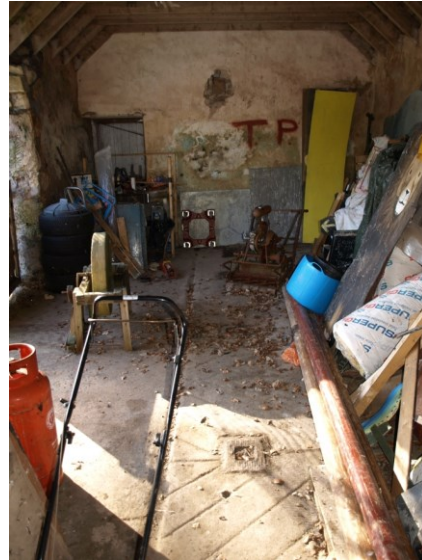
Illus 9 Stable interior. Beam end in wall aligns with post sockets in floor.

In the centre of the N and S end walls of the stable are the cut-off stubs of a large rectangular beam which would have run the length of the stable just above head height, and would have supported the partitions dividing the stalls. The floor is of concrete, with diagonal grooves and gullies for grip and drainage. At intervals there are sockets for timber posts which would have supported the partitions between the stalls, directly under the line of the central timber beam. The stall partitions themselves are no longer extant.

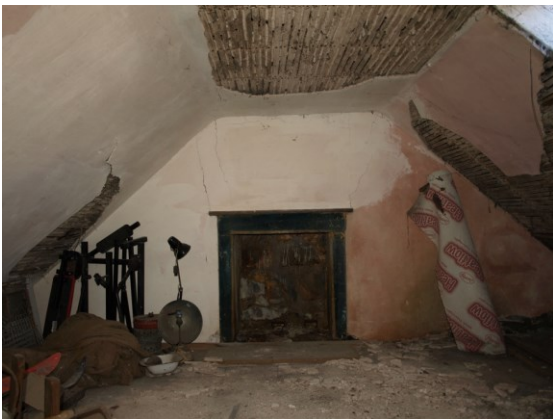
Illus 7 Loft interior.

The loft over the tack room is a very simple space, with lath and plaster on the walls and ceiling, and a simple stone fireplace in the S gable wall. There is a small roof light in the middle of the W facing slope. The plaster has been distempered, and the loft was obviously intended to be habitable, probably by a stable hand, but there is no obvious way of closing off the loft from the tack room below. The loft is now derelict and empty, except for fallen plaster and a few odd items.

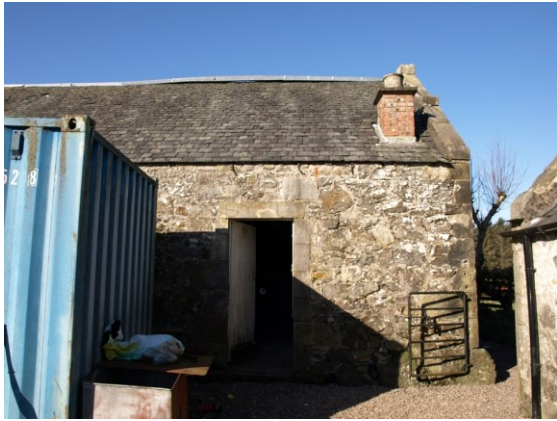
Illus 10 Wash house door and chimney.

Directly N of the stable is a store room entered from the W side of the building, and described below. N of this is a wash house which completes the N end of the building. The wash house is entered by a doorway in the E wall, towards the NE corner of the building, formed by a sandstone lintel and jambs with tooled margins. The door is as usual made of vertical tongue and groove boards.

At the NE corner of the building is a small red brick chimney, rising up through the slated roof with zinc flashing, and surmounted by a thin concrete slab cope and small buff-yellow earthenware chimney can. The chimney is built up against but not into the gable wall and E side wall. The chimney is clearly an addition, perhaps early 20th-century, to the original structure. Internally, the wash house is a very plain, almost featureless room, with exposed rubble walls, lime washed, not plastered. The roof trusses again consist of sawn rafters with high collars, covered with sarking boards, but in this room the rafter feet rest on a wall plate, rather than being embedded in the wall head.

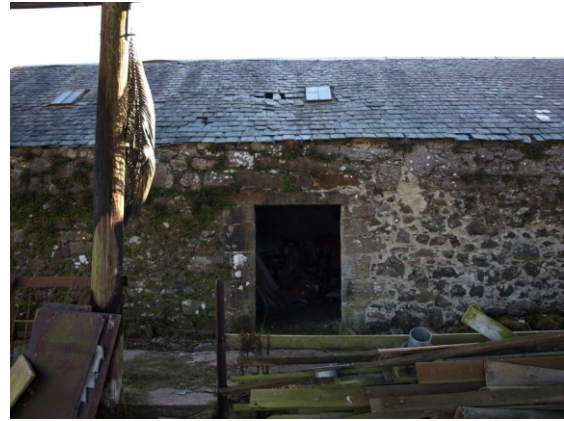
Illus 13 W Elevation. Store room door. Repointing, and change of build above lintel.

In between the stable and the wash house is a store room, entered by the only doorway in the W side wall. This is formed by a sandstone lintel and jambs with tooled margins, somewhat similar to the wash house doorway (see above). The wall in this area seems to undergo a change of build above lintel height, and there is extensive re-pointing to the S of this doorway.

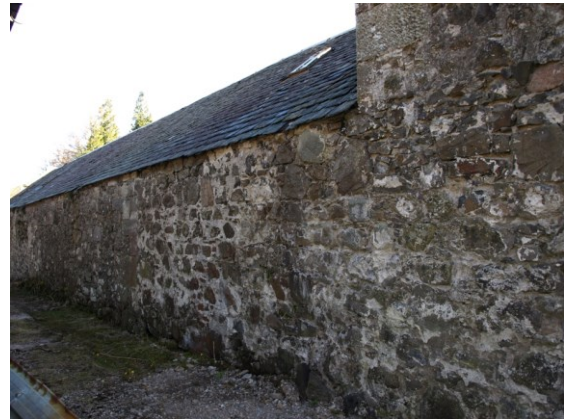
Illus 14 W elevation, S end. Changes of build. Junction of courtyard wall.

The W side wall is mostly of whinstone rubble, and largely featureless. In several places there appears to be a possible change of build above head height, and an extensive area of repairs or repointing near the middle of the wall.

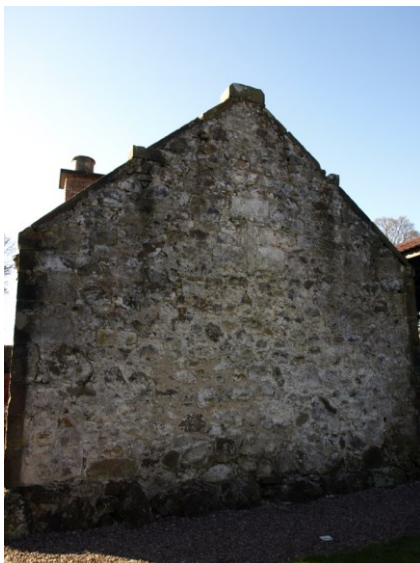
Illus 12 N gable with vent slot and finial.

The N gable is a rather plain, symmetrical wall of lime-washed rubble. At the apex is a simple, flat sandstone finial with bevelled edges. The skews are covered with flat sandstone hopes, secured with a single crowstep on either side, half way down, and with plain but very solid and substantial skewputs. Below these are substantial ashlar quoins.

In the centre of the gable wall, above head height, is vertical ventilation slot, also seen internally, now blocked up, formed by large and solid but slightly irregular stone blocks.

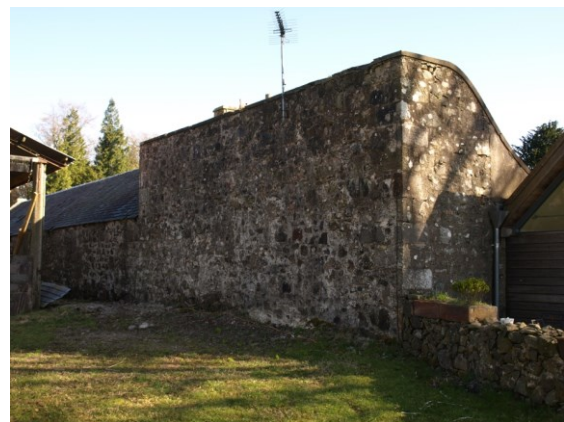
Illus 15 SW corner, courtyard wall.

The high wall which forms the SW corner of the courtyard appears to be built onto the S gable wall of the stable block. It is built mostly of whinstone rubble, with flat concrete slab coping. At its N end it turns E and runs partly over the skew of the S gable wall. At its S end it also turns E, and joins onto the original W gable end of The Long House. The coping here slopes down in a graceful curve. The E (internal) face of the wall is mostly covered with plaster, perhaps reflecting the position of a lean-to building, since removed. The E and S (external) faces of the wall are of whinstone rubble with sandstone quoins.
