Archaeological Watching Brief
Orwell Church
Milnathort

ARCHAEOLOGICAL WATCHING BRIEF
ORWELL CHURCH
MILNATHORT

MJ03

Alder Archaeology conducted a watching brief (MJ03) on installation of a new electricity supply to Orwell Church, Milnathort. This involved digging a cable trench from the E gable end of the church, along the S face and down the central path through the churchyard to the public road. The church was built on a new site in 1739, with the churchyard laid out much as it is today. As a result, no undocumented structures or burials were found. However the church foundations, and successive path surfaces were exposed, and one burial was located only 0.5 m below the surface.

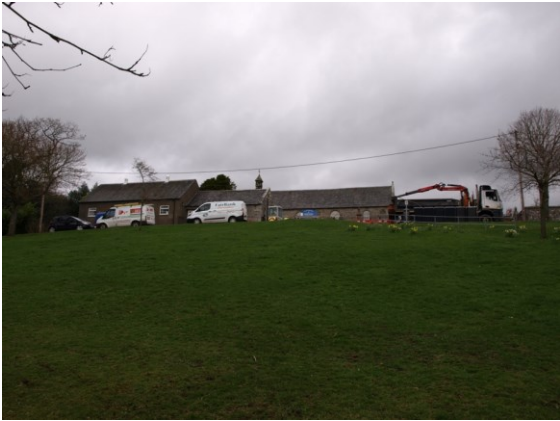
Illus 4 Church on top of Ba' Hill

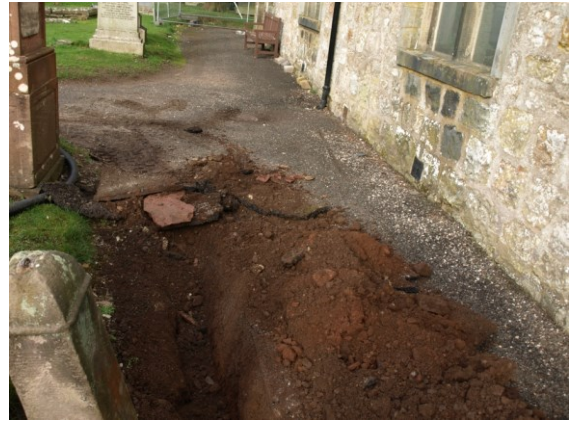
Illus 7 Joining central path. Slabs (05)

From the SE corner of the church onwards, the path was surfaced with a layer of tarmac (03), 2 – 3 cm thick. From about the E door of the church, a red sand and gravel natural layer (04) appeared in the bottom of the trench. This continued almost to the S end of the central path. At 2 m S on the central path, natural (04) rises almost to the surface of the path. At 10 m S, it is about 0.2 m down. As the path along the S face of the church reached the centre of the building, red sandstone slabs (05) appeared under the tarmac (03), evidently an earlier path surface. A similar surface of thick buff sandstone slabs (06) appeared at intervals under the central N – S path.

Although contained within the tarmac path (03), rather than in the grass beyond, where the cable track turned S to join the central N – S path, it ran very close to the edge of the path, almost clipping the corner of the grass. Here some fragments of human bone were found, and immediately reburied. Evidently the burials are squeezed very tightly up to the path edge, though apparently not beyond it; no other bones were found in the course of the excavation. It is curious that these bones were found only 0.5 m below the present surface. Perhaps in the 18th century, the later 'six feet under' convention had not yet been established, especially where later burials were being added in an established family lair.

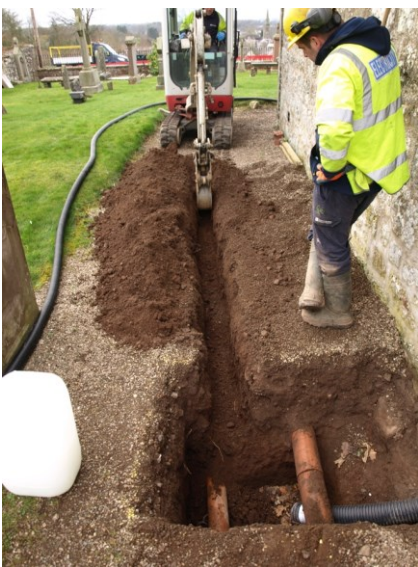
Illus 5 Initial pit beside E gable

Work began at the E gable end of the church. A small pit was opened up N of the centre of the gable to expose the wall foundation 06, and make an opening through the wall to feed the new cables into the church. The pit was 1.3 m long by 1 m wide and 0.9

At the E gable end of the church, the path was made of modern stone chips (02) over a red clay loam. In the initial pit the wall foundation (01) was 0.6 m deep. Beside it was an older cable duct, and a red clay field drain, perhaps inserted to dry out the ground around the wall foundation.

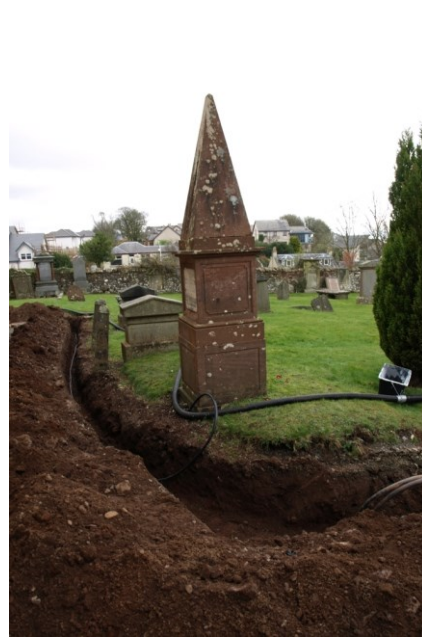
Illus 8 Trench turns S (looking E)

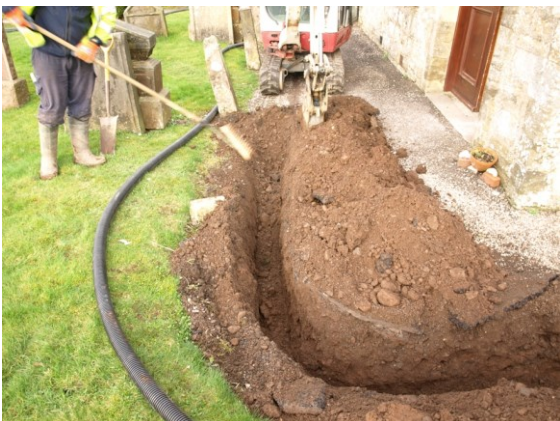
Illus 6 Trench turns W beside E door

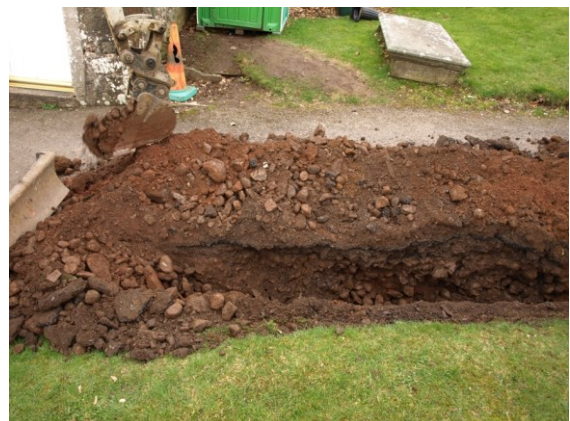
Illus 9 Cobbles (08) near S end of path

About 10 m N of the main entrance gate, the slabs, loam and natural deposits under the tarmac all gave way to a deep deposit of large, coarse rounded cobbles (08), which continued for about 2 – 3 m, stopping about 7 m N of the Ba' Hill boundary wall. This would not have been another path surface, as it would have been very difficult and dangerous for pedestrians, like walking on a cobble beach. The path and churchyard slope down steeply N – S, and could have been awash with surface water during wet weather. The cobbles (08) could have served as a soakaway under the path surface,

preventing a deep puddle from forming at the entrance gate, or a torrent of rainwater flowing out into the street beyond.

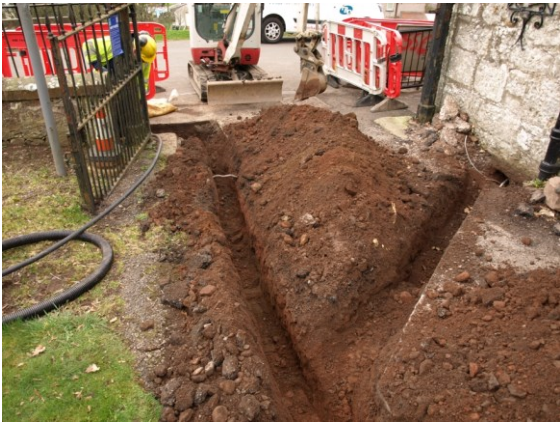
Illus 10 Trench arrives at entrance gate.
Branch to cottage

South of the cobbles (08) and down to the entrance gate the trench bottomed on coarse buff sand (09), either a change in natural or an artificial bedding layer under the path and gate threshold. In this area the cable trench was crossed by a lead water pipe supplying the cottage, and joined by very short spur trench to carry a new electricity supply cable to the cottage.

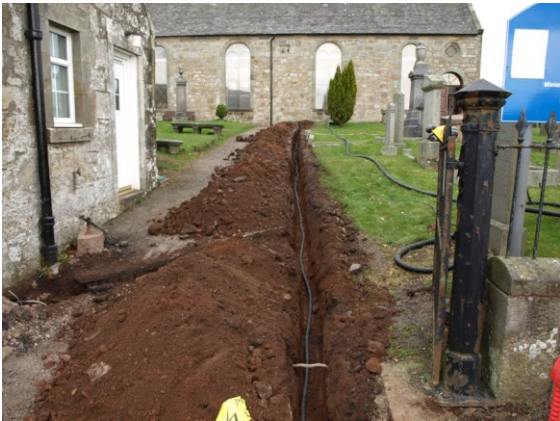
Illus 11 Trench complete, looking N
