Archaeological Watching Brief
Orwell Church
Milnathort

MJ03

ARCHAEOLOGICAL WATCHING BRIEF
ORWELL CHURCH
MILNATHORT

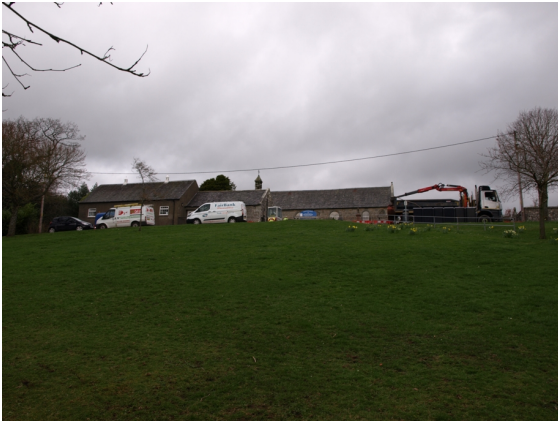
Illus 4 Church on top of Ba' Hill

Orwell Church is B-listed (LB17632) and is located on the N edge of Milnathort, on the N side of an E – W road called Ba' Hill. This was presumably also the name of the high ground on which the church stands. The present church was built in 1729 to replace an earlier church on the N shore of Loch Leven, located some 3 km to the ESE and now in ruins. The church seems to have been modified and heightened in the 1880s. This can be seen, for example in a change of build in the S wall, level with the spring of the arched windows.

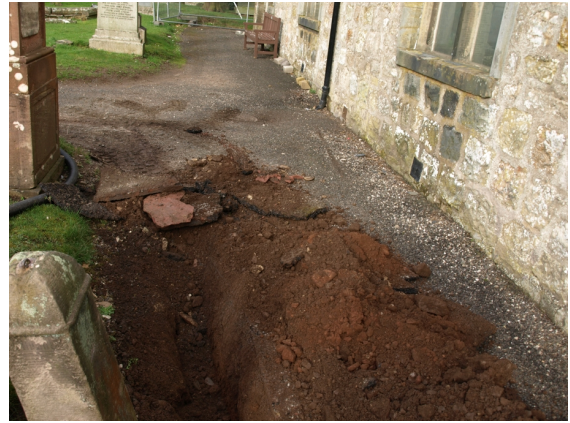
From the SE corner of the church onwards, the path was surfaced with a layer of tarmac (03), 2 – 3 cm thick. From about the E door of the church, a red sand and gravel natural layer (04) appeared in the bottom of the trench. This continued almost to the S end of the central path. At 2 m S on the central path, natural (04) rises almost to the surface of the path. At 10 m S, it is about 0.2 m down. As the path along the S face of the church reached the centre of the building, red sandstone slabs (05) appeared under the tarmac (03), evidently an earlier path surface. A similar surface of thick buff sandstone slabs (06) appeared at intervals under the central N – S path.

Illus 7 Joining central path. Slabs (05)

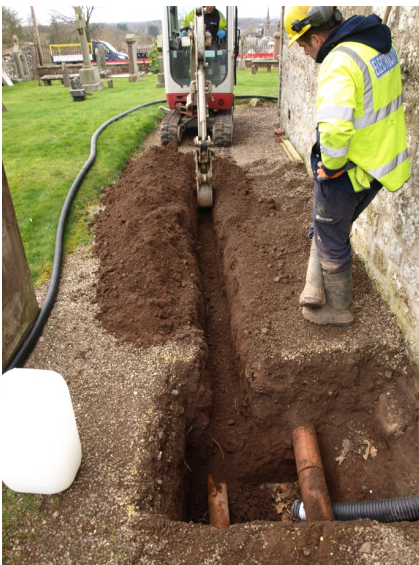
Work began at the E gable end of the church. A small pit was opened up N of the centre of the gable to expose the wall foundation 06, and make an opening through the wall to feed the new cables into the church. The pit was 1.3 m long by 1 m wide and 0.9

At the E gable end of the church, the path was made of modern stone chips (02) over a red clay loam. In the initial pit the wall foundation (01) was 0.6 m deep. Beside it was an older cable duct, and a red clay field drain, perhaps inserted to dry out the ground around the wall foundation.

Illus 5 Initial pit beside E gable

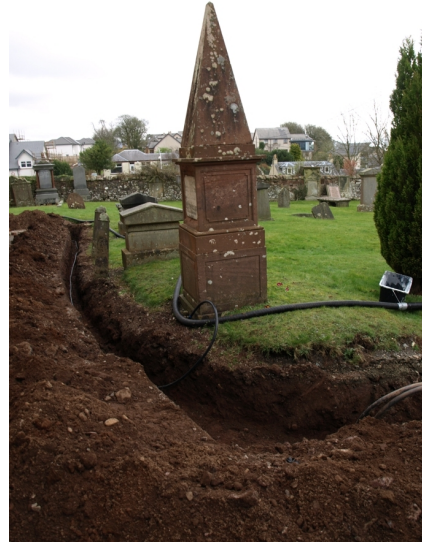
Although contained within the tarmac path (03), rather than in the grass beyond, where the cable track turned S to join the central N – S path, it ran very close to the edge of the path, almost clipping the corner of the grass. Here some fragments of human bone were found, and immediately reburied. Evidently the burials are squeezed very tightly up to the path edge, though apparently not beyond it; no other bones were found in the course of the excavation. It is curious that these bones were found only 0.5 m below the present surface. Perhaps in the 18th century, the later 'six feet under' convention had not yet been established, especially where later burials were being added in an established family lair.

Illus 8 Trench turns S (looking E)

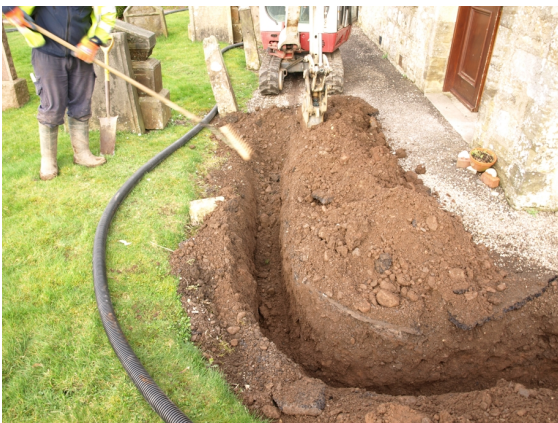
Illus 6 Trench turns W beside E door

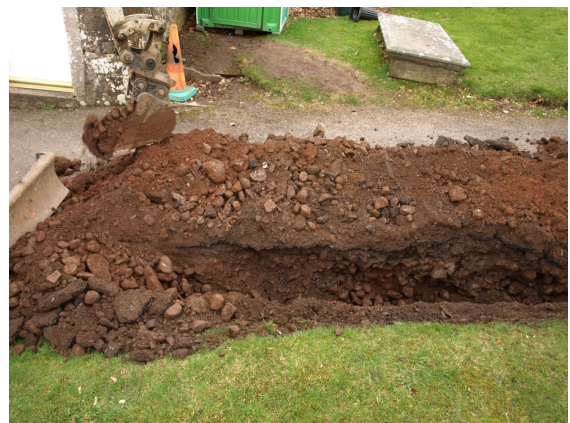
About 10 m N of the main entrance gate, the slabs, loam and natural deposits under the tarmac all gave way to a deep deposit of large, coarse rounded cobbles (08), which continued for about 2 – 3 m, stopping about 7 m N of the Ba' Hill boundary wall. This would not have been another path surface, as it would have been very difficult and dangerous for pedestrians, like walking on a cobble beach. The path and churchyard slope down steeply N – S, and could have been awash with surface water during wet weather. The cobbles (08) could have served as a soakaway under the path surface,

preventing a deep puddle from forming at the entrance gate, or a torrent of rainwater flowing out into the street beyond.

Illus 9 Cobbles (08) near S end of path

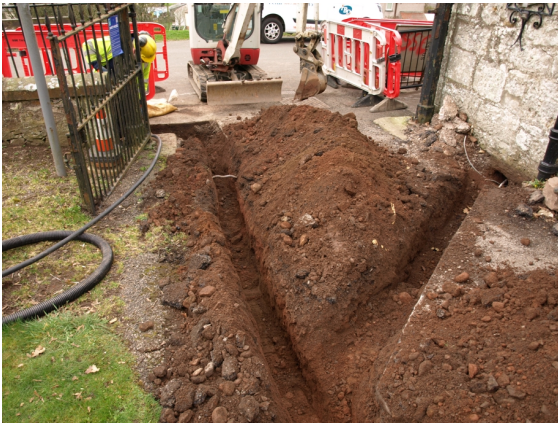
South of the cobbles (08) and down to the entrance gate the trench bottomed on coarse buff sand (09), either a change in natural or an artificial bedding layer under the path and gate threshold. In this area the cable trench was crossed by a lead water pipe supplying the cottage, and joined by very short spur trench to carry a new electricity supply cable to the cottage.

Illus 10 Trench arrives at entrance gate.
Branch to cottage

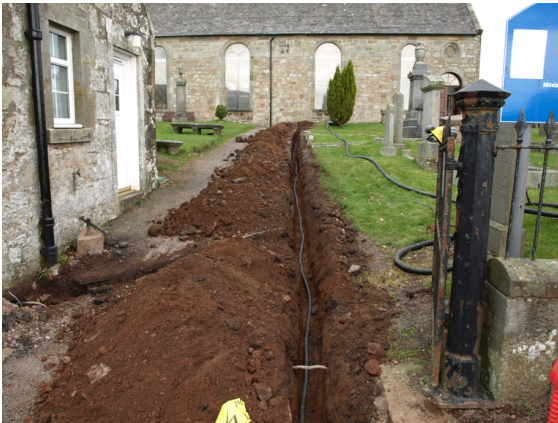
The excavation of the cable trench showed that the church stands on the sand and gravel layers of Ba' Hill, probably a glacial feature, and probably quite well drained. As expected, there were no surprising burials or structures encroaching on the central path or the original church foundations, though at least some of the burials were shallower than might have been expected. The layout of the church and churchyard seems to be still more or less as planned in 1729. The surface of the path has undergone a change from sandstone slabs to a tarmac layer, perhaps to provide a suitable smooth and flat surface, free of the trip hazards that form as stone slab surfaces settle into relatively uncompacted ground.

Illus 11 Trench complete, looking N

No further excavations are required in connection with the present works. It appears that the established central path is free of burials and structures, apart from the path surfaces, and therefore a good choice for any future service tracks if required. The burials, though well laid out, can lie as close as 0.5 m to the surface, and this should be borne in mind if any works are required amongst the graves, for example if the lighting system is to be renewed in the future.
