Archaeological Standing Building Record Tay Ropeworks Magdalen Yard Road DUNDEE DD61

ARCHAEOLOGICAL STANDING BUILDING RECORD TAY ROPEWORKS DUNDEE

The C-listed façade of a former ropeworks and newer buildings to the rear were recorded in advance of the demolition of the buildings and reconstitution of the façade as part of a new housing development. The base of the façade possibly dates from 1837, with the first floor from 1910. The rear buildings were found to incorporate brick and stone standing walls deriving from the original ropeworks, most of which had already been demolished. The survey (site code DD61) was carried out on 6th August, 2021.

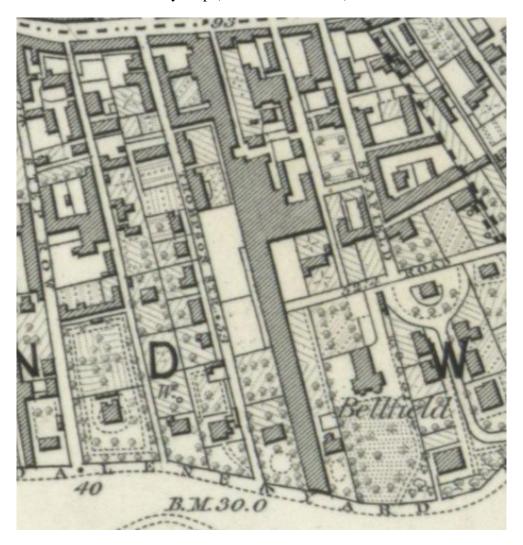
OS 1st Edition, surveyed 1860-62; the ropeworks appears as part of a continuous building conglomeration stretching between Magdalen Yard and Perth Road. The N part of this area is now broken up by the Seafield Close/Lane housing development.

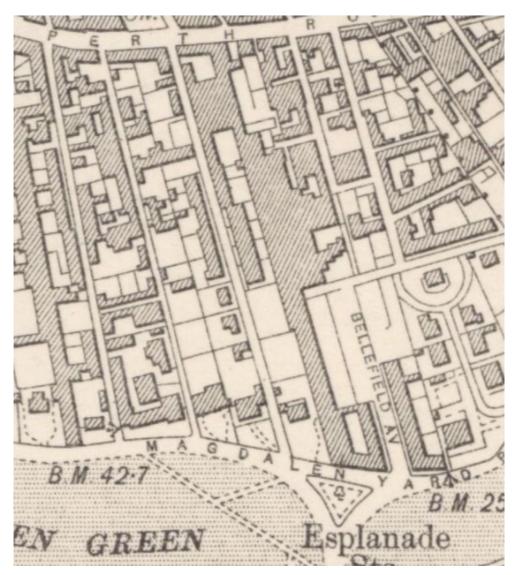
OS 2nd Edition, revised 1898, published 1903

The Second Edition map shows no major changes, beyond the construction of Bellefield Avenue and a building at the SE corner:

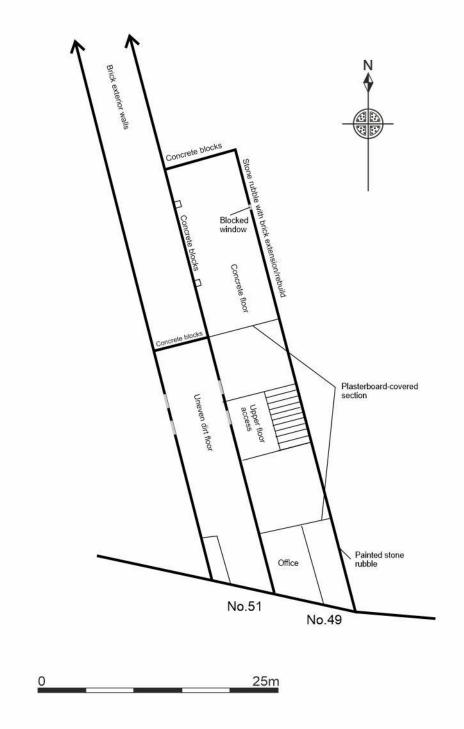
Illus 2 Floor plan of E and W standing buildings

E building

The E wall was constructed largely of original sandstone rubble, standing 3.40m tall to the wallhead; there had been some brick rebuilding/extending at the wallhead to reach this height, except at the N end where the stone reached fully to the top. A brickblocked window, 1.10m tall x 0.75m wide, was located 6.00m from the N end, 1.00m above the modern concrete floor. Another window, also blocked, sat directly above at the wallhead, with a second 0.80m to the S. The opposite, W, wall was largely built of concrete blocks; the base of this wall on the E (outer) face was of brick, but no trace of this was apparent in the interior. Brick buttresses were spaced along the length of this wall. The NNW elevation was of concrete blocks, while 17.91m to the SSE was a wooden partition, beyond which the central core of the building was clad in plasterboard and subdivided into modern office spaces. No original features were visible in this area, which also featured an upper floor (not safely accessible). The SSE end of the E elevation, beyond the plasterboard cladding, was once again of exposed stone rubble, but this had been painted white and extensively graffitied. No features were visible, except a 0.20m tall layer of bricks at the wallhead to support the corrugated metal roof. The base of the W side of the SSE elevation was within an enclosed office formed from wooden partitions. This elevation featured a window set within an embrasure measuring 1.20m tall x 1.00m wide, 0.55m deep (wall thickness); the window itself (of modern glass) was 0.90m x 0.50m and clearly replaced what was probably an original feature. Within the same office space, the W elevation featured a stretch of exposed, black-painted stone wall, standing 1.80m tall, around a modern aluminium flue and presumed former location of a gas heater. The office itself enclosed an area 6.39m NNW-SSE x 3.64m transverse.

W building

This comprised a single room, measuring19.32m NNW-SSE x 5.21m, 8.75m tall from an uneven, guano-covered floor to a high, wooden A-frame roof which was possibly original, or incorporated some original beams. Rows of steel girder corbels indicated a former first floor 2.00m above the ground and a second floor at 4.20m. Blocked arches in the W elevation, ground floor, were probably ornamental, while a pair in the opposite E elevation may once have been entrances to the E building. The W elevation also featured a row of five blocked, rectangular, 2.50m tall windows at first floor level, while the E elevation included smaller, arched, blocked windows at first floor and glazed widows at the wallhead. Both E and W walls were red brick, while the NNW elevation was of concrete blocks. The SSE elevation, the rear of the Magdalen Yard Road façade, was of white-painted stone rubble.

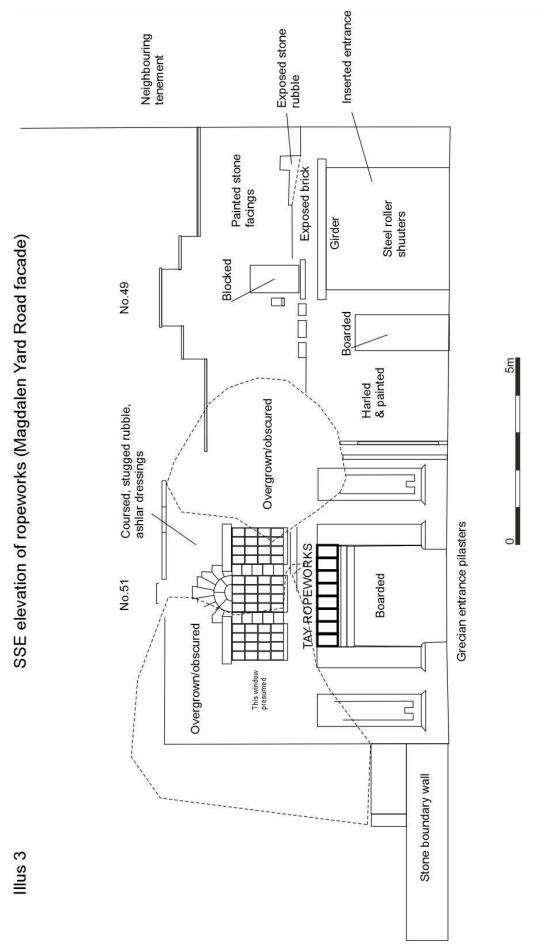
Illustration 3: SSE elevation of ropeworks (Magdalen Yard Road façade)

The ground floor of the Magdalen Yard Road façade (S elevation of the buildings) was, on the W of the two buildings, of grey-painted ashlar blocks, with side pilasters bearing

inscribed neo-Classical panelling. Although heavily overgrown with ivy and overhanging trees, the entrance sign- "Tay Ropeworks"- was still visible in embossed, painted lettering. The first floor was of coursed, stugged rubble with ashlar dressings, including an arch framing a Venetian-style window, still glazed. Below the sign, a row of eight modern fixed panes sat above the boarded entrance. The E building featured an inserted steel roller door below modern brick reinforcement; the remainder of the ground floor was harled and painted. The first floor featured a stepped gable façade with painted stone facings overlaying a rubble core (visible in a damaged section near the base of the E side). A blocked first floor window with ashlar façade casing, measuring 1.20m x 0.55m, was visible just E of the centre line, above the W end of the inserted door. A boarded ground floor doorway, 2.50m x 0.90m, was positioned just W of centre.

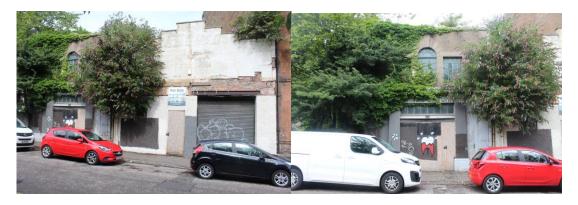
Magdalen Yard Rd façade

W end of same

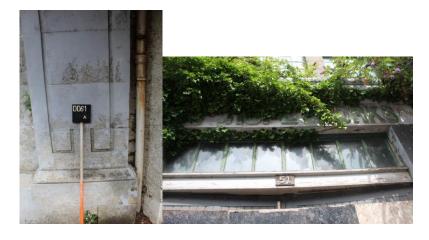
Detail, Grecian decoration

Detail, embossed sign

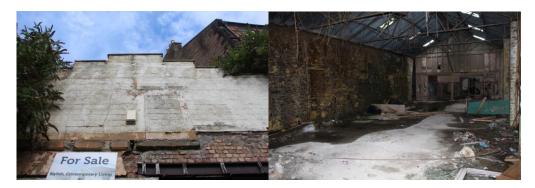
Detail, stepped gable

General view, interior of E building
