Historic Building Survey
Easter Dalmeny
South Queensferry
CITY OF EDINBURGH
EB16

**HISTORIC BUILDING SURVEY
EASTER DALMENY
CITY OF EDINBURGH**

EB16

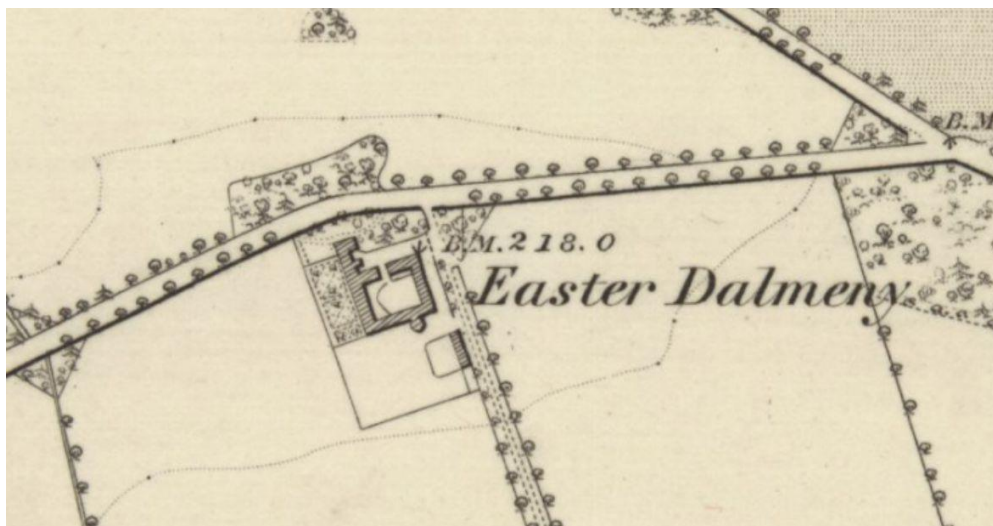
OS 1st Edition (published 1856), the S block is joined to the remainder of the steading

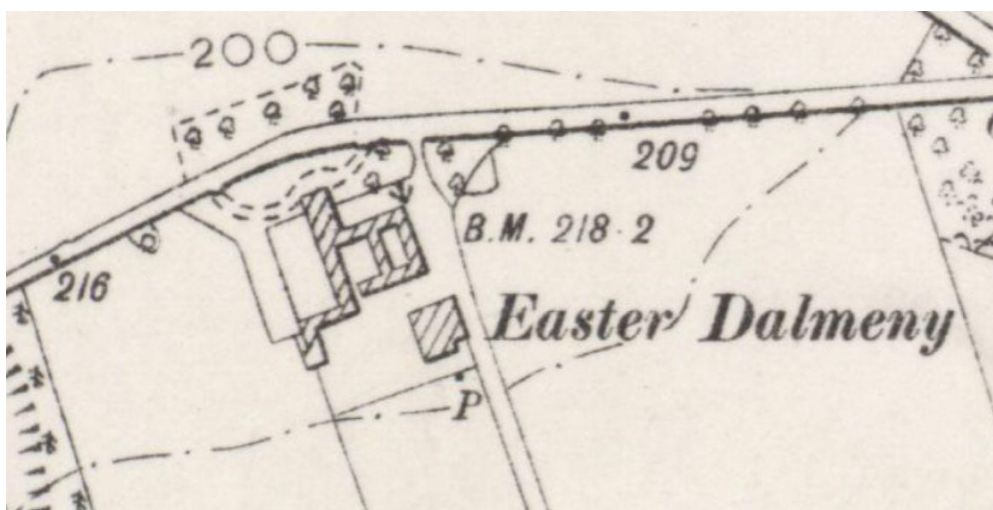
OS 2nd Edition (published 1897), the S block is detached at the W end and an additional linking block has been constructed around the mid-point of the N elevation

W elevation: this was mainly blank, but bore traces of a gable ghost at the approximate level of the first floor, probably indicating the W junction (since demolished) of the S block with the rest of the steading, as indicated on the 1st Edition OS map (see above).
