Archaeological Standing Building Survey  
Parkside  
Arbuthnott  
ABERDEENSHIRE  
INTERIM REPORT  
LK06

**ARCHAEOLOGICAL STANDING  
BUILDING SURVEY  
PARKSIDE  
ARBUTHNOTT**

**LK06**

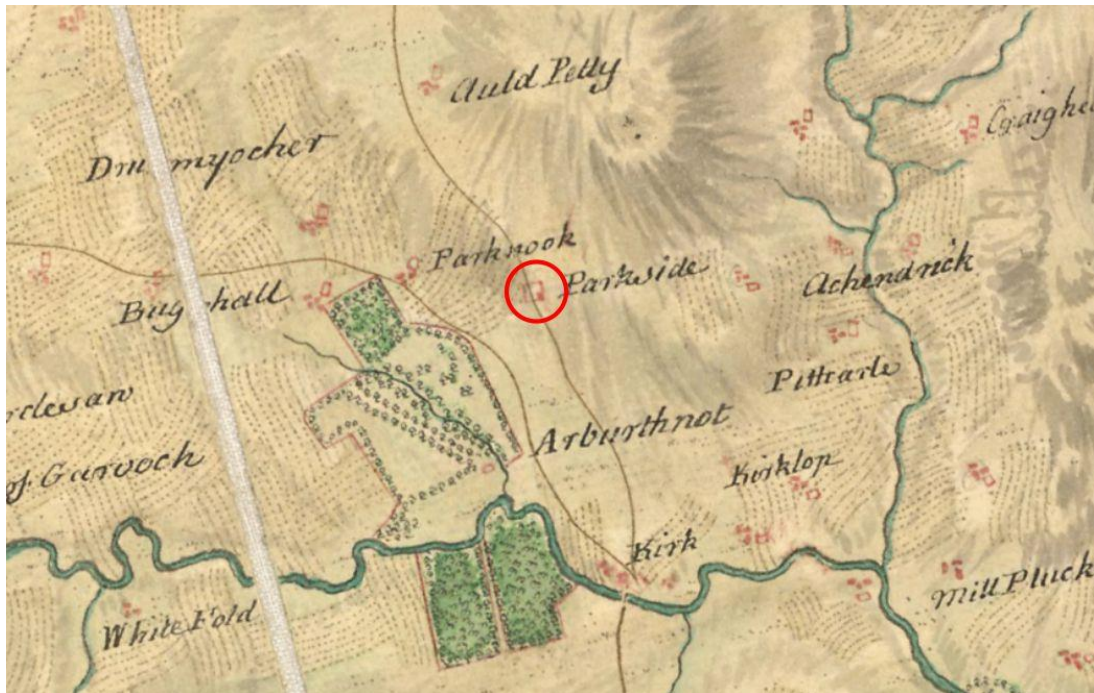
*Roy, 1747-52. Parkside is depicted as a building and attached enclosure- probably the present ruin is intended rather than the standing cottage to the SW (not shown).*

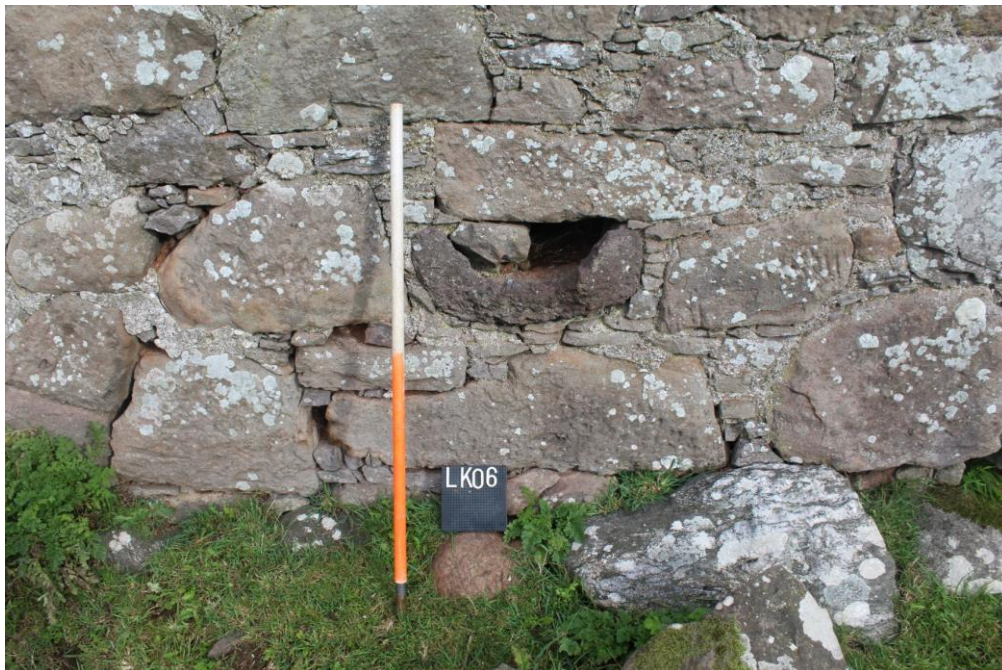
### *The water bowl/trough*

The centre of the elevation featured an open, unglazed, ground floor window, 1.15m tall x 0.80m wide, 1.20m above the present external ground surface. The sill was a single, roughly-moulded block, but the lintel was formed from two unequal blocks, possibly suggesting a repair to an originally single-piece lintel which had cracked. 0.95m W of the window were the remnants of a stone water bowl, trough or fountain, carved from a single (now broken) boulder and standing 0.50m above the present ground surface. This might perhaps have been intended for animal use, if not for general hand-washing.

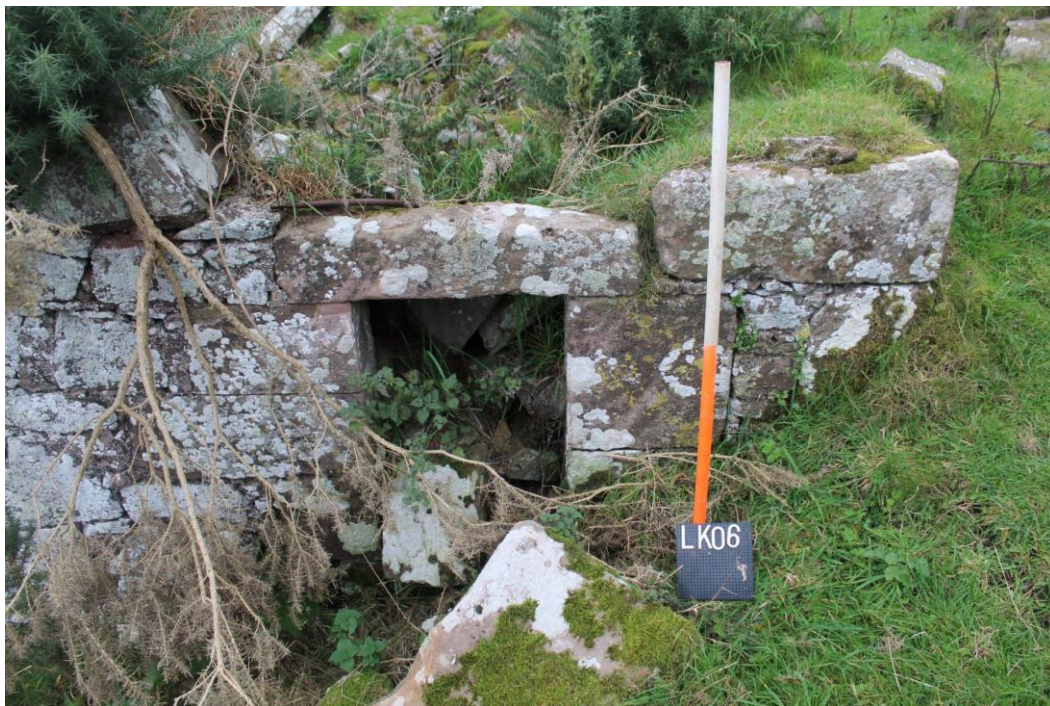
#### *The ground level window*

The E elevation was attached to the E of the S block in similar fashion, with a vertical line at the N end of the S block (see below). The elevation N of this line was mostly destroyed, surviving as footings up to 0.80m tall (albeit partly dug into the slope), across the 5.20m width of the central block. The only feature, which was nevertheless notable, was a ground level window or vent, partially blocked with rubble and c.0.60m tall x 0.40m wide:

This suggested there may have been a cellar floor beneath the central block, the interior of which was too full of tumbled stone rubble to discern any further such evidence.

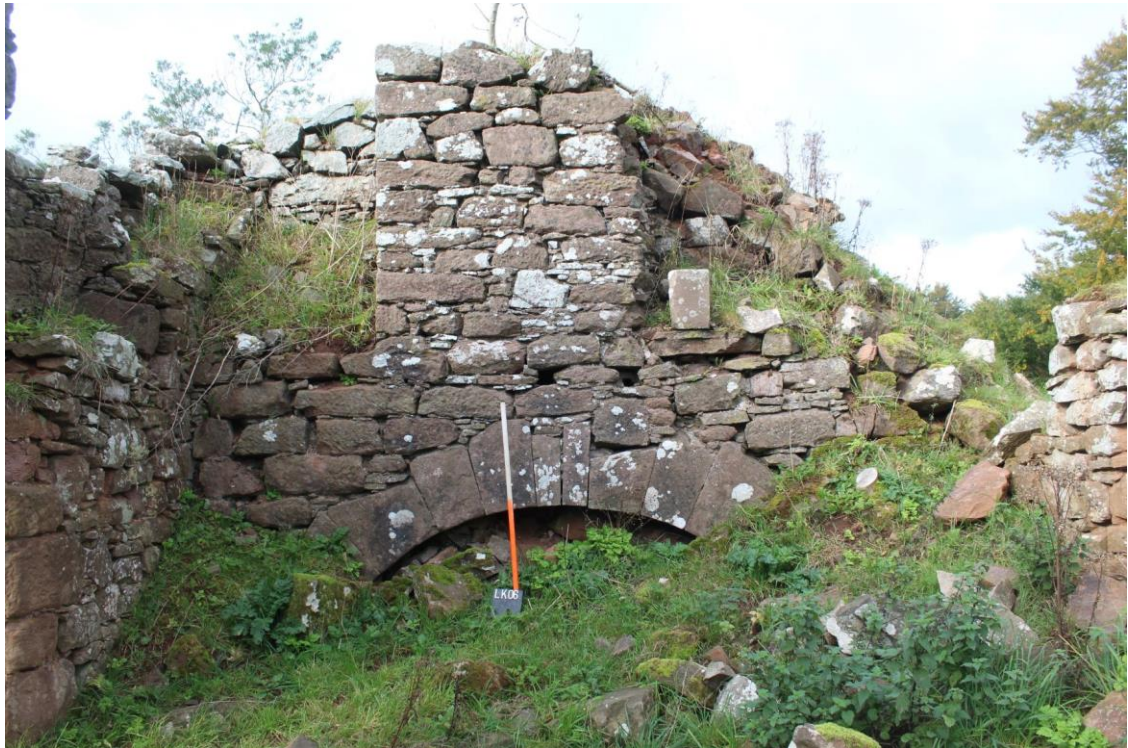
roofless condition was relatively recent. A possible beam slot for the first floor was also present in the S elevation, with three similar features in the W elevation (approximately 0.10m above the lintel of the S elevation ground floor window). The most notable feature, however, was a chimney flue built against the W elevation (into which the beam slots were cut), with an arched fireplace below. The flue was the full height of the interior wall face (3.00m), while a 2.00m wide, 1.00m high stretch of the fireplace arch was visible above the tumbled rubble. The arch was formed of rough-dressed, stugged, precisely-fitted blocks and would have been quite an unusual, archaic feature by the 18<sup>th</sup> Century, which might indicate an earlier foundation date for the house.

*Fireplace and flue, central block main room*

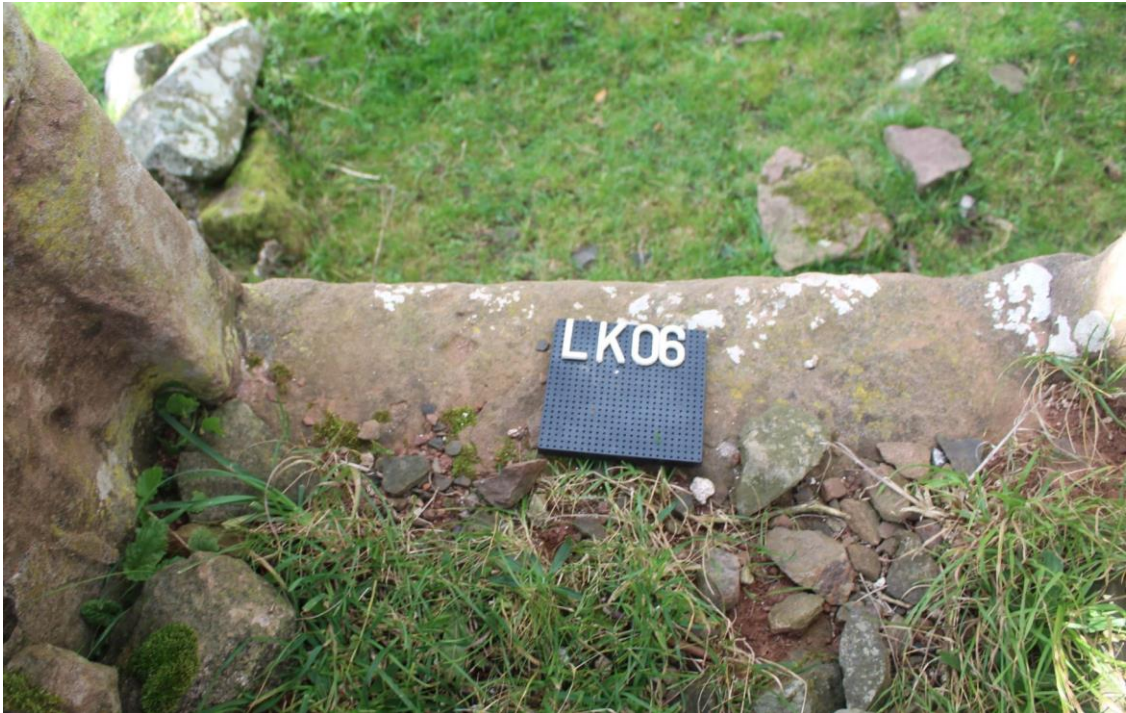
The S block interior was also filled with rubble, obscuring most of the internal wall faces. However, the windows in the E and W elevations (see above) could be examined and were found to feature quite finely moulded interior jambs. The W elevation window, moreover, featured a small, angular hole in the sill which may have been a socket for a vertical bar.

*Window sill, S block*
