**Photographic Building Recording
The Lodge
Ruthven Towers
AUCHTERARDER**

**PHOTOGRAPHIC BUILDING
RECORDING
THE LODGE
RUTHVEN TOWERS
AUCHTERARDER**

Hallgate Construction Ltd commissioned Alder Archaeology Ltd to undertake a photographic survey of a small lodge close to Ruthven Towers in Auchterarder. The work was carried out on the 26th of October 2009 in good weather conditions. The aim was to provide a photographic record of the lodge prior it being demolished. The building was extensively photographed externally and internally and was found to be of very late 19th century or early 20th century date. There were two 20th century extensions, probably dating to the 1930s. The site code was AA12.

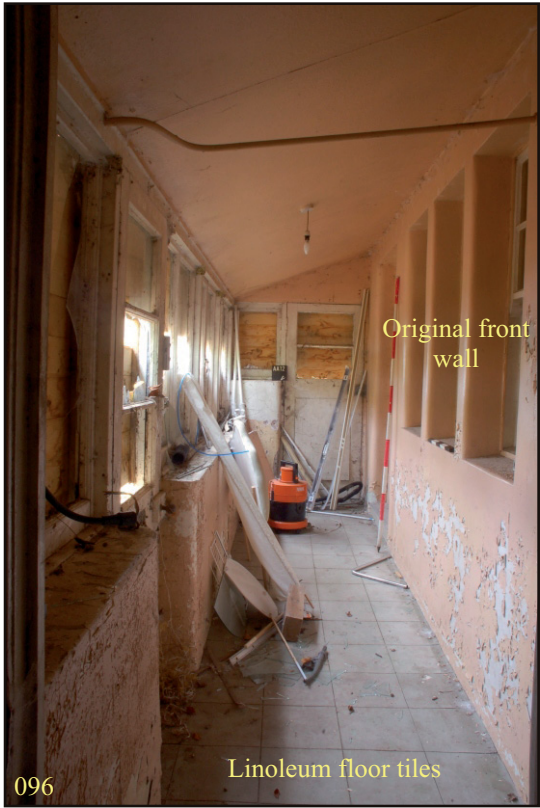
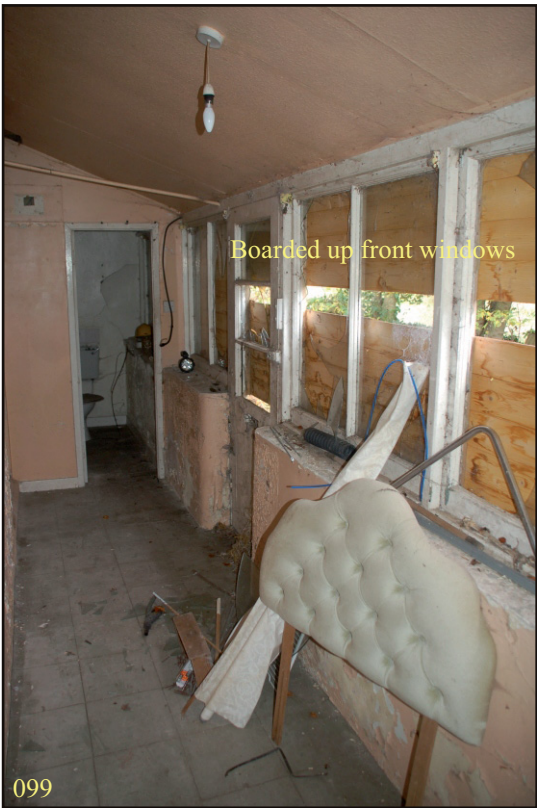
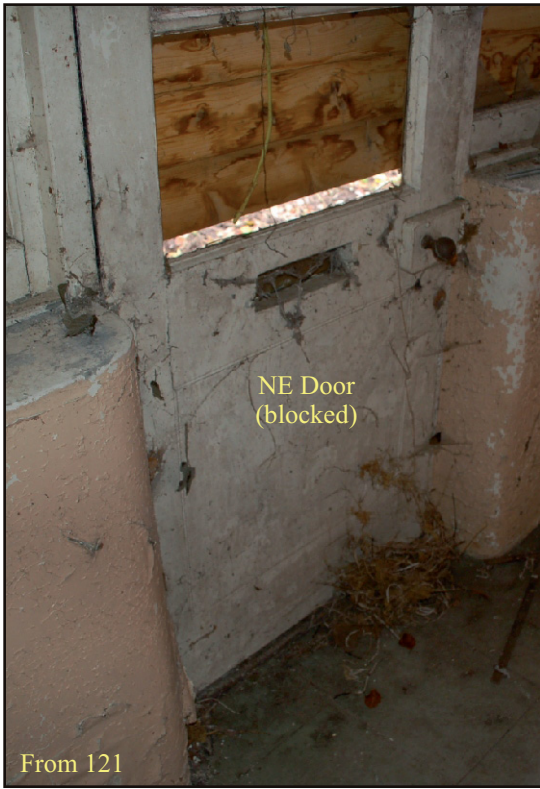
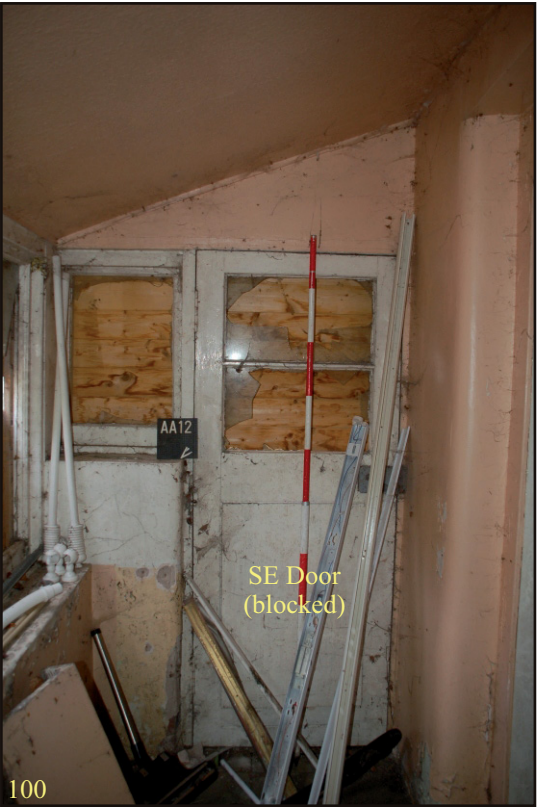
Illus 10 The front extension (excluding bathroom)

The second phase is represented by the building of extensions to the front (NE) and back (SW) of the house, essentially a couple of lean-tos. The front extension is little more than a metre high wall with a continuous line of casement windows above (now boarded up). Its roof is at a shallow angle and is covered in darker, thinner more uniform slate than the original roof. The rear extension is slightly wider than the front with a 1.8m high wall containing just 3 windows (now blocked). The roof of the rear extension is covered in similar slate to that of the front but is at an even shallower angle. This area seems to have been used as a kitchen and storage area.
