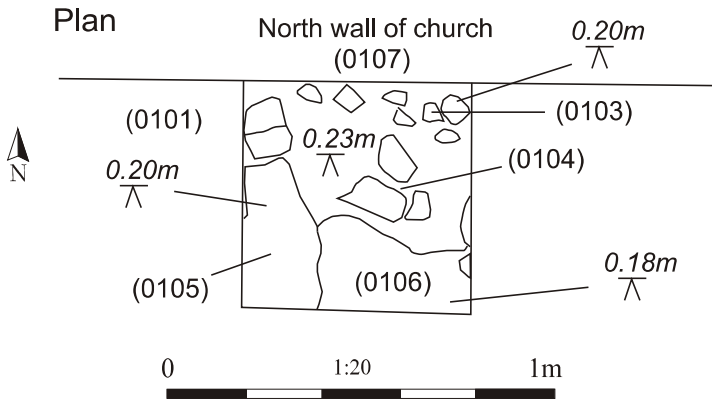
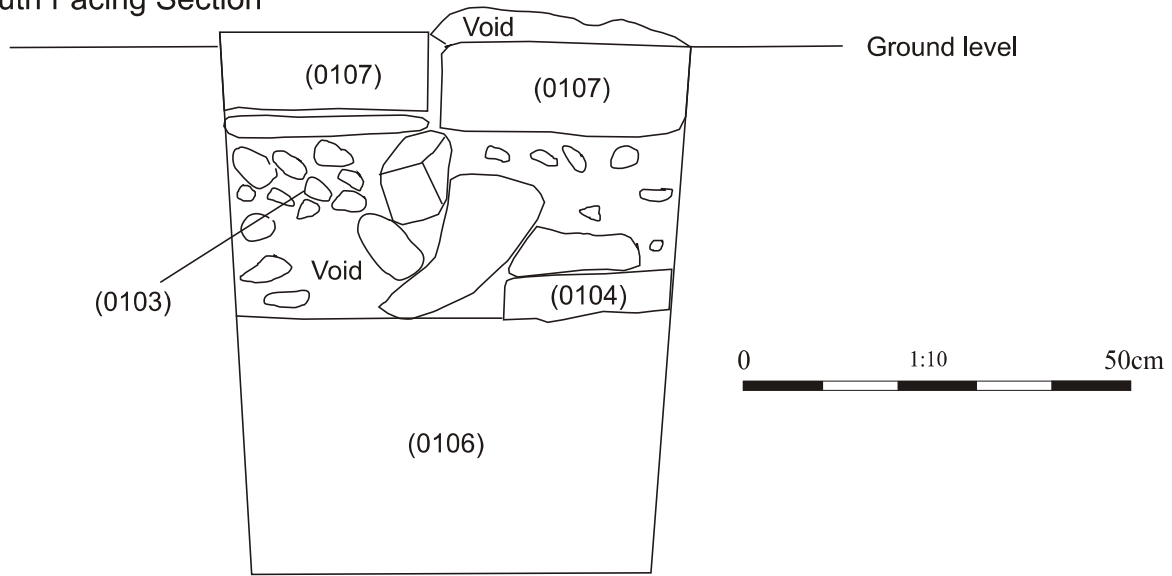
**South Facing Section**

- (0101) Turf
- (0103) Small fragmented stone packing against wall
- (0104) Medium sized stone fragments and large rounded split boulder
- (0105) Crushed yellow / light brown sandstone below turf
- (0106) Mid brown clayey silt with occ small stone frags - hill wash
- (0107) North wall of church

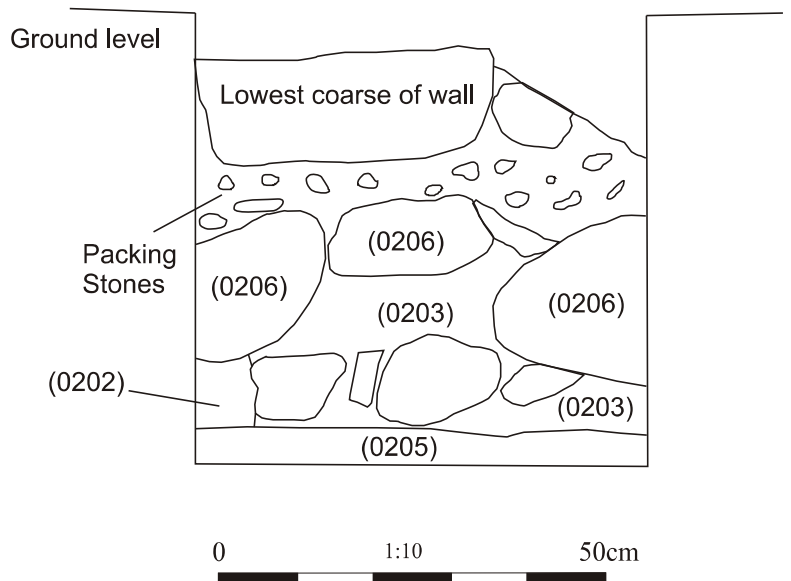
**East Facing Section**

- (0201) Topsoil containing mortar
- (0202) Degraded sandstone, sub-angular to sub-rounded, continues to natural
- (0203) Dark reddish brown silty clay firmly compacted with mortar frags
- (0205) Natural, reddish brown silty clay
- (0206) Large sub-rounded boulders

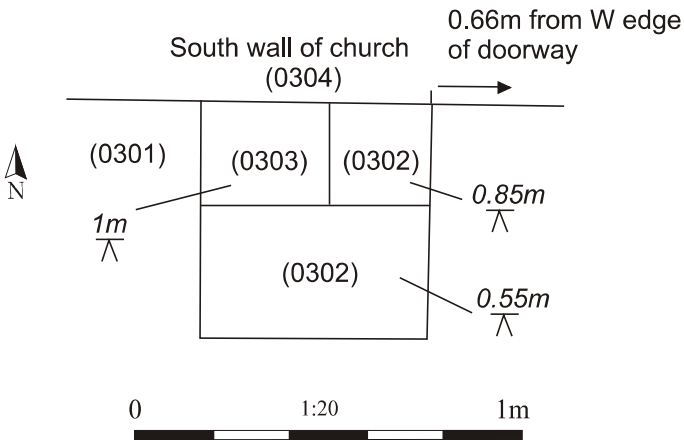
**South Facing Section**

- (0301) Turf
- (0302) Grave yard soil, black loam with disarticulated human bone
- (0303) Mid-light brown hard compact silt
- (0304) South wall of church, stonework dressed
- (0305) Foundation stone, undressed fragmented

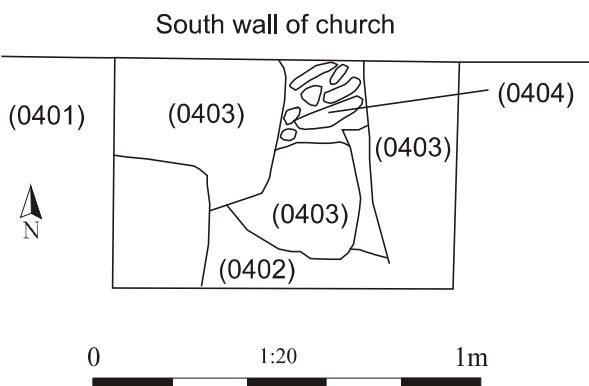
**South Facing Section**

- (0401) Topsoil
- (0402) Medium brown clayey silt medium compaction
- (0403) Very Large sub-rounded boulders
- (0404) Jumble of sub-angular and angular medium stones
