Archaeological Watching Brief  
at  
The Fair Maid's House  
21 & 23 North Port  
PERTH  
PE50

ARCHAEOLOGICAL WATCHING BRIEF  
FAIR MAID'S HOUSE  
PERTH  
PE50

*Neilson Binnie-McKenzie, on behalf of their client, the Royal Scottish Geographical Society, commissioned Alder Archaeology to undertake an archaeological watching brief (Alder Archaeology site code PE50) on the site of the redevelopment of the Fair Maid's House, 21 & 23 North Port, Perth as the headquarters and collection store of the RSGS. The work took place between April and November 2010.*

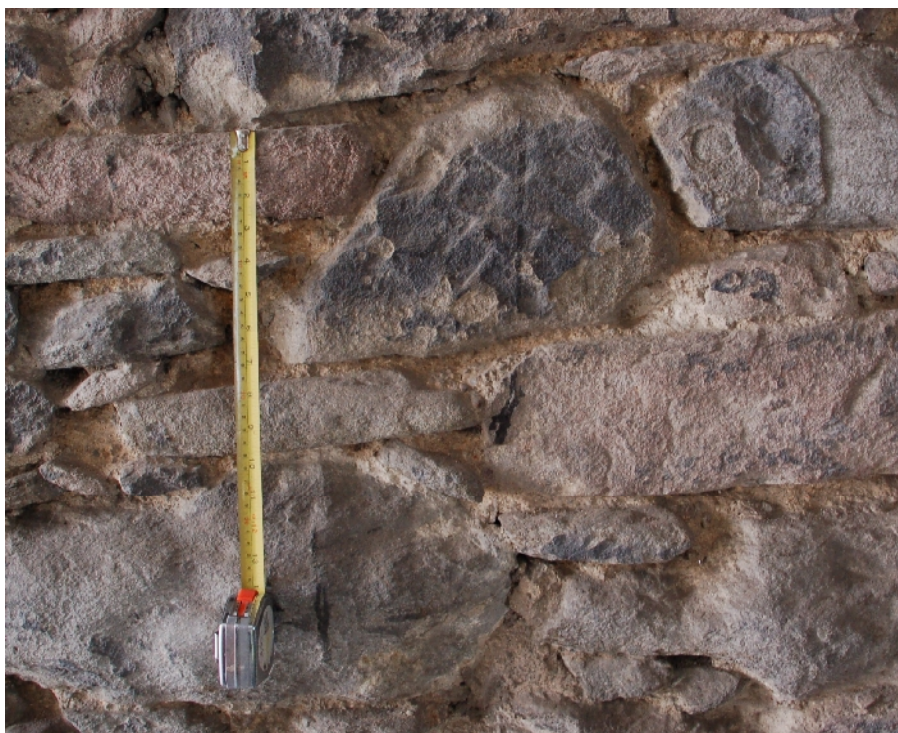
*Illus 4 Stone with chisel blade marks in wall 046*

The E wall of the new entrance lobby is formed by the 'Blackfriars Wall' (**046**), in which are a number of features – two fireplaces (probably original as they are at different floor levels from the current levels), a recess (**104**) (inserted later as it is at the current floor level), a salt cellar, evidence of a possible second salt cellar and a corbel (see below for more details about the two ground floor fireplace **098** and recess **104**). One stone in the face of the wall has chisel blade marks (Illus 4).

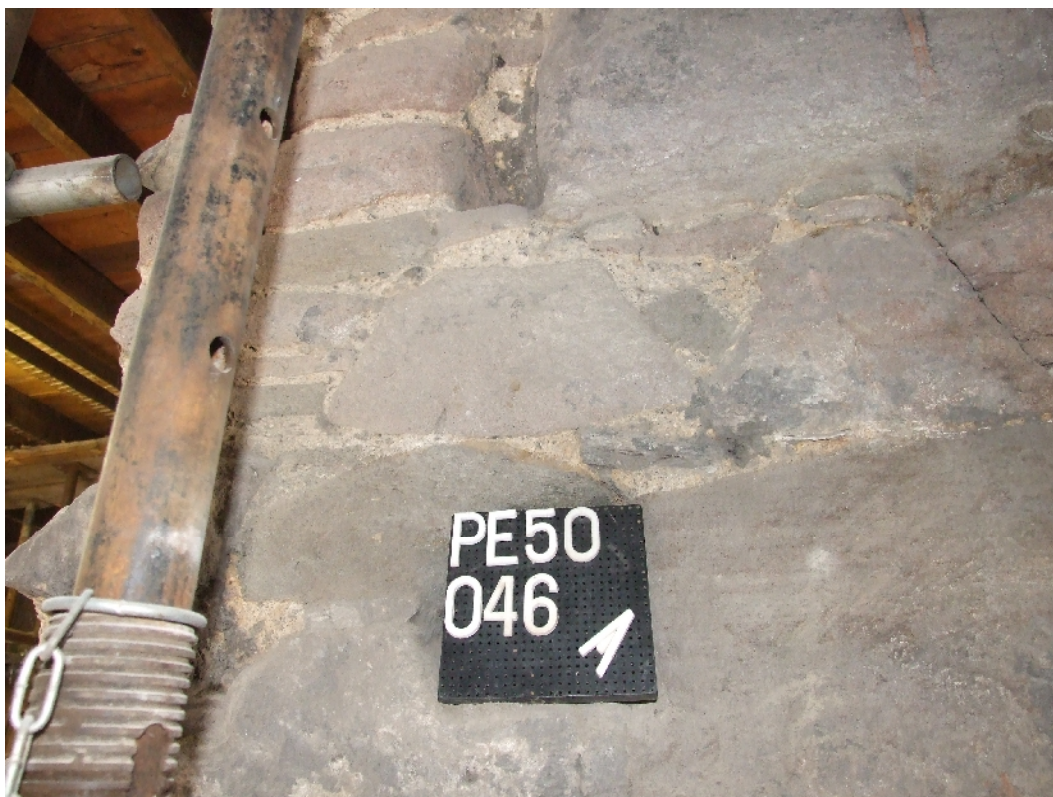
*Illus 5 Reused voussoir in outer face of wall 046 with oyster pinning, looking NW.*

Adjoining the S end of the 'Blackfriars Wall' was a rubble wall bonded with cement (**106**) in which was a segmental arch-headed fireplace with traces of paint on the voussoirs (**107**). The removal of this wall revealed the original external corner of the 'Blackfriars Wall' (the lowest stone of the N jamb of the fireplace was left in situ). The corner was composed of large quoins with a rounded edge at the corner. Oyster shells were visible between some of the quoins. One reused stone, a voussoir (Illus 5), was visible in the outer face of the original frontage wall, as were two, possibly three sockets, presumably for keying in stones of an extension wall or of an external addition (gallery?) to the frontage. The removal of wall **106** revealed that the original stone gable of Lord John Murray's stables had been replaced with a brick wall (**112**), leaving only the quoins on the street frontage. Excavation of a foundation for the new door (Pit D) did not extend below the existing concrete floor.

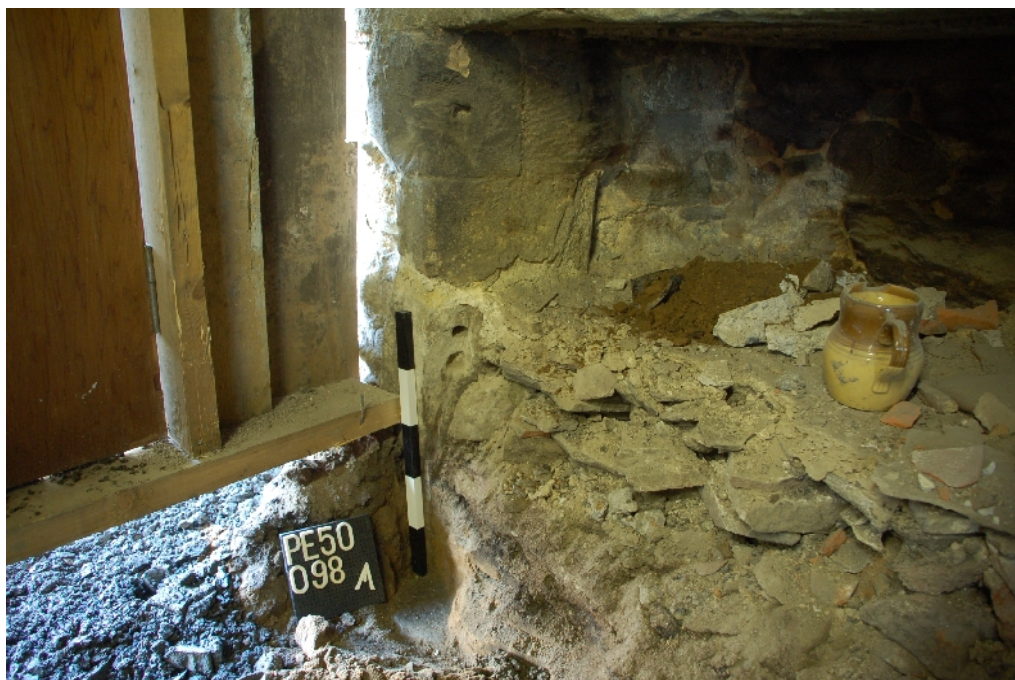
*Illus 6 Socketed stones in N jamb of fireplace 098 in wall 046, looking N.*

surface (101), which extended under the back wall of the recess. Under the bedding sand (102) for the cobbles was another levelling layer (105) that extended under the stone foundations (054) for the brick back (N) wall (096) of No 21 North Port. Beneath that layer were two large foundation stones of wall 046, one of which extended under the back (E) wall of the recess (these two stones remain in situ). The back wall of the recess contained a rotted horizontal timber, possibly a former floor timber at about the level of the recently removed raised concrete step. The base of the fireplace (098) was not reached, but a possible stone base was recorded at a depth of 0.95m below the chimney lintel (Illus 6). Two stones in the N jamb of the chimney have square sockets in them, but there are no sockets in the opposite jamb.

097	Same as 011
098	Lower fireplace in wall 046; 0.69m deep, 0.62m high above floor level, 0.915m wide; upper stone in N jamb of fireplace has a square socket 30mm wide, 25mm high, 35mm deep; lower stone in N jamb has two sockets 30mm apart; upper socket 25mm wide, 24mm high, 35mm deep; lower socket 30mm wide, 28 mm wide, 40mm deep (stone broken on face); removal of part of fill revealed that the two jambs on

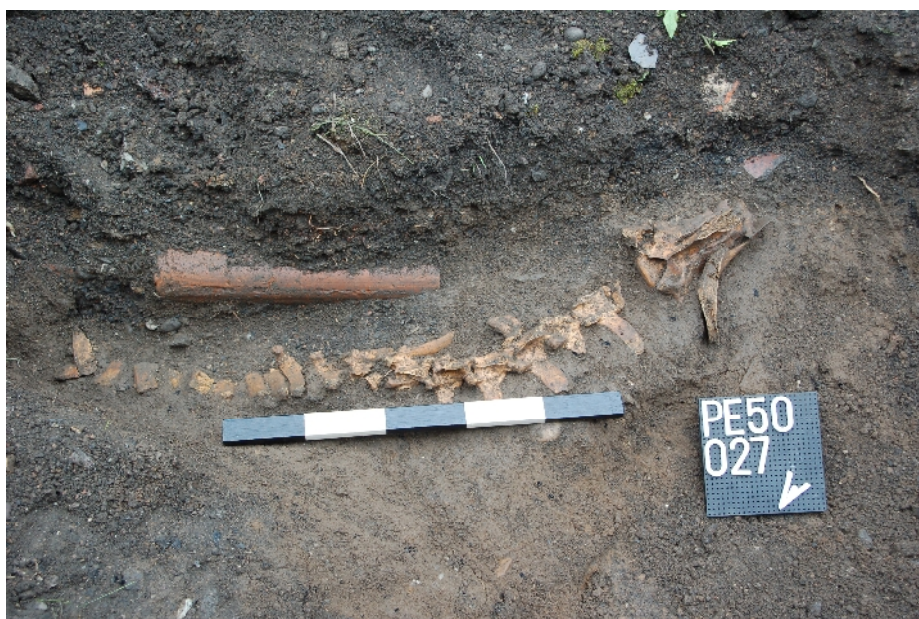
*Illus 7 Detail of cow spine in situ, 027, looking SE.*

The general stratigraphy in the garden area was straightforward. Above orange natural sand (050) was a thick layer (up to 0.5m) of 'garden soil' (012). Within the uppermost part of this layer was the articulated spine of a cow (027; Illus 7). Above that were mixed deposits removed as one layer (016), 0.4m thick. Above that was the turf and topsoil (006), up to 0.4m thick. Cut into the topsoil was a pet burial containing a cat skeleton (031).

deposits in the town centre in the 12th, 13th and 14th centuries. On this site on the northern edge of the medieval burgh, these distinct occupation remains have not survived because the continued re-working of the soil for building or cultivation or other use has prevented the development of anaerobic soil conditions, which would have allowed the survival of these features (Carter 2001). The recovery of the cow spine (**027**) from the 'garden soil' (the legs of the animal had been cut away by modern intrusions) is surprising. In the subsistence economy of medieval Scotland all parts of an animal carcass would have been used for food or other use; that this animal had been buried in a back garden suggests that it was diseased and unfit for human consumption.

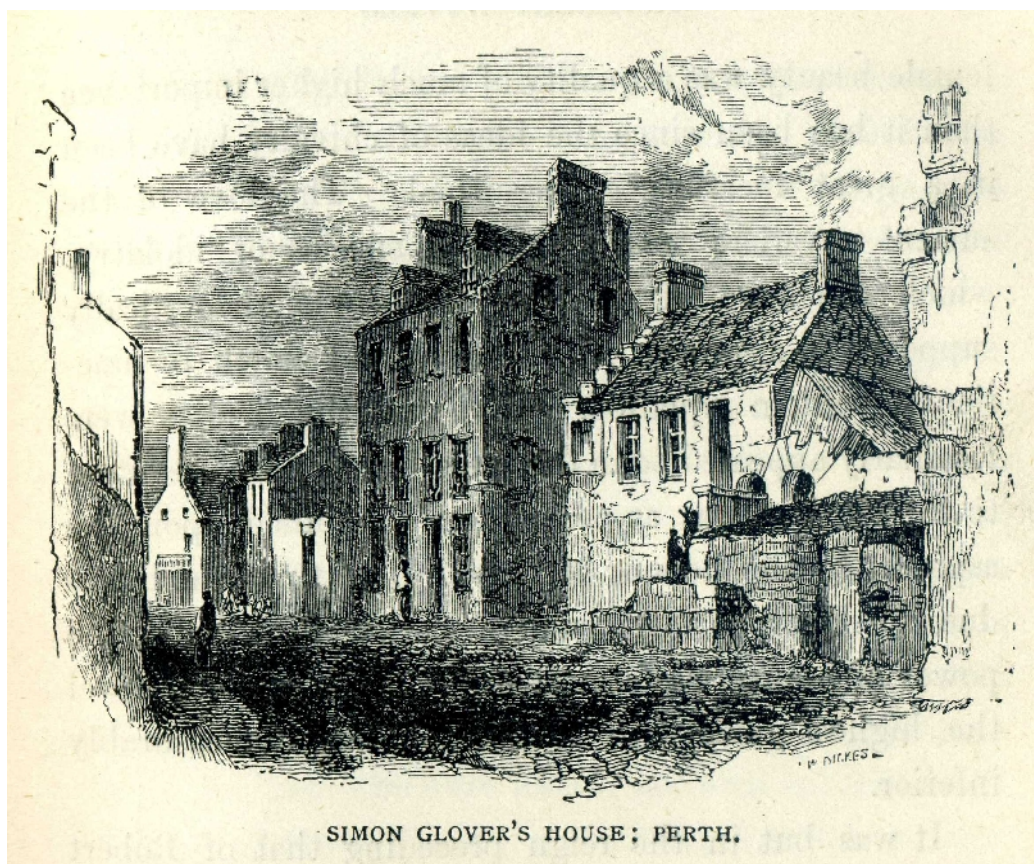
*Illus 8 'Simon Glover's House, Perth' by W Dickes, from The Fair Maid of Perth, 1879*

By 1879, when a drawing by W Dickes of 'Simon Glover's House' appeared in an edition of *The Fair Maid of Perth* (Illus 8), the roof of the western part of the building had apparently been altered to sit at a right angle to North Port. The lean-to in front of the building was still standing.

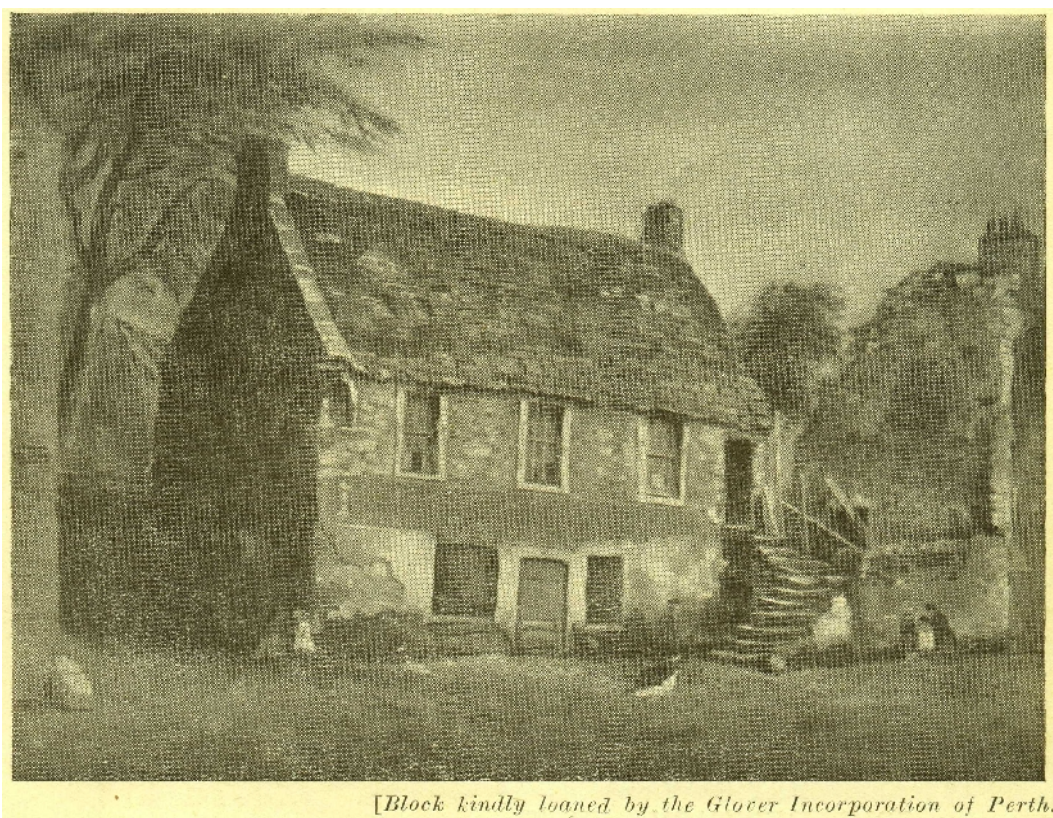
*Illus 9 The Glovers' block of the Fair Maid's House, (from P Baxter, Perth and Sir Walter Scott, 1932.)*

A print of the Fair Maid's House (Illus 9) from an undated wood block belonging to the Glovers Incorporation appears to show that No 21 North Port was roofless, if not demolished, with the lean-to in front of it now roofless. The gable with Lord John Murray's stables is visible although only a recess or door (**104?**) is visible.

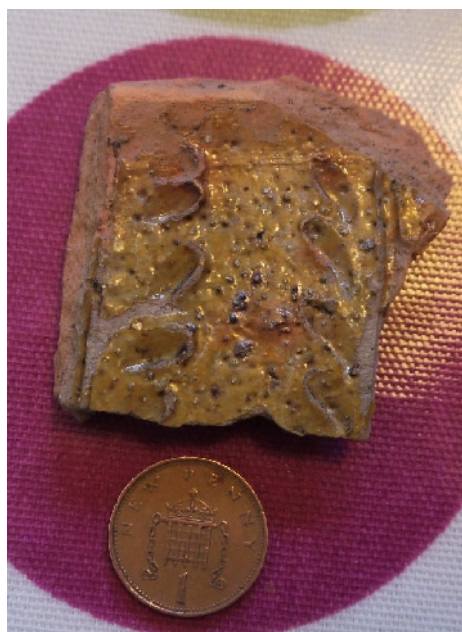
*Illus 10 Redware platter or dish found in Context 006.*

The 37 sherds in this fabric from this project, apart from a single sherd from Context 006, are all from splash glazed jugs dating between the 13th and 16th centuries and include a ribbed rod handle from Context 012 which is copying a Yorkshire vessel type. The single sherd from Context 006 appears to be from a green glazed platter or dish with incised floral decoration and is probably of 16th or 17th century date and is an unusual vessel type in this fabric (Illus 10).
