Geophysical Survey Ashton Keynes New Main Route

Abstraction and interpretation of magnetometer anomalies

FIG 04

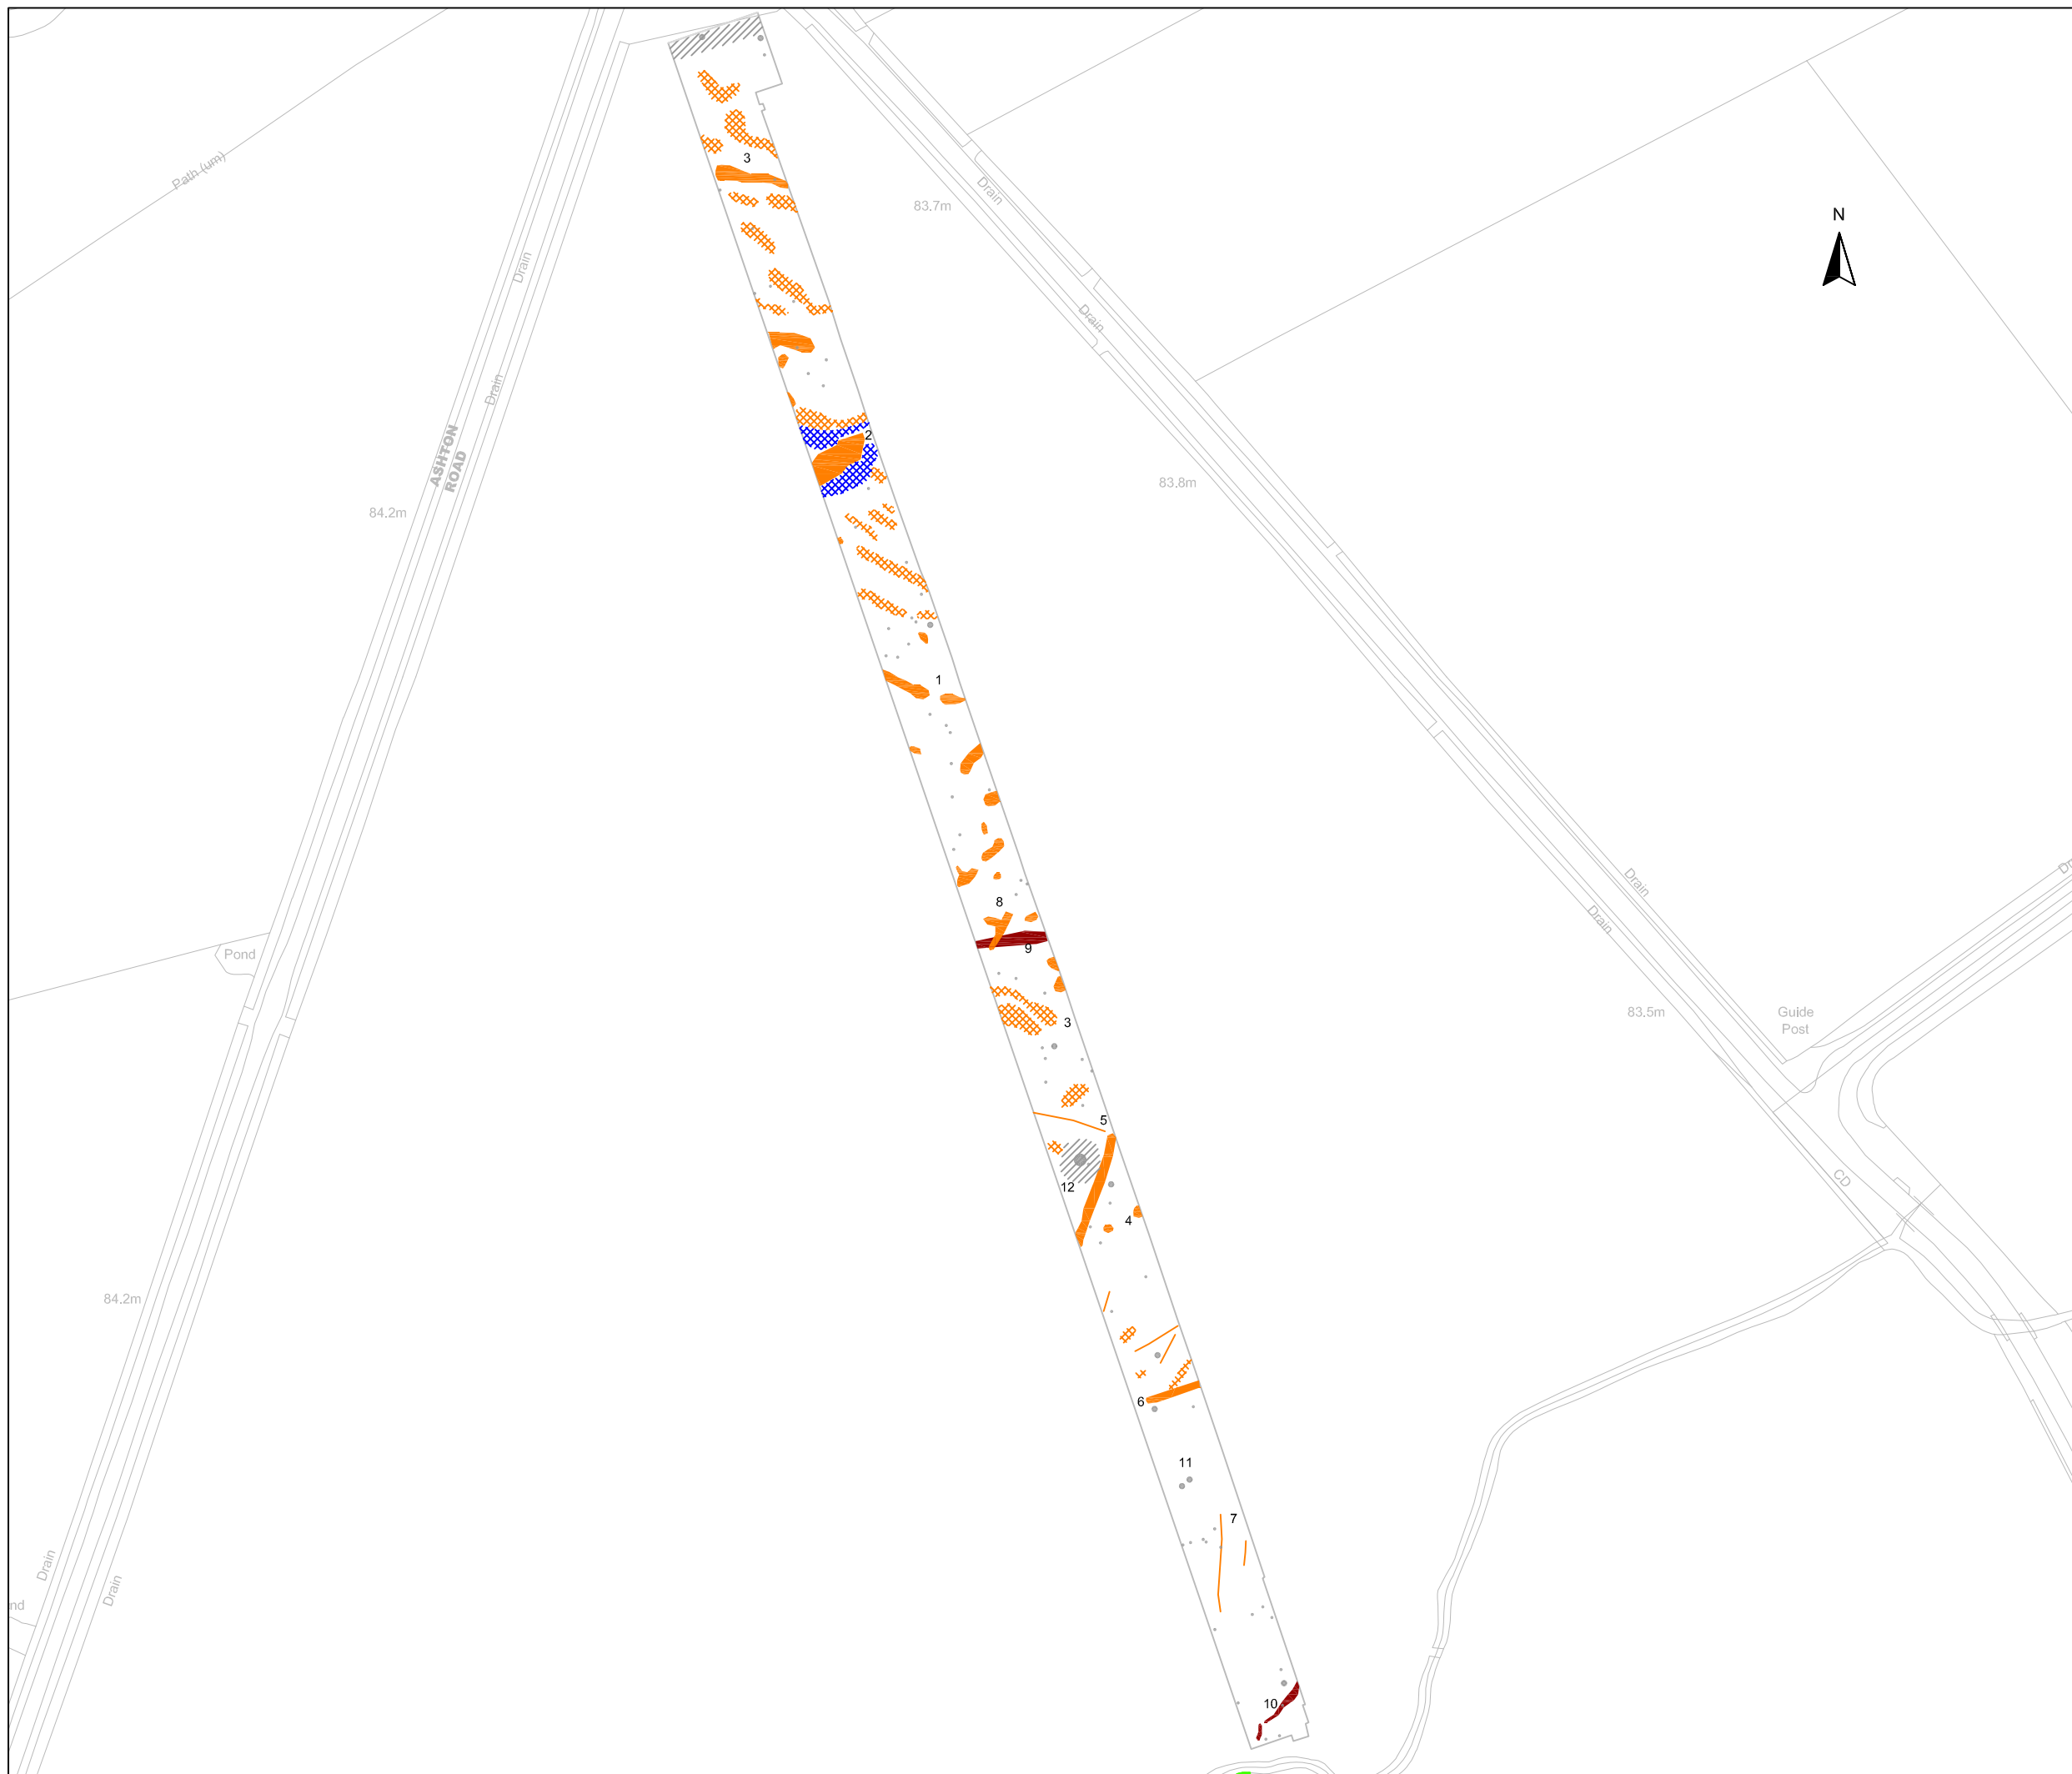
Positive linear anomaly - possible ditch-like feature
-

Positive linear anomaly - possible former field boundary
-

Discrete positive response - possible pit-like feature
-

Weakly positive anomaly - magnetically enhanced material
-

Negative anomaly - material of low magnetic susceptibility
-

Magnetic disturbance from ferrous material
-

Strong dipolar anomaly - ferrous object
