**Melksham Link
Wilts & Berks Canal
Wiltshire**

MAGNETOMETER SURVEY REPORT

Wilts & Berks Canal Trust

Ref. no. 586

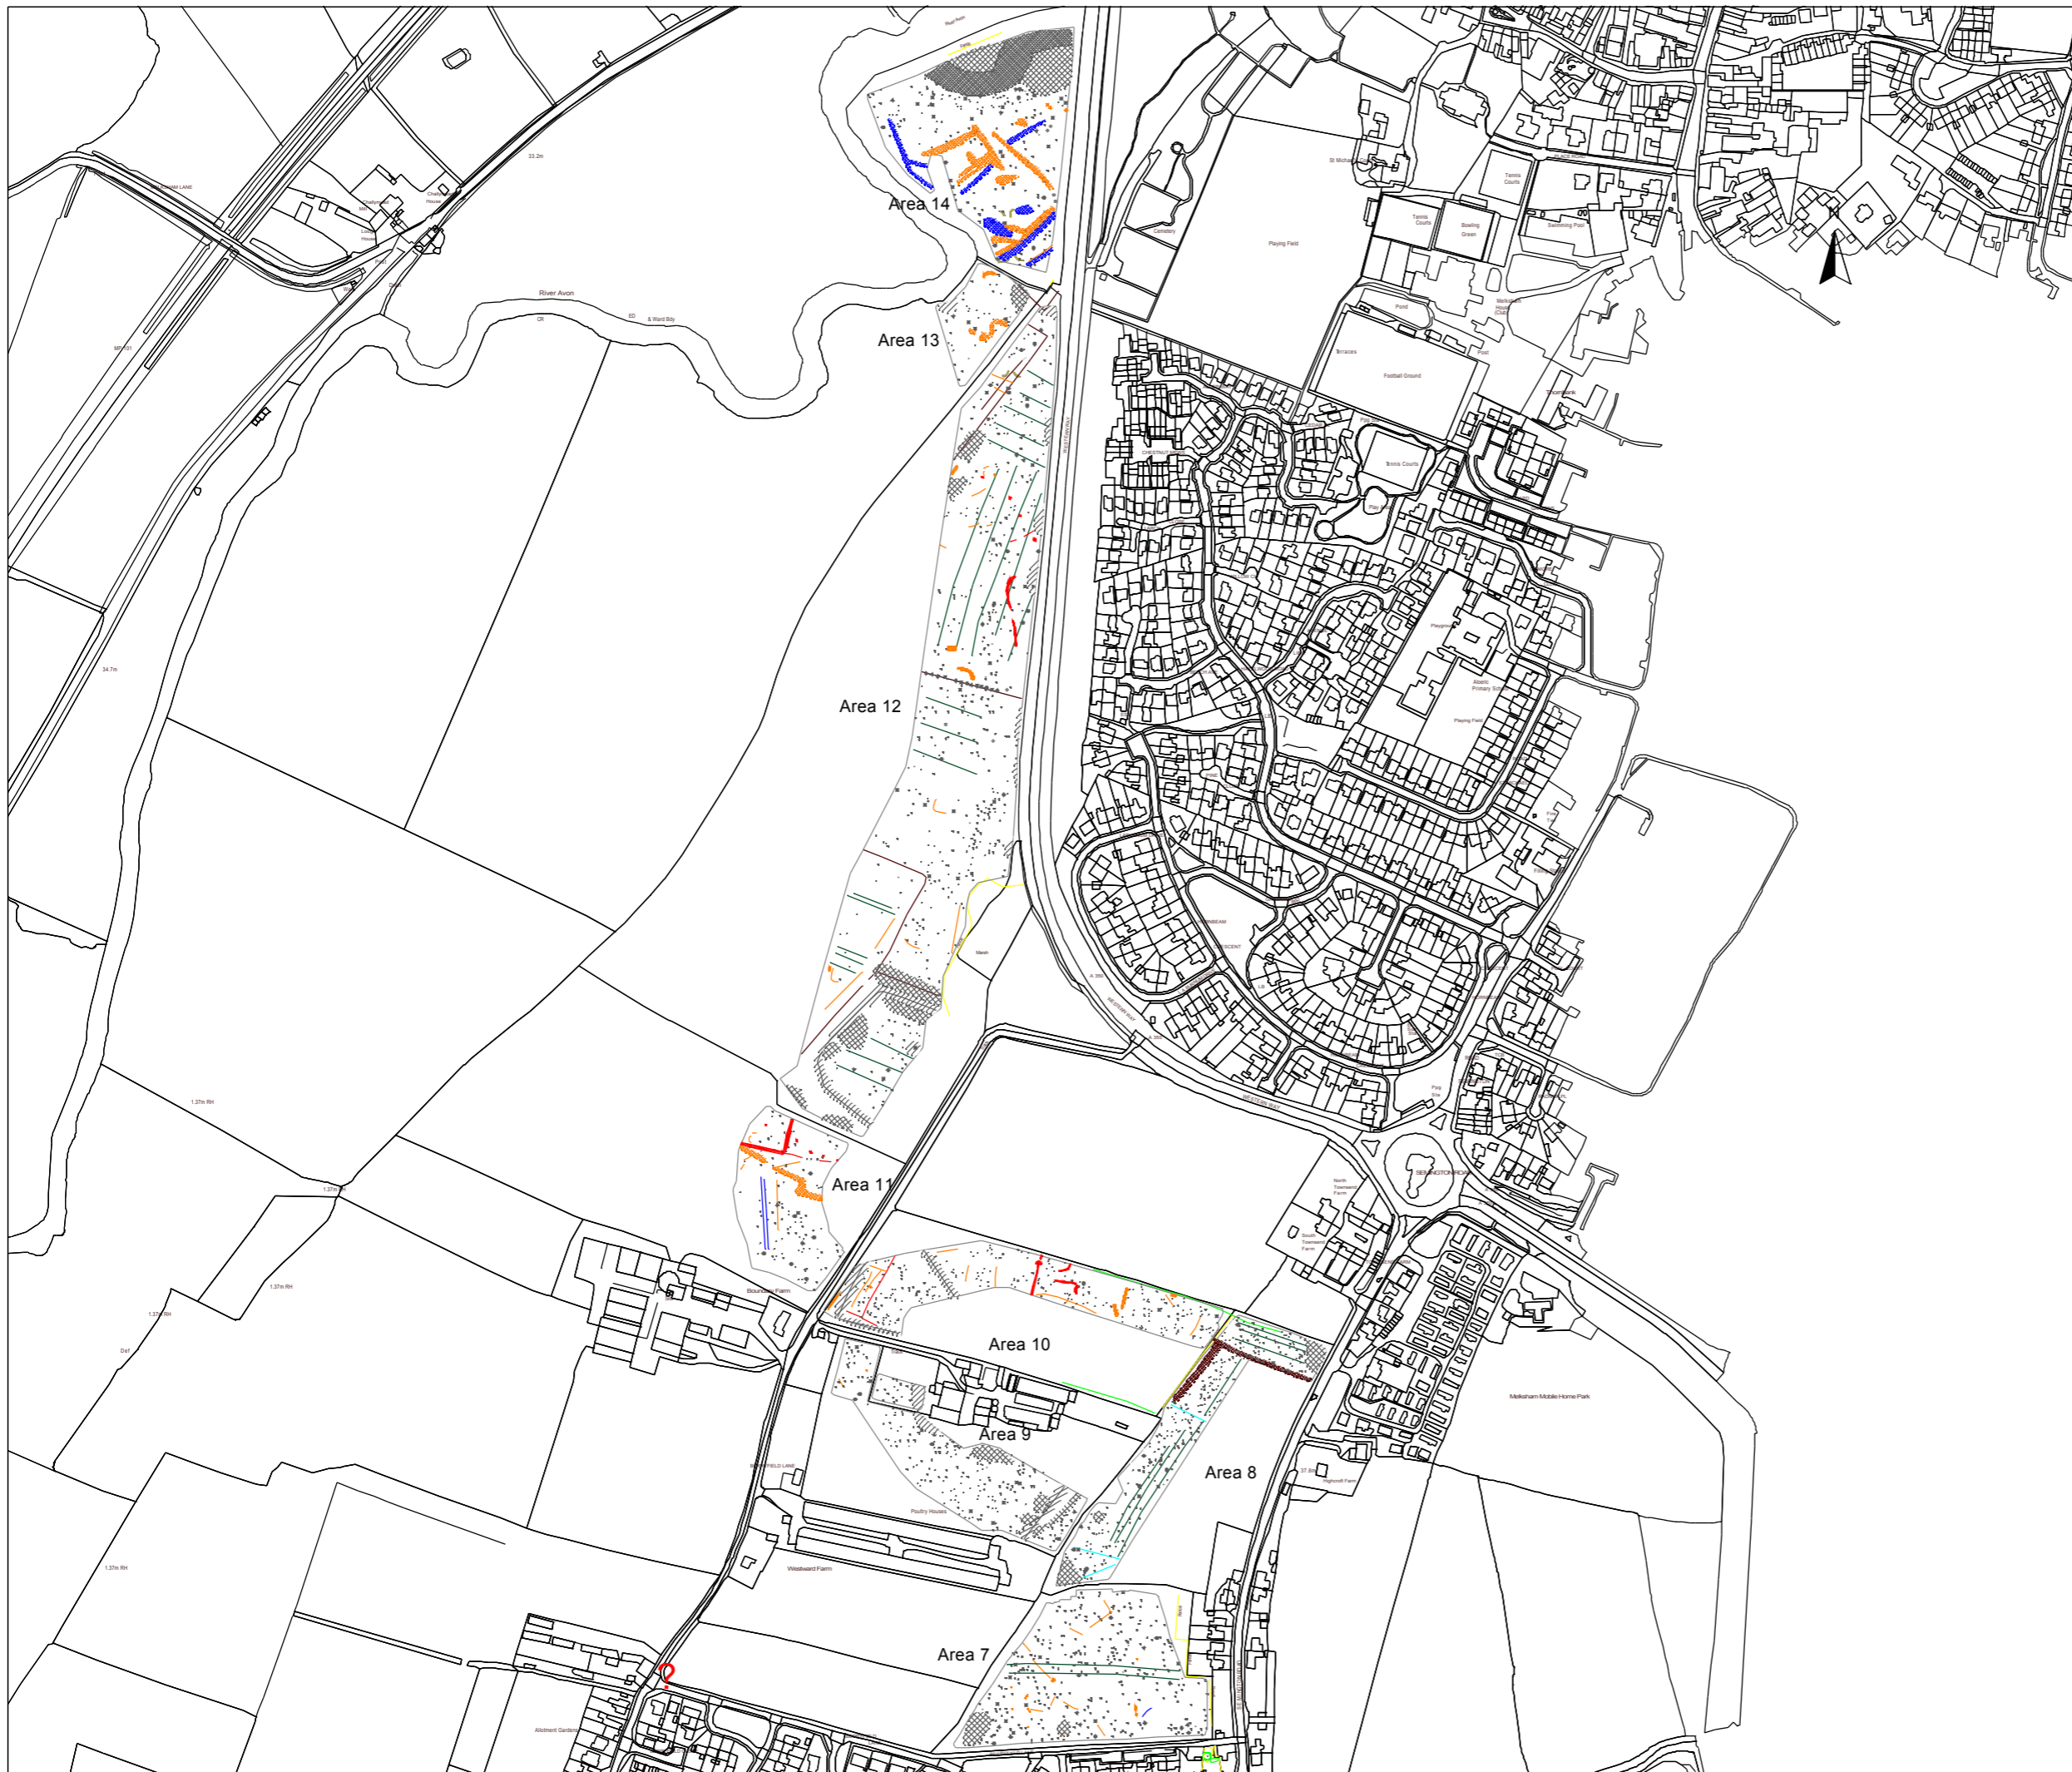
**Greyscale plot of minimally
processed magnetometer data -
Area 1**

Area centred on OS NGR 389812 161142, see Figures 07 & 08.

- (1) – A positive linear anomaly extends across part of the survey area. It is possible that this relates to an unmapped extension for the field boundary to the north east.
- (2) – The survey area contains a number of weakly positive and negative linear anomalies. It is possible that they relate to former ridge and furrow but their origin is uncertain.

- (3) – The survey area contains zones of magnetically variable responses which are likely to relate to natural features within the underlying soils and geology.

- (4) – Small patches of magnetic debris are evident at the southern end of the survey area. They may be a response to dumped magnetically thermoremnant material, such as brick and tile, that has been used for ground consolidation.

- (5) – Two strong, multiple dipolar, linear anomalies have been located within the survey area. These relate to a buried oil pipeline extending north west to south east

along the long axis of the survey area, and another service extending north east to south west near south eastern end of the survey area.

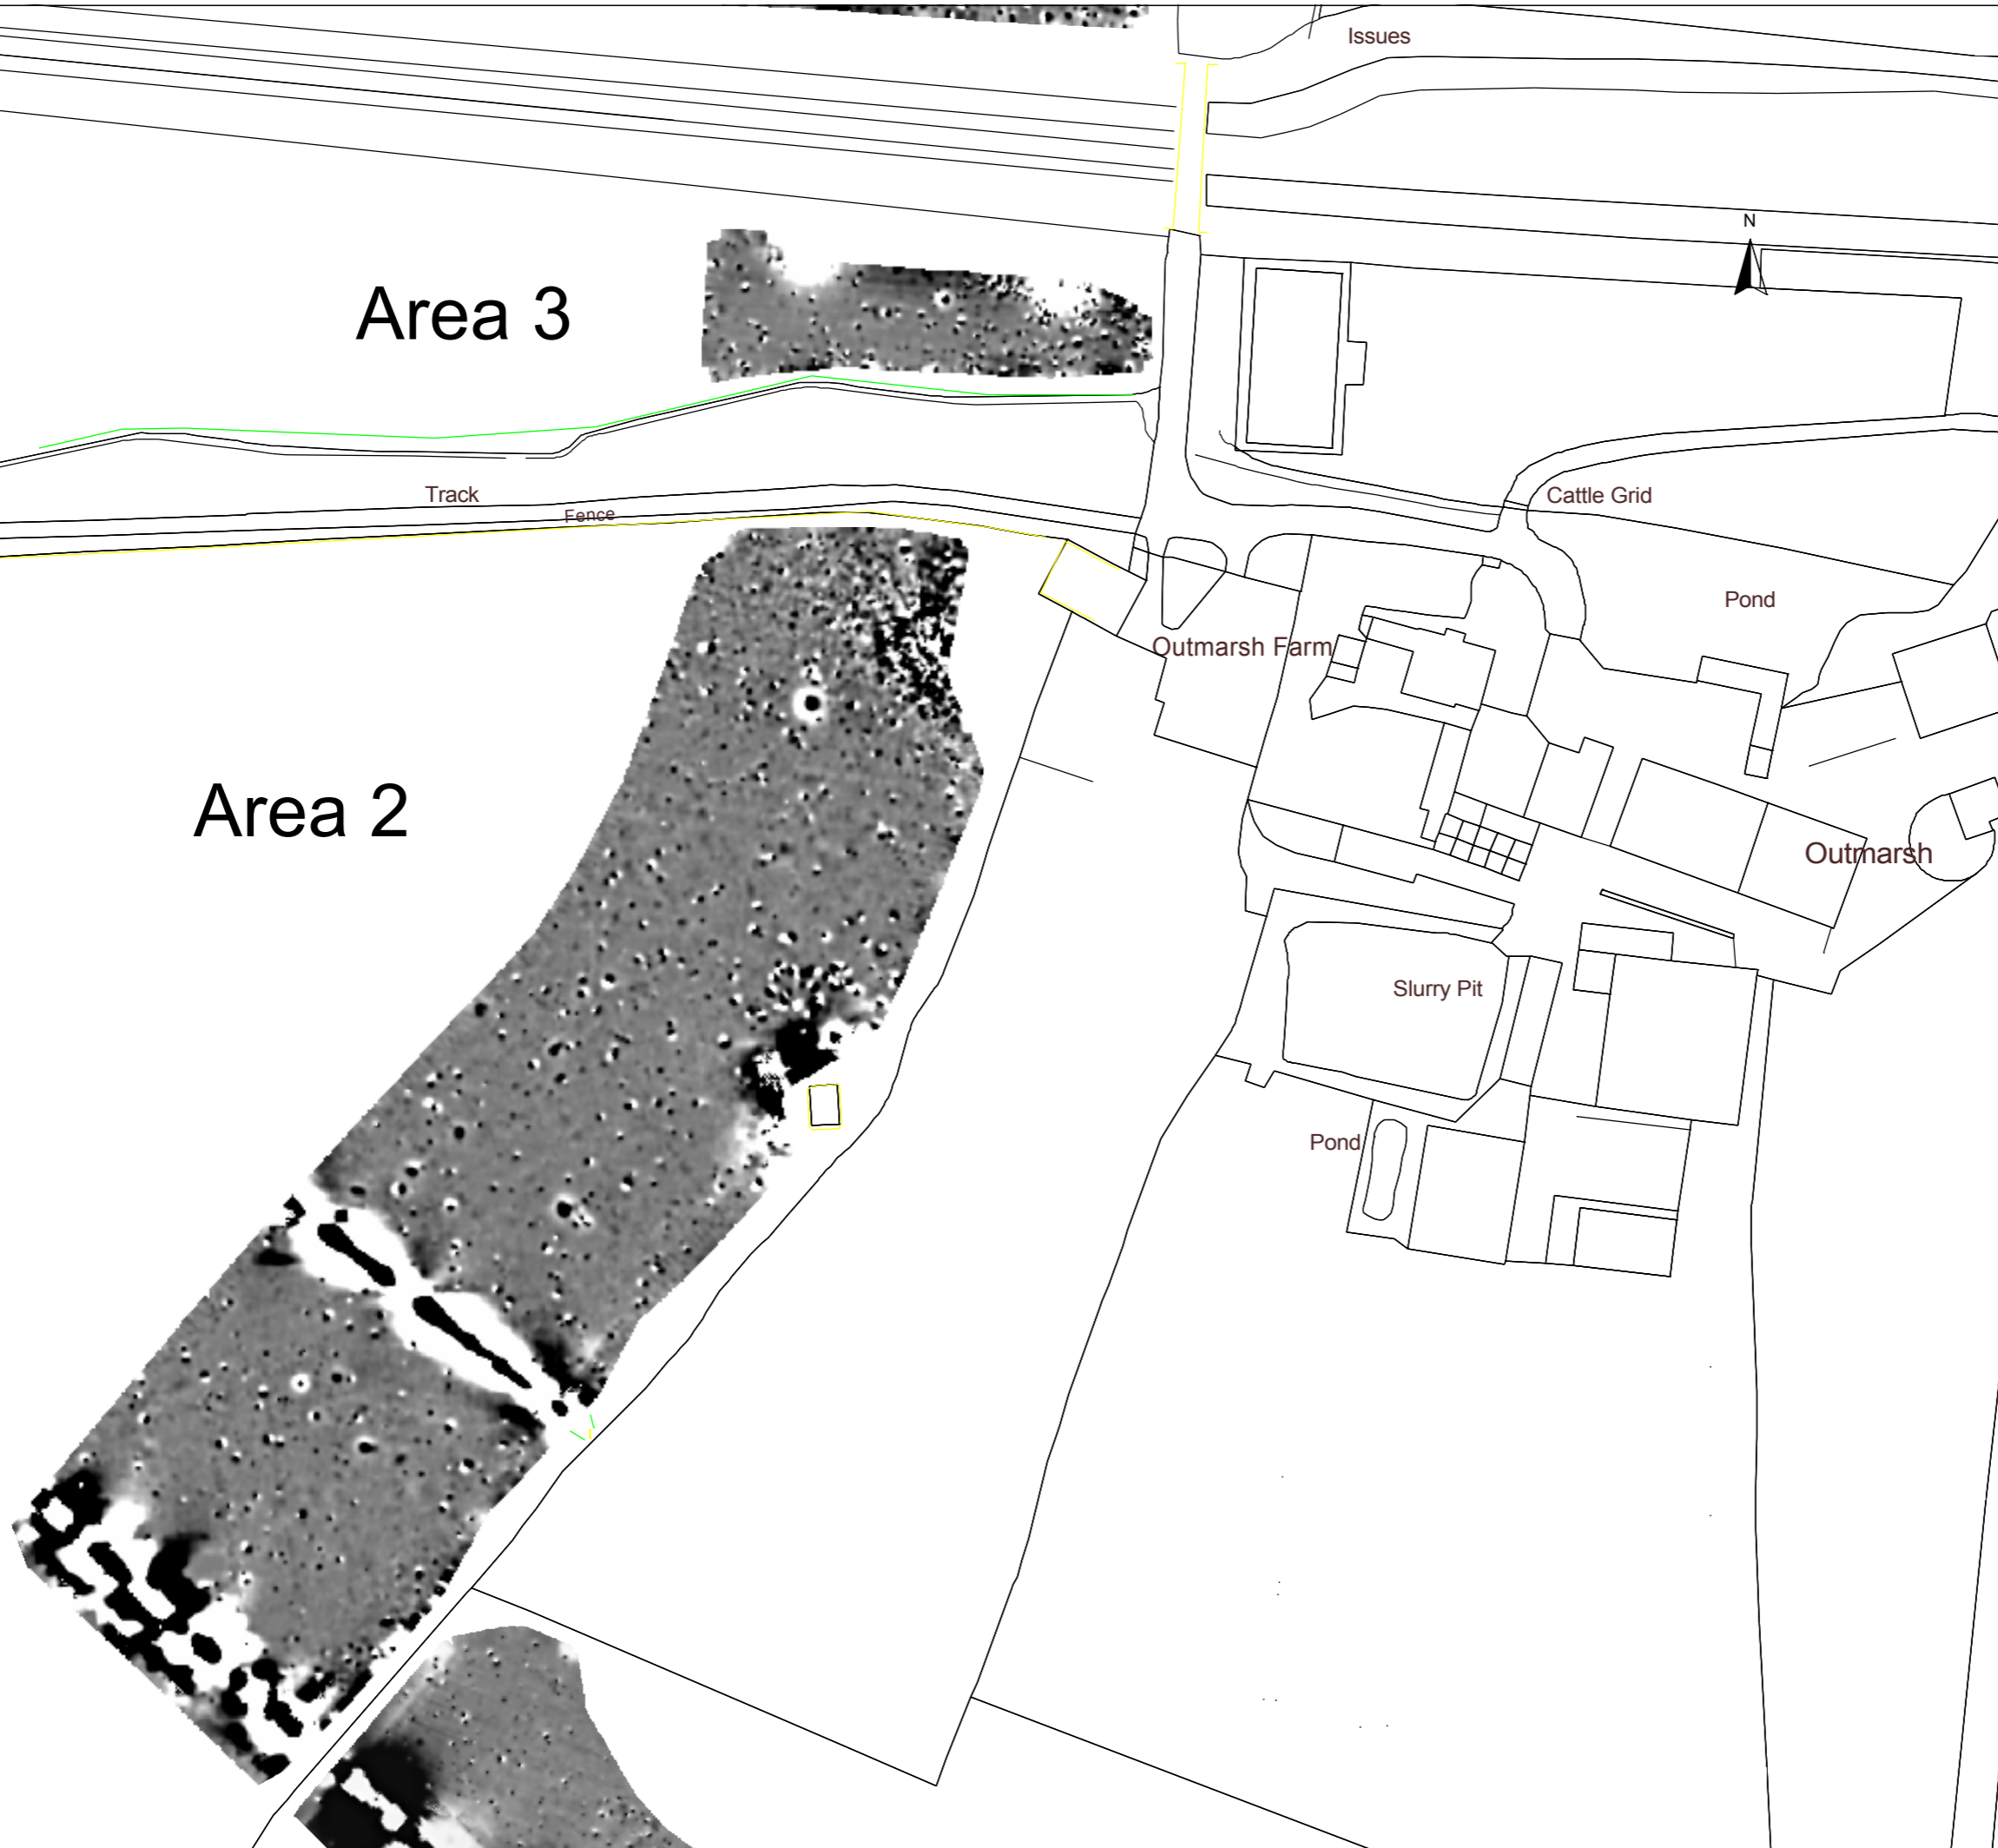
**Greyscale plot of minimally
processed magnetometer data**

Area centred on OS NGR 389724 161356, see Figures 09 & 10.

(6) – The survey area contains a small number of discrete positive responses. They are 10-20nT in magnitude, indicating that they are moderately enhanced features. It is possible that they are anthropogenic in origin, but their archaeological potential is uncertain.

(7) – The survey area contains several series of parallel weakly dipolar anomalies that are indicative of ceramic land drains.

(8) – Patches of magnetic debris can be seen at the north eastern corner next to Outmarsh Farm buildings and along the eastern edge adjacent to a WWII pill box.

(9) – The oil pipeline seen in Area 1 also extends across the southern edge of Area 2. Another buried service is located parallel with it, 75m to the north east.

Area 3 contains magnetic debris and widespread ferrous and magnetically thermoremanent objects within the topsoil. Inspection chambers were noted along the northern edge of the survey area.

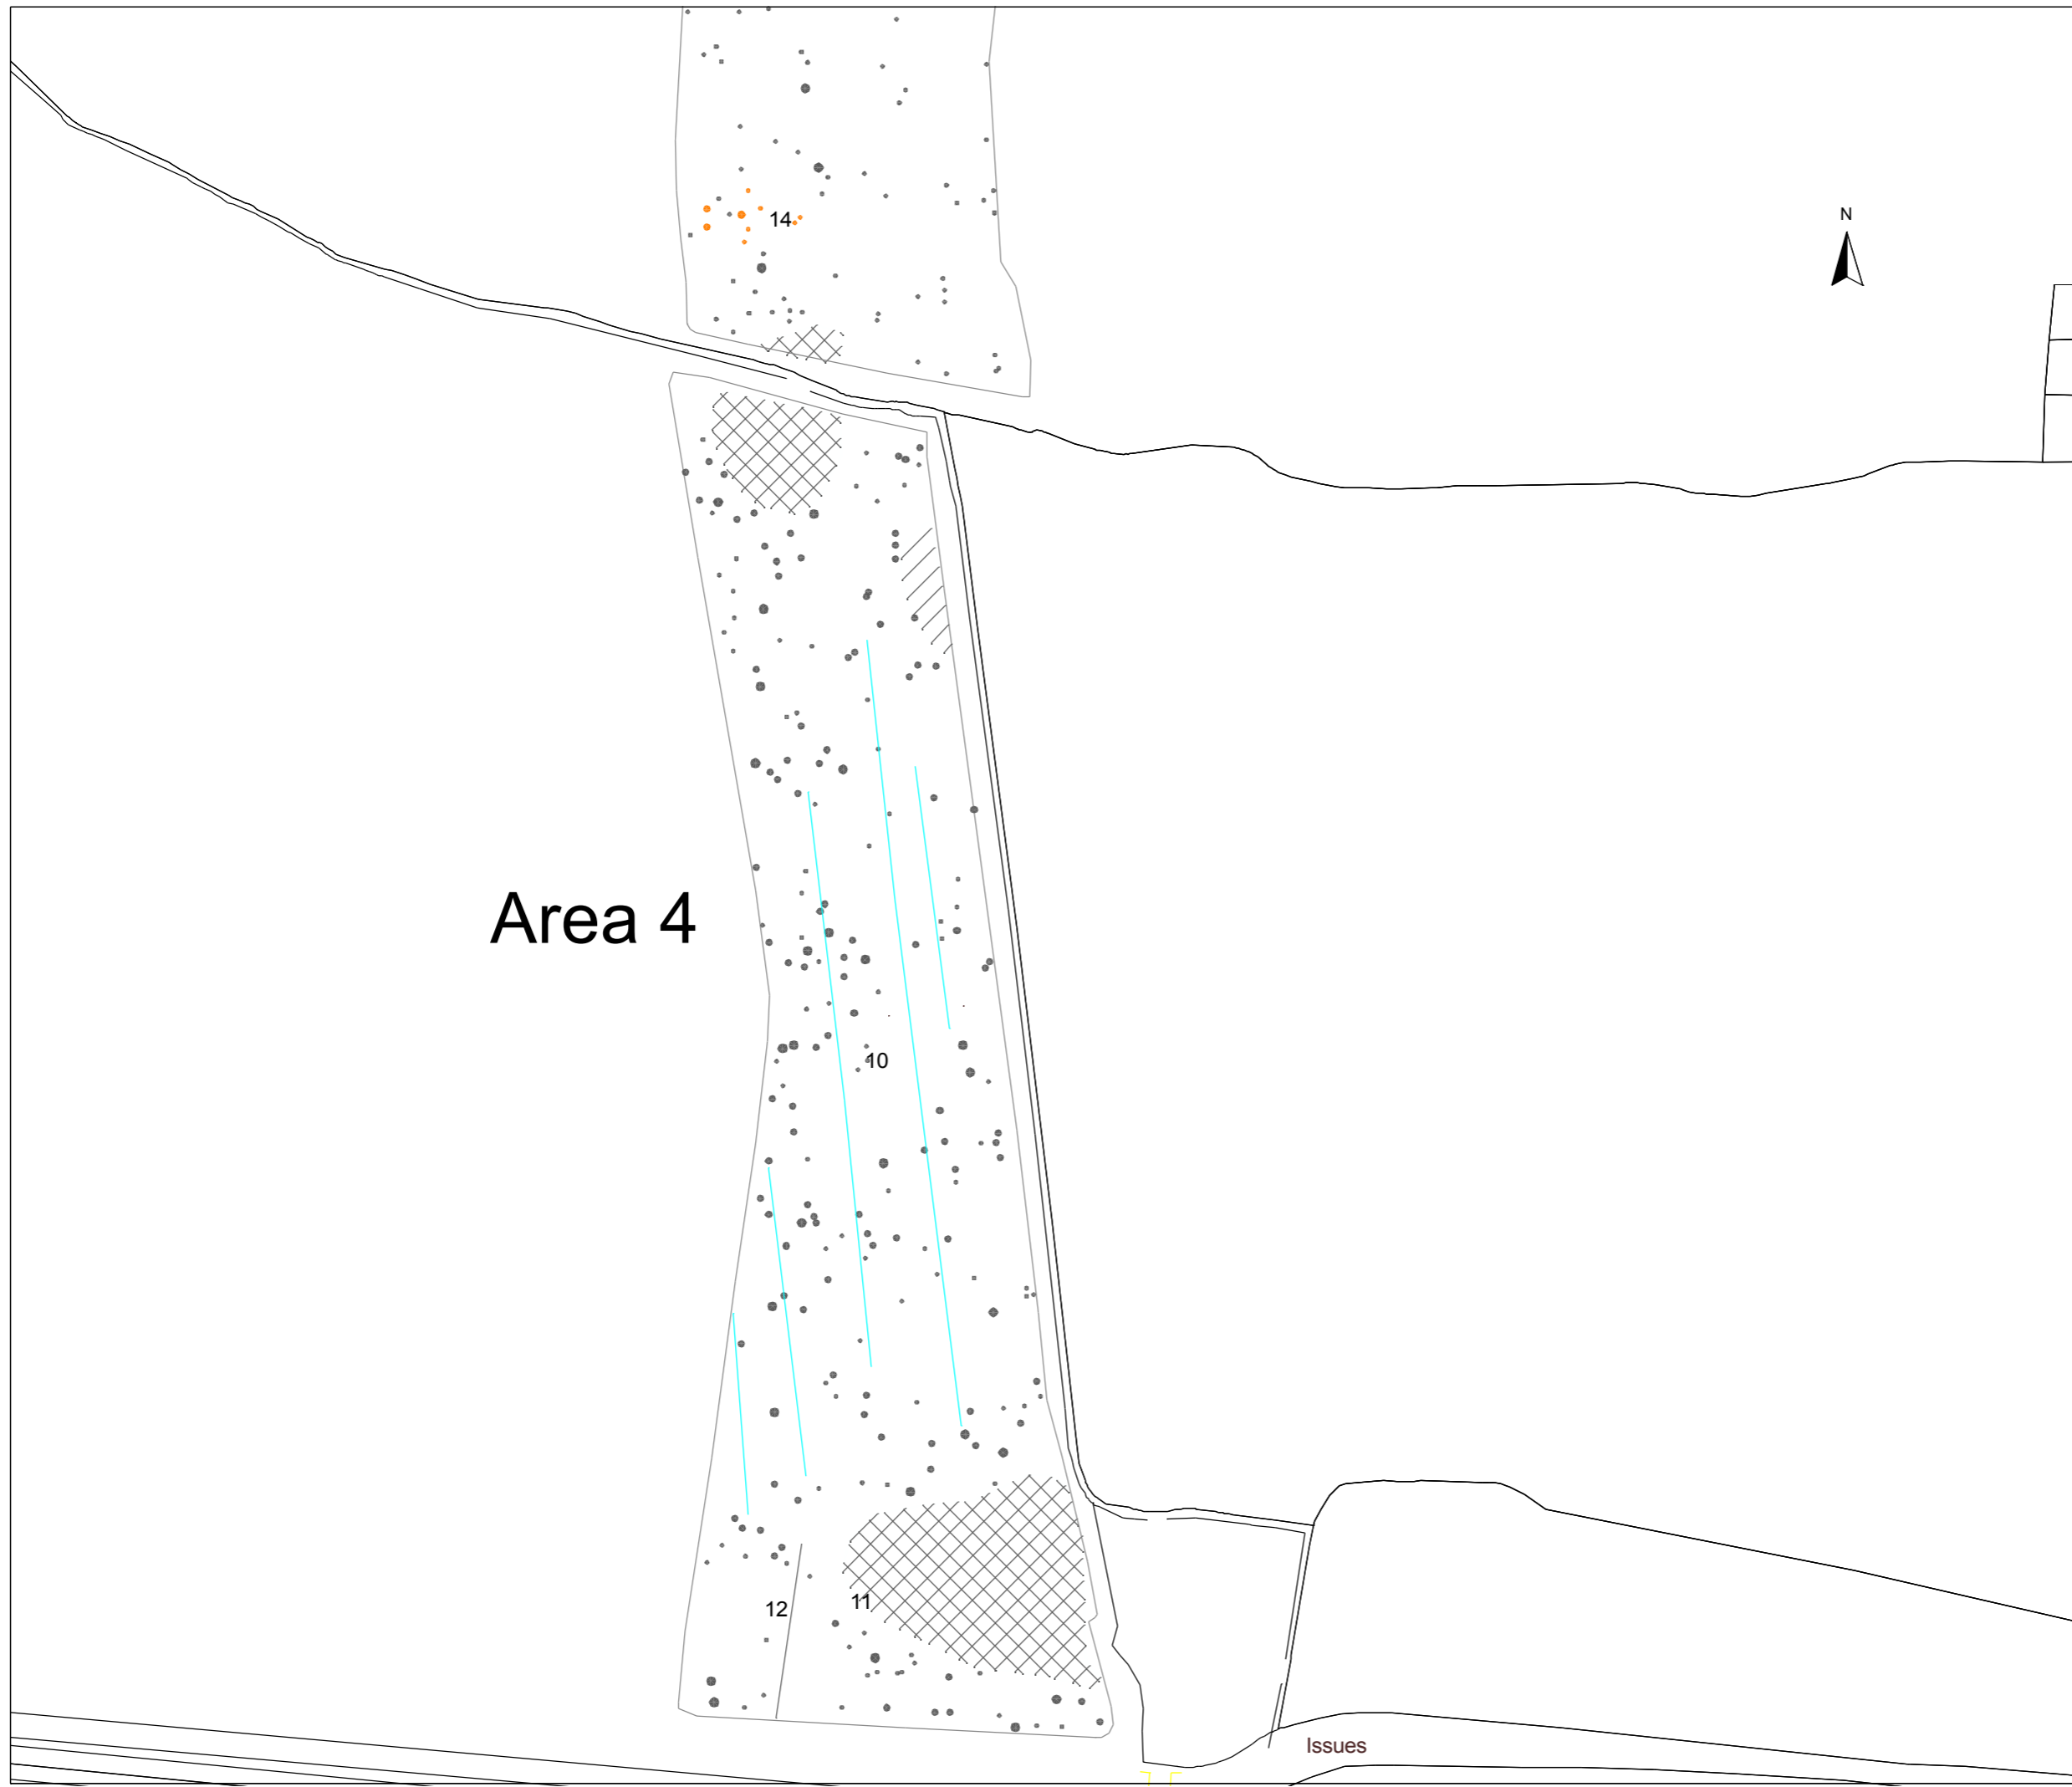
**Greyscale plot of minimally
processed magnetometer data -
Area 4**

Area centred on OS NGR 389786 161706, see Figures 11 & 12.

(10) – A series of parallel linear anomalies can be seen within the survey area. These appear to relate to land drains.

(11) – Patches of magnetic debris can be seen at the south eastern and north western corners of the survey area. These relate to magnetically thermoremanent material that has been used for ground consolidation. Modern ferrous debris and Carboniferous limestone were visible on the field surface near the southern end of the area.

(12) – A short section of a strong, multiple dipolar linear anomaly can be seen extending northwards for 35m. It may relate to a short section of pipe, or possibly a buried piece of wire fencing.
