ARCHAEOLOGICAL SURVEYS GEOPHYSICAL SURVEY REPORT

Bristol Northern Relief Main Keynsham

Geophysical survey

Wessex Archaeology

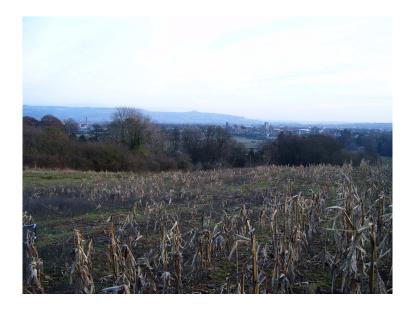
Plate 1 Survey Area 4 - looking east towards Keynsham and the Avon valley

4	Ruined	Worcester association –	Triassic Keuper	Land drops steeply
	maize/sweetcorn	typical argillic pelosols	Marl	towards the east -
	(see Plate 1)			survey affected by
				standing crop and
				rough ground/hedge
				along field margin
5	Rough pasture	Worcester association –	North western part	North eastern side
		typical argillic pelosols	on higher ground,	of corridor is
			Keuper Marl –	variably affected by
			River Alluvium on	embankment
			lower eastern part	associated with the
				A4175
6	Playing field – mown	Worcester association –	Mainly River	Metal fencing close
	grass	typical argillic pelosols	Alluvium	to southern and
				eastern ends
		Fladbury 1 association –		
		pelo-alluvial gley soils		
7	Playing field – mown	Fladbury 1 association –	River Alluvium	Rough areas close
	grass	pelo-alluvial gley soils		to northern
				boundary – survey
				corridor shifted
				south due to mature
				trees and shrubs

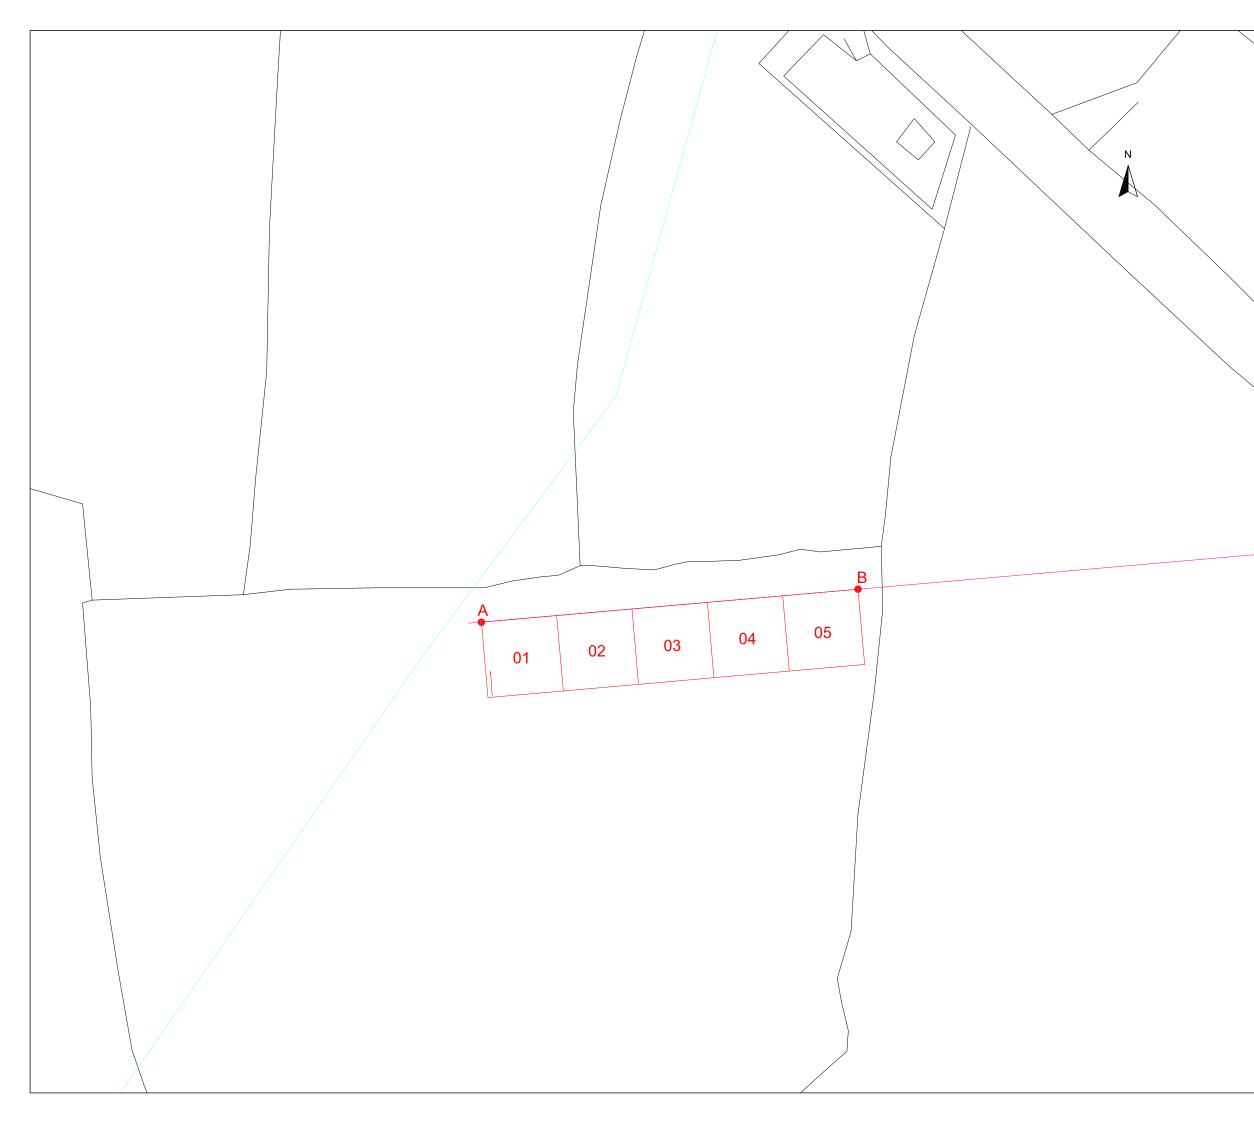
Archaeological Surveys
	Geophysical Survey Bristol Northern Relief Main Keynsham
	Referencing information
\langle	Based on OS grid coordinates (OSGB36)
	A 363831.26, 169508.83
	B 363930.88, 169517.56
	A - B Baseline
	Proposed pipeline route
	— Survey start and traverse direction
_	
	SCALE 1:1000
	0m 10 20 30 40 50m
	FIG 03
