FORTH VALLEY COLLEGE, ALLOA ARCHAEOLOGICAL EVALUATION

PROJECT 2957

carried out
on behalf of
Halcrow Group Ltd

FORTH VALLEY COLLEGE, ALLOA
ARCHAEOLOGICAL EVALUATION
DATA STRUCTURE REPORT

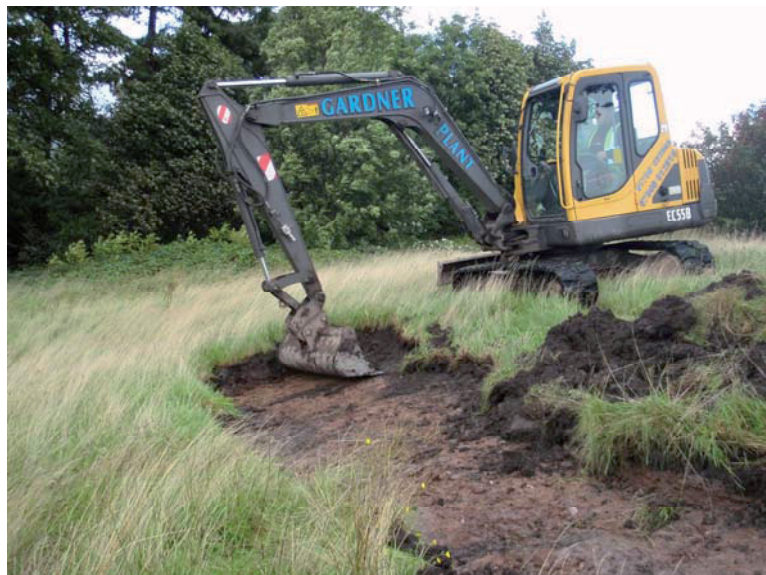
Plate 1:
Working shot of TR11.

A total of eleven trenches, measuring c. 25 m by 1.6 m, representing a 5 % sample of the proposed development area were excavated by a tracked machine excavator, fitted with a flat-bladed ditching

bucket, under close archaeological supervision (Figure 1; Plate 1). The topsoil was removed until the surface of the subsoil or the first archaeological horizon was reached, whichever was encountered first. Digital photographs were taken of the excavated trenches and trench sections. All contexts encountered were recorded by writing description and the presence of modern artefacts was noted. Some finds were also catalogued and retrieved. The bank encountered in Trench 1 was recorded as well by a measured section drawing. The trench locations were surveyed prior to the evaluation.

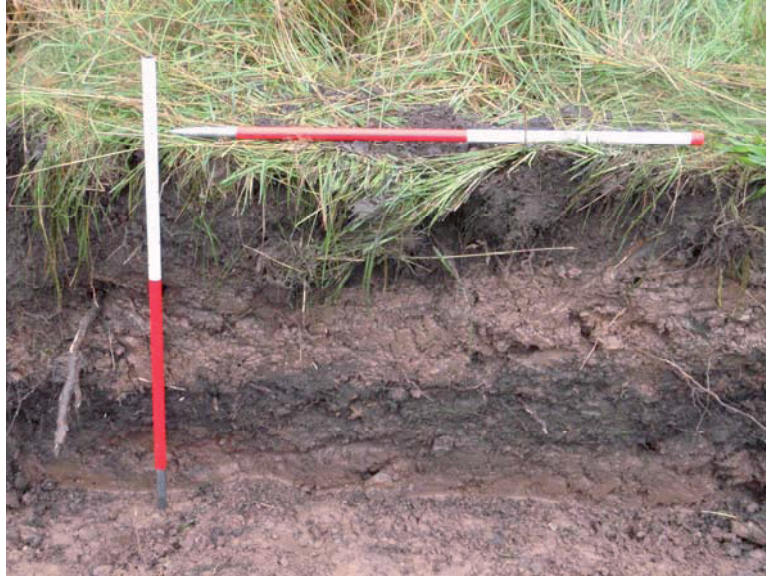
Plate2:

The excavation of evaluation trench 1 revealed a bank orientated N/S and built of re-deposited natural subsoil (1004) above the old topsoil surface (1001) and covered by a new layer of topsoil (1003) (Plate 2). A modern cable was observed running across this bank. The location of this bank was the same location as the putative cairn (SSMR 1155.03). While, due to the lack of finds and other features, the bank could not be dated, its absence on the First Edition Ordnance Survey map suggests a modern date. Other than field drains, plough marks and modern trial pits, the rest of the trenches were archaeologically sterile.

TR1 south facing section of the bank.
