**New Car Showroom Site, 73 Whiffler Road,  
Norwich, Norfolk**

**Planning application: 11/01747**

**Archaeological Monitoring Report**

(April 2012)

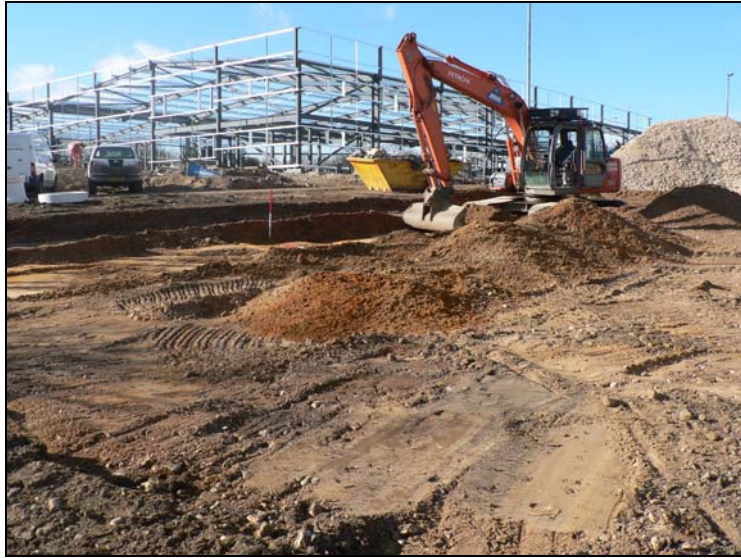
General view of site from south-east

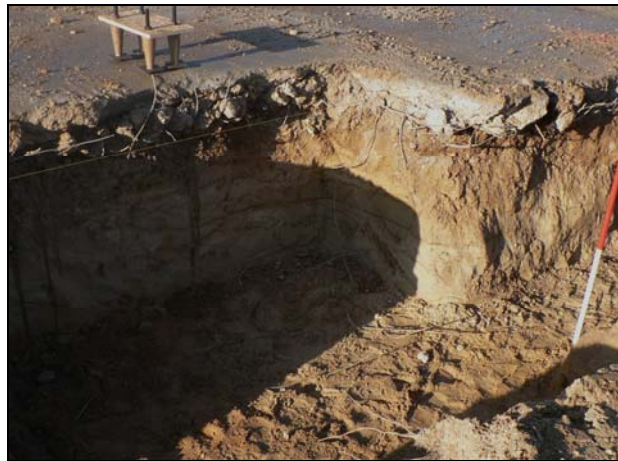
Eastern foundation trench to new car showroom

3.1 The foundation trenches for the new showroom were close to 300m long by 700mm wide with 2000mm x 2000mm pad pits at regular intervals along each side. As indicated above the existing concrete floor level within the building footprint is being left in place for re-use and, as might be expected for a previously developed site, any original topsoil has already been removed in the mid 20<sup>th</sup> century. In the area within the perimeter formed by the new foundation trenches 350mm of concrete floor and make-up could be seen in the exposed deposit profiles above the locally occurring natural glaciofluvial deposits which at this site are yellow sands with small and medium flints. On the outer face of the foundation trenches up to 200mm of mid brown sandy subsoil was still in place though it was often mixed with intrusive modern brick and tile debris. No archaeological features or finds were visible in the excavated trenches and no evidence could be seen for the cropmark anomaly noted above in section 1.3 which runs across the south-eastern part of the footprint.

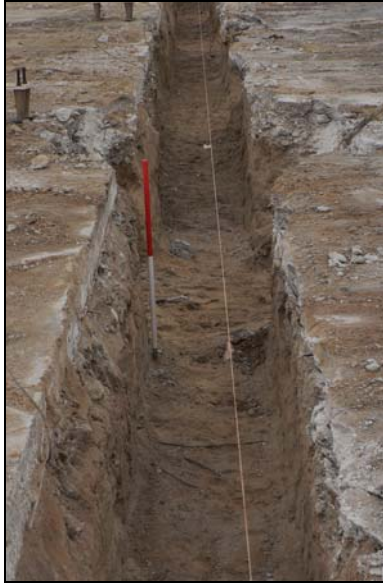
Southern foundation trench to new car showroom

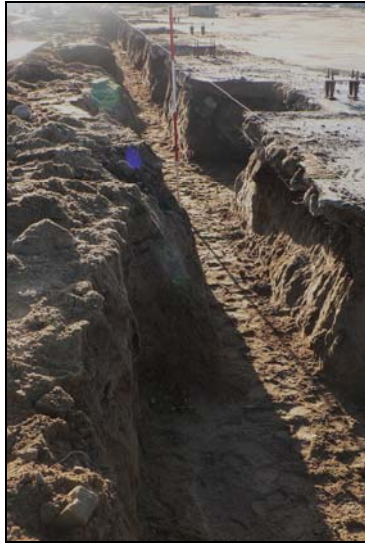
Western foundation trench to new car showroom

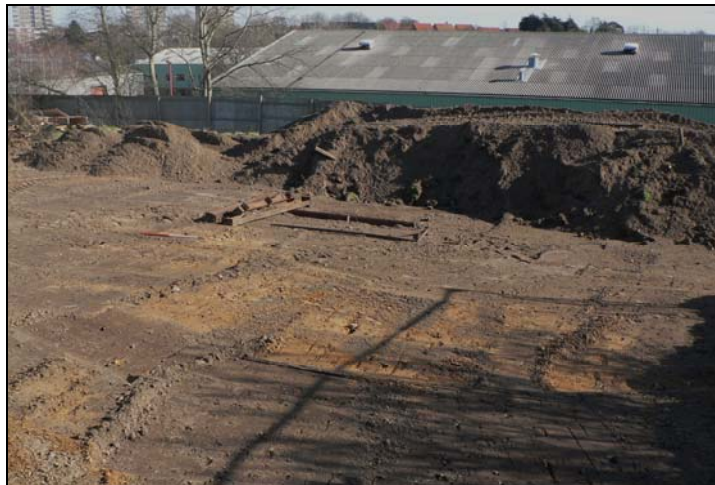
Area stripped for car in north-eastern quarter of the site

3.3 Across the car parking area of the development in the north-eastern quarter of the site 250mm of topsoil was removed leaving the base of the topsoil, which in part may be recently redeposited material, in situ plus any underlying subsoil. Therefore no archaeological features were visible and if any were present they would be preserved in situ.

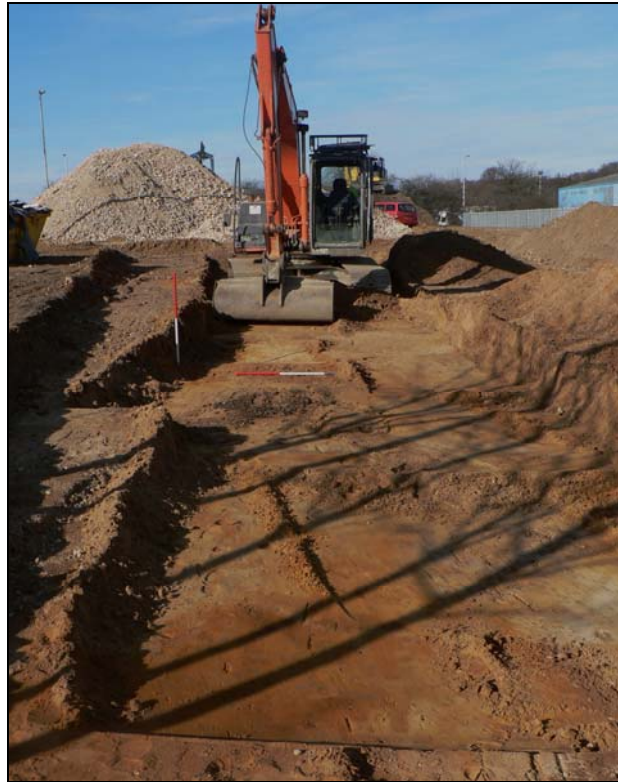
Soil stripping for storm water tank area

3.2 The area for the storm water tank in the south-eastern quarter of the development site covered an area of some 700m<sup>2</sup>, this area had not been developed previously and was watched as 250mm of topsoil and 200mm of mid brown sandy subsoil was removed. This soil stripping revealed clean yellow sand with small and medium flints and occasional irregular very pale brown silty bands. No archaeological features were present and the topsoil contained only modern debris.

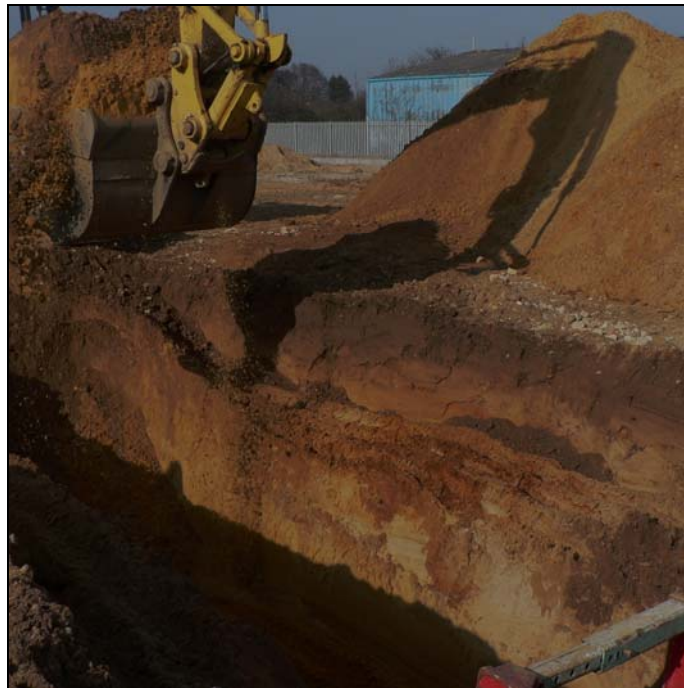
Pipe trench crossing line of cropmark anomaly from south-west

be at least 3m-4m deep and c4m across at the top as the naturally occurring local sands proved to be moderately unstable. However at the northern end of the drain run trench width could be limited to 1000mm. Again these trenching works did not reveal any archaeological features. A particularly careful observation was maintained as the pipe trench crossed the line of the cropmark anomaly recorded running across the site, HER site 53550 as outlined in section 1.3 above, but all that could be seen in this area was a band of clean brown sand with an irregular profile suggesting a glaciofluvial origin for this feature (see Appendix I- Images).
