**Lime House & London House, The Green,
East Rudham**

Planning application: 11/00950/F

HER Ref: ENF 129410

Archaeological Monitoring Report

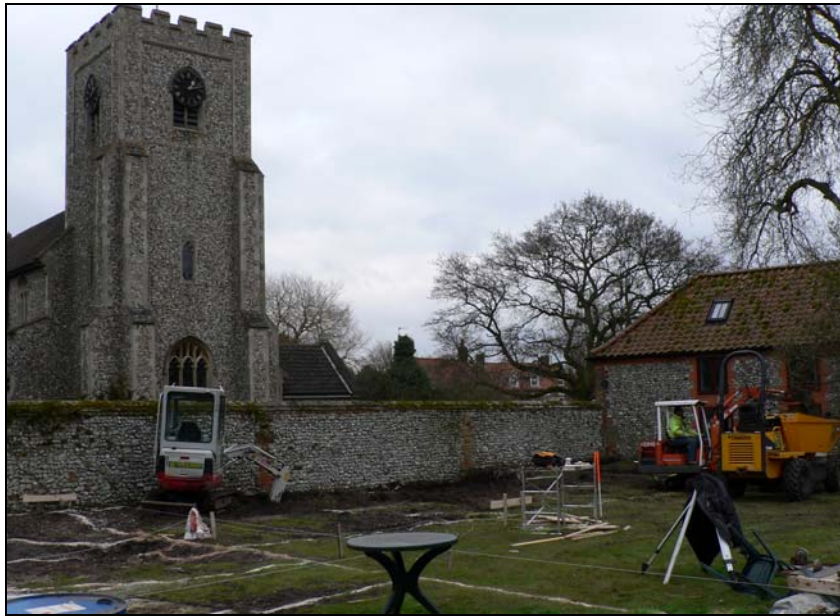
View of new dwelling site from north-west

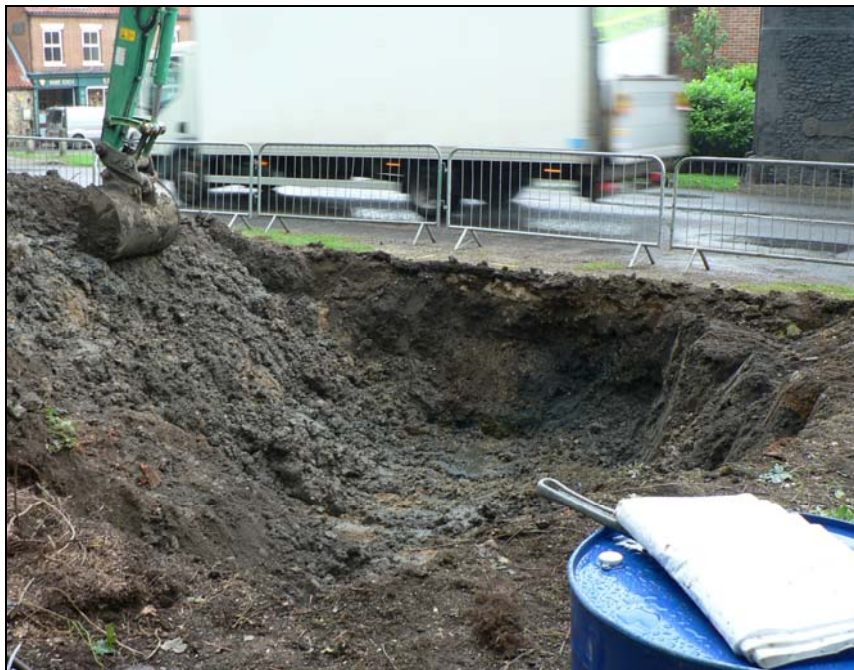
Removal of fuel tank from north-west

3.1 Excavation of the 3.5m x 4m pit on the eastern side of London House (see Fig. 2) revealed a moderate sized metal tank with evidence for the leaking of hydrocarbons into the immediately surrounding deposits. Only when the tank and adjacent deposits had been removed could the excavated area be entered briefly due to the continued presence of contaminated ground. Investigation of the exposed deposit sections revealed an upper layer of topsoil with some evidence of a former recent yard surface close to London House. This upper deposit was above a uniform dark brown silty subsoil which graded to a mid brown silty subsoil. These subsoil deposits contained occasional small later medieval and Post medieval tile and brick fragments. Towards the base of the subsoil, at a depth of 1300/1400mm below modern ground level, a few sherds of medieval, 11th/12th to 14th century, pottery sherds were recovered from the exposed section on the western side of the excavated area (see section 4- The Finds below). In addition one small and shallow possible archaeological feature was examined in the north-western corner of the excavated area at a depth of 1500mm and cut into the locally occurring natural glaciofluvial silty sand deposits. No finds were recovered from this feature and the presence of hydro-carbons precluded any detailed examination though at only 80mm deep the feature could possibly be interpreted as the a natural undulation in the local glaciofluvial deposits.

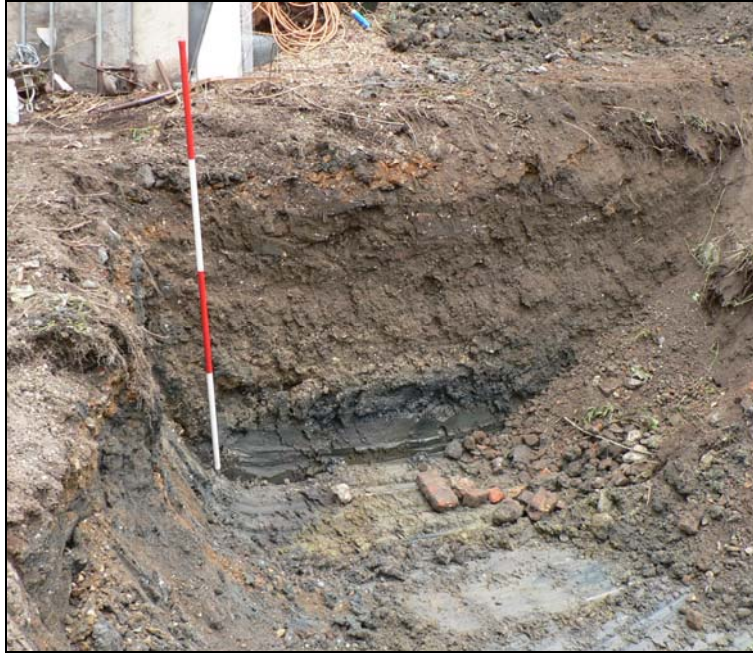
Removal of fuel tank, view from south

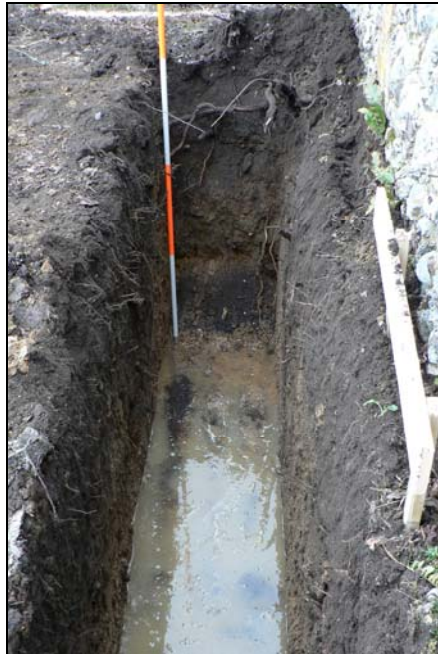
Foundation trench on east side of new build

3.2 In total nearly 60m of mainly 600mm wide and 1500mm deep foundation trench were examined along the sides and across the footprint of the footprint for the new dwelling (see Fig. 2) on the northern side of the stable building. The deposit profile exposed in the trenches across the footprint area comprised 400mm to 600mm of topsoil over 400mm to 500mm of a mid brown silty sand subsoil close to the stables

at the southern end with the subsoil deposit increasing gradually to a thickness of 1000mm at the northern end. Below the subsoil the locally occurring natural glaciofluvial Till deposits at the site proved to be a pale brown very silty sand with flints.

3.3 No archaeological features were revealed in the foundation trenches though with ground water being encountered at a depth of 1300mm to 1400mm the base at 1500mm was largely flooded making visibility at this depth poor in places. Close inspection of the upcast spoil and sides of the trenches revealed only occasional small pottery sherds of later Post medieval white wares and blue and white transfer printed wares plus small fragments of clay tobacco pipe stem and small fragments of Post medieval brick and peg tile. At one point close to the wall of the stables building trench collapse also revealed a larger group of pottery sherds and other domestic debris of early to mid 20th century date.

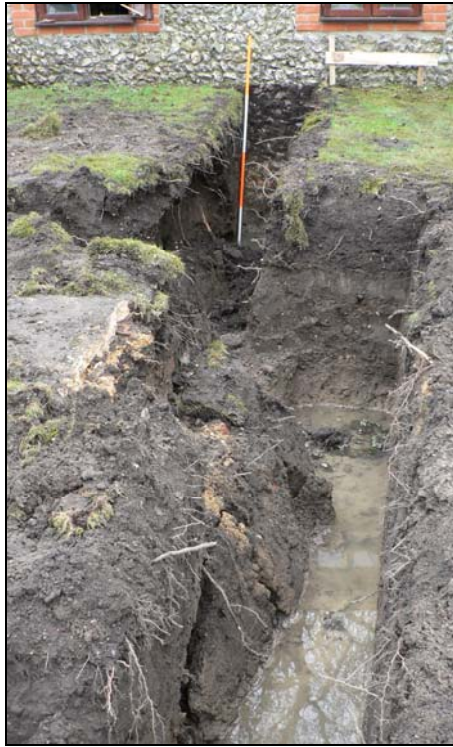
Foundation trench close to stables building with collapse

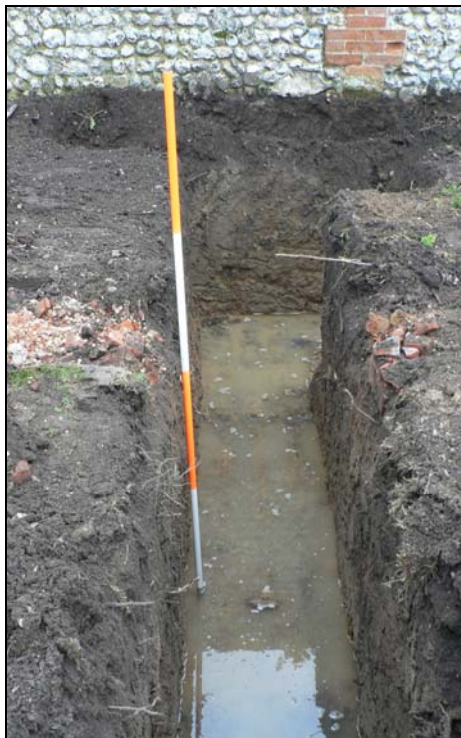
Foundation trench, north-eastern corner

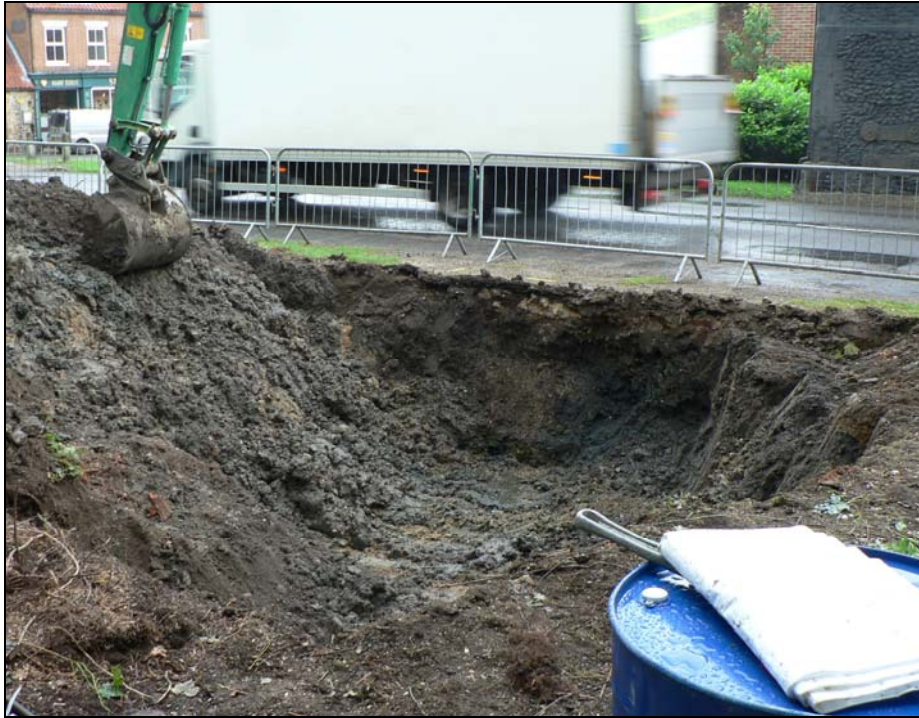
Tank removal pit from north

Site monitoring: an area of 6m along its north-south side and 3.5m/4m on its east-west side and 2m east of the eastern wall of London House was mechanically excavated in order to remove an early/mid 20th century fuel tank prior to the construction of a drive across the area to give access to the rear of the property and to the planned new dwelling behind Lime House. The excavation was taken to a depth of 1500mm where the locally occurring natural glaciofluvial deposits were exposed which proved to be a greenish pale to mid brown very silty sand containing small and medium flints. While the deposits adjacent to the fuel tank could not be closely examined as they contained hydrocarbons the exposed sections to the excavated area were inspected. The upper 300/400mm was largely made up of root disturbed topsoil save close to London House where flints had been set in a sandy matrix to form an area of hard-standing. Below this upper level the deposits were uniform and consisted of 500mm of dark brown silty subsoil which contained occasional Post medieval tile/brick fragments which in turn lay over 500mm of a mid brown silty subsoil. A number of digital images were taken to record the monitoring and exposed deposits (see below).

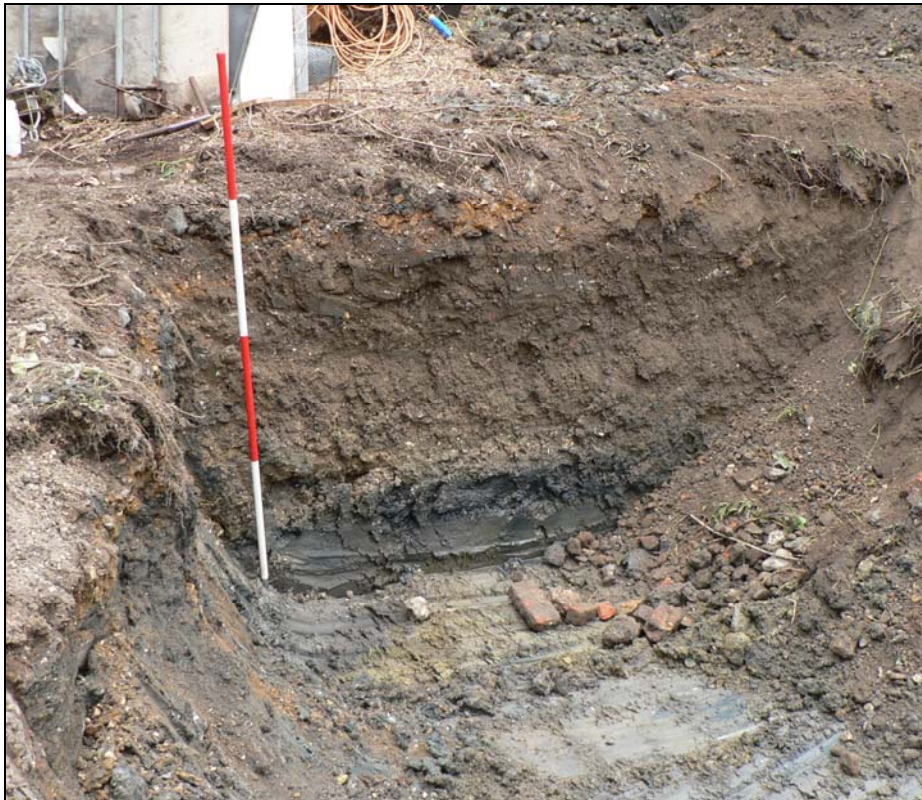
Tank removal pit- northern section

While the only finds seen in the excavated spoil were of 18th century or later date a few medieval coarseware pottery sherds were recovered from the western section of the excavated area at a depth of 1300/1400mm from an area in the mid brown silty subsoil which also contained occasional oyster shells and charcoal fragments. One, possible, archaeological feature was examined in the north-western corner of the excavated area apparently cutting into the natural glaciofluvial deposits. However as this possible feature was only 80mm deep it may have been caused by a shallow

undulation in the glaciofluvial deposits of natural origin. This possible feature did not contain any finds and had a similar fill to the subsoil above.
