**Sir Robert Hitcham Primary School,
School Corner, Debenham, Suffolk**

Planning application: 2559/12

HER Ref: DBN 148

Archaeological Evaluation Report

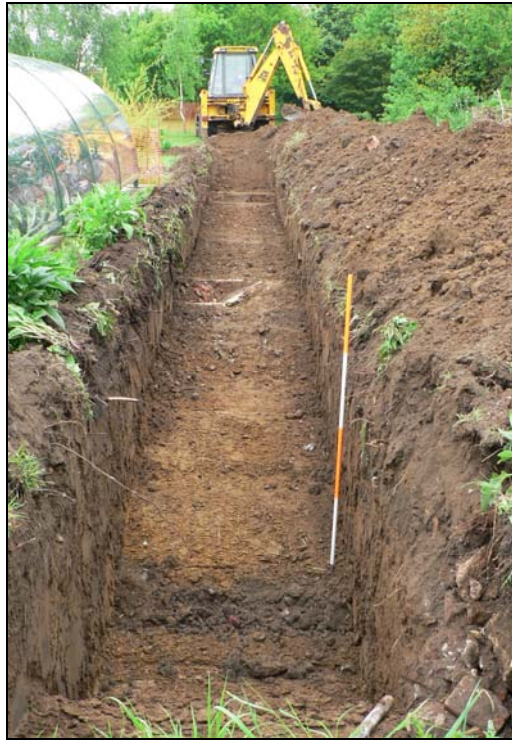
Trench from south

3.2 As table 1 indicates the depth of top and subsoil revealed along the trench was substantial with the southern, down slope, end being particularly deep with 500mm of topsoil over 1500mm of mid brown silty sand subsoil over the locally occurring glaciofluvial deposit of pale brown sand with flints. A large pit of recent date was also exposed in the south-eastern corner of the trench and with this combination of trench depth and loose fill the southern quarter of the trench was not entered though no archaeological features could be seen in the natural sand with flints at its base.

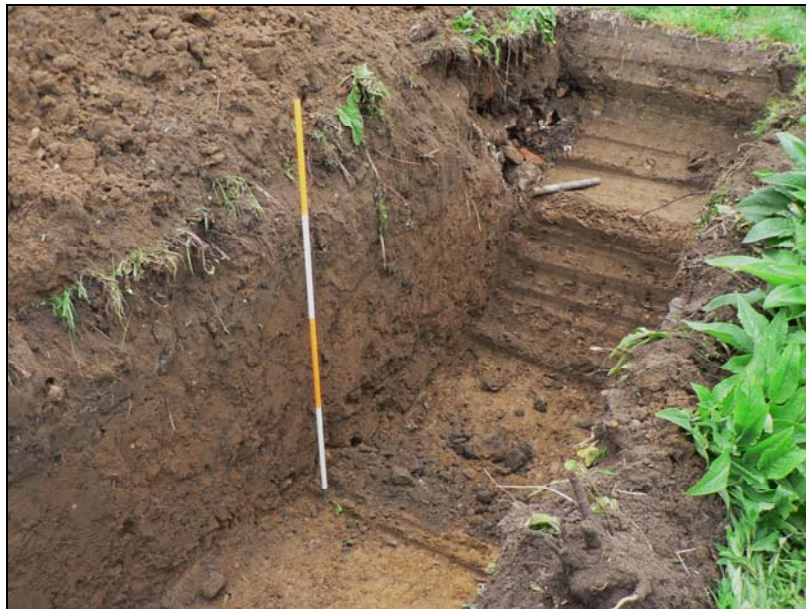
Southern end of trench from north-west with modern pit in corner

3.5 Apart from brick debris around the two exposed ramp entrances and modern debris from the pit in the south-eastern corner of the trench the only finds from the upcast spoil of the trench were occasional blue and white transfer printed pottery sherds of later Post medieval date and a single small sherd (3g) of glazed red earthenware of 18th century date plus a few small fragments of Post medieval peg tile. The detector search recovered only occasional small iron nails and scraps of hinge or bracket of indeterminate date.

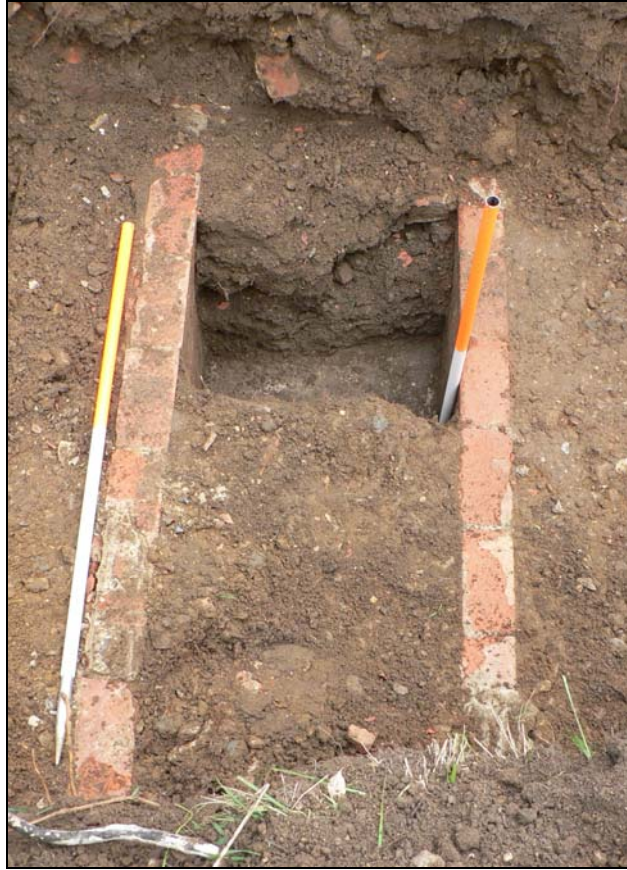
Northern air raid shelter from west

3.4 The two ramp entrances were identical in construction and size with each having an external width of 800mm and an internal one of 600mm and the drop on the ramp base for the northern example across the trench from east to west was 700mm. The walls on each side of the two ramp entrances were of a single brick thickness with all of the bricks being of a common red type stamped LBC 6, for the London Brick Company, and 'PHORPRES' within the frog recess and of a standard size of 9 inches x $4\frac{1}{4}$ inches x $2\frac{7}{8}$ inches (228mm x 109mm x 74mm) while the ramp surface was concrete.

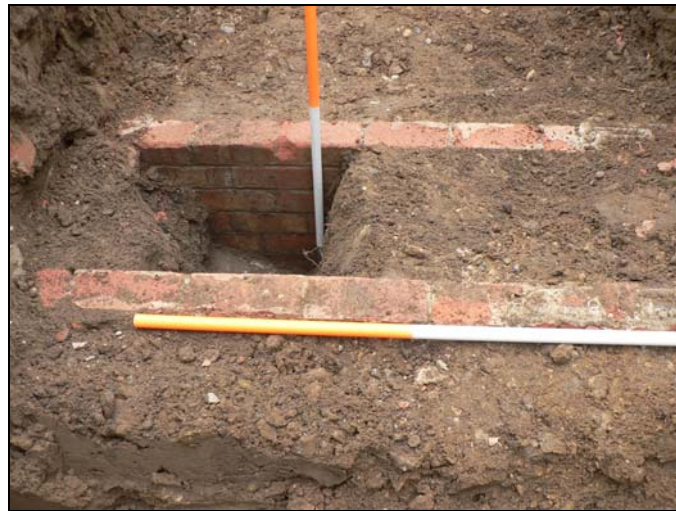
Northern air raid shelter entrance from north

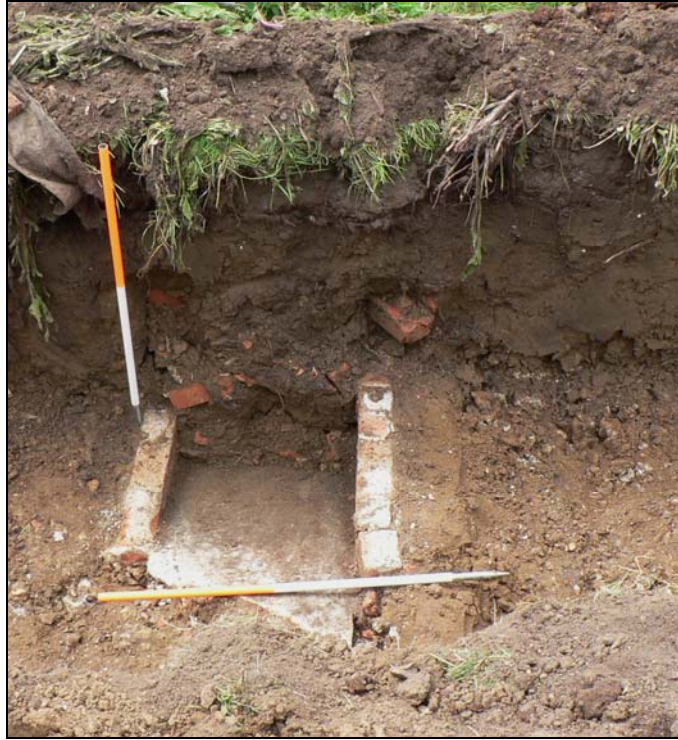
Southern air entrance from east
