**Brook House, Quay Street,
Halesworth, Suffolk**

Planning application: DC/12/0505/FUL

HER Ref: HWT 038

Archaeological Monitoring Report

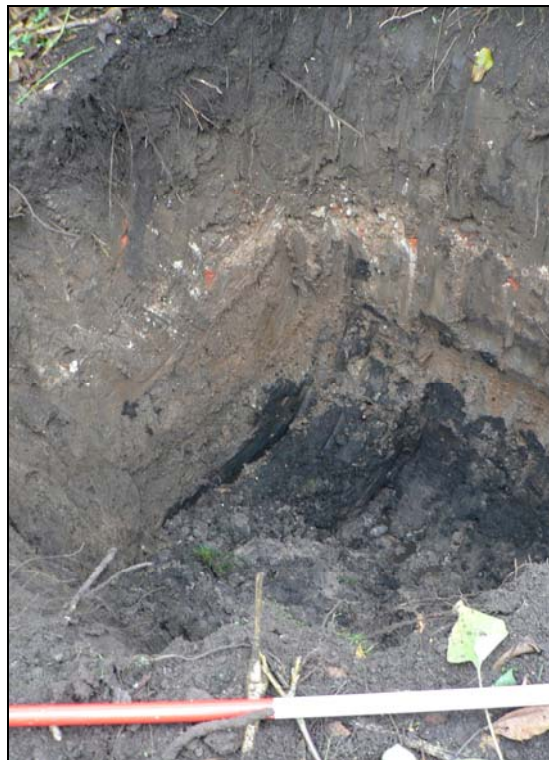
Treatment pit- top & subsoil over mixed mortar/cbm layer then alluvial deposit over black organic rich silty basal layer

3.1 The pit for the treatment plant (Fig. 2) was located some 15m to the rear of the house and was 2.20m square. Below 350mm of topsoil a 350mm of mid brown silty subsoil lay over a 250mm layer which comprised a mixture of dumped mortar and small brick and tile fragments of later Post medieval date. Under this mixed material a 1000mm thick layer made up of a pale to mid grey silty deposit which was largely stone-free but did exhibit some iron staining was revealed and this in turn lay over a 350mm thick black organically rich silty peat deposit (see Appendix I). Finally at the base of the pit at a depth of 2300mm the locally occurring natural glaciofluvial deposit comprising a pale grey sand with flints was exposed. The only finds in the upcast spoil came from the top and subsoil and mixed mortar deposit in the upper part of the pit and in addition to the small fragments of later Post medieval brick and tile was made up of a few sherds of 19th century to earlier 20th century pottery and glass. The silty deposit below the mixed mortar deposit and the silty organic layer at the base of the pit was very clean and did not contain any finds or any evidence for human activity such as charcoal fragments.

4.1 While only the ground works for the relatively small treatment plant pit went to a sufficient depth to reveal past deposits of any interest and no significant finds were revealed during the monitoring some useful topographic information was recorded. The upper 950mm in the exposed pit profile is clearly of recent date and it seems likely that the mixed mortar and brick/tile layer at a depth of 700mm to 950mm was deposited deliberately to raise the level of the garden to the rear of Brook House in the later 18th to 19th century period when the house was constructed. Below the mixed mortar and brick/tile layer the 1000mm thick stone-free silty deposit can be interpreted as alluvial material in all probability deposited gradually during numerous flood episodes by the nearby River Blyth. Finally the basal organically rich silty layer can be concluded as being the result of a long period when standing water hindered the full decay of plant material at some point in the distant past before deposit of the alluvial material above gradually raised the floodplain. From this overall interpretation it can therefore be concluded that the line of Quay Street to the north in front of Brook House in all probability represents the northern edge of the floodplain.
