**Naughton Mill House, Nedging Road, Nedging-with-
Naughton, Suffolk**

Planning application: B/14/00240/FUL

HER Ref: NDG 014

Archaeological Monitoring Report

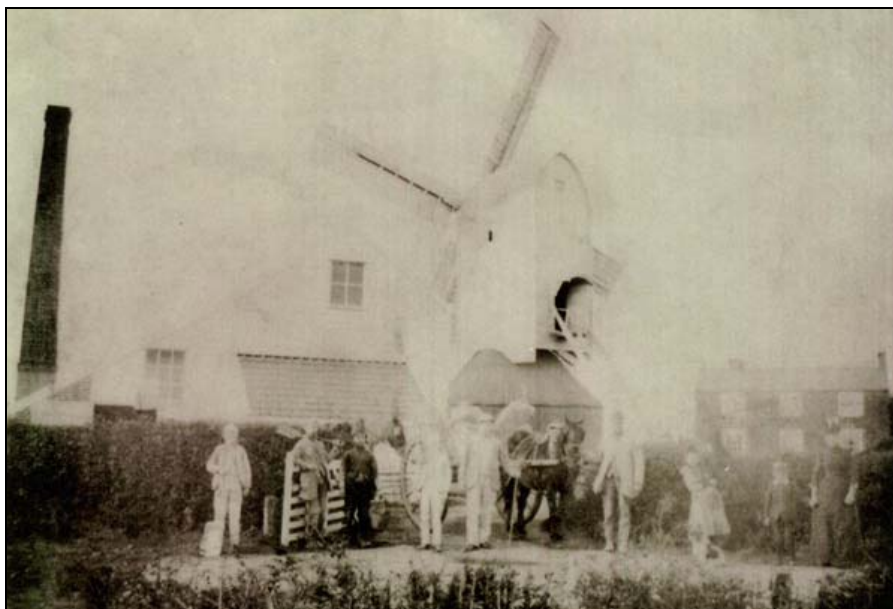
Frontispiece: Photograph of Naughton Mill from south c1900
(Mill House to right background, chimney for later steam to left, web source 1)

1.3 Archaeological interest in this development was generated by its location at the site of Naughton Post Mill (HER NDG 008- see frontispiece) which is recorded as being in existence prior to 1824 from a study of historic cartographic sources and which burnt down in 1909 though the brick built roundhouse survived for some time afterwards (see below web source 1). Post mills were the earliest type of windmill in Europe and by the later Post medieval period were a common site across East Anglia though by the mid to late 19th century steam mills became increasingly more efficient and productive and it is interesting to note that a steam mill was constructed immediately to the west of the Naughton Post Mill in this period. The main part of this steam mill later becoming a Youth Hostel before conversion to a private residence.

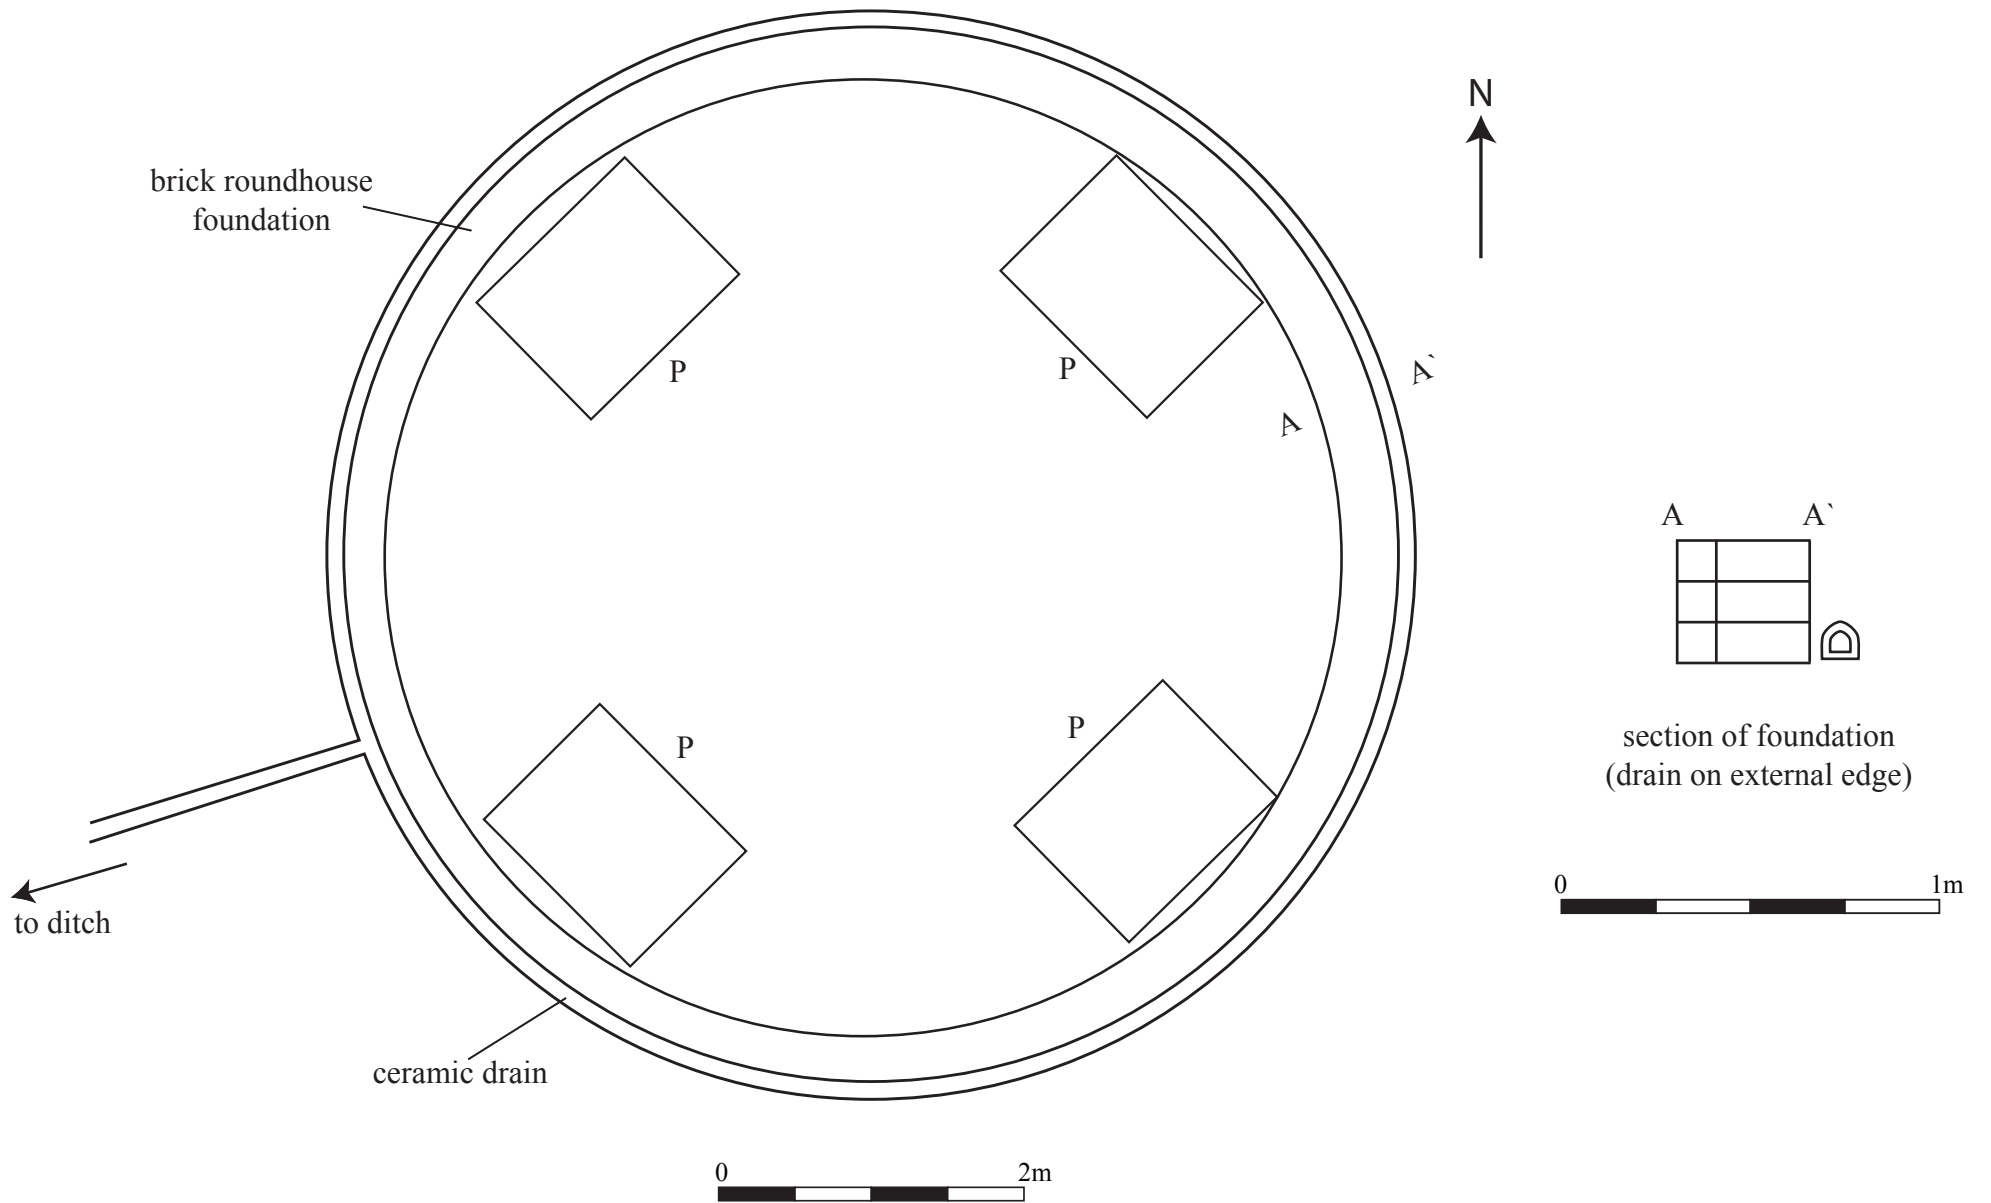
Fig. 3: Windmill brick roundhouse foundation (P = brick trestle base pad).

3.3 The area of the post mill was immediately apparent on the first visit to the site as a small and fragmented area of bitumous flooring was visible through a cover of topsoil with some grass. This area of flooring, which was 1900mm along its north-south axis and up to 600mm wide at the widest part of its east-west axis, was shovel scraped and trowelled clean before being recorded photographically (see Appendix I- image 2). As ground works were carried out at the site the trench across the central part of the southern half of the house footprint revealed the foundation of the brick roundhouse as being three courses high (342mm) high and 340mm wide with bricks set as headers around the outer side of the foundation and as stretchers around the inner edge (see Fig. 3 & Appendix I- image 3). In addition a ceramic land drain was recorded running round the outer edge of the roundhouse foundation with excess water being taken to a ditch to the south-west of the mill site.

3.4 The roundhouse proved to be 7m in diameter and when the over-site was stripped from the footprint area four brick built pads were revealed with each being a uniform 1400mm along the side facing the inner edge of the brick roundhouse and 1100mm along the other side. These pads were constructed in the same size bricks (see section 4 below) as the roundhouse and were located against the inner side of the roundhouse at its north-east, south-east, south-west and north-west cardinal points (see Fig. 3) and while the roundhouse foundation was removed from the site these pads were left in situ. No other features were revealed relating to the post mill.

5.1 As anticipated the ground works for the new house revealed the foundation to the brick roundhouse, it's associated outer ceramic drain and the four brick pads which would have acted as trestle bases for the post mill mechanism above. While earlier post mills often did not have a roundhouse these were built either in timber or

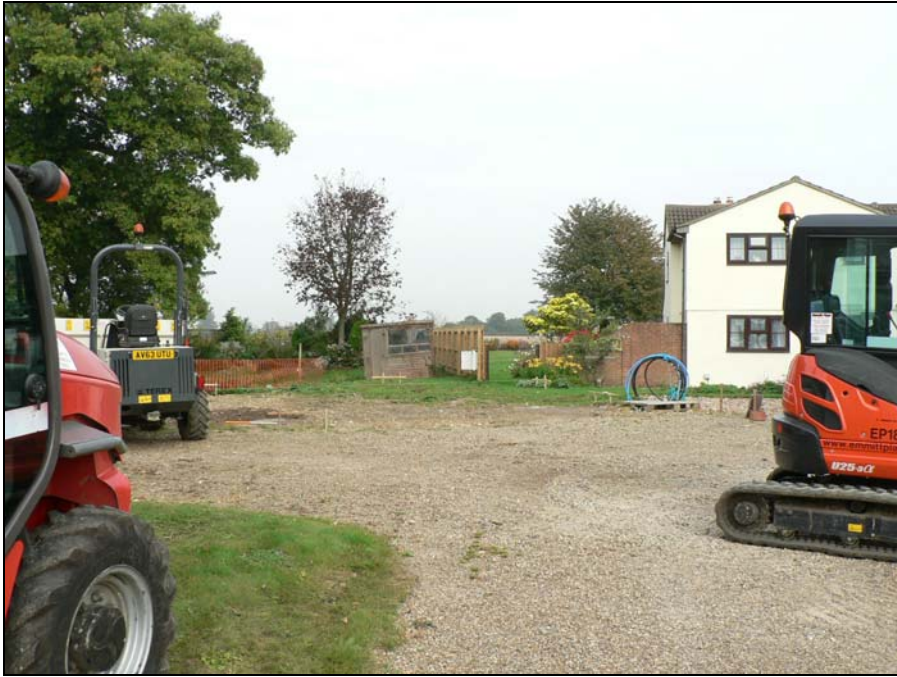
1. General view from south

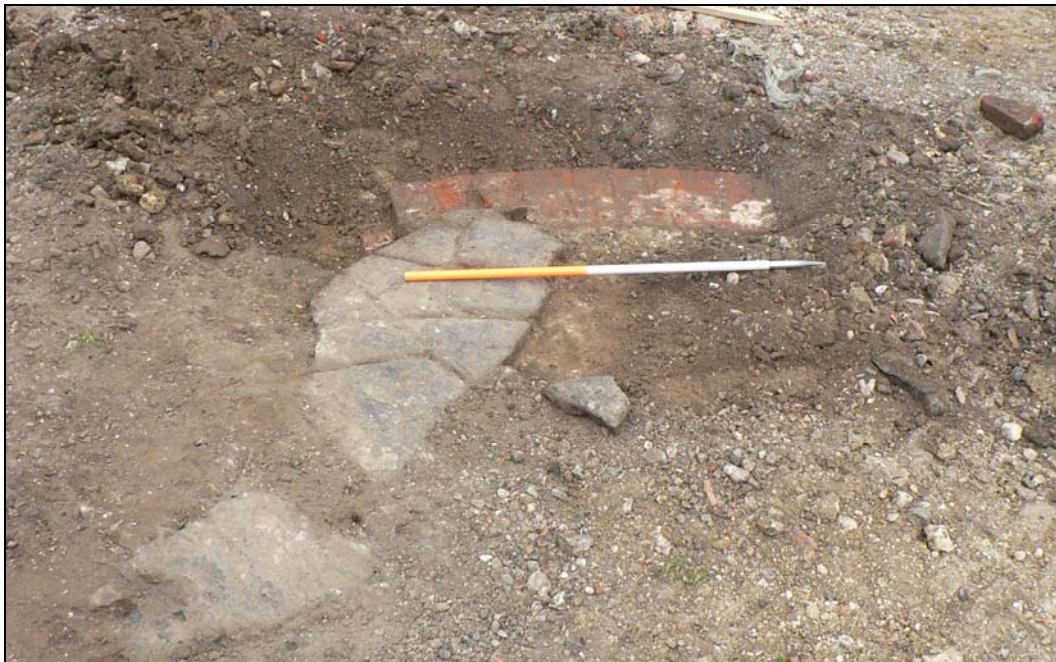
2. Area of bitumous flooring & wall foundation on northern edge of mill

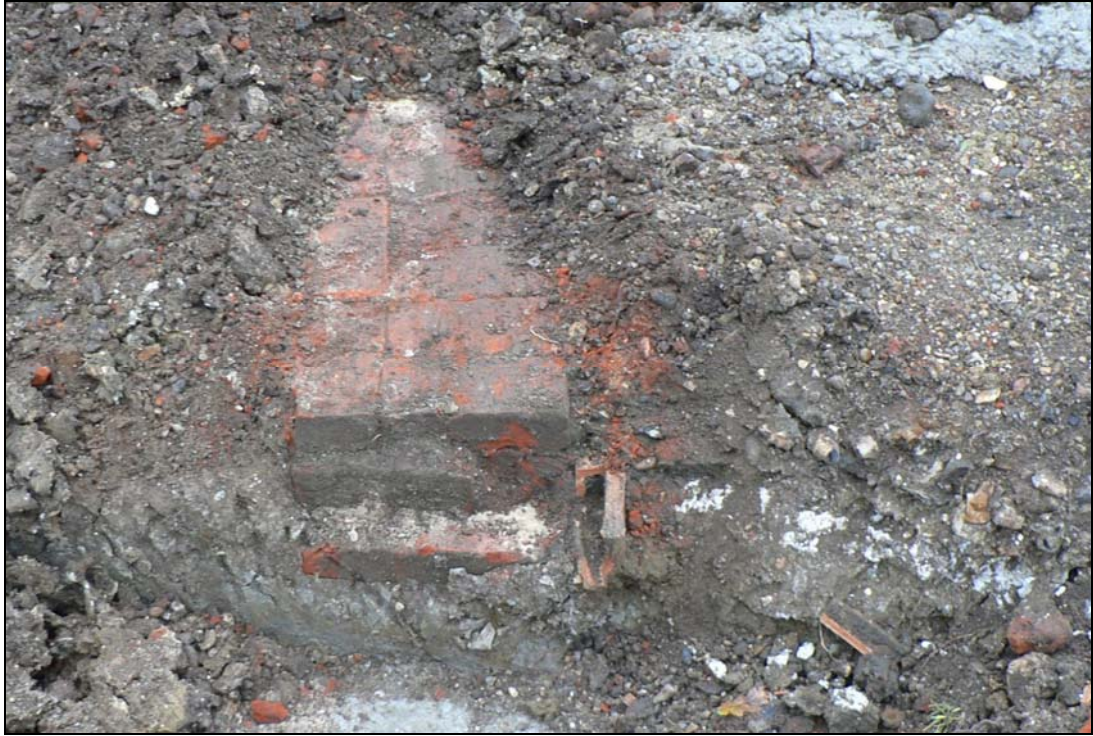
3. Section of roundhouse wall & ceramic drain on outer edge

4.2 An incomplete drainage tile (925g), collected as a sample from a field drain laid around the perimeter of the mill, was in a medium sandy oxidised fabric with common fine chalk inclusions and occasional ferrous fragments. The drain was U-shaped in section with a flat top (78mm high, 59mm wide, 12mm thick) and was a machine-extruded type of mid to late 19th-century date. Complete examples on the site measured 304mm (1ft) in length (J. Newman pers. comm.).

4.3 A complete red brick (3123g) recovered as a sample from the round house was in a medium sandy fabric with occasional large rounded quartz pebbles. A pale buff lime mortar with very little sand aggregate was thinly applied to the upper and lower surfaces. The brick measured 220 x 108 x 68mm (8 ⁵/₈in. x 4 ¹/₄in. 2 ⁵/₈in.) and was likely to be of 19th-century date. Although not closely datable, on balance it was probably later than the c.1800 date suggested for the original construction of the mill.

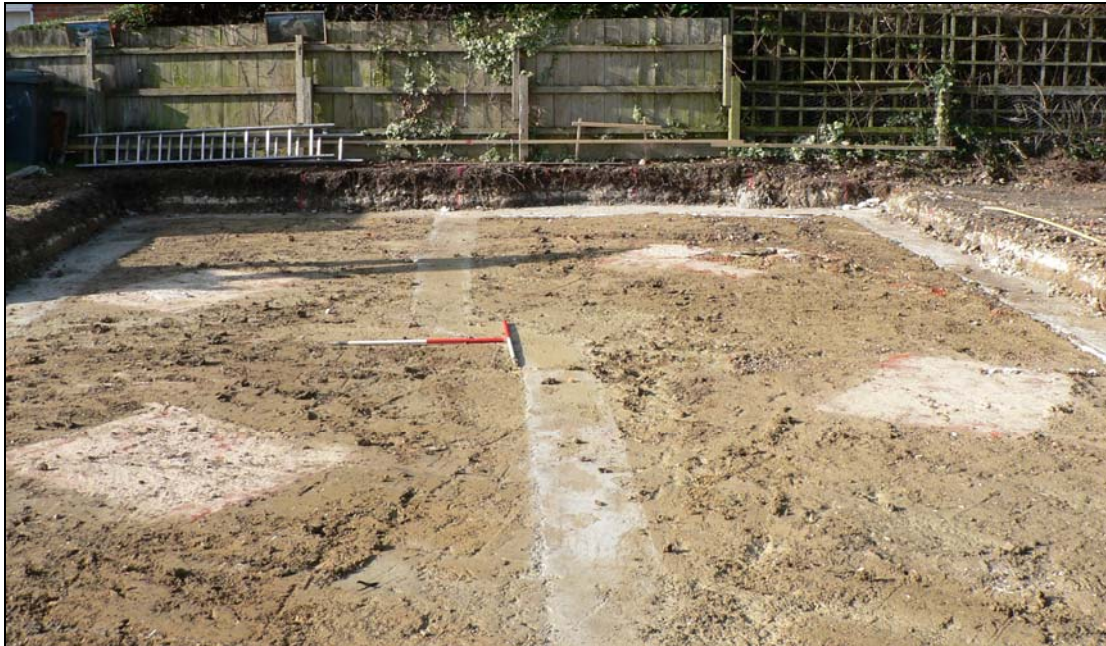
4. Brick pier bases from east

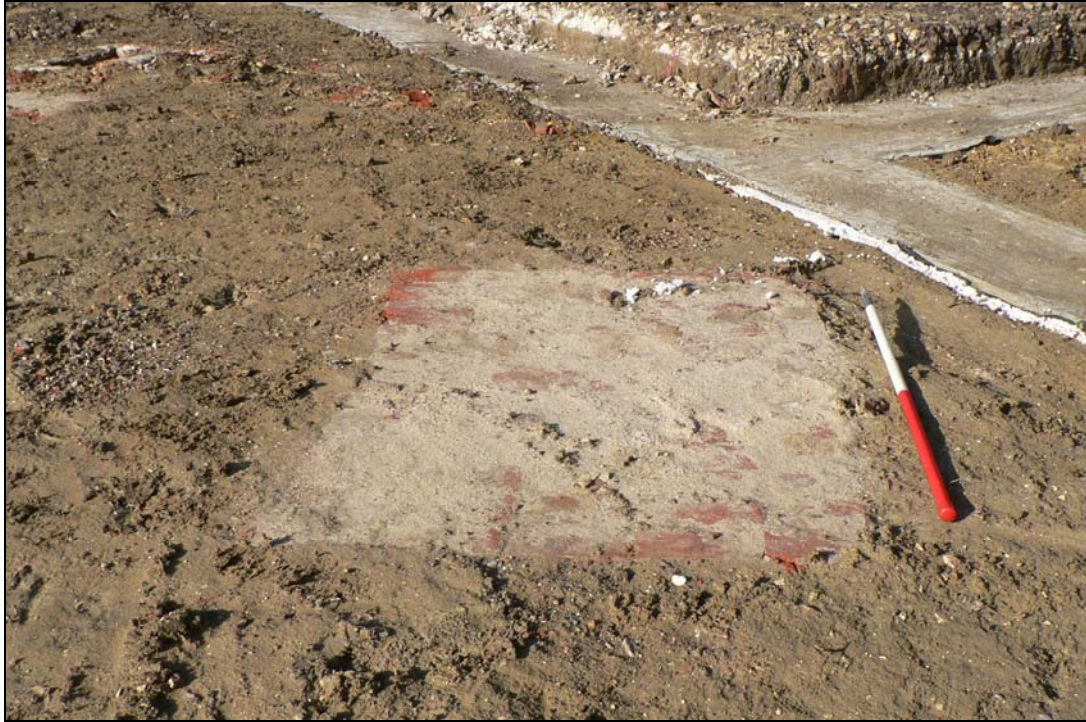
5. Detail of brick pier base
