HISTORIC RECORDING

**THE BARNES
DIAL FARM
CODDENHAM GREEN
SUFFOLK**

GEORGE TANNER HOLDINGS LTD

**RJF/NJR/1481
JUNE 2014**

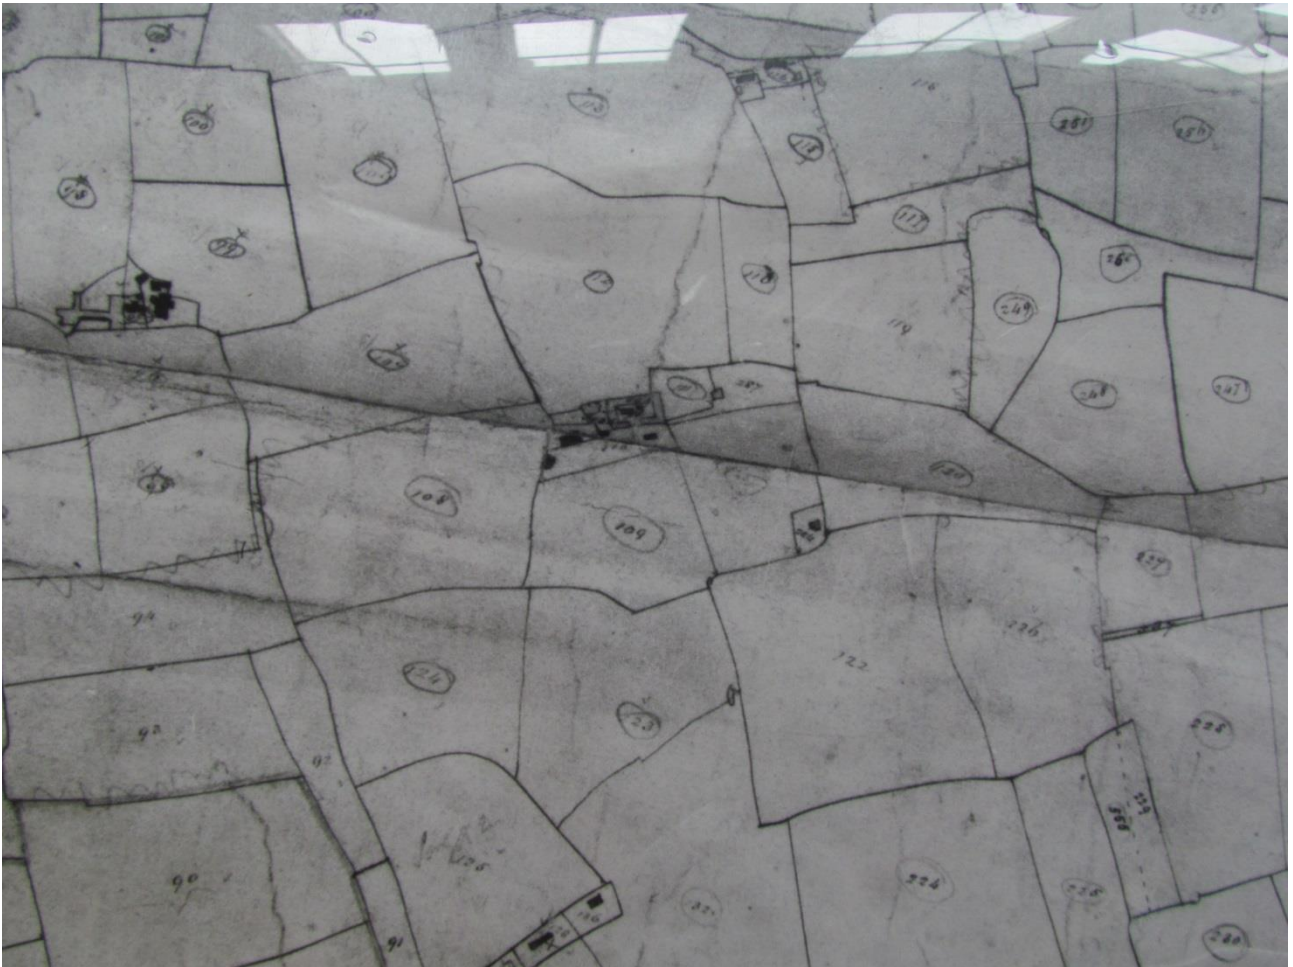
1838 Tithe Map

This indicates the existence of the timber framed elements of both barns

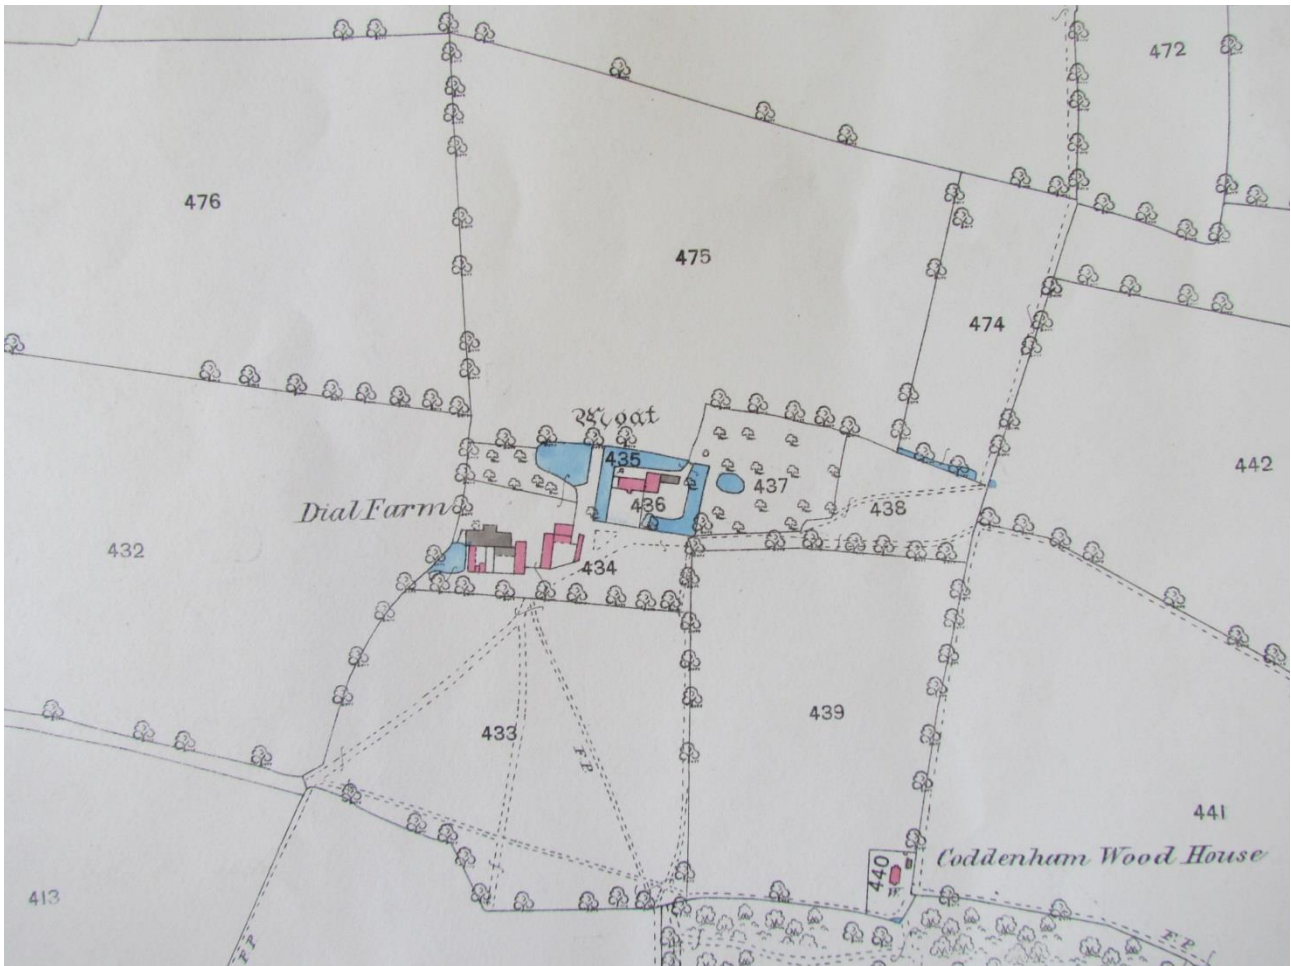
1885 OS Map

This indicates subsequent construction of structures to the south of both barns to create enclosed yards and pens.

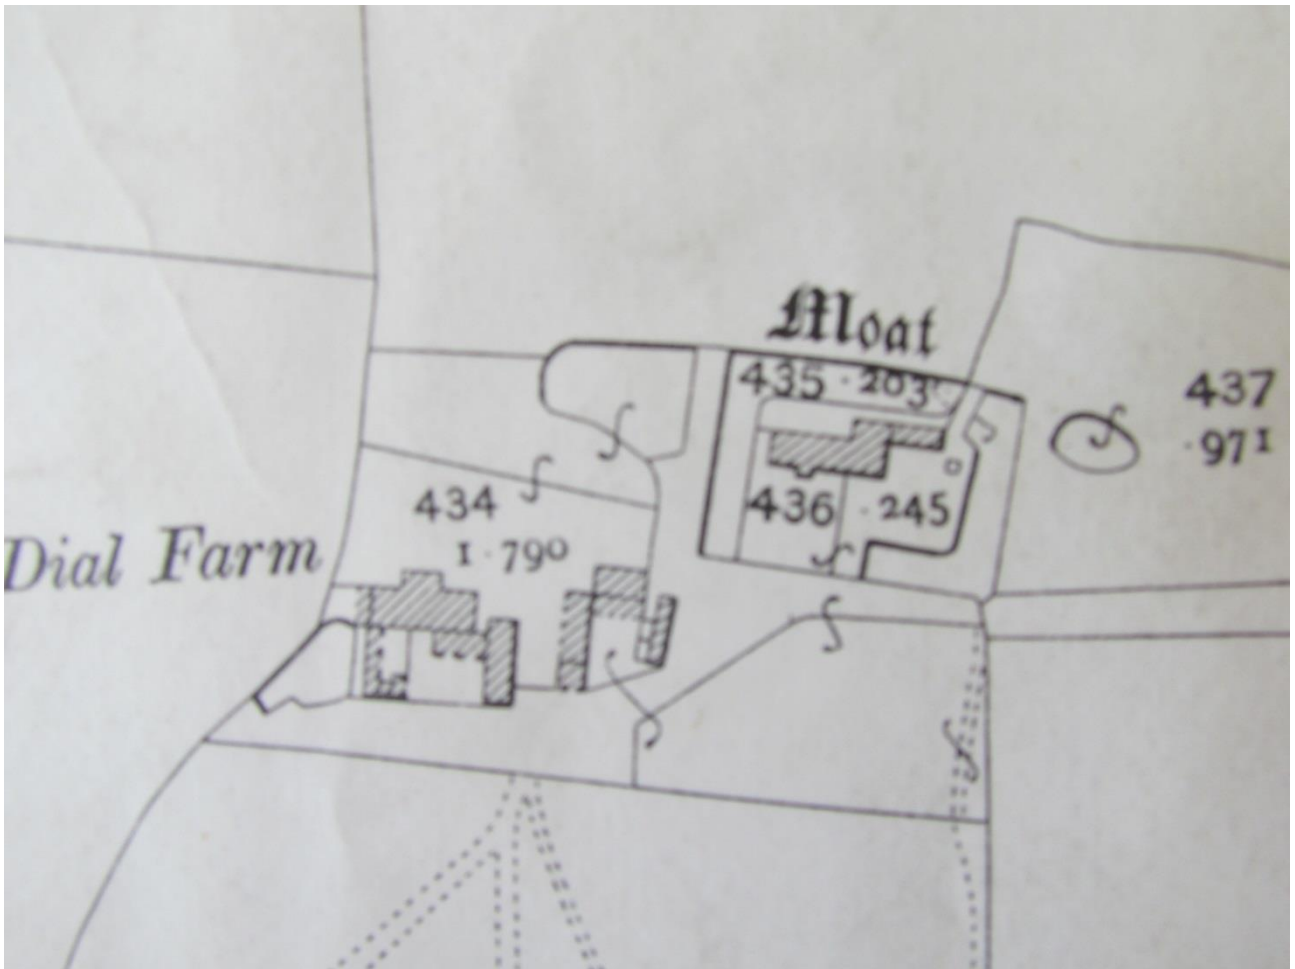
1904 OS Map

This indicates that the general layouts of structures has remained static.

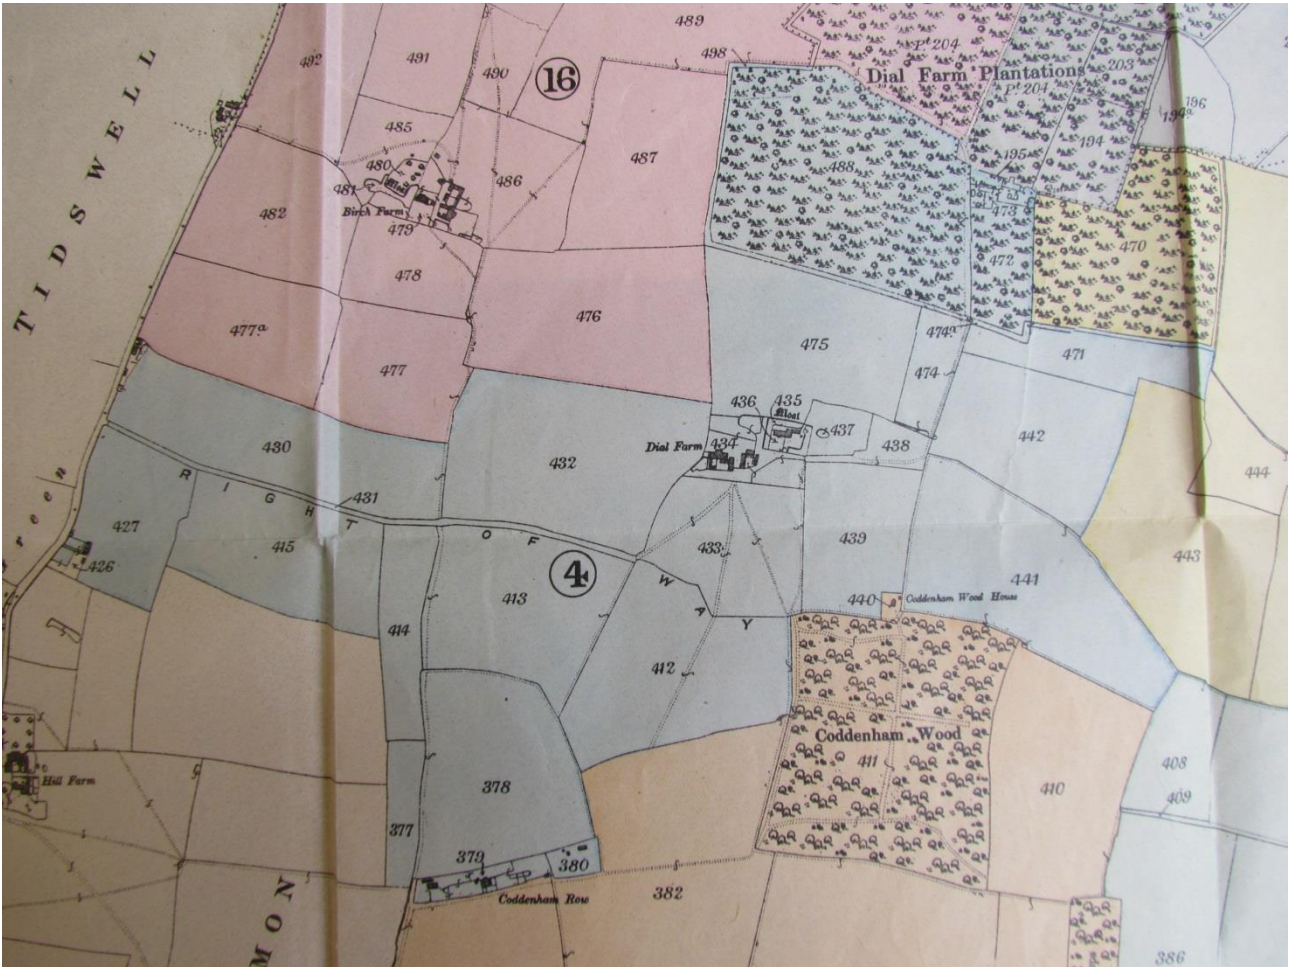
1922 Sales Particulars

Again, this indicates that the general layout of the structures has remained static.

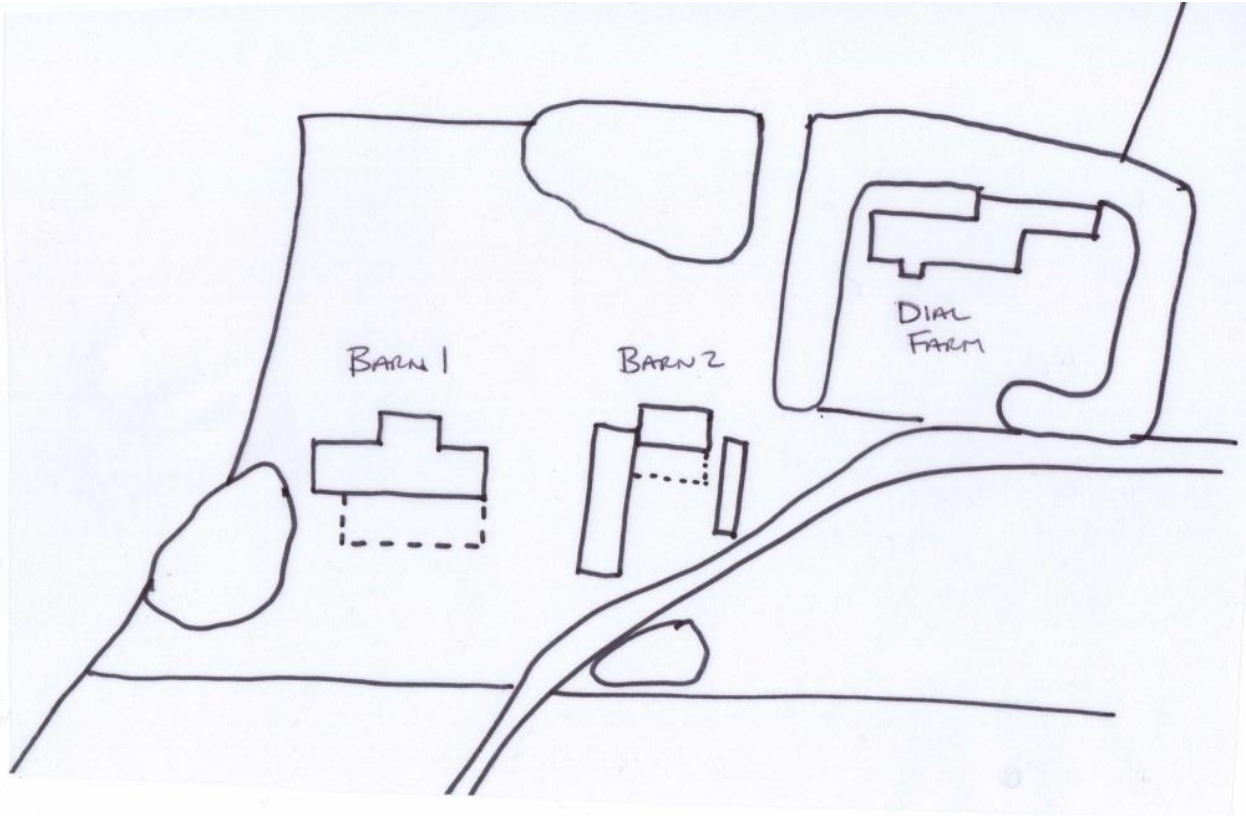
Present Day

Barn 1 – all of outbuildings and yards added post 1838 have been removed

Barn 2 – configuration of structures as first appears of 1885 OS.

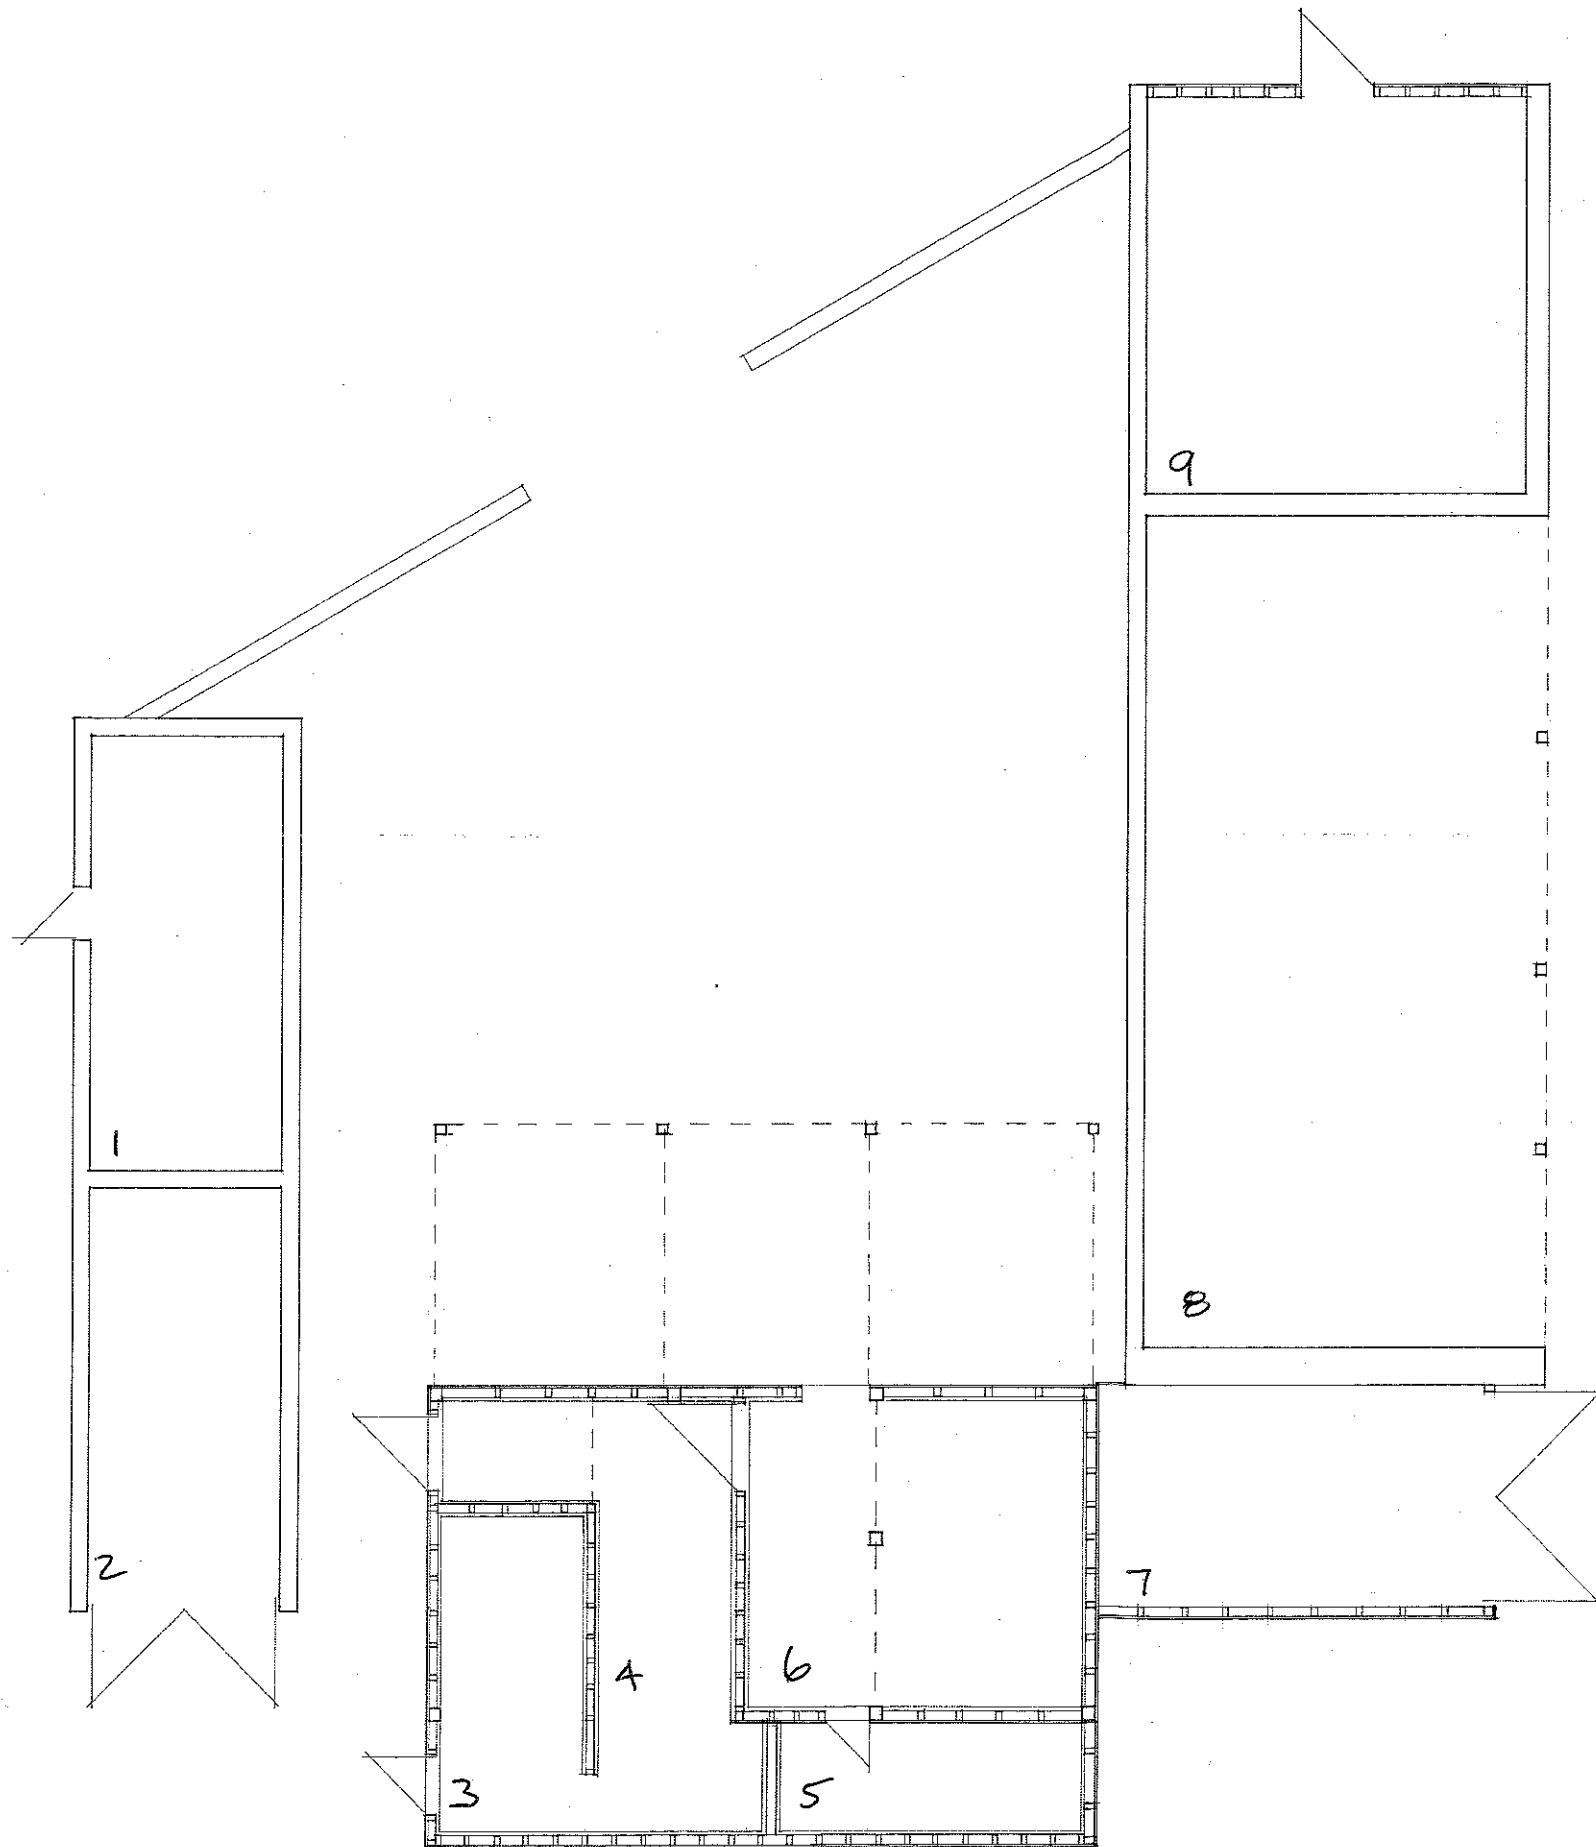
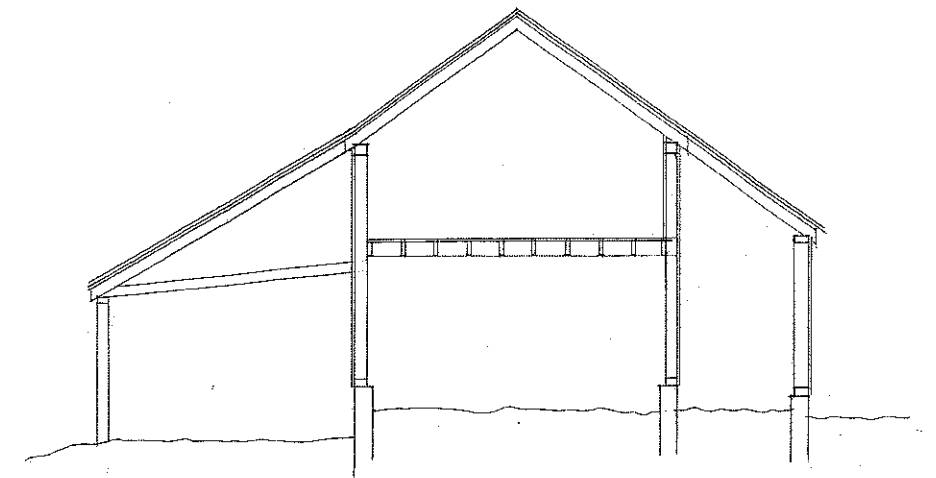
Drawn
BARN 1
AS EXISTING

Barn 1 is a timber framed weather boarded structure in five bays on an east/west axis extending to 19.5m in length by 7m overall. Its walls rise to a height of 4m at their wall plates from the internal floor of 20th Century concrete and the level ground to the north but to a height of 4.5m above ground level to the south. A later mainstry extends by a further 3.6m from the central bay of the north elevation. The doorway to the north has been reduced in effective height by the insertion of softwood rails and weatherboarding externally. Openings in the north and south central bays show much evidence of adhoc and temporary structural repairs to ensure the stiffness of the existing eaves beams. Each side of the northern porch there are later softwood framed lean-to and weather boarded structures with access doors having been created in the return walls of the porch either side for access. The gable peaks to the east and west are later softwood contemporary with the lightweight softwood roof structure evident supporting lightweight profiled sheeting roof covering. At lower level in the east and west gables are window openings which appear to have been inserted into the frame. To both the east and west gables in the absence of intermediate horizontal plate the existing timber studs are considered to be too slender and remedial work will be necessary.

The north and south walls comprise timber framing over a brick plinth with an intermediate horizontal plate at mid height in the walls. The spacing of vertical studs above and below the plates is not always consistent.

The configuration suggests a typical threshing barn of 5 bays with midstry on the northern side and a later open sided lean-to on the southern side.

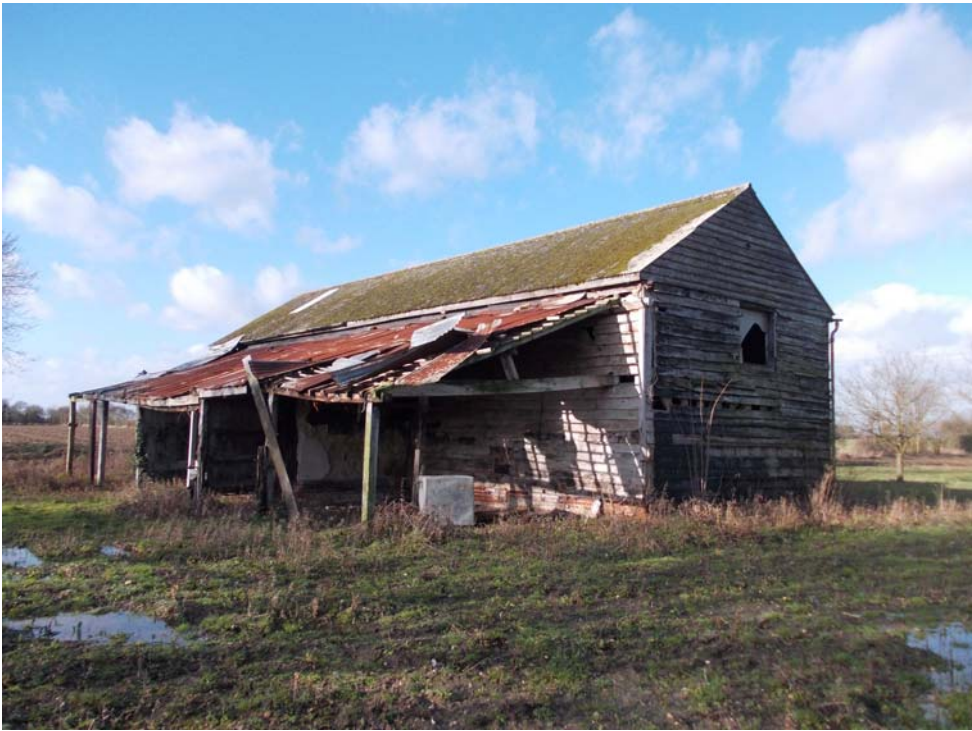
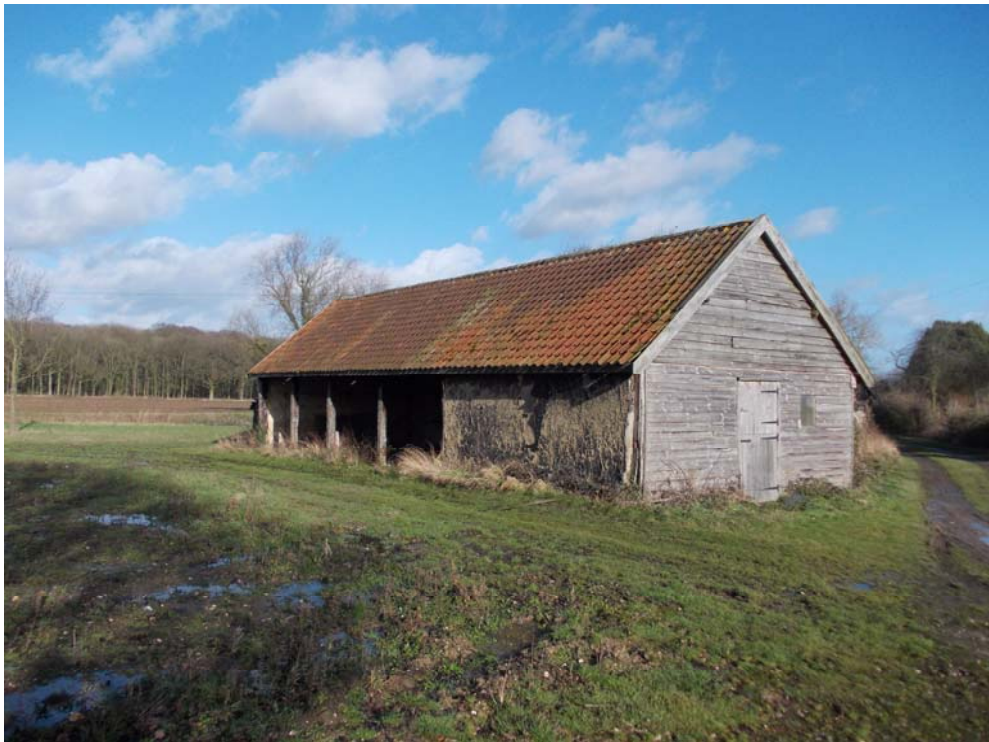
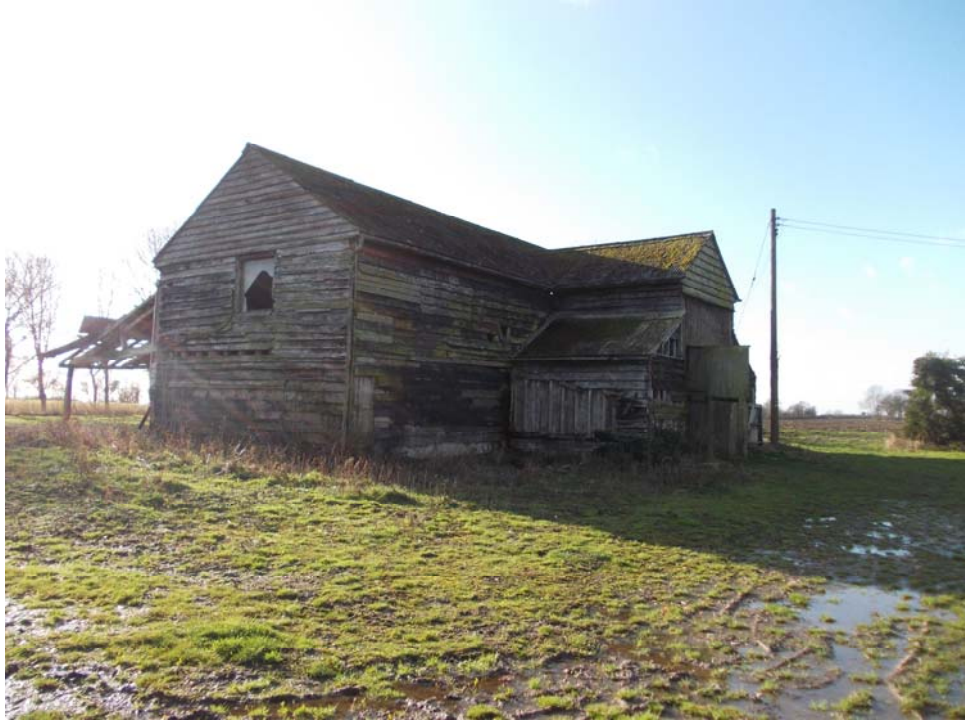
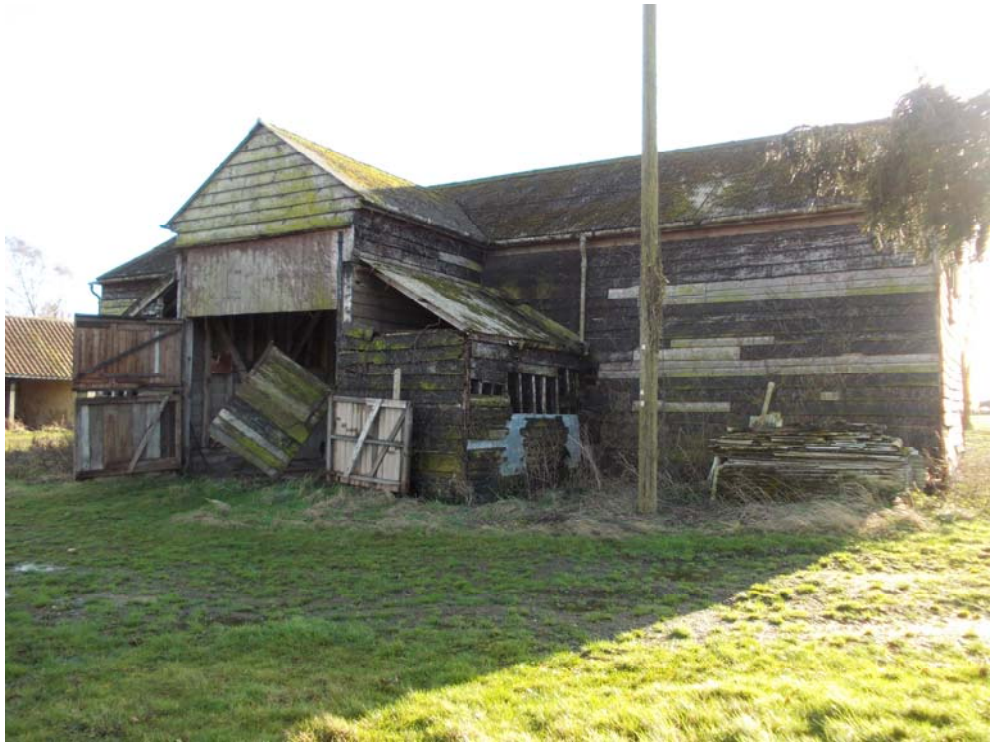
BARN 2
AS EXISTING

Barn 2 in fact comprises a group of three separate detached buildings forming three sides of an enclosed yard, the fourth southern side being enclosed by a wall containing a gateway. It would appear that this building has been used for livestock rearing over a period of years resulting in significant erosion of ground levels within the courtyard and within the timber framed building to the north of the courtyard.

The buildings to the east and west of the courtyard are constructed from earth bricks over a brick plinth rendered internally and externally supporting softwood roofs covered with pantiles.

The third element enclosing the courtyard is a timber framed structure incorporating an area of first floor. The overall size 9mx6m with an eaves height of approximately 2.3m.
