**Little Wenham Hall, Hall Lane, Little Wenham,
Suffolk**

Archaeological Monitoring Report

(October 2015)

Works monitored: Excavation of three small test pits

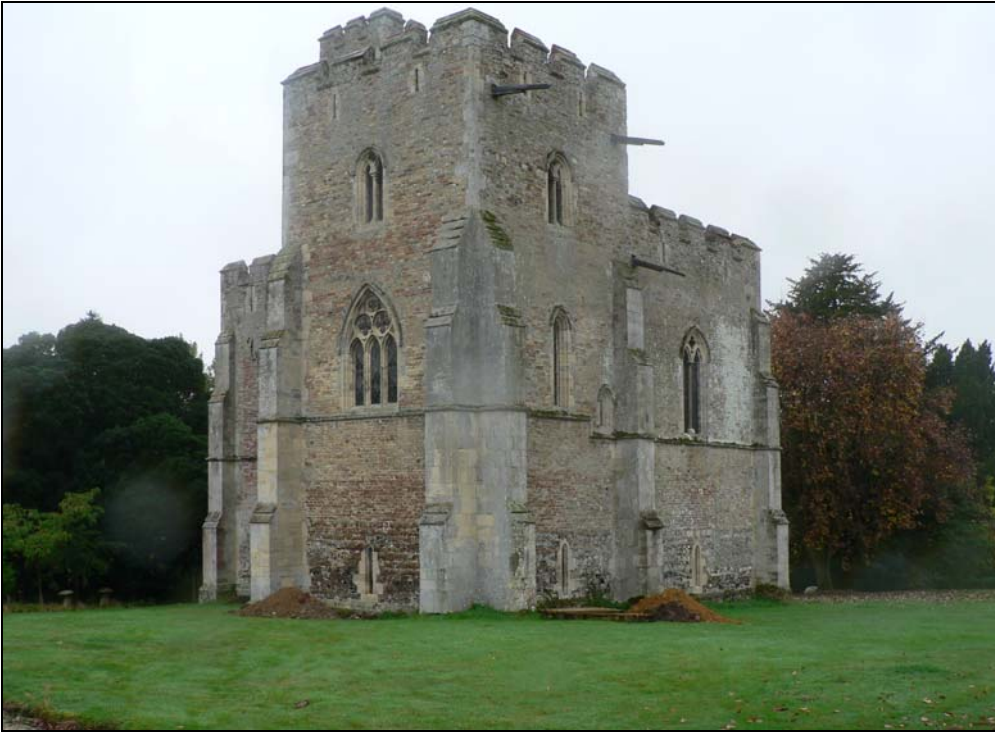
Wenham Castle from northeast with test pits

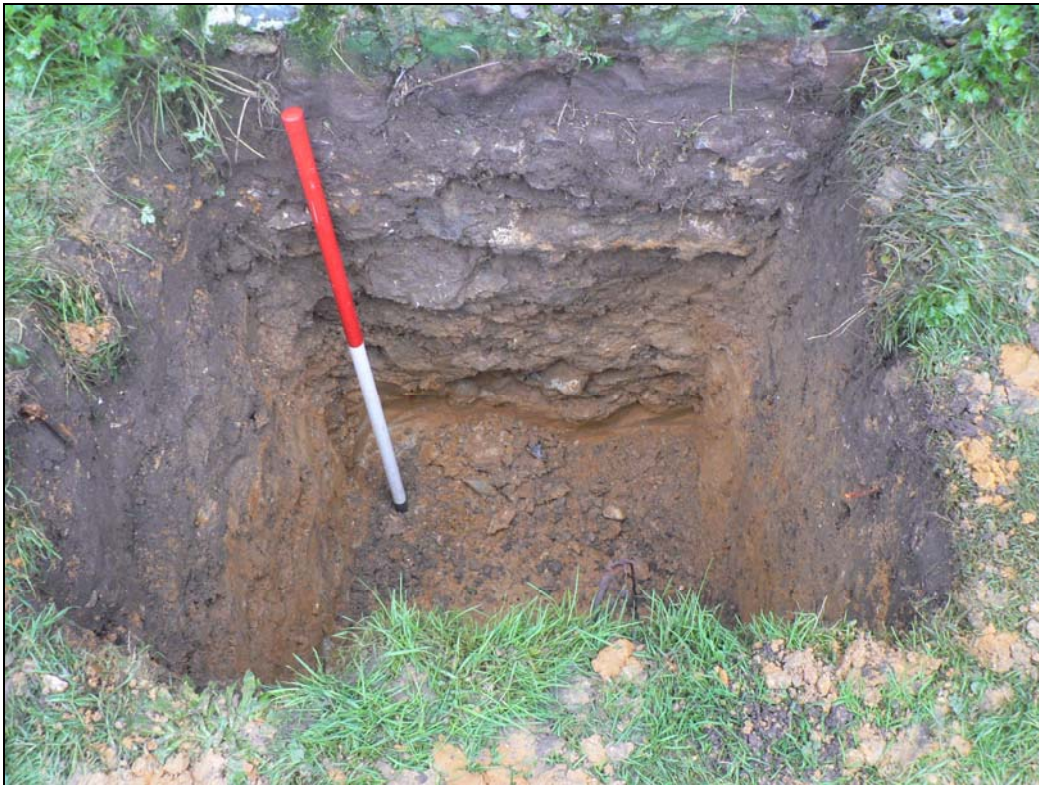
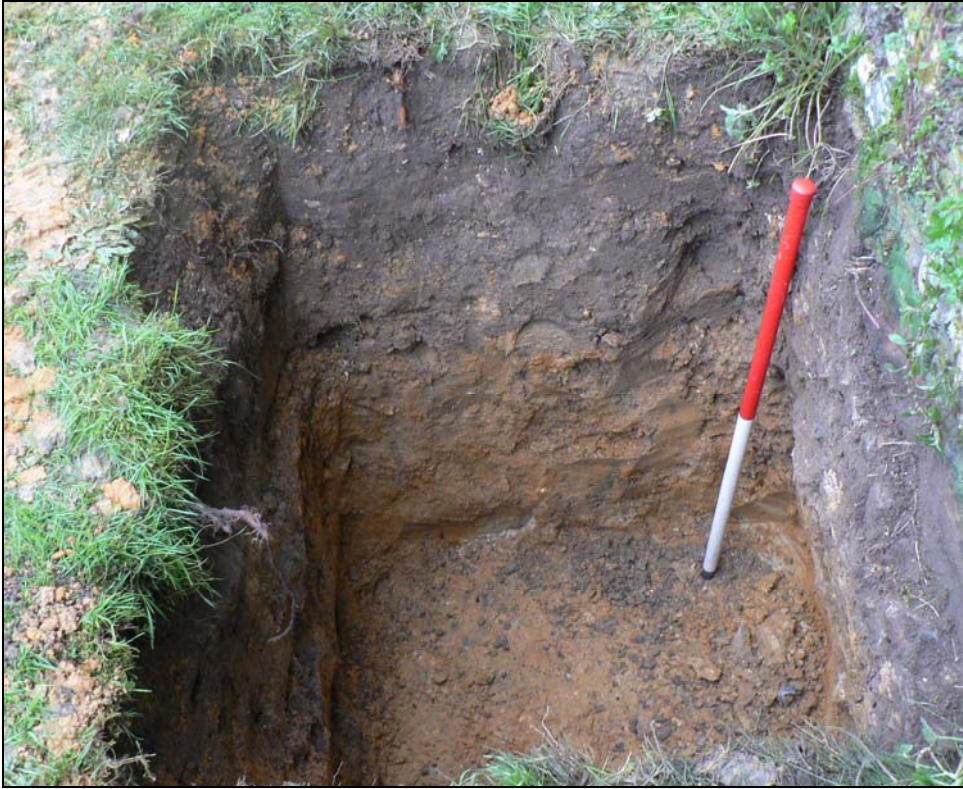
3.1 Test pit 1 was towards the eastern end of the northern side of the building. This revealed 300mm of topsoil and 400mm of pale to mid brown silty sand subsoil with

the locally occurring glaciofluvial natural deposit being a silty and largely stone-free orange sand. The top and subsoil was largely clean with the only finds being occasional small brick and tile fragments of Post medieval date. The base of the test pit was taken to a point 1200mm below ground level (and 1500mm below the base of a narrow window above) so it was at the same depth as the undercroft floor inside the building and it was notable that the base of the pit exhibited no indication of ingress of ground water.

Test pit 1 from north

Test pit 1 from northwest

4.1 Firstly it can be confirmed that the excavated test pits did not reveal or disturb any deposits of archaeological significance. To the north of the building test pit 1 revealed clean top and subsoil to a depth of 700mm suggesting that drainage remediation works along this side of the structure would cause little disturbance to archaeological deposits or features associated with Wenham Castle though any such works should clearly be archaeologically monitored and recorded. To the east of the building while a fragment of later Post medieval roughly lain brick flooring was exposed this was at a depth of 600mm giving some leeway for drainage works if these are required in this area. The brick flooring can in all probability be associated with farm use of the area around Wenham Castle with, perhaps, some type of 18th or 19th century outbuilding standing against the medieval building. With 600mm of subsoil mixed with later Post medieval building debris on the eastern side of the standing building it is also clear that present ground levels may be deceptive in interpretations of the overall site as landscaping works and ground level changes have clearly taken place in the last 100/120 years. To the north of the SM test pit 3 did not reveal anything of archaeological significance.

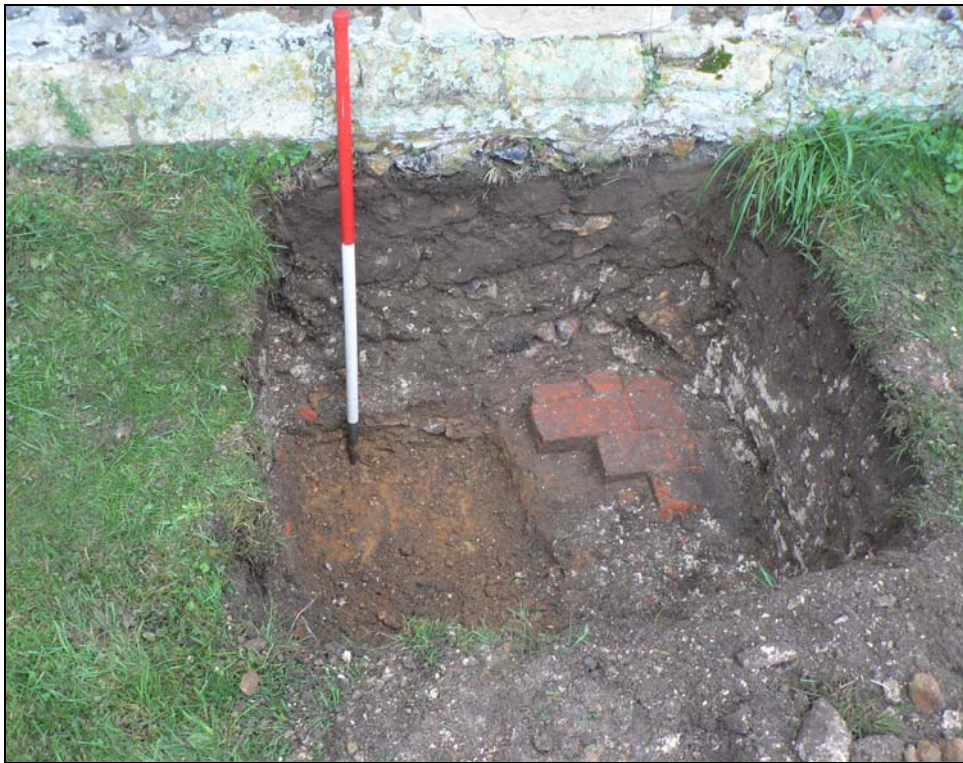
3.2 Test pit 2 on the eastern side of the main range of the building revealed 200mm of topsoil above 600mm of mid to dark brown silty subsoil which contained a large quantity of later Post medieval building debris comprising brick, tile and mortar fragments. In this pit only the southern part against the adjacent wall was taken to a depth of 800mm to reveal the natural silty orange sand and this remained dry. At a depth of 600mm from the ground level a small area of roughly lain brick floor was exposed in the northern part of the pit and butting up against the adjacent wall and this was left in situ. The bricks were 9.25in. x 4.50 in. x 2.25 in. indicating a later Post medieval date. In addition a 19th/early 20th century sheet iron vessel was exposed in the south-eastern corner and was left in situ.

Test pit 2 from east

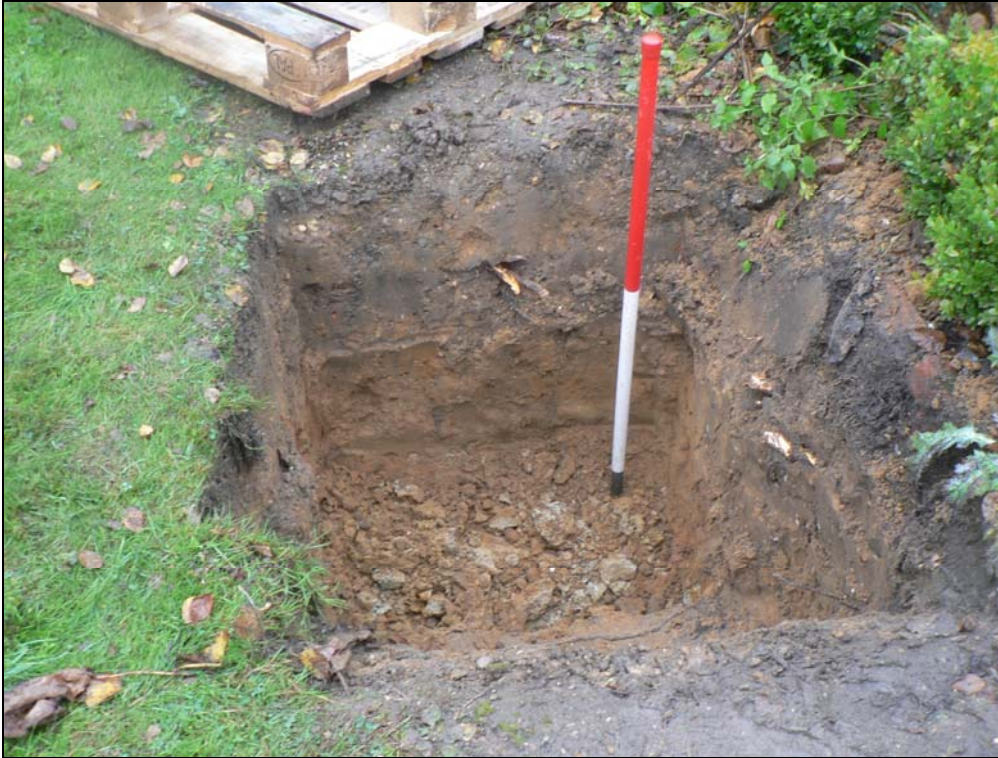
3.3 Test pit 3 was excavated in a garden path 24m to the north of the castle structure and this revealed 300mm of topsoil above 200mm of pale to mid brown silty sand above silty orange sand. The top and subsoil were clean and the pit remained dry.

Test pit 3 from west

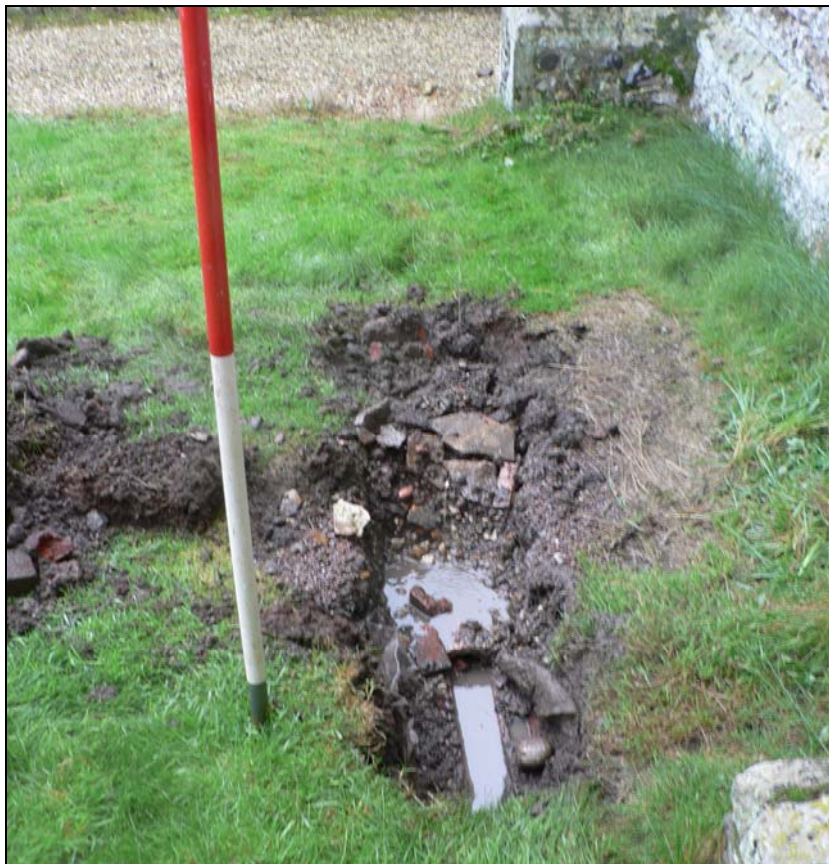
3.4 Finally a minor investigation exposed a 20th century land drain on the south-eastern side of the building.

Land drain at south-eastern corner from south
