Remedial Works to Foul Water System at Ickworth House, Suffolk

Archaeological Monitoring Report

Development: Proposed development: Re-direction and repair of foul water system to north and west sides of west wing and re-direction of storm water system to south side of west wing.

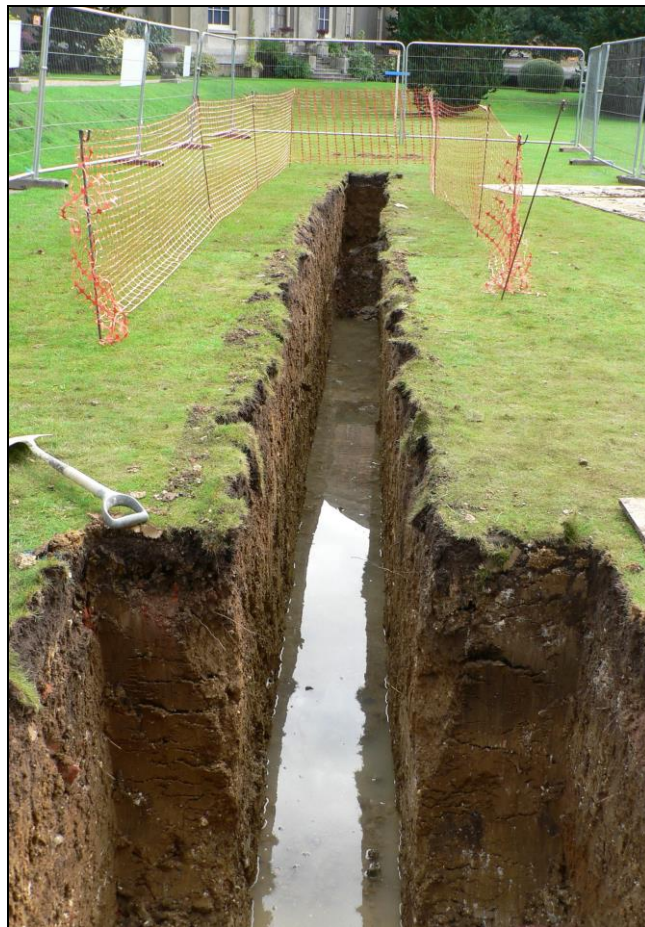
Trench to the rear of the west wing

3.1 In the Italianate garden to the rear of the west wing (A1), and below the terrace immediately adjacent to the rear wall of the wing, the mechanically excavated trench across the lawn was 700mm wide and 1100mm to 1300mm deep and in its western part was enlarged to locate the existing red brick culvert. This red brick culvert, which had a double brick wall construction, was on a north-east to south-west alignment at a depth of 1200mm and it had an external width of 1500mm and internal diameter of 700mm with the bricks being of a similar 19th century type and size to bricks which can be seen above ground at various points at Ickworth House. The deposit profile within the trench comprised 150mm of topsoil above 150mm of mid brown clay subsoil, both with small fragments of brick and tile, and the naturally occurring glaciofluvial deposit seen in all of the ground works was stiff pale brown chalky clay with flints. No other archaeological features were revealed in the area of the Italianate garden.

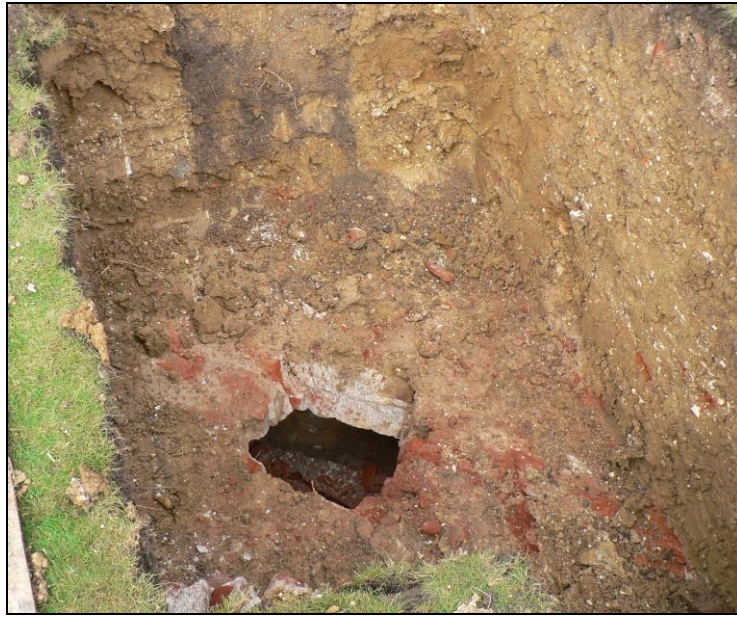
Brick culvert in Italianate garden to rear of west wing

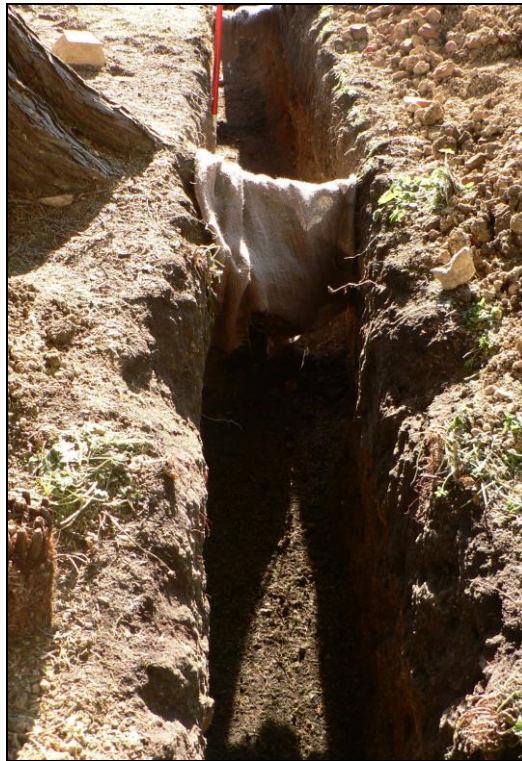
Hand excavated trench to rear of east end of west wing

3.2 At the eastern end of the rear wall to the west wing a short length of new pipe trench was hand excavated as it ran through a planted border with trees to minimise disturbance and protect the roots (A2). This length of trench was 500mm wide and 500mm to 1000mm deep and it was clear from the trench sides that the terrace along the back of the west wing is in all likelihood made up of re-deposited material containing a lot of Post medieval brick and tile fragments. In addition a number of pottery sherds (0001) were collected from the upcast spoil of this length of trench.

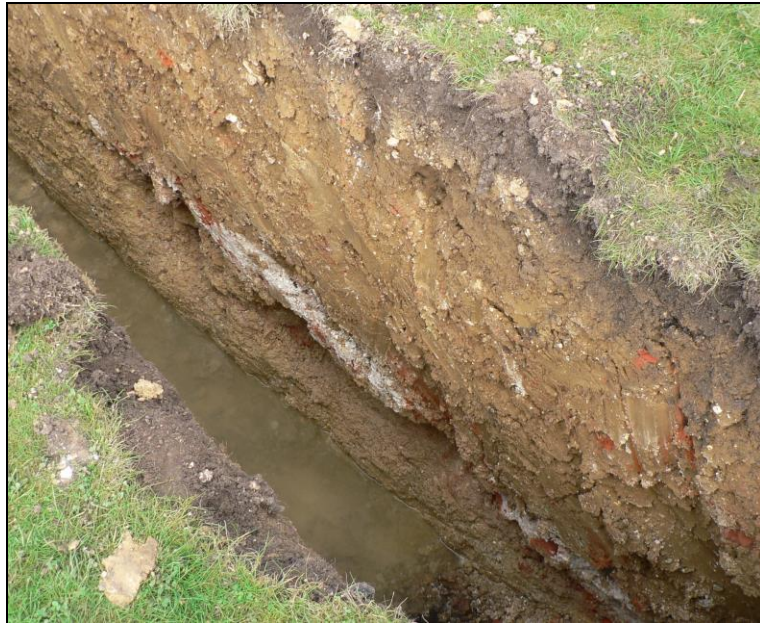
Trench in Italiante garden deposit profile

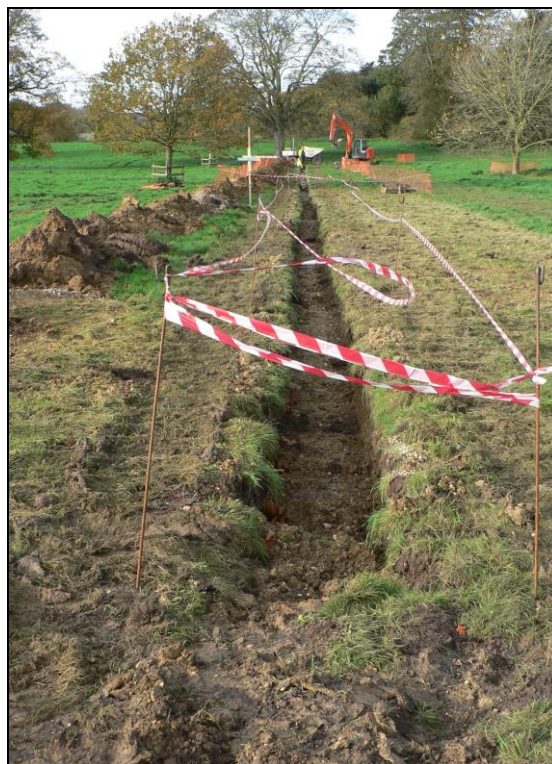
Trench to west of Parsons Pond from east

3.4 To the east and west of Parsons Pond (A4) the 600mm wide and 500mm to 800mm deep new pipe trench revealed a typical deposit profile of 200mm of topsoil above 100mm of mid brown clay subsoil with a possible former track surface 22m to the west of the existing track and made up of small brick, tile and clinker fragments (see Fig. 2). No other archaeological features were revealed though small numbers of pottery sherds were recovered from the upcast spoil to the east (0002) of Parsons Pond and to the west (0003). In addition a red brick culvert (brick size 9in. x 4.25in. x 3in.) was revealed at a depth of 500mm to the west of Parsons Pond (point 4 on Fig. 2).

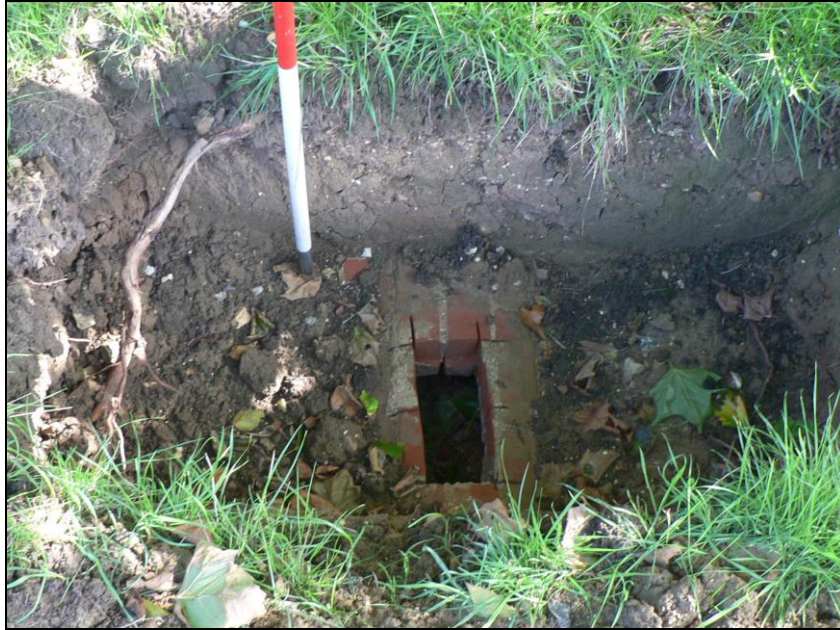
Brick culvert to west of Parsons Pond

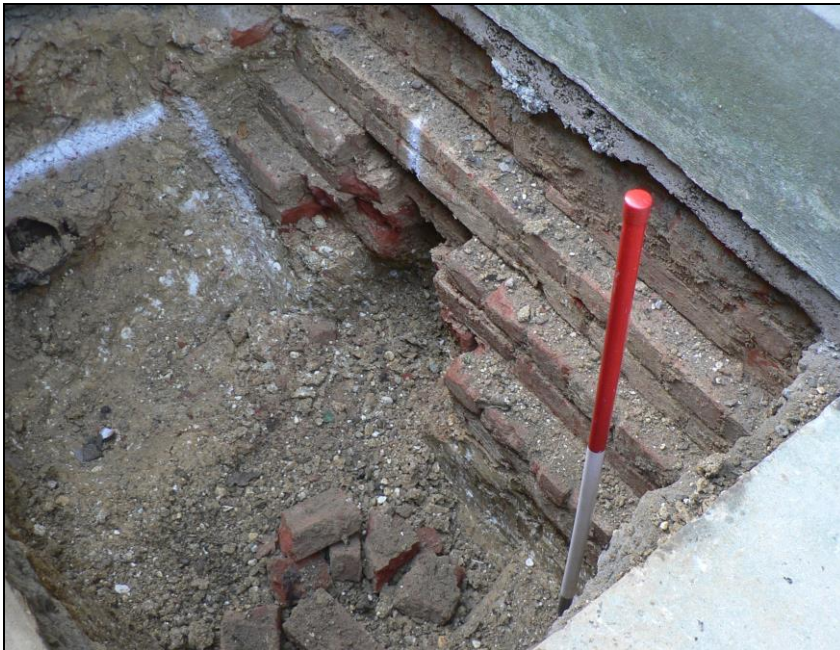
Pit in dry moat to front of west wing

3.5 To the front of the west wing a pit in the dry moat revealed an 8 brick deep foundation for this wall (A5).

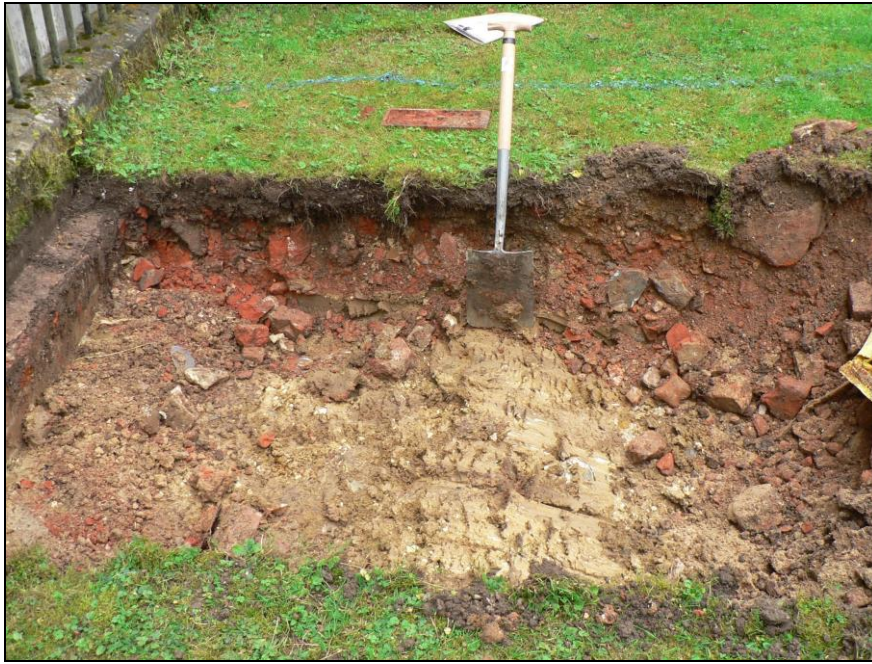
Trench to front of dry moat to front of west wing showing brick and tile debris below turf

3.6 To the north, and in front, of the dry moat in front of the west wing (A6) trenching revealed 100mm of topsoil below the turf over 300mm of subsoil containing a large number of later Post medieval brick, tile and slate fragments. Again no archaeological features were revealed but the contractors were able to collect a large number of pottery sherds, glass fragments and iron debris of 19th to early 20th century date (0004) from the upcast spoil.
