Cable Trenching at Melford Hall, Long Melford, Suffolk

HER Ref: LMD 265

Archaeological Monitoring Report

(February 2017)

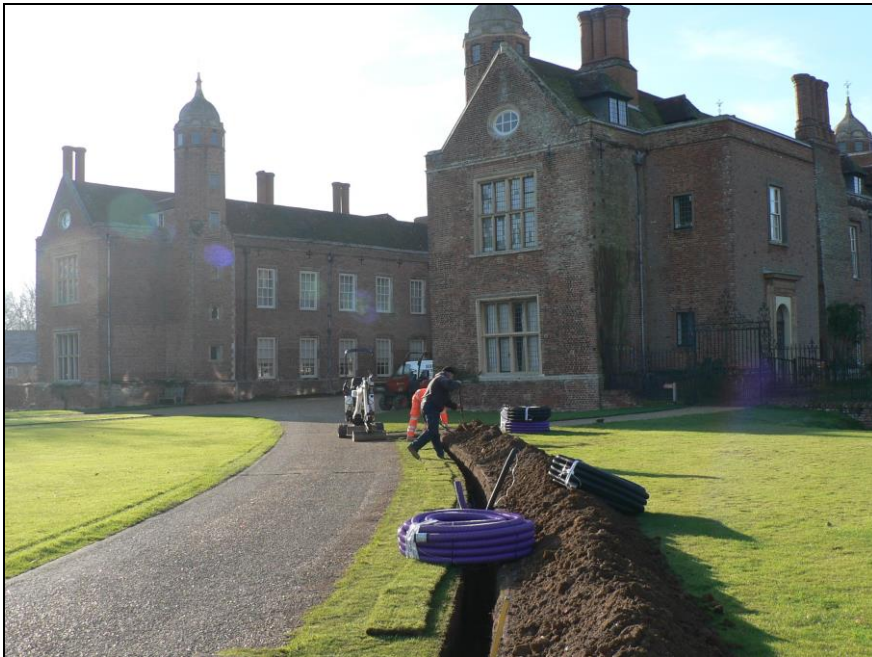
General view of cabling works from northwest

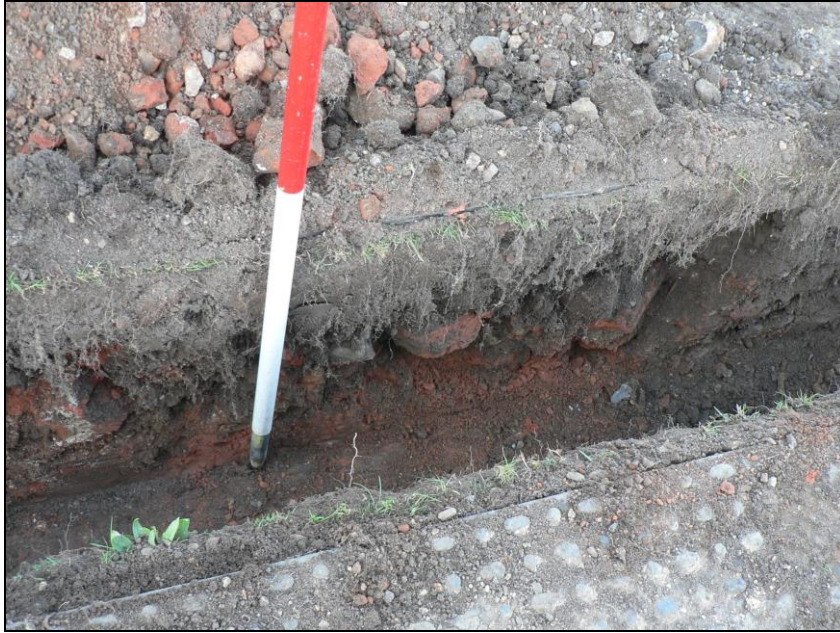
Brick wall foundation 0002 in base of trench

3.2 In the courtyard area on the eastern side of the north wing the trench revealed 250mm of yard surface and make-up over 250mm of mid brown sandy subsoil and a few brick fragments but no archaeological features. The first definite feature to be revealed in the trench was a red brick wall foundation (0002) which was 450mm wide and 250mm deep and was located 800mm south of the path that runs north of the north wing. In the next 40m of the trench while brick debris and other stray finds (0012) were present in the upcast spoil no archaeological features were revealed. However to the east of the ha-ha and raised walk a number of red brick foundations were revealed. From the south these comprised a 240mm wide east-west aligned red brick wall foundation (0003) then nearby to the north a 800mm wide brick foundation (0004) again on an east-west alignment and then, again nearby, a north/north-east to south/south-west red brick wall foundation (0005) in the eastern side of the narrow trench. Adjacent to the latter wall foundation on its northern side a 5m length of rammed chalk surface (0006) was exposed at the base of the trench. In this length of the cable trench east of the ha-ha the upcast trench spoil and trench sides contained a lot of brick debris making the identification of brick foundations difficult but it is felt with some confidence that the wall foundations described above (0003, 0004 & 0005) were clear enough to be identified as such. In addition a few stray finds (0013) were recovered from the upcast spoil in this area.

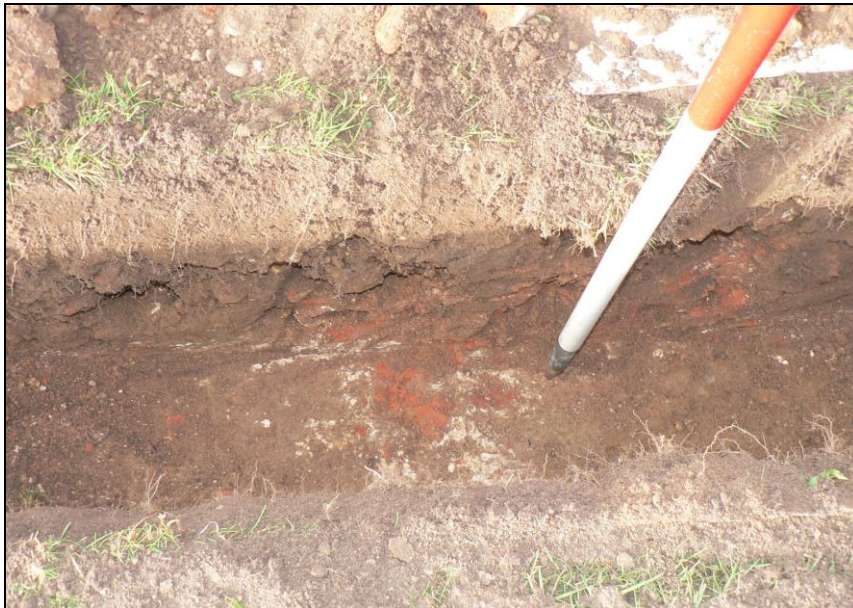
Brick wall foundation 0003 in base of trench

5.1 From the results of this monitoring it is clear that the red brick foundations (0003, 0004 & 0005) revealed to the east of the ha-ha and 60m north-east of the north wing of the hall mark the site of the outer gate house shown on the Pierse map of 1613. The middle wall foundation (0004) in particular being quite substantial with a width of 600mm suggesting that this marks the line of one of the main gate house walls with the nearby north/north-east to south/south-west wall (0005) being of an unknown width as it ran obliquely along the line of the cable trench. In addition the wall foundation (0002) near the north wing is probably the line of another wall on this map which ran east from the north-east corner of the north wing before turning north to run to the south-western corner of the outer gate house. It is also likely that the rammed chalk surface (0006) directly to the north of the outer gate house foundations is related to this structure.

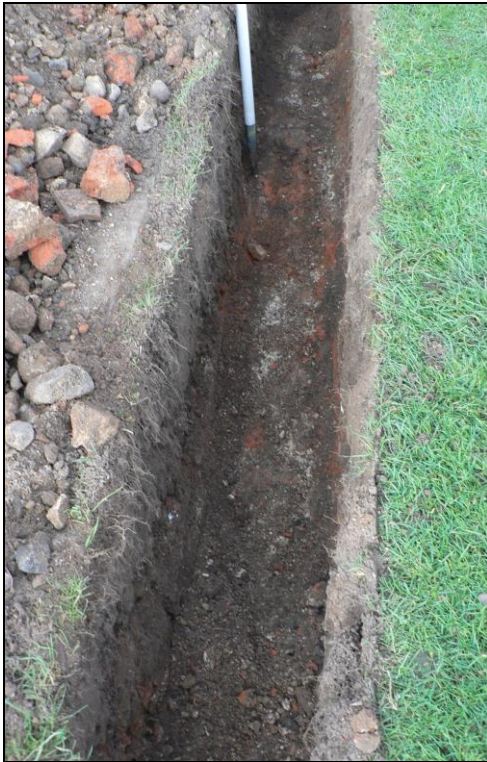
Brick wall foundation 0004 in base of trench

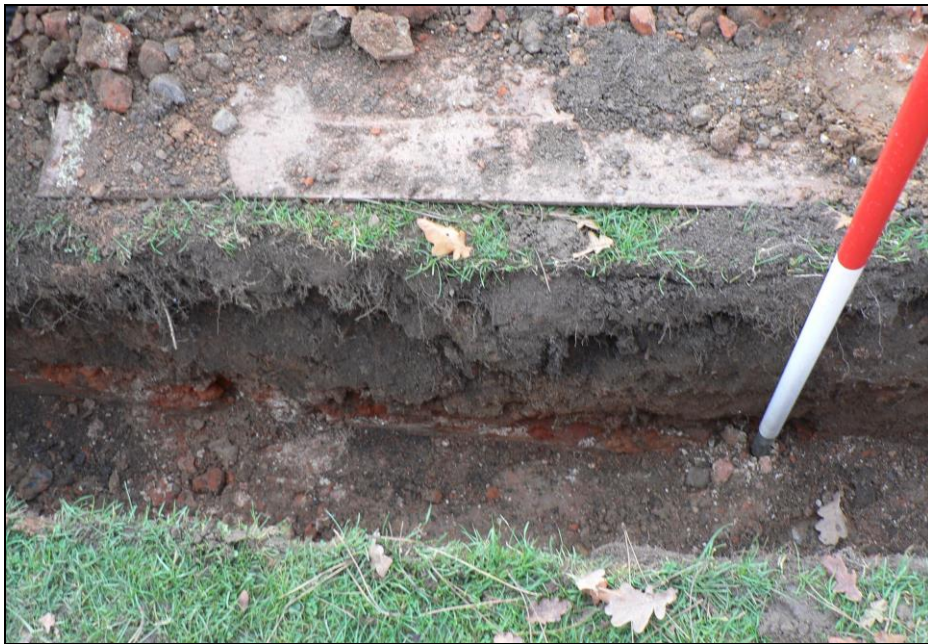
Brick wall foundation 0005 running along eastern side of trench

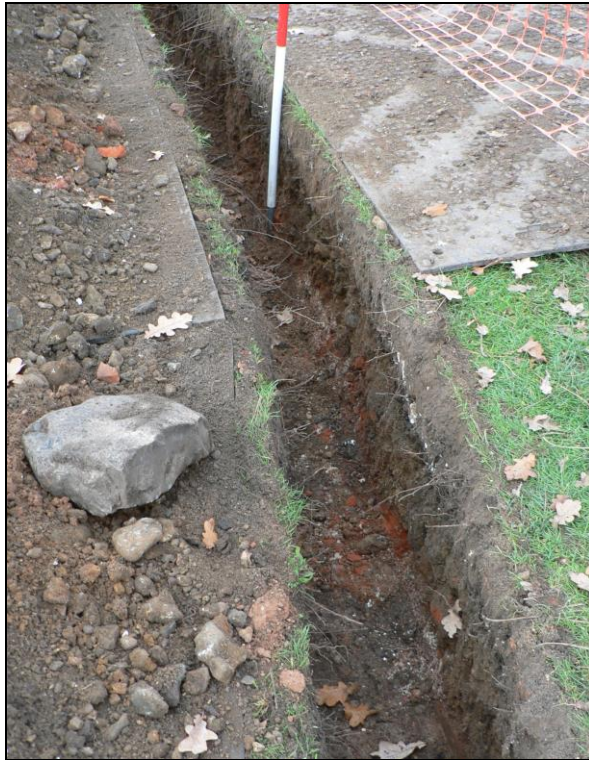
Possible brick wall foundation running along side of trench

3.4 To the north of the ha-ha on the main east-west length of the cable trench further red brick wall foundations were exposed with one (0007) being c600mm wide on a north-south alignment as was another probable foundation nearby to the west (0008) which was again c600mm wide. Slightly further to the west another possible brick wall foundation (0009) was identified running on a north/north-west-south/south-east orientation at an oblique angle to the narrow trench making secure identification of this feature difficult.

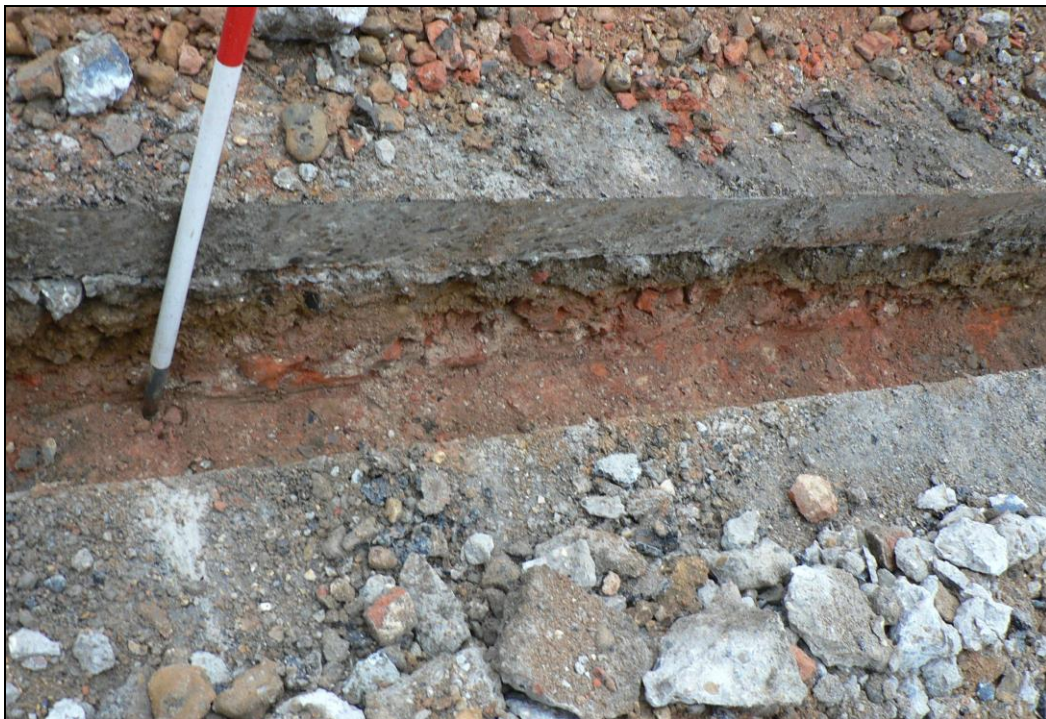
Brick wall foundation/floor 0010 just inside entrance to park at gate house

3.6 The remaining red brick built structural evidence that was exposed in the base of the 500mm deep trench was in that part of the cable trench which cut across the drive on the inner side of the existing gate house at the entrance to the park from the road to the west. The larger of these features (0010) was 2.20m from the southern edge of the drive and was 1600mm wide on its north-south dimension. At this width the feature (0010) is probably better interpreted as part of a brick surface though the possibility of it being a very wide wall foundation cannot be ruled out. The smaller feature was a red brick wall foundation (0011) that was 900mm from the northern edge of the drive and was 500mm wide on an east-west

orientation. These two features were made out of 2 inch thick red bricks which were relatively soft and similar in form and fabric to the brick foundations revealed to the east of the ha-ha (0003, 0004 & 0005) and those to the north of the ha-ha (0007, 0008 & 0009). In addition these bricks are all similar to those examined in the hall itself confirming a 16th to 17th century date for these foundations and possible floor surface.
