## Leez Priory, Hartford End, Great Leighs, Essex

Planning application: 17/00845/FUL

**Archaeological Monitoring Report**

Development: Erection of accommodation blocks

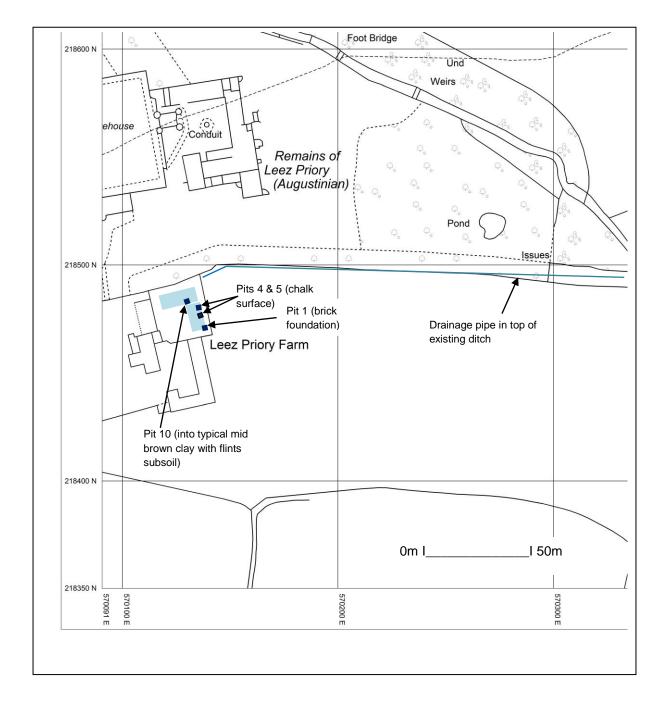
Fig. 2: Location of monitored areas (light blue- new accommodation blocks with drainage run to east, for pile pits shown see Appendix I – Images; in total 24 300mm x 300mm x 200mm deep pits were opened around the perimeter of the block footprints with evidence for a red brick foundation in pit 1 and a chalk surface in pits 4 and 5, otherwise only mid brown clay subsoil as shown for pit 10 in the remaining 21 small and shallow pits)

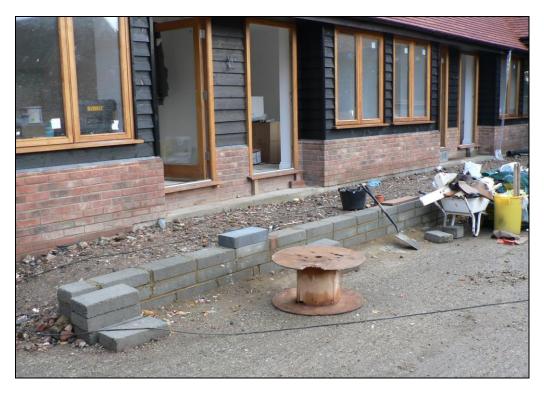
New accommodation blocks on concrete yard

2.1 Two visits were made to the site to monitor the relevant ground works with initially the small pile pits being examined followed later by the related drainage works. On each visit a small number of digital images were taken to record the exposed deposits and to confirm that the main build is above the existing concrete yard surface (see Appendix I).

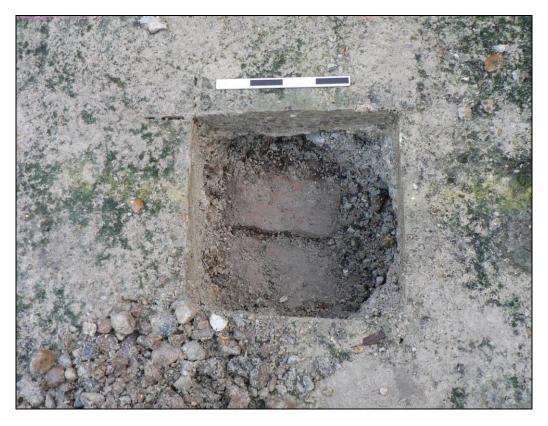
Brick foundation in pit 1

- 3.1 In total 24 No. 300mm x 300mm pits were cut carefully though the concrete yard surface for the new accommodation blocks to a depth of 200mm and only one of these (Pit 1) revealed some evidence for a red brick foundation of later/earlier Post medieval date. In addition two of the pile pits (Pits 4 & 5) revealed evidence for a chalk surface below the concrete. The remaining 21 pits only revealed mid to dark brown clay subsoil (see Appendix I for pit 10 into typical clay subsoil).

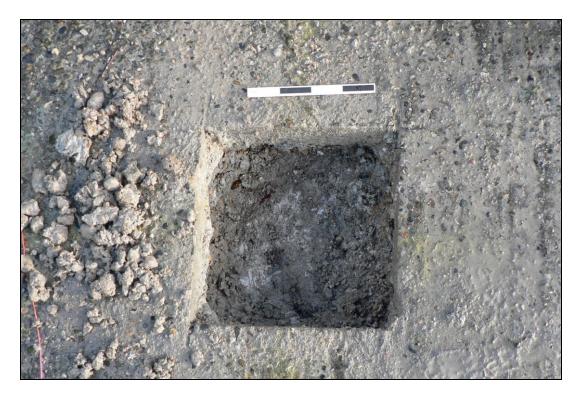
Chalk surface in pit 4

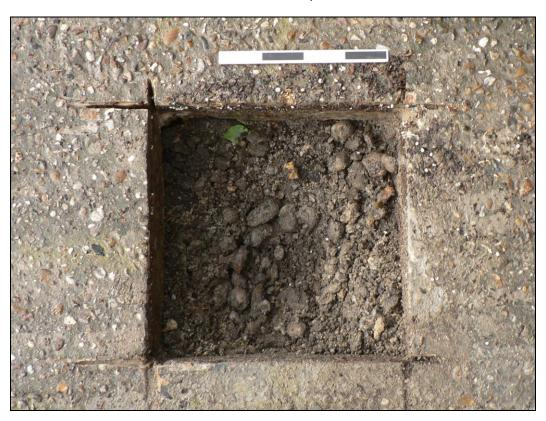
Pit 10

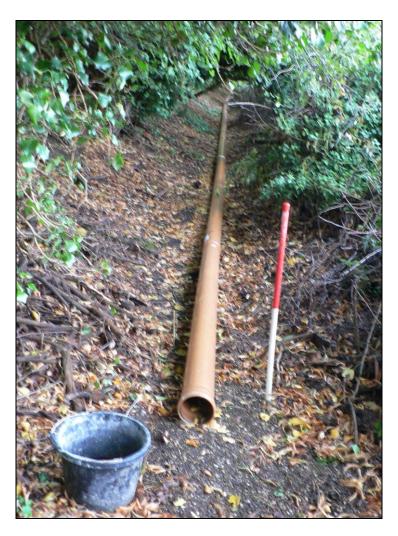
Drainage pipe in ditch

- 3.2 While the initial plan was to place the drainage pipe for the new build in the upper part of the silt within the existing ditch to the east of the accommodation blocks a review of the drop between the site and the lower area to the east confirmed that the pipe needed to be at present ground level in the ditch so no disturbance was required and in all likelihood the pipe will be left under a shallow depth of redeposited top soil.
