Pentney Abbey, Pentney, Norfolk

Archaeological Monitoring Report

(Continuous observation of ground works)

Development: New septic tank, feeder drain and soak away drains

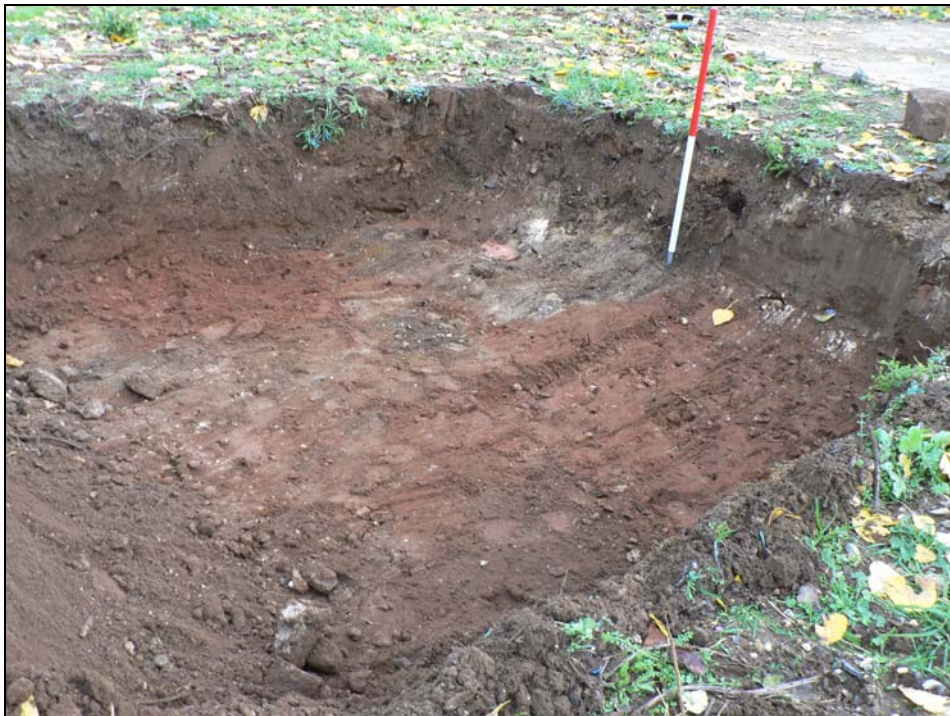
Image 2: Septic tank area after removal of overburden from south-west

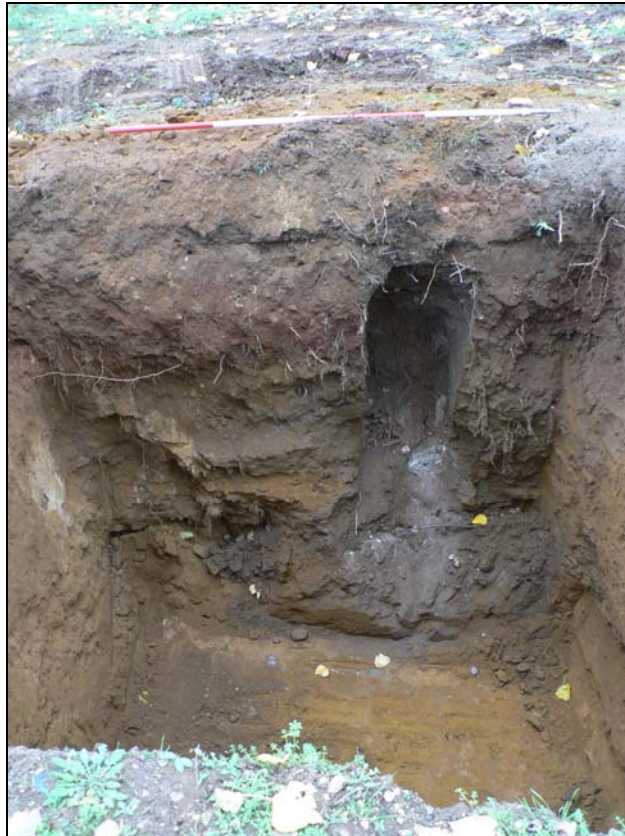
3.1 The site for the new septic tank (see Fig. 2) is located 27m south of Abbey Farmhouse and adjacent to an existing concrete pad on the boundary between the grassed area around the house and outbuildings and a pasture field to the south. Information from an employee of the working farm that existed at Abbey Farm until the later 20th century indicates that the concrete pad formed the base for a small cattle shed. The 3m by 3m and 3m deep pit for the new septic tank was mechanically excavated using a wide, toothless, ditching bucket under close supervision. The sandy topsoil proved to be 300mm deep and removal of this layer revealed a sand naturally occurring drift geological deposit with numerous small to medium carstone fragments. The only feature was a modern pit with a diameter of 700mm in the north western corner which contained an unconsolidated fill comprising sand and modern debris. This pit was clearly very deep as its base was not revealed in the 3m deep excavation and it seems likely that this feature is a borehole, perhaps created for the cattle shed noted above as having occupied this area in the recent past. Examination of the upcast spoil noted only a few small 19th century and later brick/tile fragments and assorted modern debris.

Image 3: Septic tank pit- western section showing modern pit/borehole

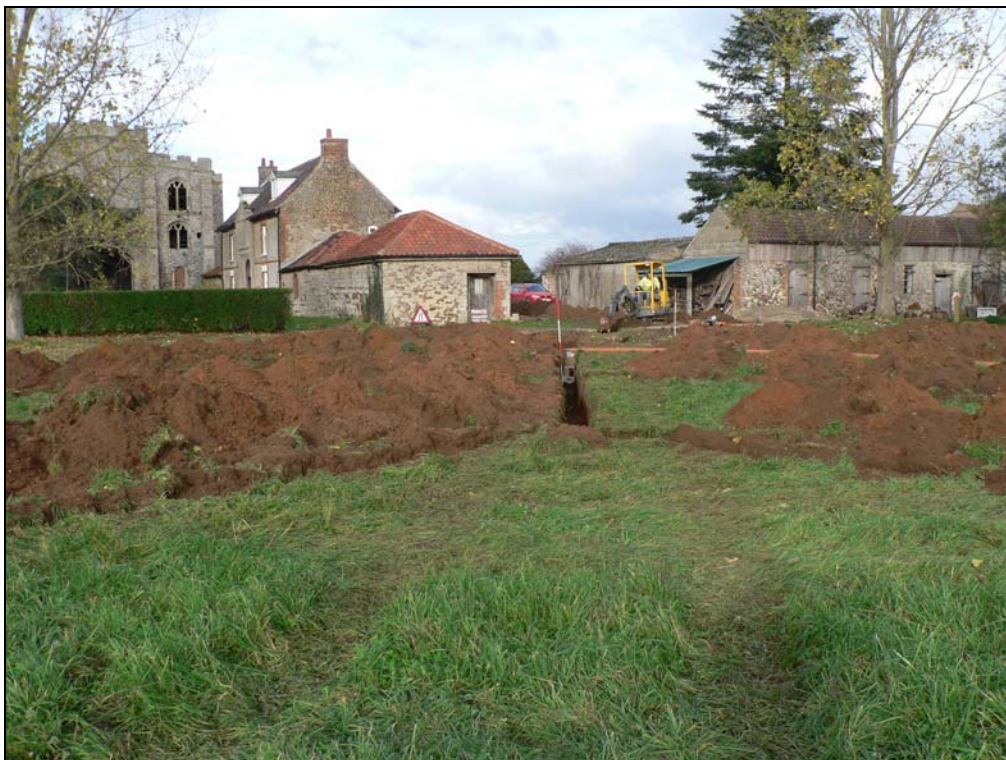
Image 4: Area of overflow drains from south

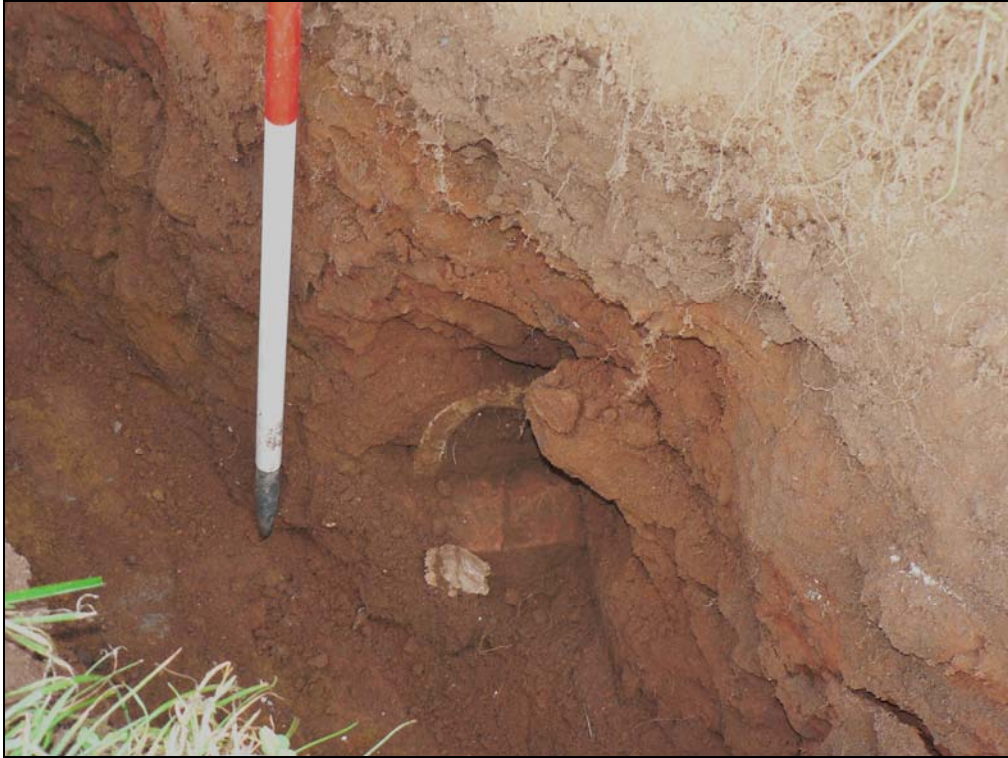
3.2 The overflow drains from the septic tank pit, as noted above, were excavated using a 400mm wide toothed bucket in the field to the south (see Fig. 2). The main run is aligned north-south and is 17m long with 3 spurs on each side, each 12m long. The overflow drains were excavated to a depth of 900mm revealing 400mm of a dark brown sandy topsoil over the naturally occurring sand and carstone drift deposit below. The upcast spoil did not reveal any finds and the only feature noted was a north-south aligned ceramic field drain at a depth of 750mm towards the eastern end of the north-eastern spur (see Fig. 2 & image 5). This field drain comprised a series of flat tiles laid as a base with inverted U shaped tiles above. These tiles are quite substantial being 0.75 inch (200mm) thick with a likely date range between the later 18th and 19th century period.

Image 5: Ceramic field drain in overflow drain trench

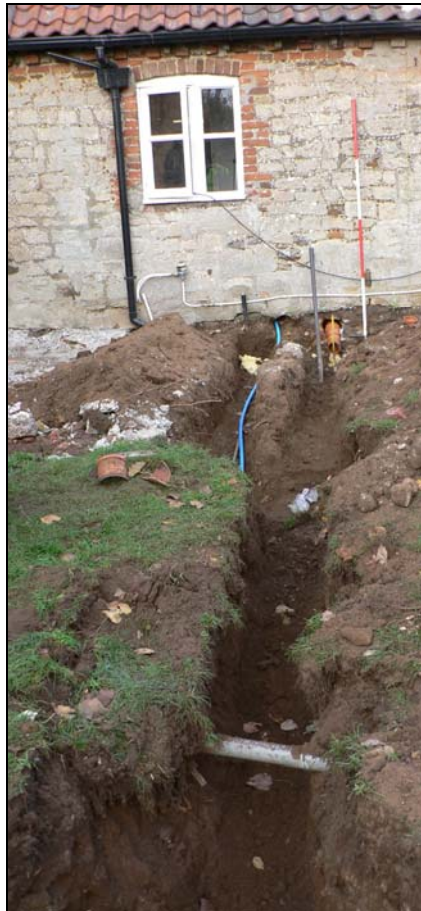
3.3 The drain from the south-eastern corner of the Abbey Farmhouse to the new septic tank (see Fig. 2) ran mainly on a north-south alignment between existing outbuildings before turning south-west and was excavated using a small mini-digger equipped with a 300mm toothed bucket under constant supervision. Near the house the new drain ran partly on or close to existing drain runs and in order to gain the correct drop on the run to the tank was relatively shallow at a depth of between 300-400mm. The drain trench in the area close to the house therefore remained in a mid to dark brown sandy subsoil containing 19th century and later debris and did not expose any underlying drift geological deposits. Therefore whether any earlier features relating to the medieval priory exist in the area of the 10m-15m drain run nearest to the Abbey Farmhouse is unknown though if present would remain undisturbed by these works. From a point near the southern edge of the outbuildings south of the house the required drop for the drain took the excavation to 450-550mm and the natural underlying sand/carstone mix was exposed under a mix of topsoil

Image 6: Drain trench near house from south

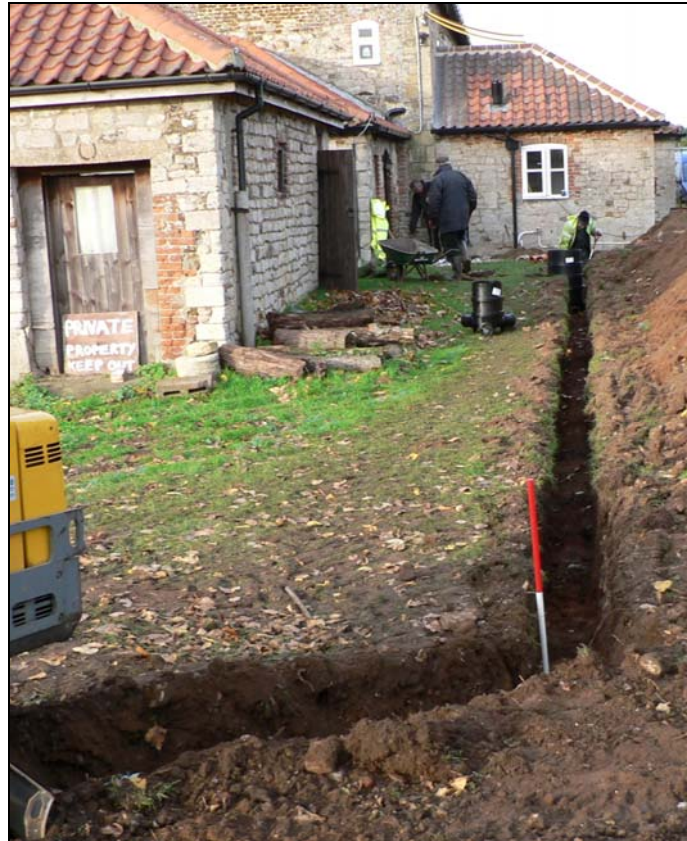
Image 7: Drain trench from south

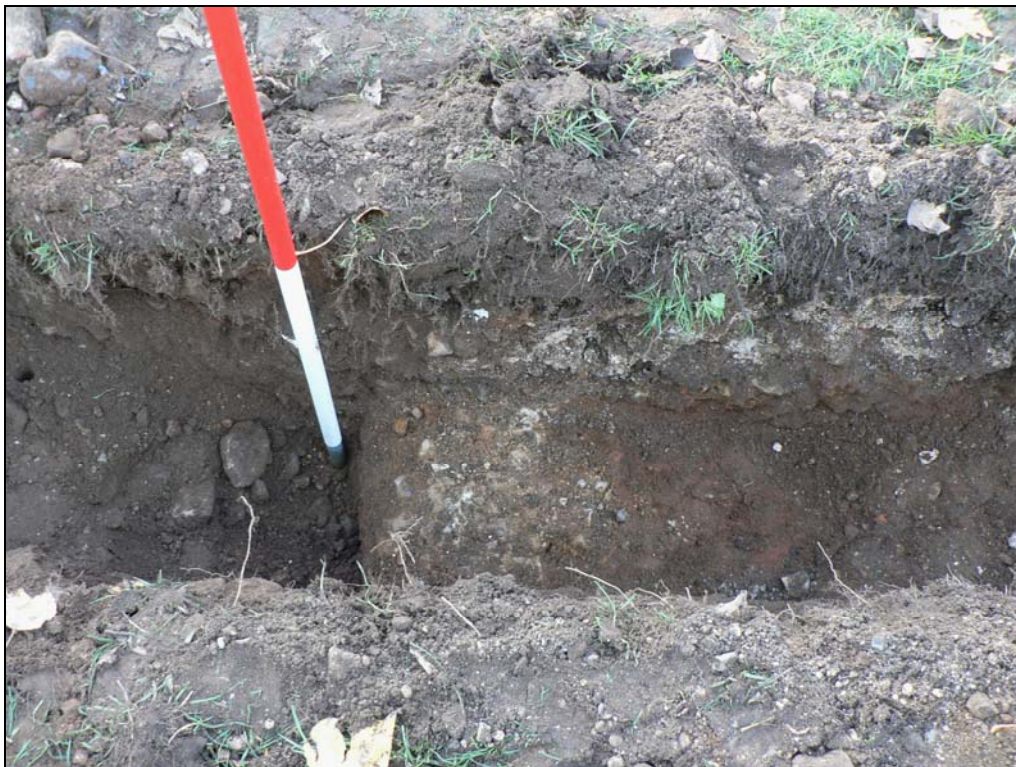
and scattered Post medieval building debris. Just to the north of the change of direction in the drain run, where a small inspection chamber was created, a possible remnant of wall foundation was noted running on an east-west alignment (see Fig. 2 & image 8). This possible wall foundation was at a depth of 400mm and is 380mm wide comprising small flints packed into the top of the underlying sand/carstone mix. While this feature is not directly dateable it does run on a parallel alignment to the southern walls of the existing outbuildings nearby and, given the limited exposure of the feature in the trench, it is also possible that it is a natural feature. Disturbance to this feature was kept to a minimal level to accommodate the 100mm drainage pipe. The remaining run of the trench to the septic tank did not reveal any features and the only finds in the upcast spoil were brick and tile fragments of recent date and iron fragments from items of relatively modern agricultural and domestic origin.

Image 8: Possible wall footing in drain trench from east
