**Torhouse Mill, Wigtown, Newton Stewart
Wigtownshire, Dumfries & Galloway:
Archaeological Works**

**by Rebecca Shaw
18th March 2018**

Data Structure Report - Torhouse Mill, Kirkcowan

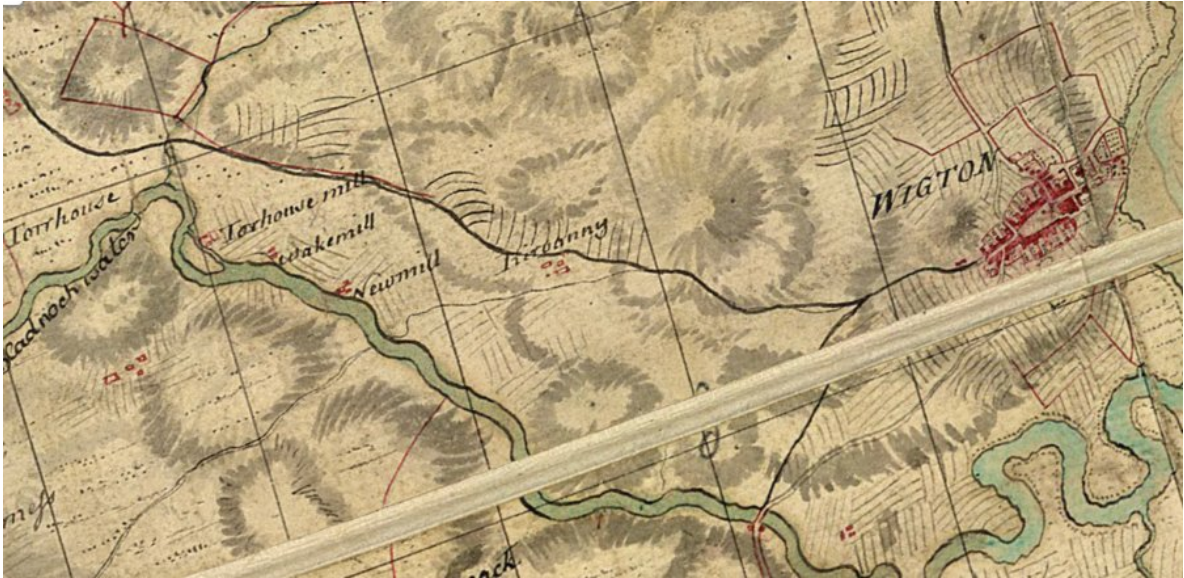
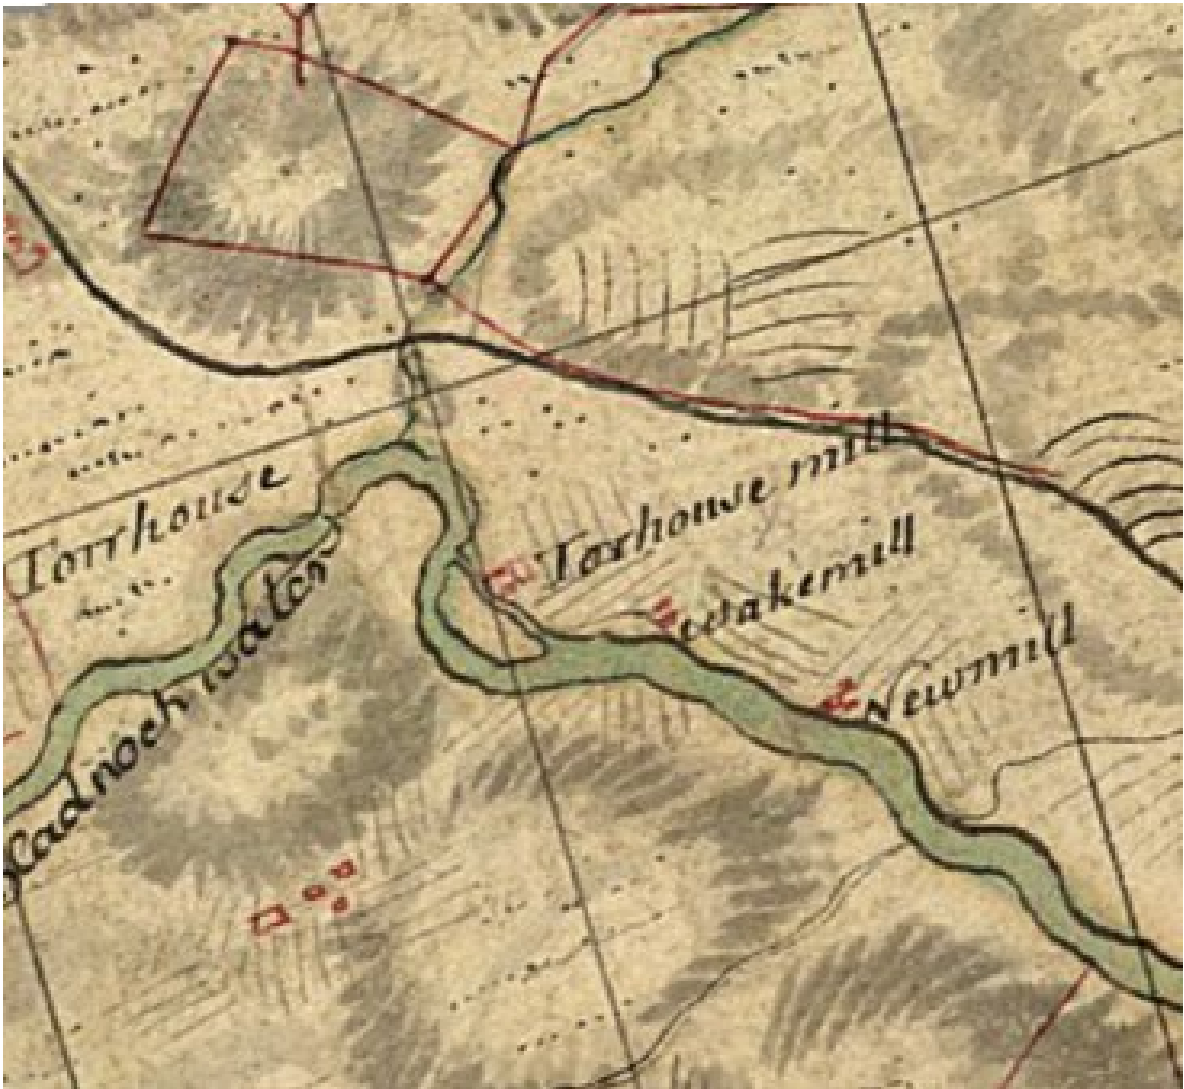
Figure 3a – Roys Military Survey Map of Scotland (1747-55)

Figure 3b – zoomed in detail of Roys Military Survey Map of Scotland (1747-55)

Torhouse Mill is depicted on sound mapping dating to the mid eighteenth century (Roy - Figure 3a-b) and on subsequent mapping by Ainslie (1782) (Figure 4a) and Thomson (1832) (Figure 4b).

Sound mapping sources indicate that Torhouse Mill existed from at least the mid eighteenth century (Figures 3a-b). On this mapping the mill is depicted as a rectangular structure with associated enclosures located immediately adjacent to a diverted section of the river.

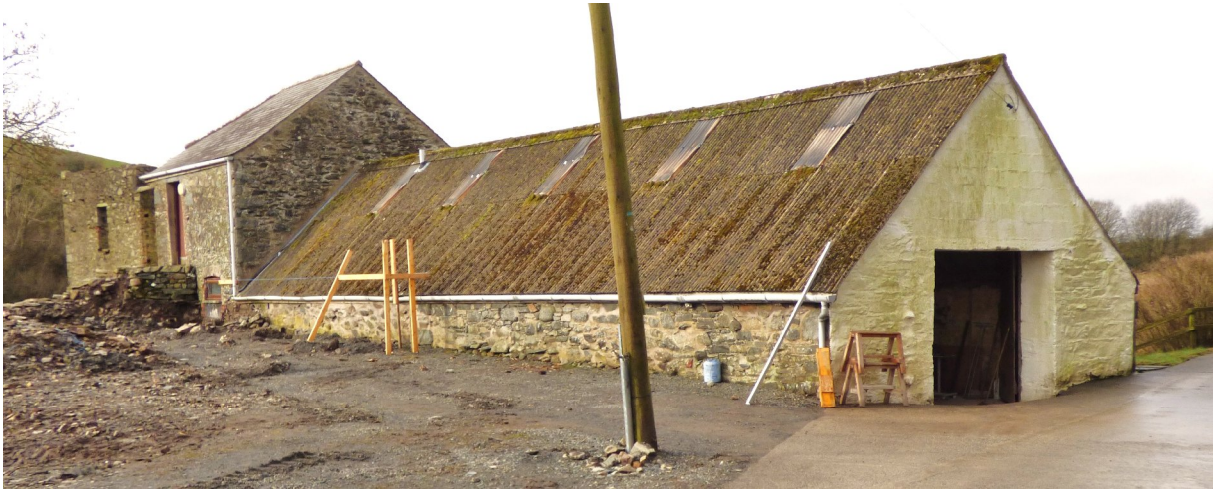
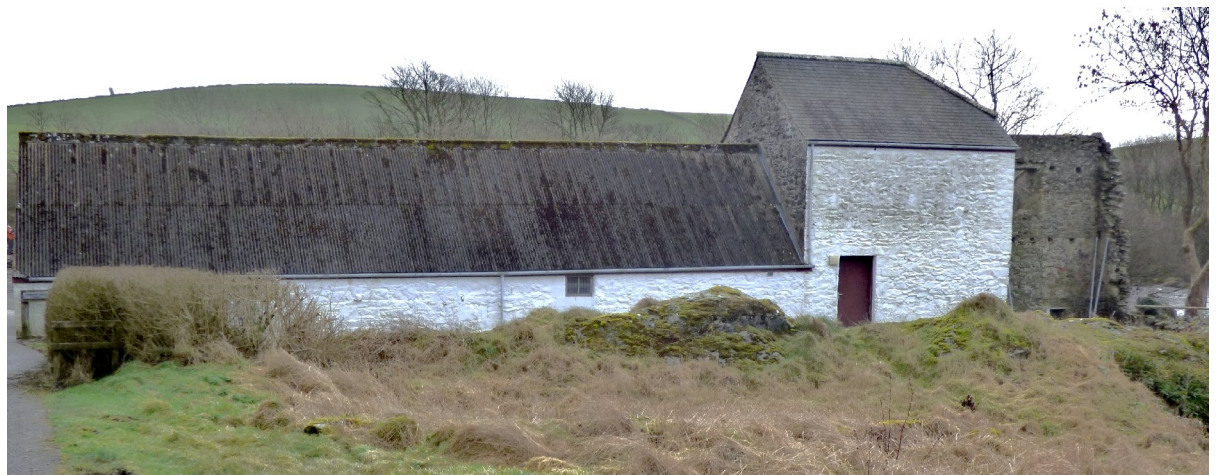
Figure 5a – general of SE elevation

Figure 5b – general of NW elevation

The structure that was subject to HBR works (the NE / SW range) comprised a single storey rubble built rectangular building with a pitched roof of corrugated fibre cement sheets – five plastic skylights were visible along the SE pitch (Figures 5a-b). Attached to the SW end of the rectangular building was a 2-storey rubble built square building with a pitched slated roof (Figure 5c). At the very SW end of the structure, adjacent to the river, were the ruins of another 2-storey rubble built building which only survives as the SE elevation with a very slight wall stub to the SW (Figure 5c).

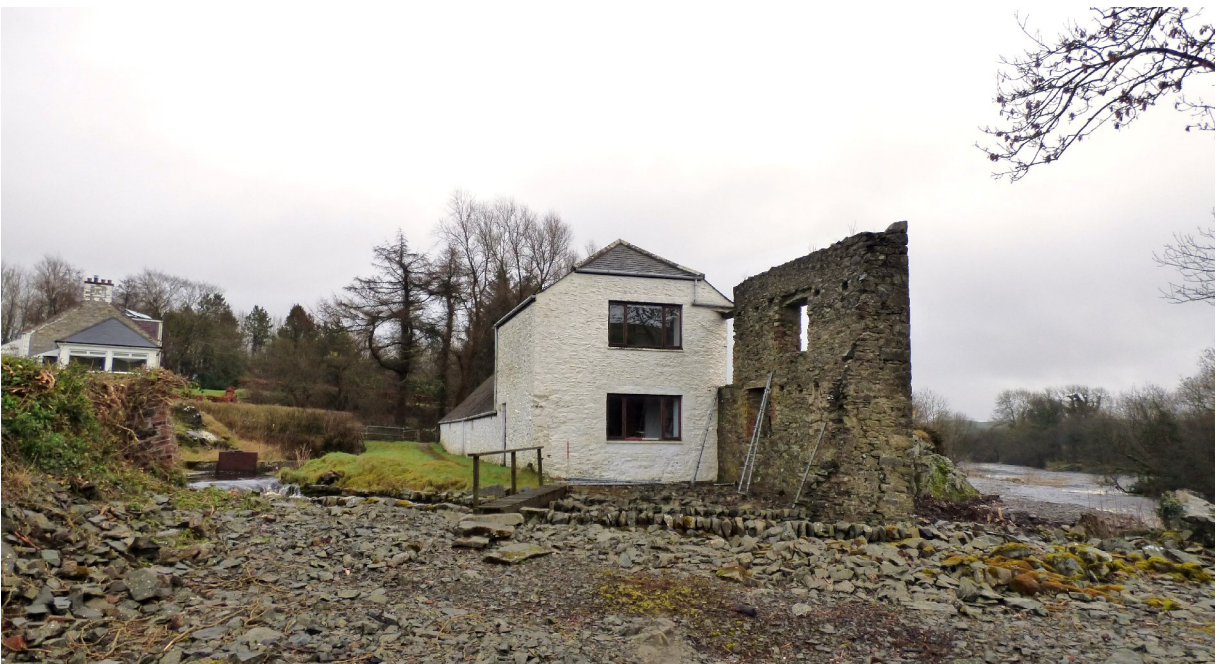
Figure 5c – general of existing mill buildings (from W)

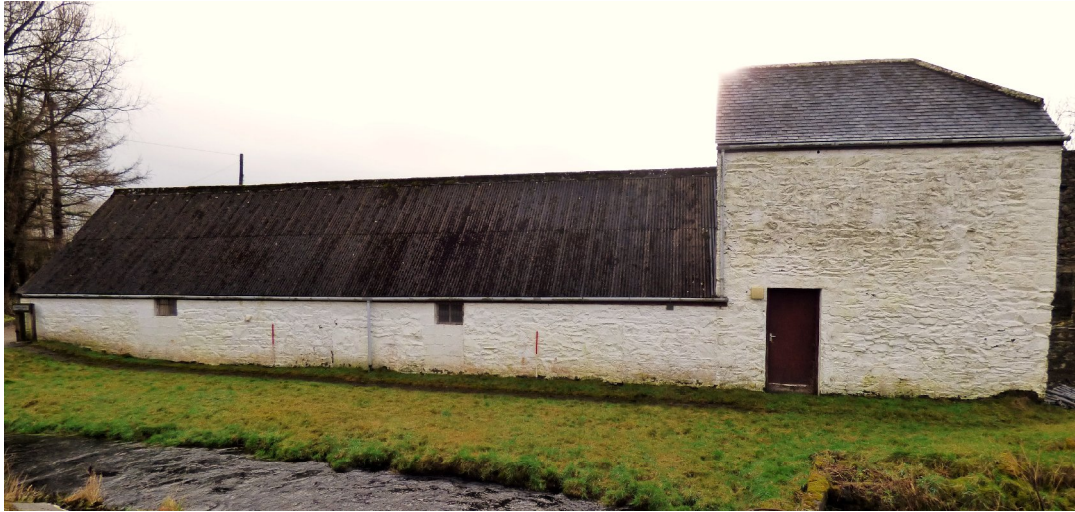
Figure 6a – general of NW elevation of single storey & 2-storey buildings (from WNW)

The external NW elevation (Figure 6a) comprised four infilled (partially infilled) / blocked-in openings: from SW to NE the openings comprised: 1 – a large opening that had been infilled with stone (Figure 6c); 2 – an opening that has been infilled with block and made into small window (Figure 7b); 3 – a stone filled opening (Figure 7c) and 4 – an opening that has been infilled with block and made into a small window (Figure 7d). The internal NW elevation comprised three recesses: 2 – a partially block filled full height recess with a small window; 3

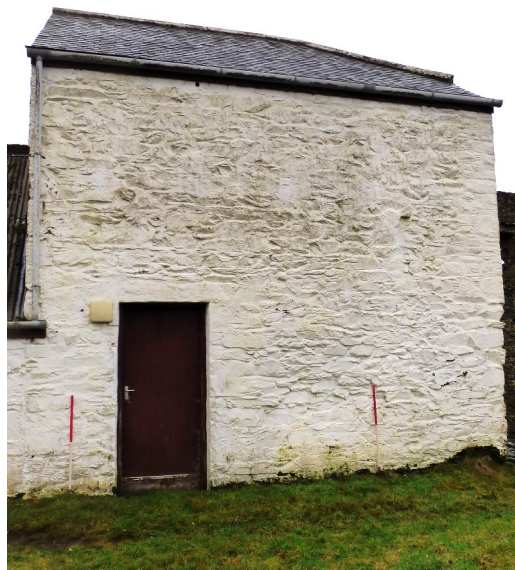
Figure 6b – NW elevation of 2-storey building showing entrance (from NNW)

The external NW elevation abutted comprised an entrance on the ground floor (Figure 6b). The external SE elevation (Figure 14a) comprised a small window on the ground floor – the window had been inserted into the upper half of a red brick arch with the lower half being infilled (Figure 14a). The upper floor comprised an entrance with a red brick surround (Figure 8c). The external SW elevation comprised a large window on the lower floor and an equivalent window on the upper floor (Figure 10a) – both of these windows appear fairly modern. The interior of both the lower and upper floors have been modernised for current use as an office (Figures 12b-c).

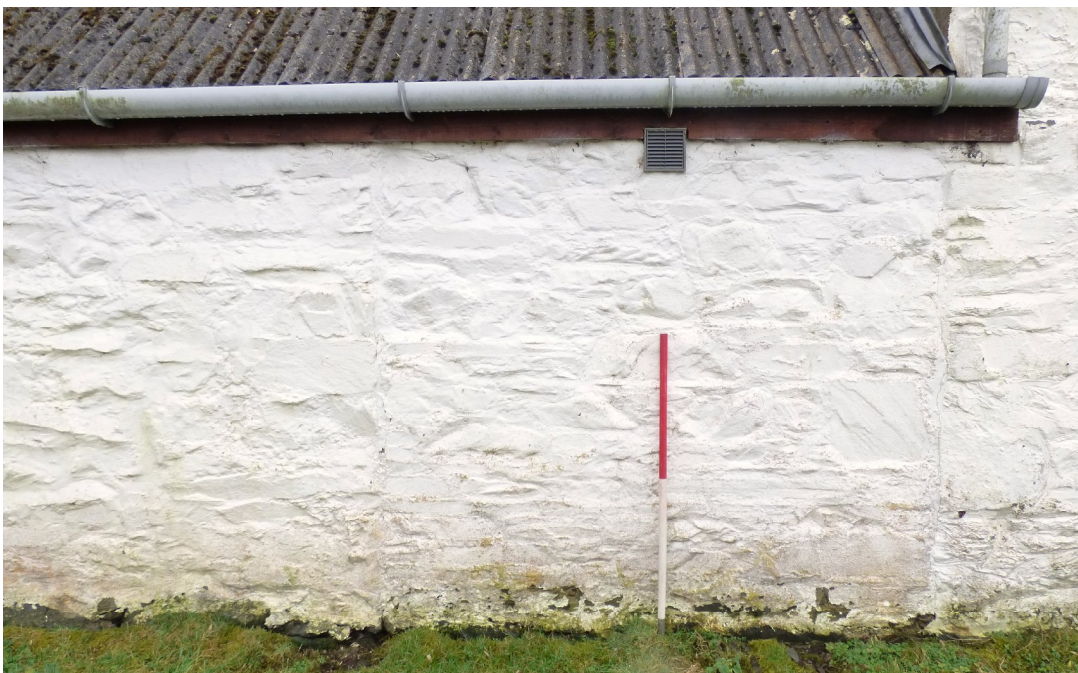
Figure 6c – infilled opening (I) in NW elevation of single storey building (from NW)

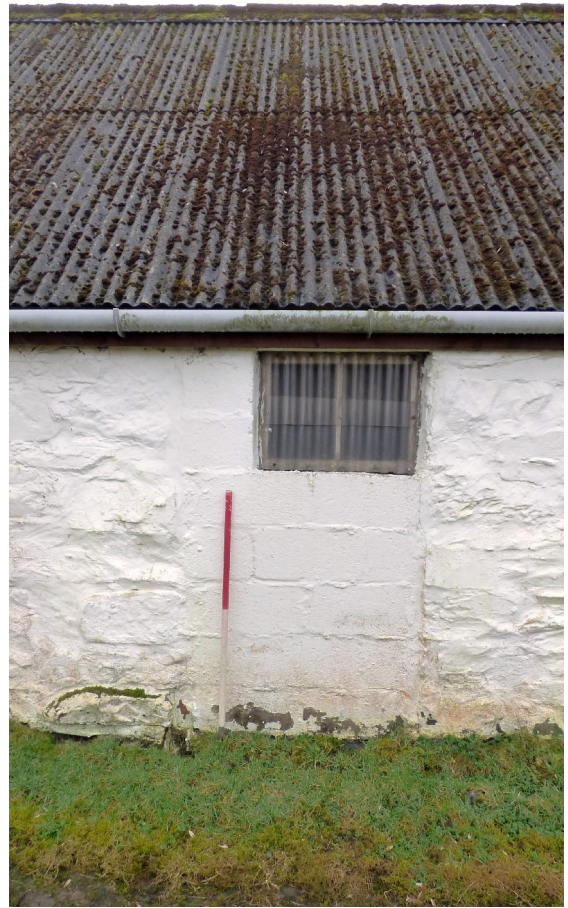
Figure 7b – partially blocked-in opening (II) in NW elevation of single storey (from NW)

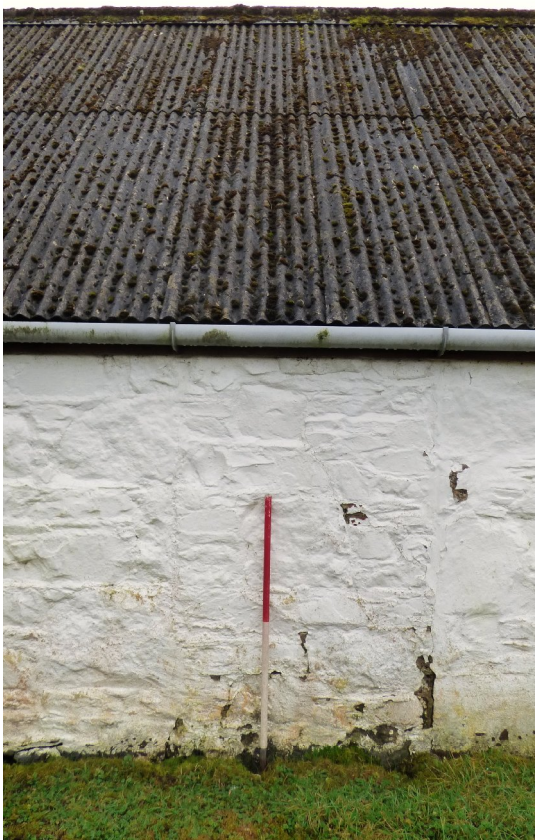
Figure 7c – infilled opening (III) in NW elevation of single storey (from NW)

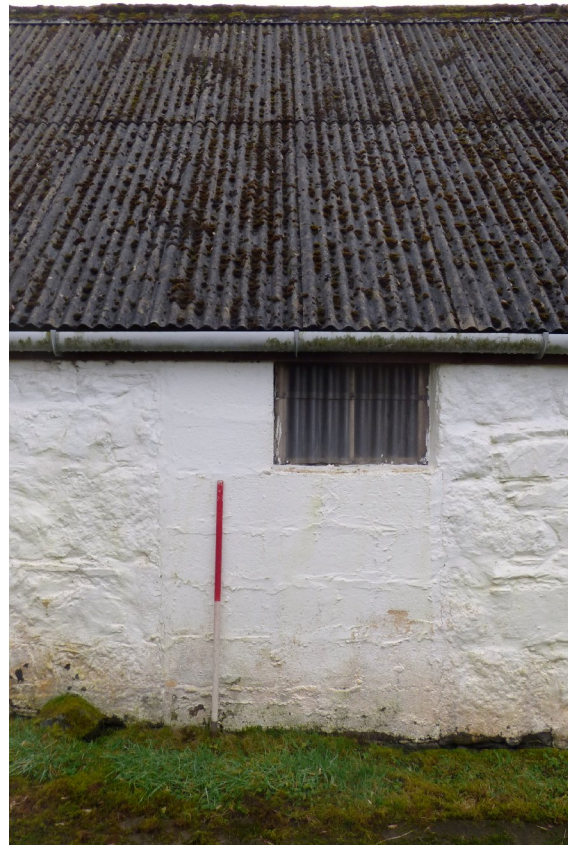
Figure 7d – partially blocked-in opening (IV) in NW elevation of single storey (from NW)

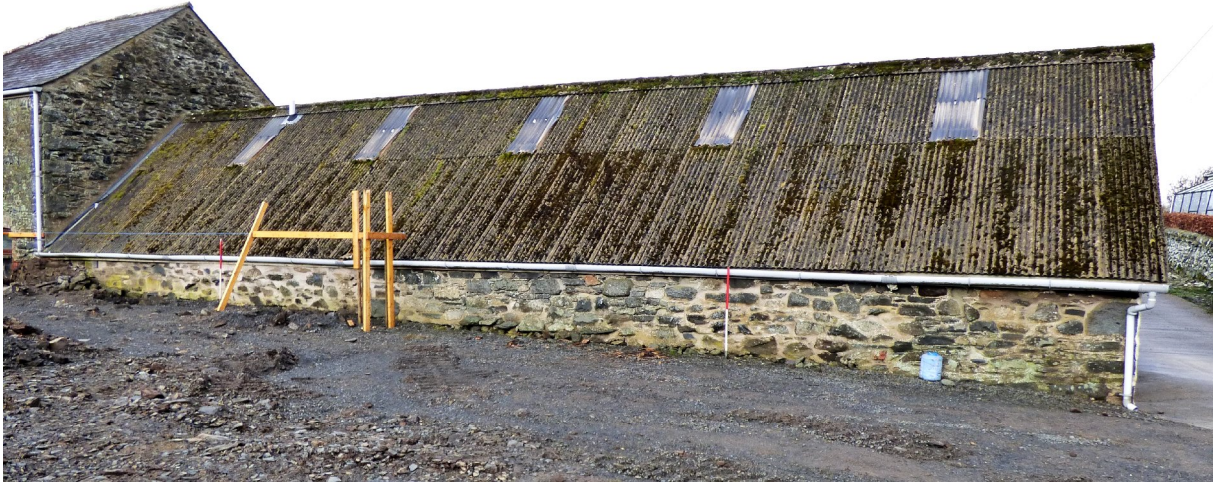
Figure 8a – SE elevation of single storey building (from ESE)

The external SE elevation of the single storey building was only visible for 0.80m (approx) below the roofline, due to the later (stone) made-up ground (Figure 8a). The only visible feature of note was a line of stones which protruded from the building at a depth of 0.60m from the roofline and measured 2.20m in length (Figures 9a-b). The internal SE elevation had 2 courses of red brick along the top of the stone wallhead and ventilation holes were visible inserted through the top of the wallhead & first bed brick layer (Figure 12a).

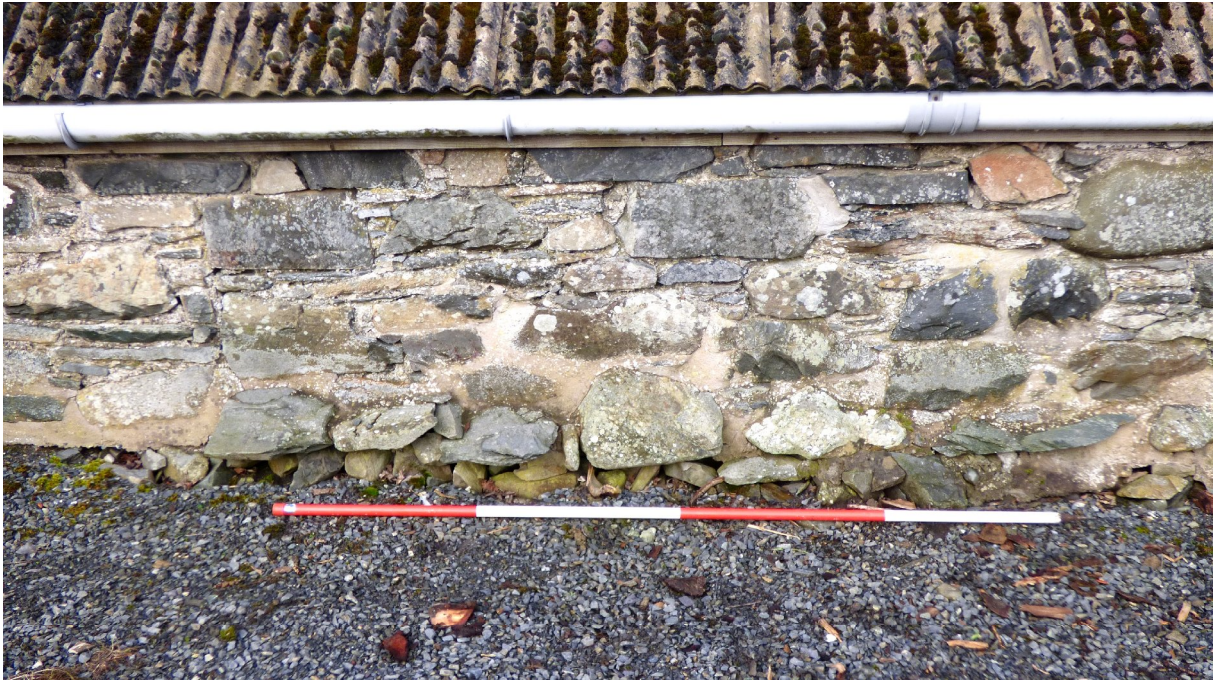
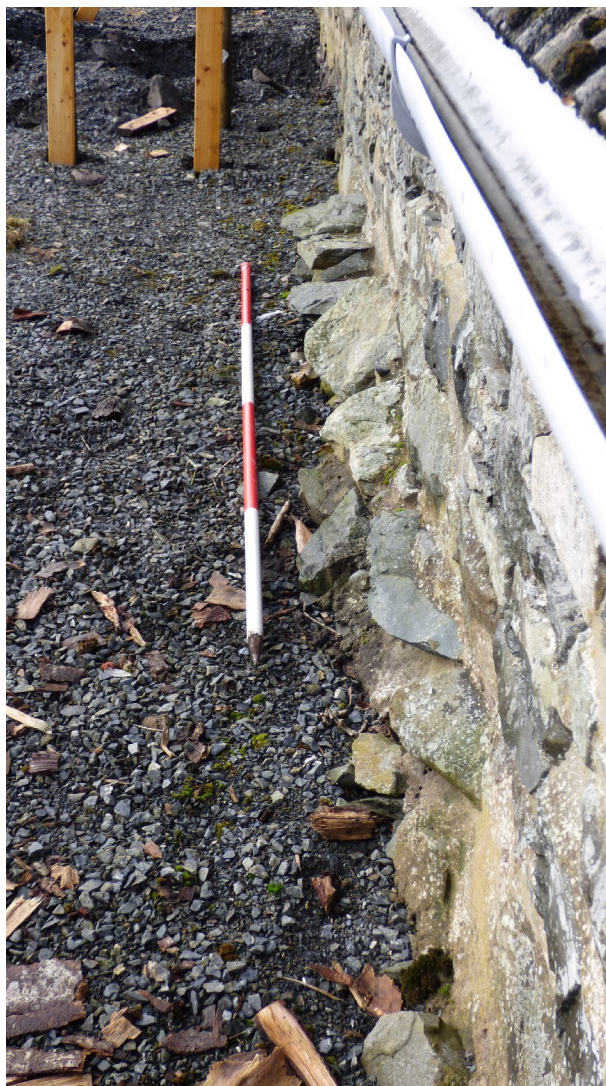
Figure 9a – showing stone protrusions in SE elevation of single storey building (from SE)

Figure 9b – showing stone protrusions in SE elevation of single storey building (from NE)

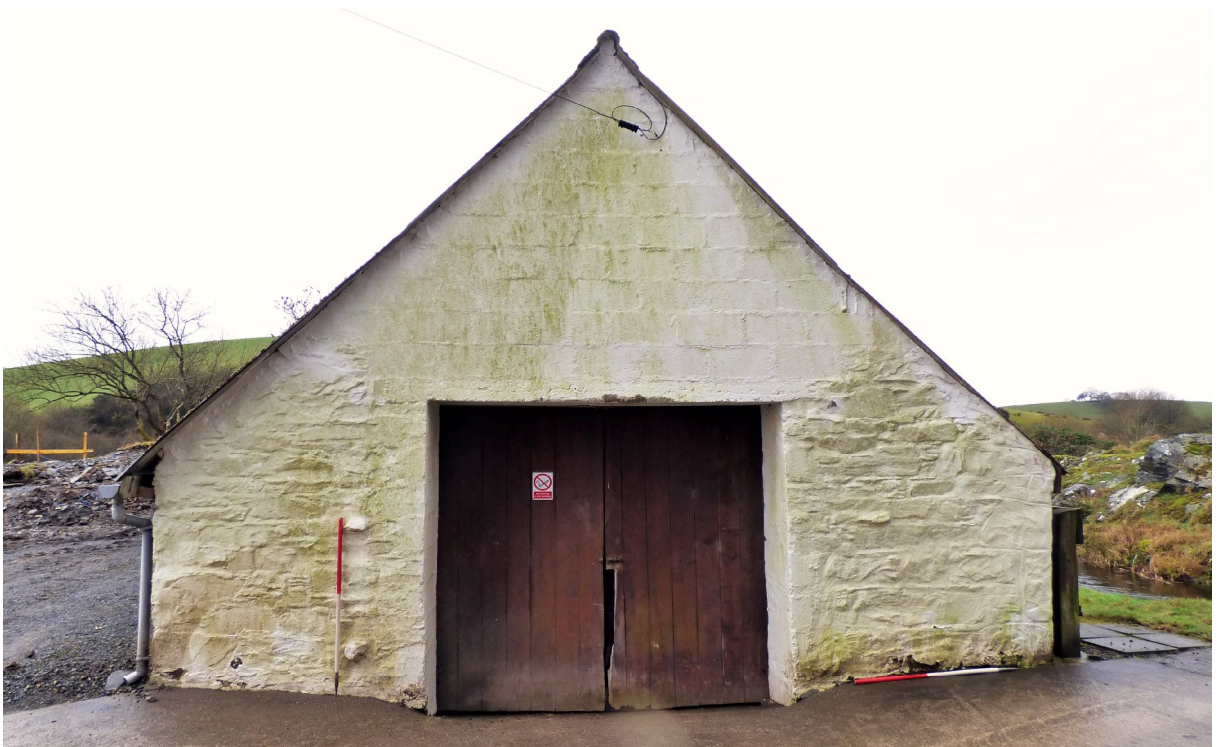
Figure 10b – NE gable of single storey building (from NE)

The NE gable of the single storey building comprised a large set of double doors (Figure 10b) the upper half of the gable was constructed from modern block, while the remainder was stone (rubble) built.

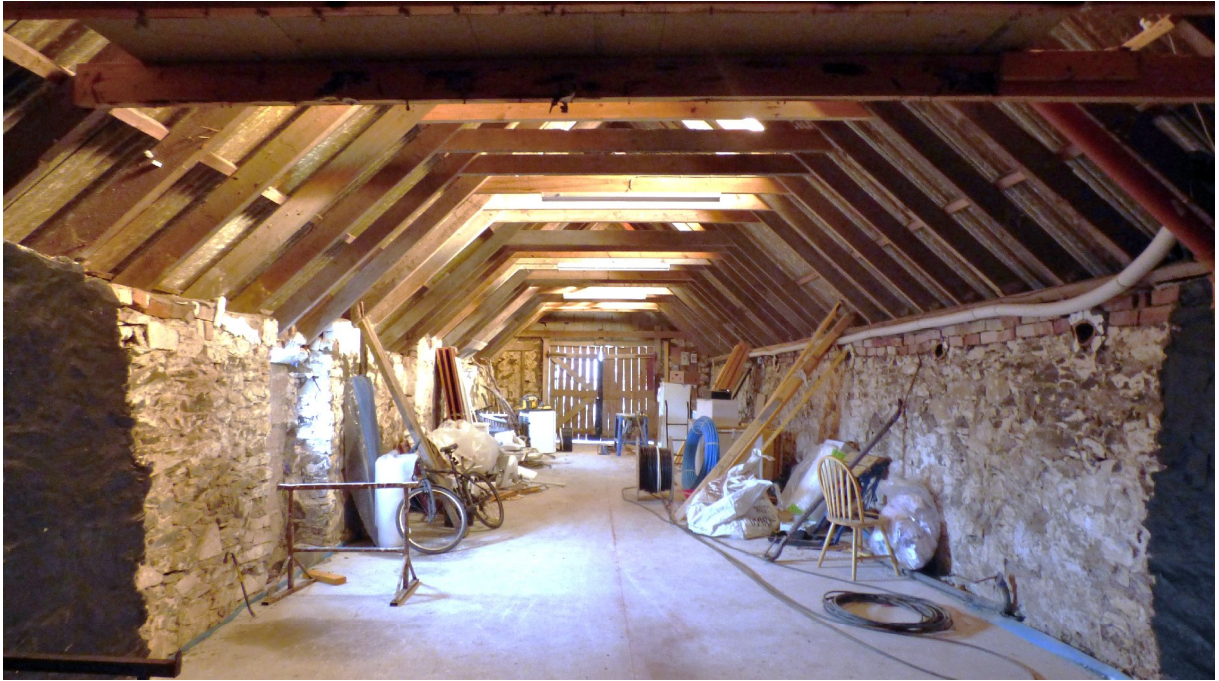
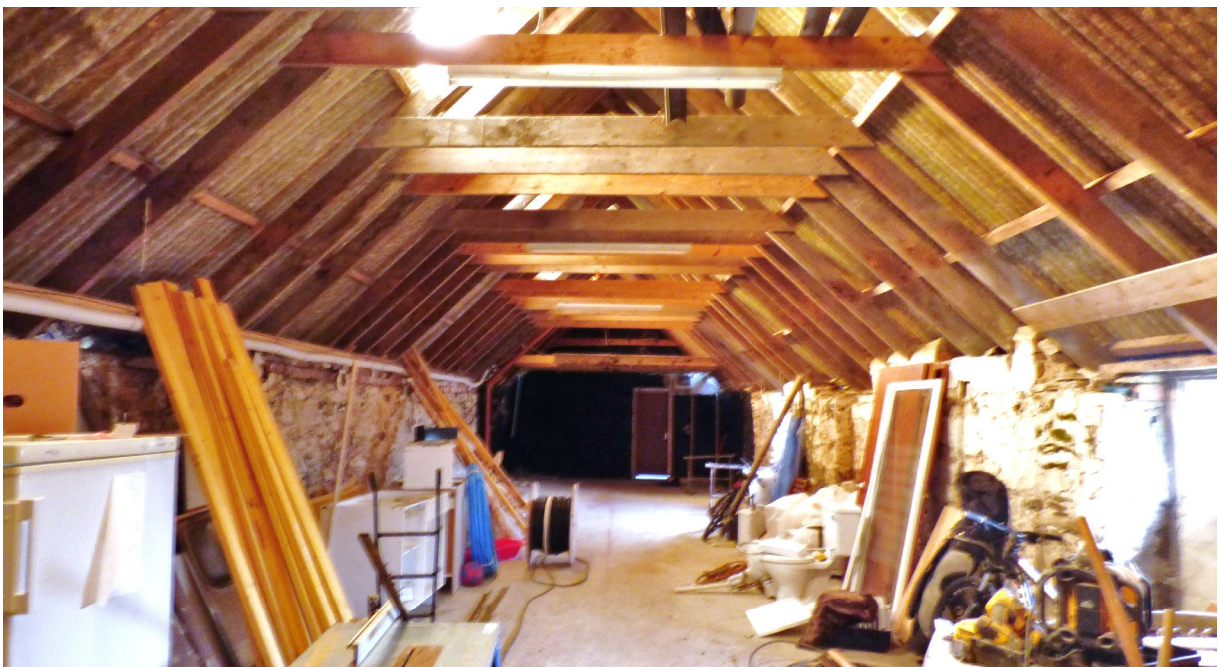
Figure 11a – general of single storey building (from SW)

Figure 11b – general of single storey building (from NE)

– a stone infilled full height recess with occasional quoin stones visible and 4 - a partially block filled full height recess with a small window. 1 – was difficult to observe as it had it had been painted with black paint. The interior comprised a fairly modern concrete floor (11a-b).

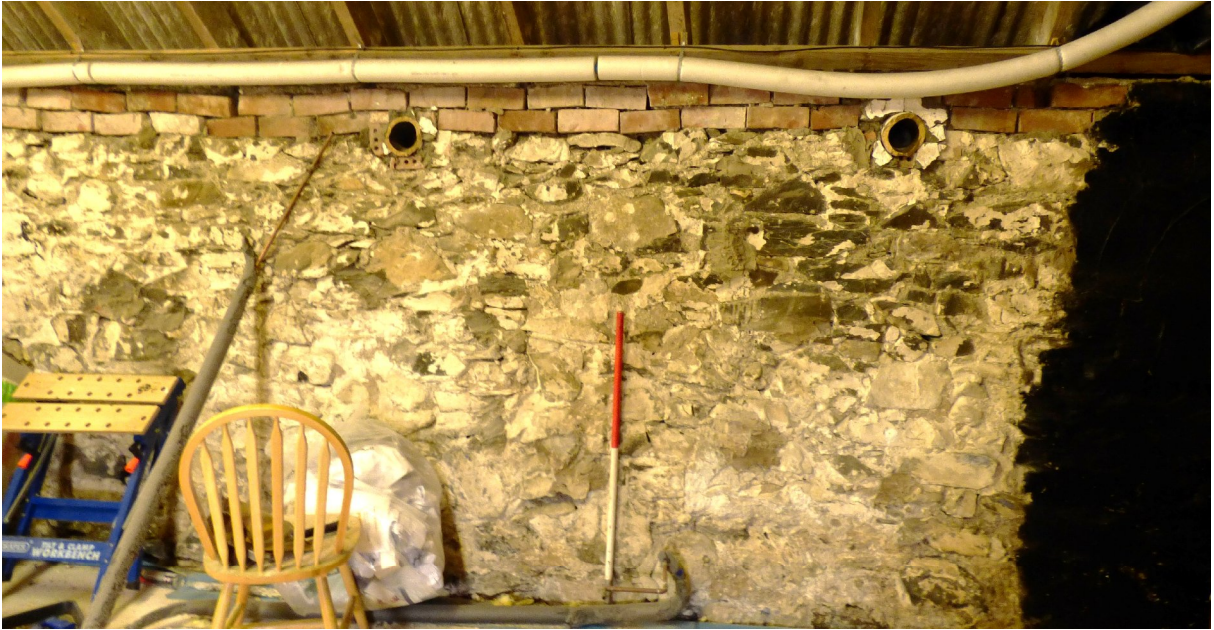
Figure 12a – single storey building (later byre) showing ventilation holes and later brickwork on top of existing stone walls to heighten roof (from NW)

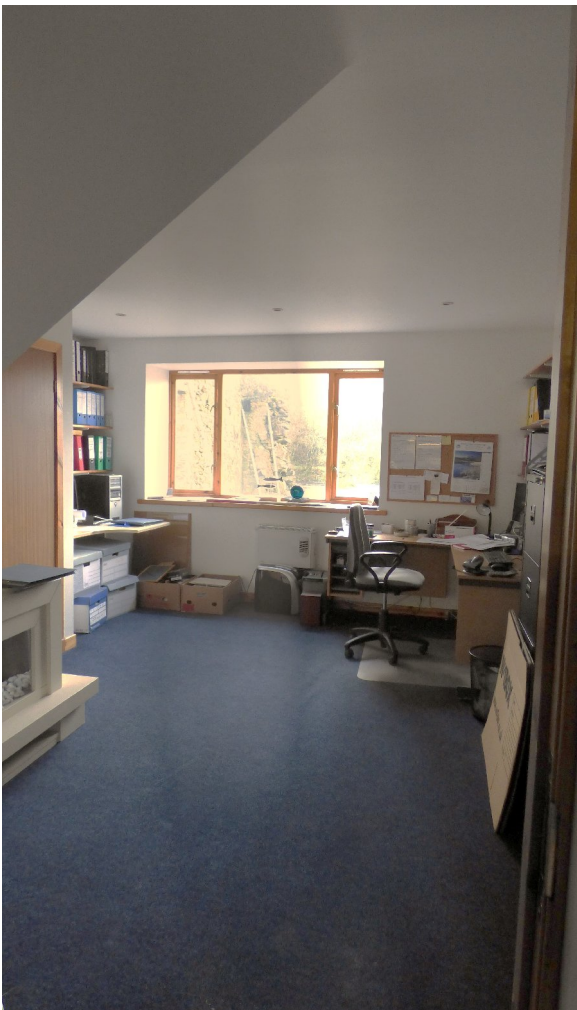
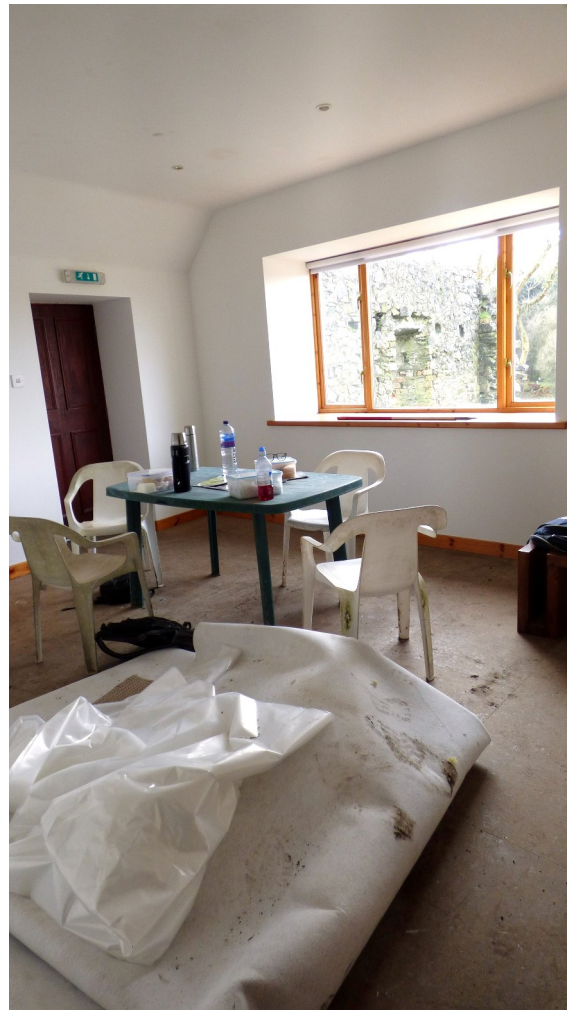
Figure 12b – general of ground floor of 2-storey building (office)

Figure 12c – general of upper floor of 2-storey building (office / tearoom)

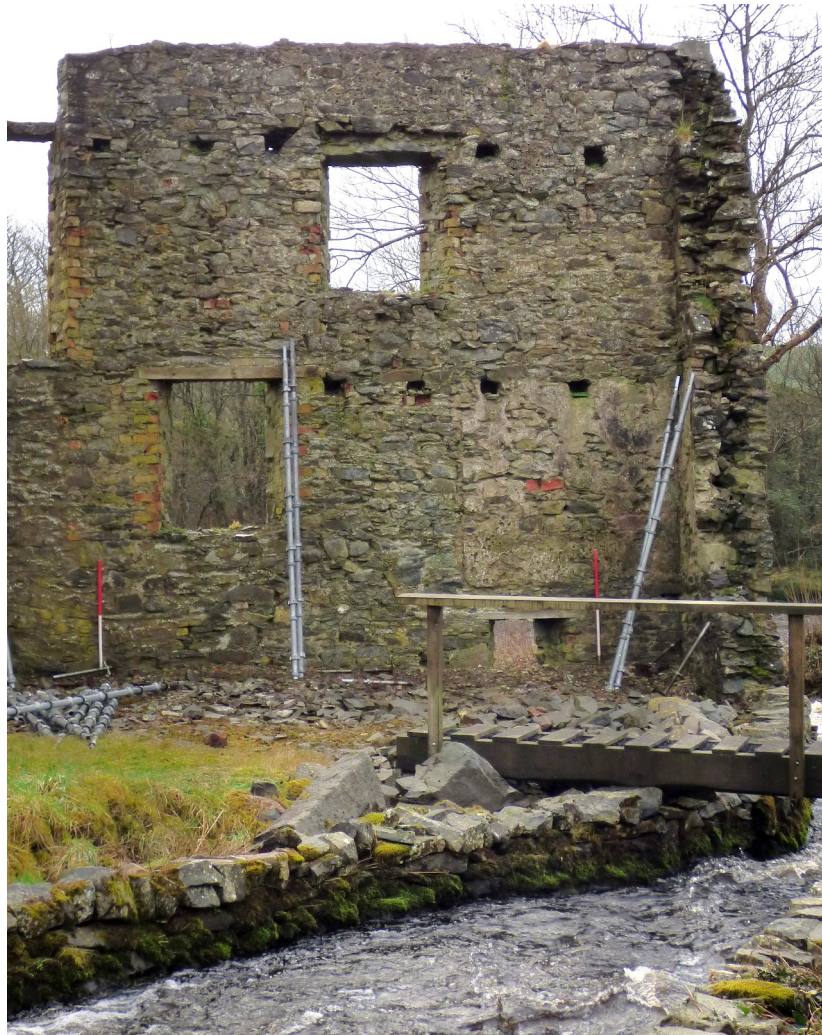
Figure 13a – general of internal SE elevation of 2-storey ruinous building (from NW)

The internal SE elevation (Figure 13a) comprised a small flared square opening with a concrete lintel and red brick on the ground floor; a flared opening (window) with a fairly modern wooden lintel and red brick surround on the first floor and a flared opening (window) with a missing lintel and occasional red brick as well as a slightly flared opening (possible entrance) with a red brick down SW edge on upper floor. Two sets of beam slots were visible on the internal elevation: both were located at the uppermost height of each respective window on the first and upper floors.

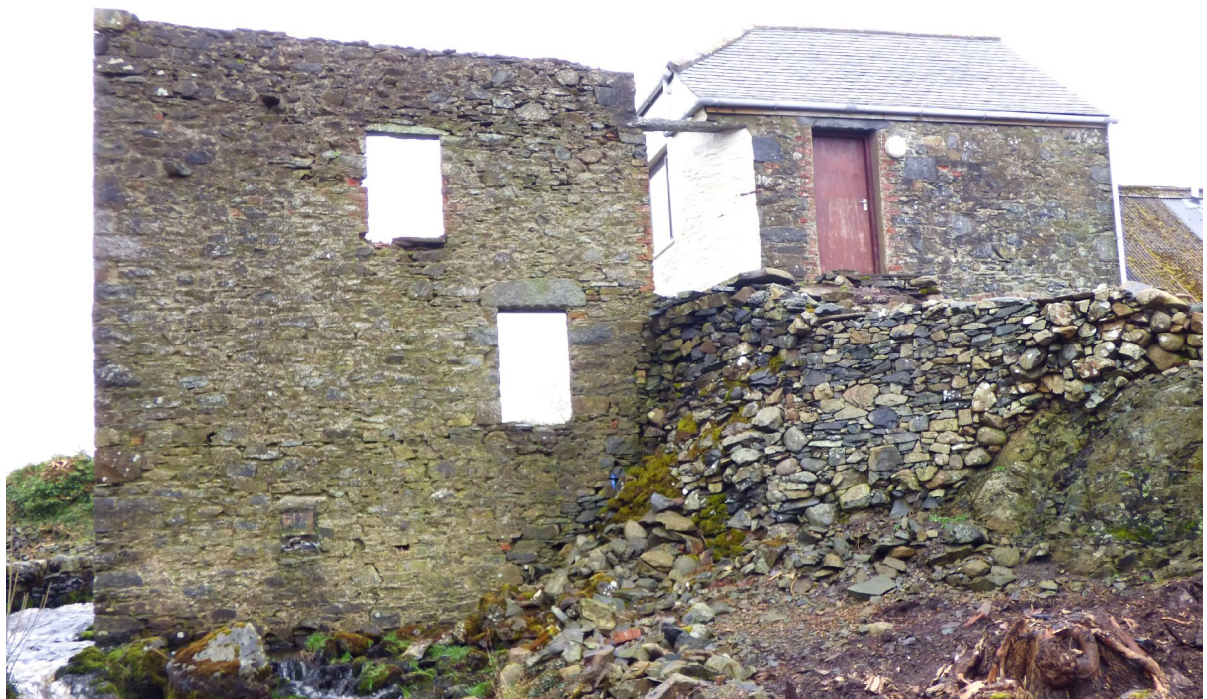
Figure 13b – external SE elevation end of 2-storey ruinous structure (from S)

The external SE elevation of the 2-storey ruinous building comprised a small square opening on the ground floor; a window with a large stone lintel & quoin stones on the first floor and a further probable window (with red brick within surround) and a possible entrance on the upper floor (Figure 13b).

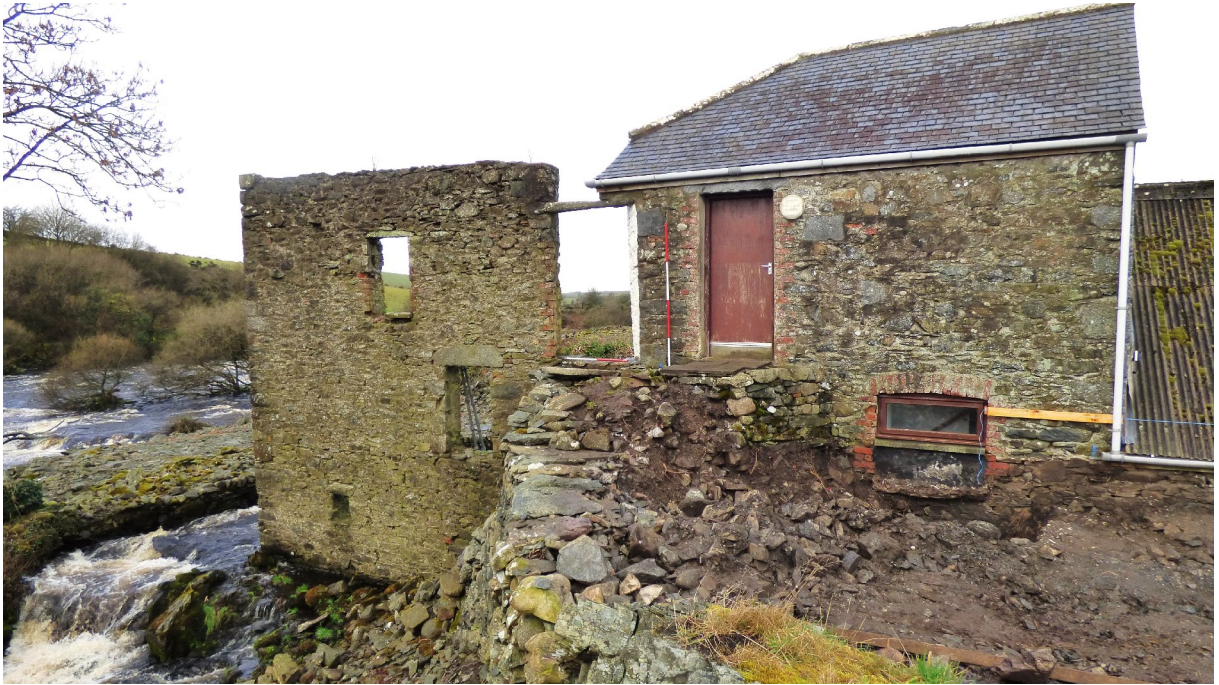
Figure 14a – SE elevation of 2-storey building & 2-storey ruinous building (from ESE)

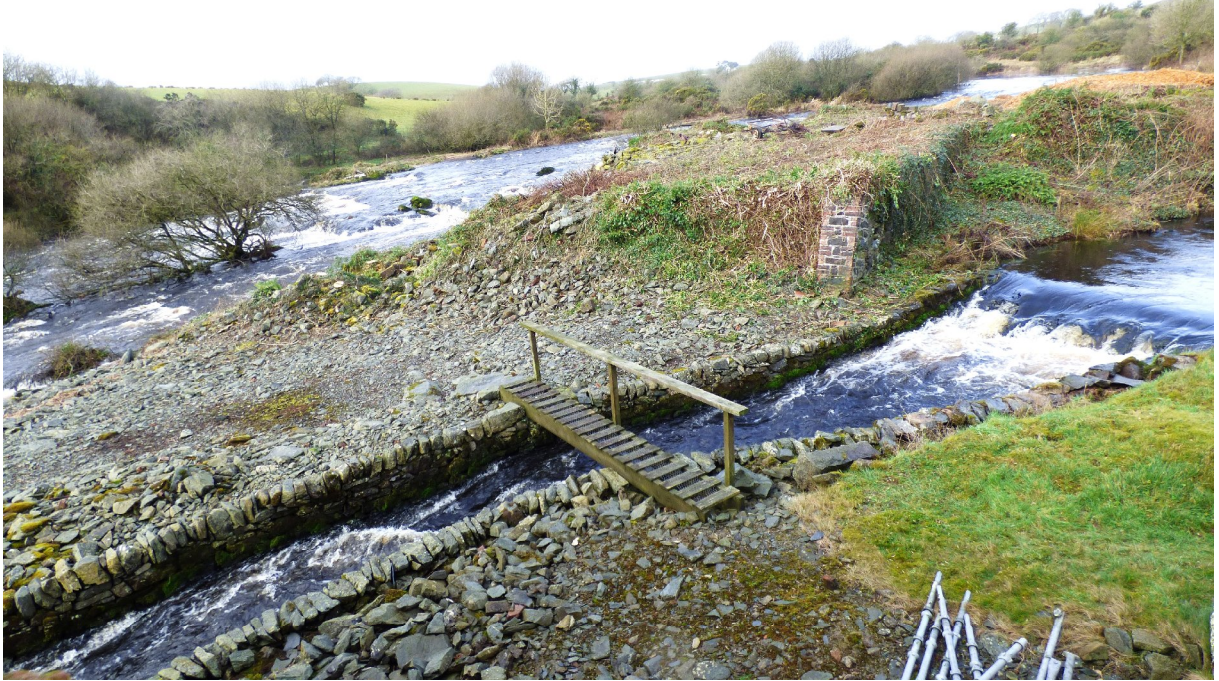
Figure 16a – looking WNW showing river, lade / channel and the demolished remains of the NW / SE range of mill buildings (from ESE)

The remains of the lade are still visible (Figure 18a) – although latter adaptations related to the trout farm have been undertaken (Figure 16a). The current lade / channel appears to empty into the river the approx location of the former tail race (Figure 18b).

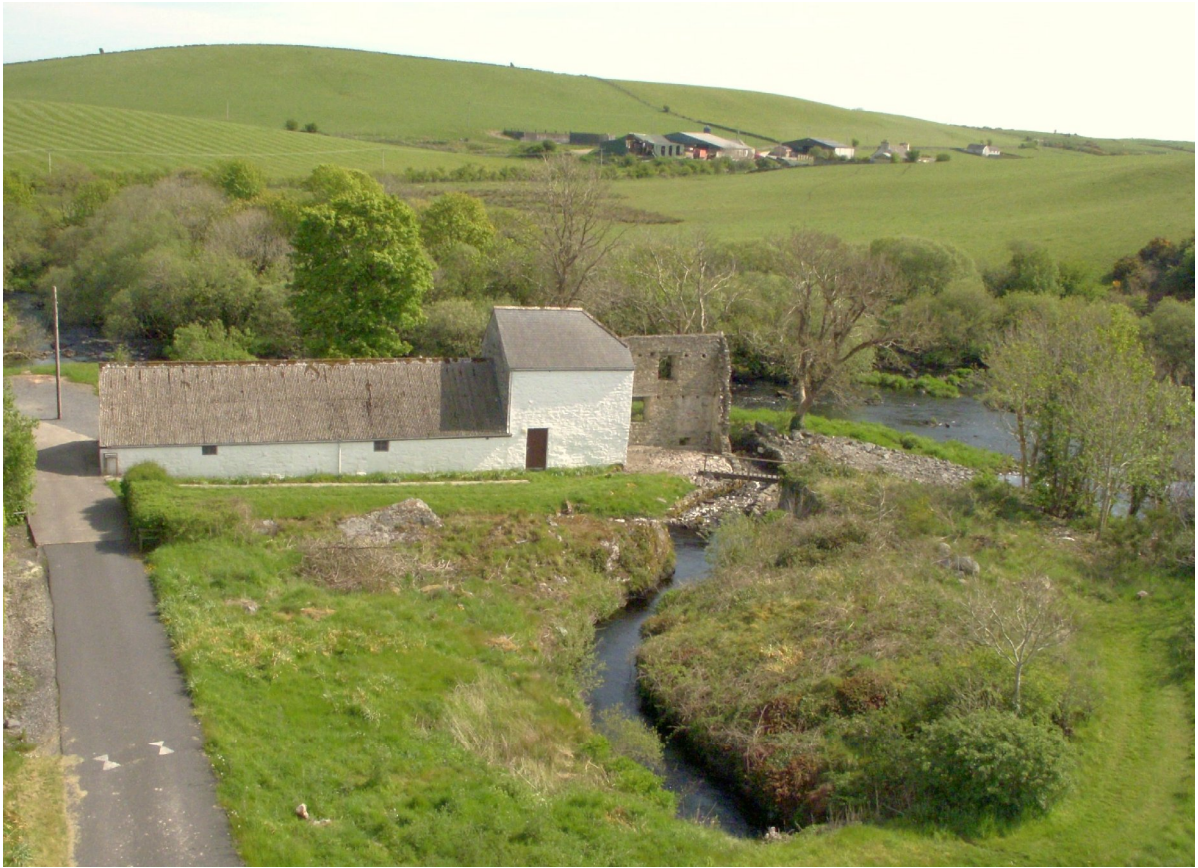
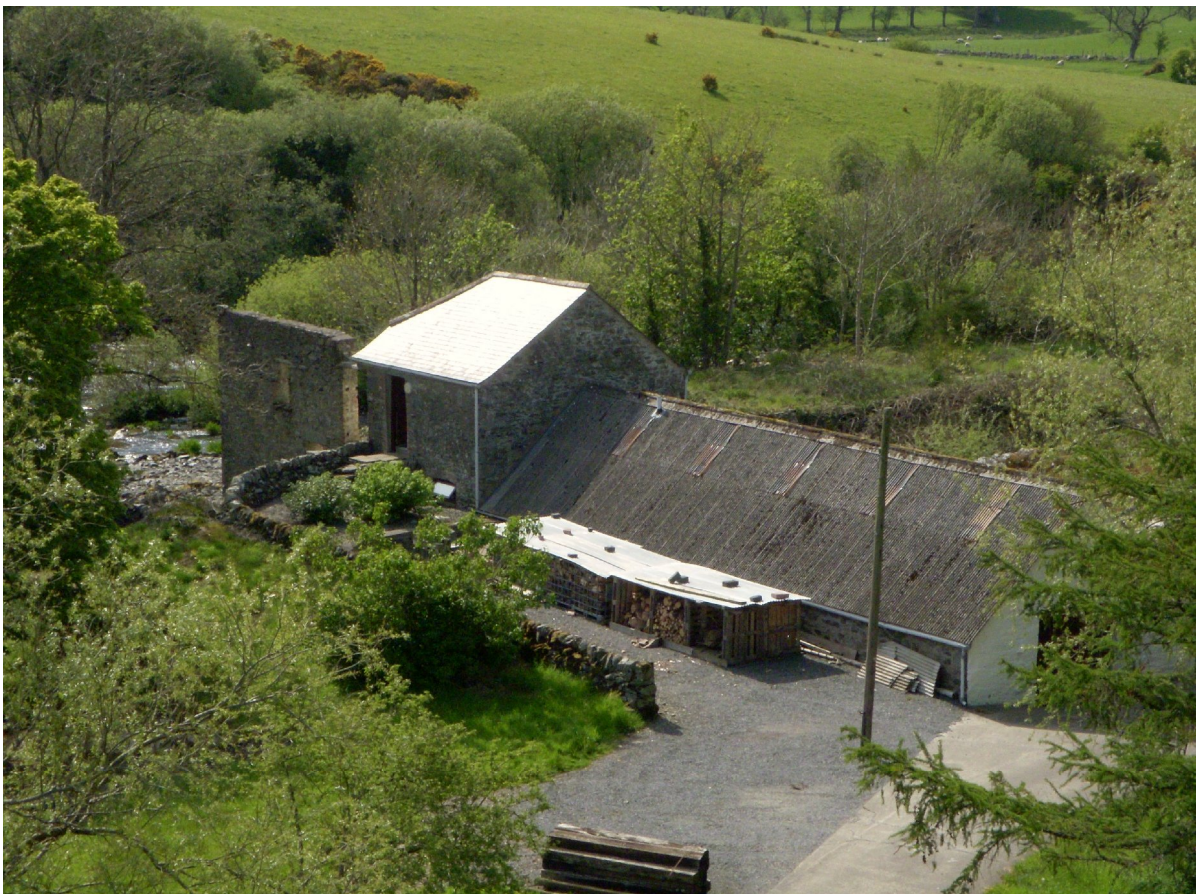
Figure 18a – aerial view of NW elevation of Torhouse Mill © Mark Davies (2012)

Figure 18b – aerial view of SE elevation of Torhouse Mill © Mark Davies (2012)

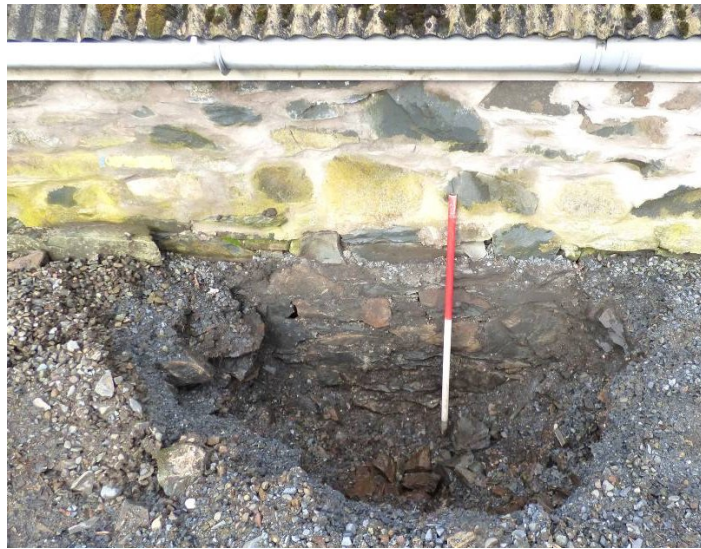
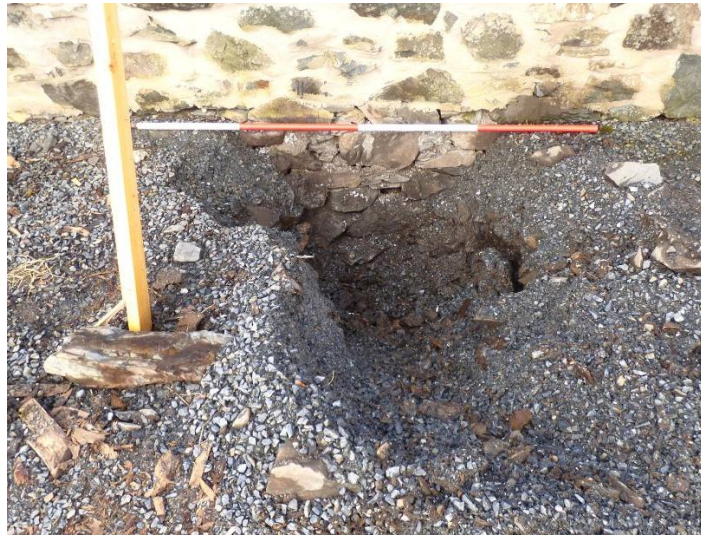
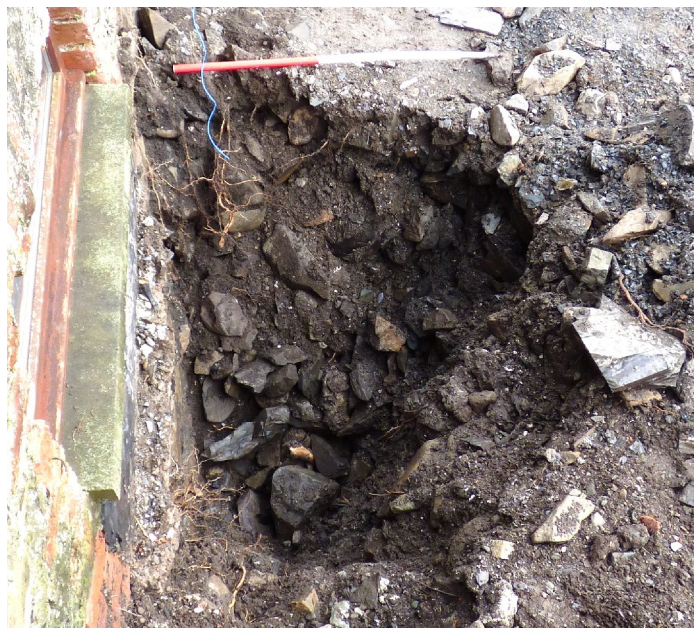
Figure 20 – site investigation pits

PIT 1

PIT 2

PIT 3

Pits 1 & 2 measured between 800mm to 1m in depth and comprised gravel (300mm / 400mm in depth) above broken rock (500mm / 600mm in depth). The broken rock has been used to build up the ground in this location and was in place by at least the mid 1980s.

In addition an archaeological watching brief was required to be undertaken during any down-cutting works. However, during the course of the HBR works, test pits were observed along the SSE elevation (in the location of the proposed new extension - figure 2) which indicated that this area comprised entirely made up ground / stone infill. Based on the results of the observation of the test pits Andy Nicholson at Dumfries & Galloway Council Archaeology Service concluded that monitoring of down-cutting works was no longer required.
