**Torhouse Mill, Wigtown, Newton Stewart
Wigtownshire, Dumfries & Galloway:
Archaeological Works**

**by Rebecca Shaw
18th March 2018**

Data Structure Report - Torhouse Mill, Kirkcowan

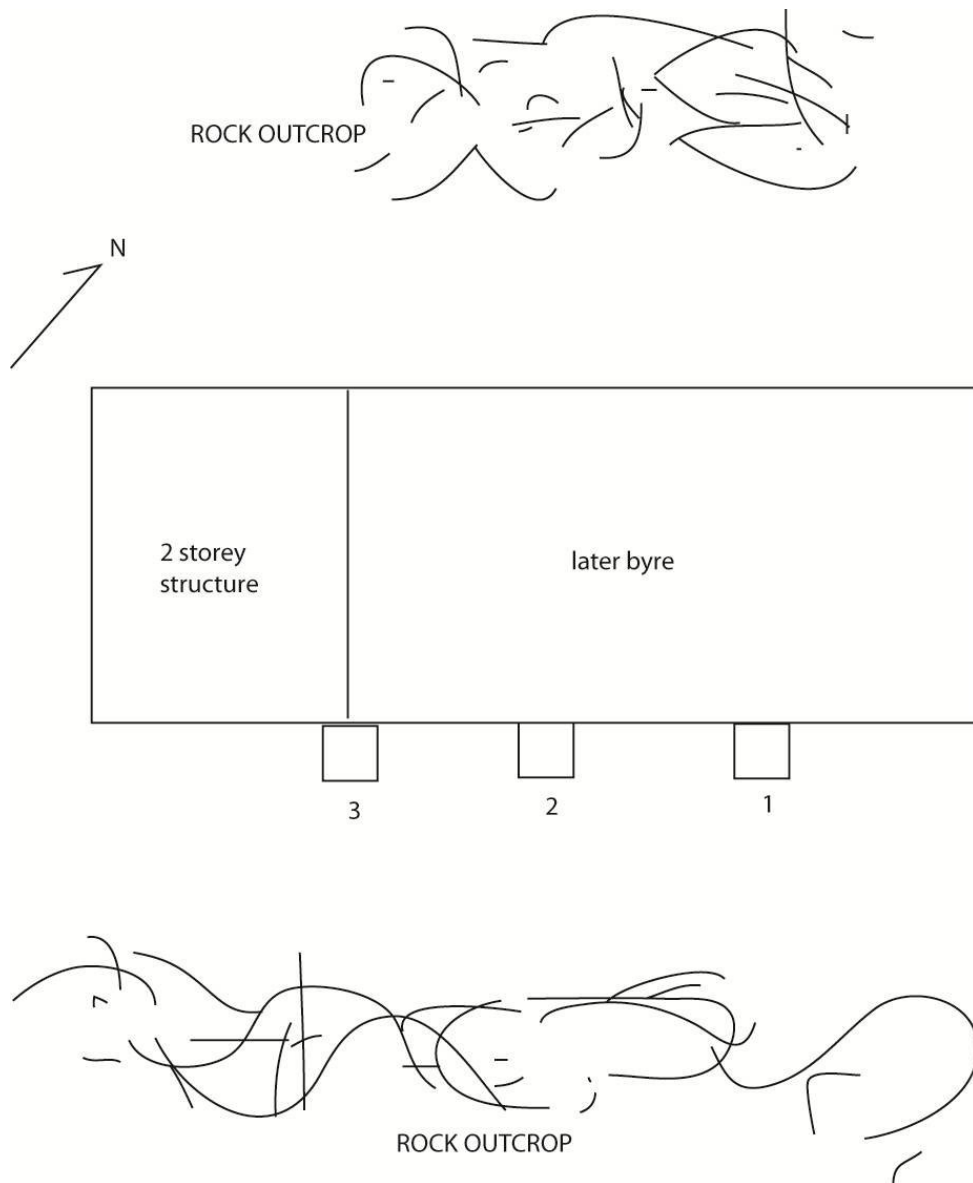
Figure 21 - sketch showing approx locations of test pits and rock outcrops (not too scale)

Rock outcrops are visible on either side of the current mill / byre buildings (see sketch) and it is probable that either the rock was quarried away in this location (possibly to build the original mill) or that the rock dipped here.
