Rebecca Shaw Archaeological Services

Glenhead Farm, Glentroll, Wigtownshire Dumfries & Galloway: Archaeological Works

by Rebecca Shaw
24th January 2019

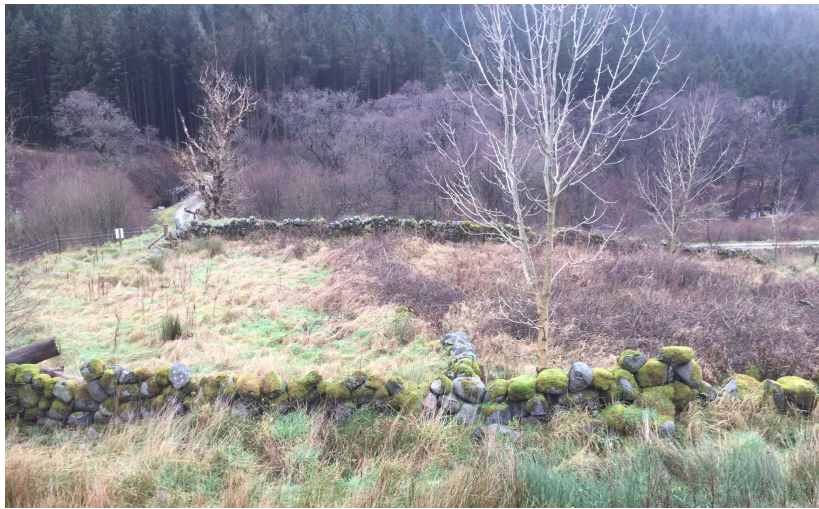
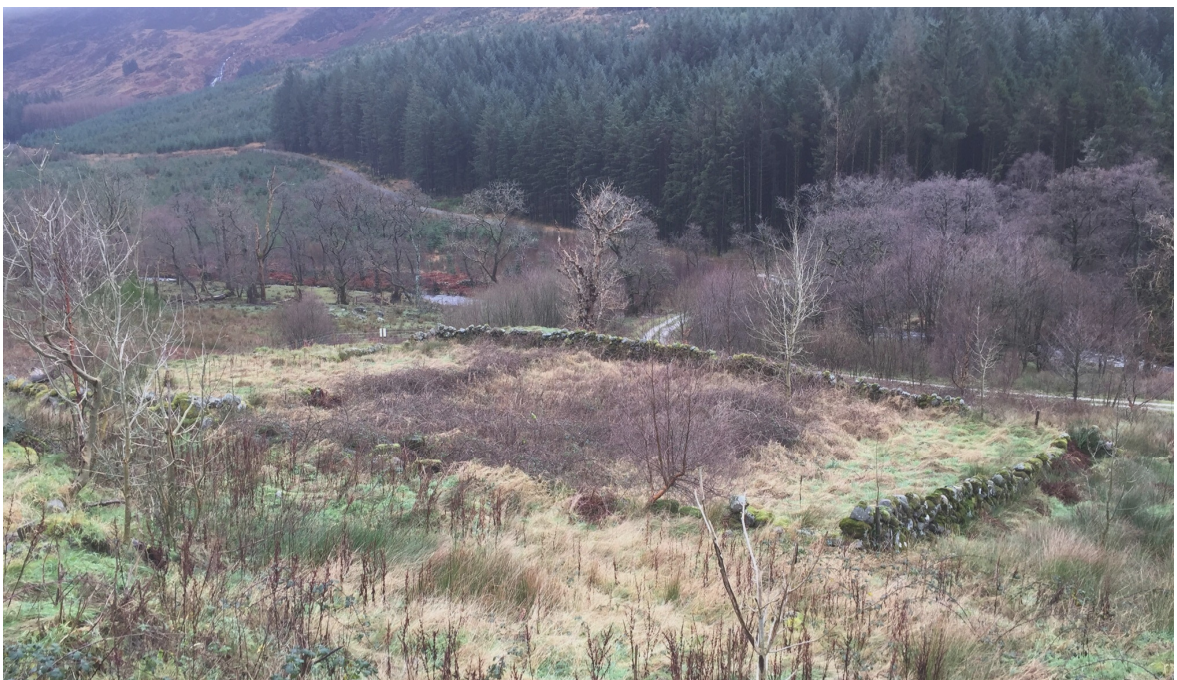
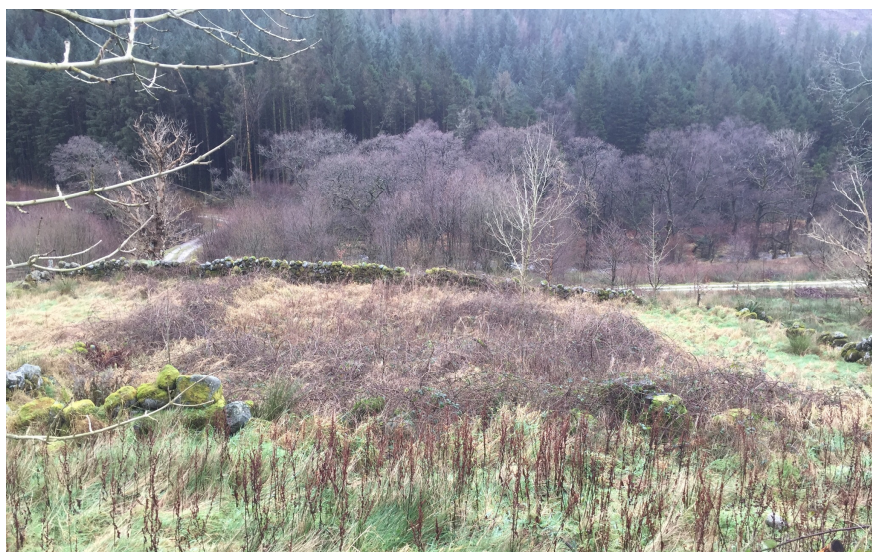
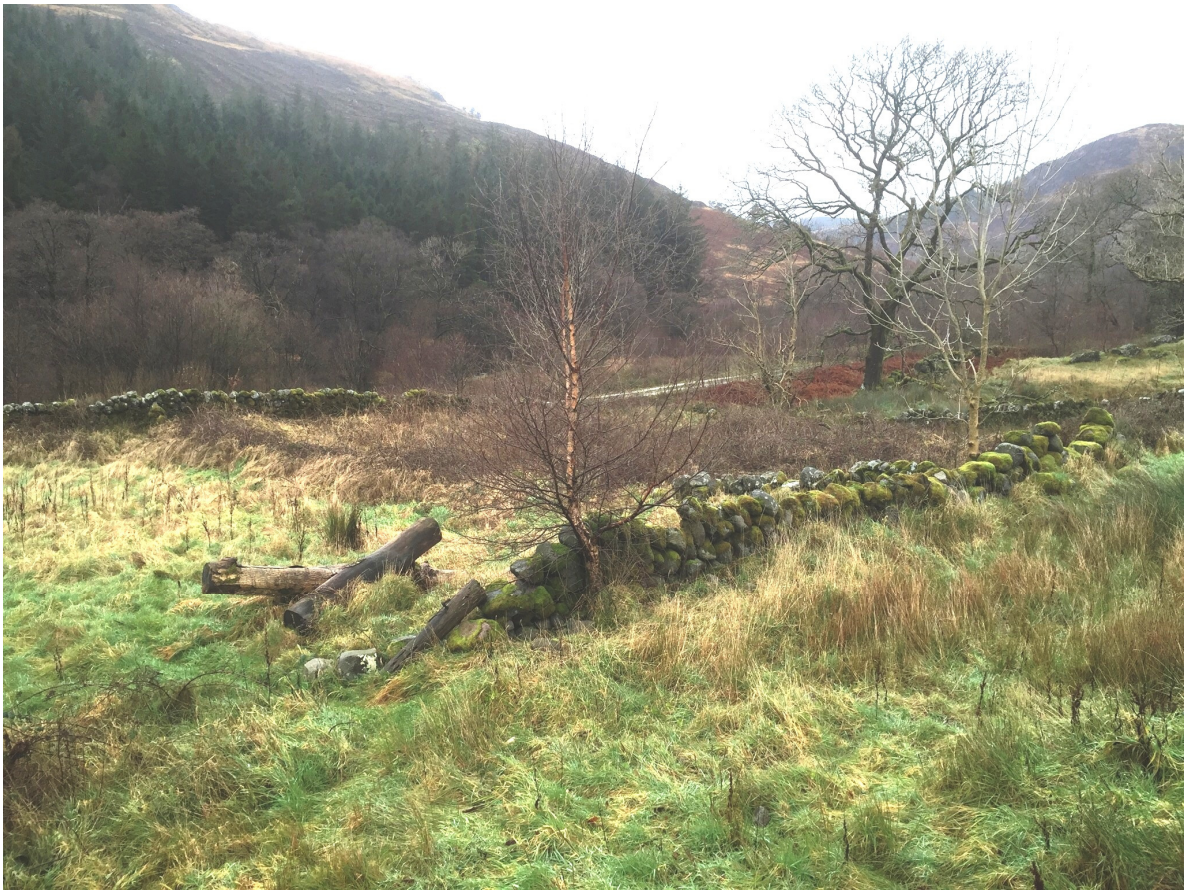
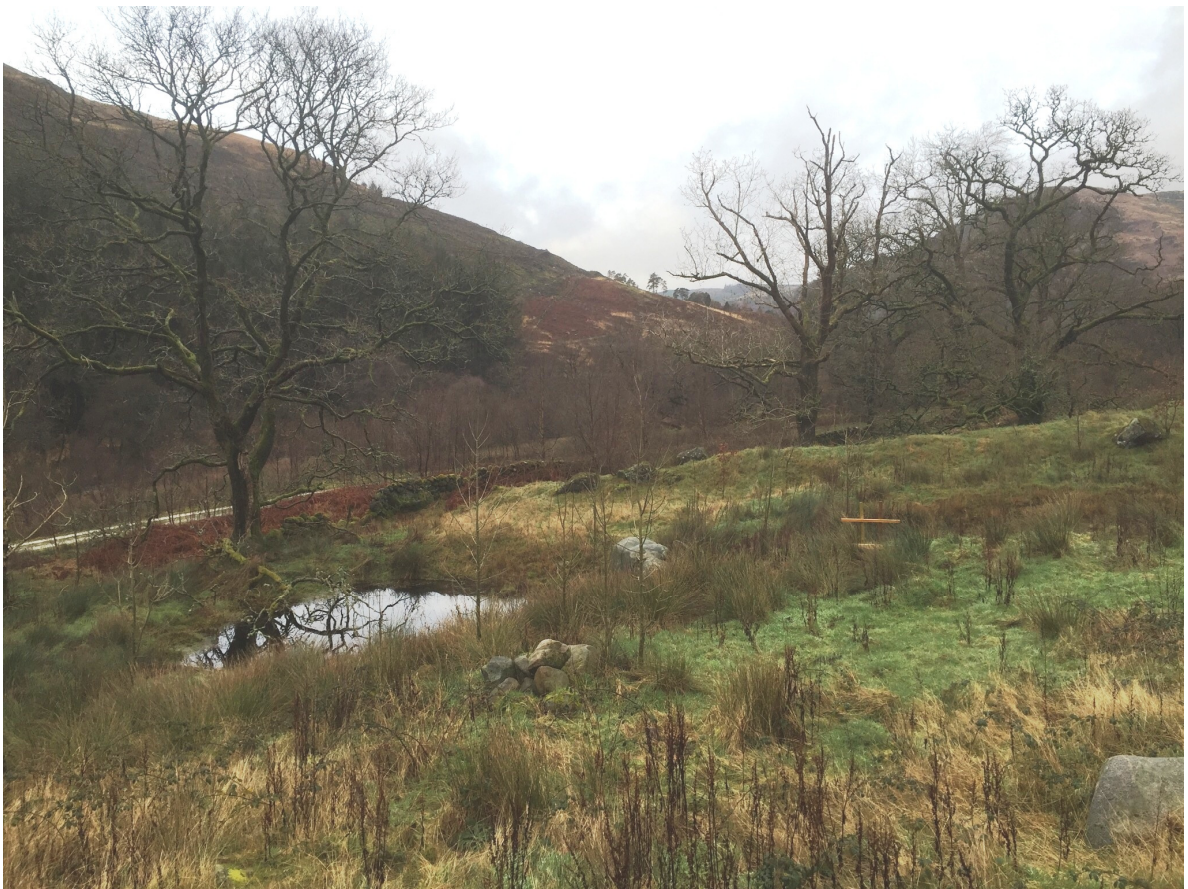
The enclosures were dense with dead brambles and comprised mostly upstanding rubble built walls - the large sub-enclosure, depicted on 2nd edition OS mapping, and the smaller square enclosure depicted on both 1st & 2nd edition OS mapping, was still mostly observable (Figures 5a-6b).

Figure 5a – SE end of enclosure(s) (I) (from NE)

Figure 5b - general of SE enclosure(s) (from NW)

Figure 5c - SE end of enclosure(s) (II) (from NE)

Figure 6a - general of enclosure(s) (from E)

Figure 6b – general of NW end of enclosure(s) (from ENE)

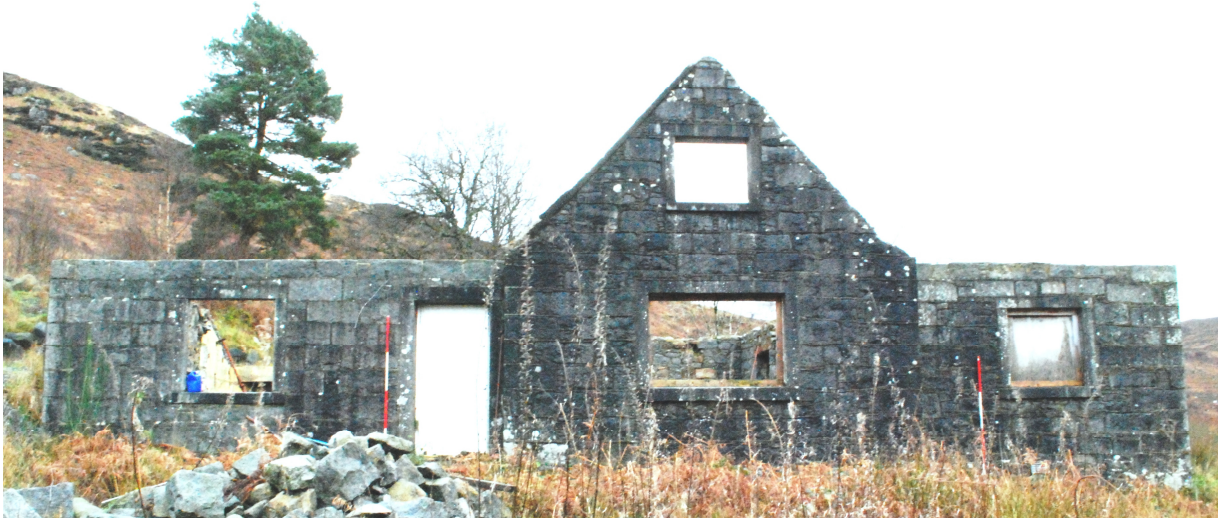
Glenhead Farm House comprised the unroofed remains of a stone built former farmhouse with granite facings (Figure 7a). The structure is roughly T-shaped in form with the longer section (cross section of the T) aligned N / S and the shorter section (upright section of the T - extended area) aligned E / W with an upstanding gable to the west (Figure 7b & 8a-b). There is a small extension to the E of the northern half of the N /S aligned section.

The western (front) elevation comprised three windows and an entrance on the ground floor with a single window on the upper gabled section (Figure 7a). The eastern (rear) elevation (Figure 7c) comprised three blocked-in windows, two of which were in the small extension (Figure 12a) and one in the recessed area between the small extension and upright section of the T - however, the lack of window facings indicate this may be a later window. The southern end wall(s) comprised two blocked-in windows (Figure 9a) and there are indications that the E half (upright section of the T) is probably a later extension to the main rectangular structure (cross section of the T). The northern end wall comprised no windows or doorways and it was not easily visible where the small extension had been added (Figure 9b). The southern wall of the small extension comprised a blocked-in doorway (Figure 11c) and the northern wall of the extended area comprised boarded up window (Figure 12c).

Figure 7a - front elevation (from W)

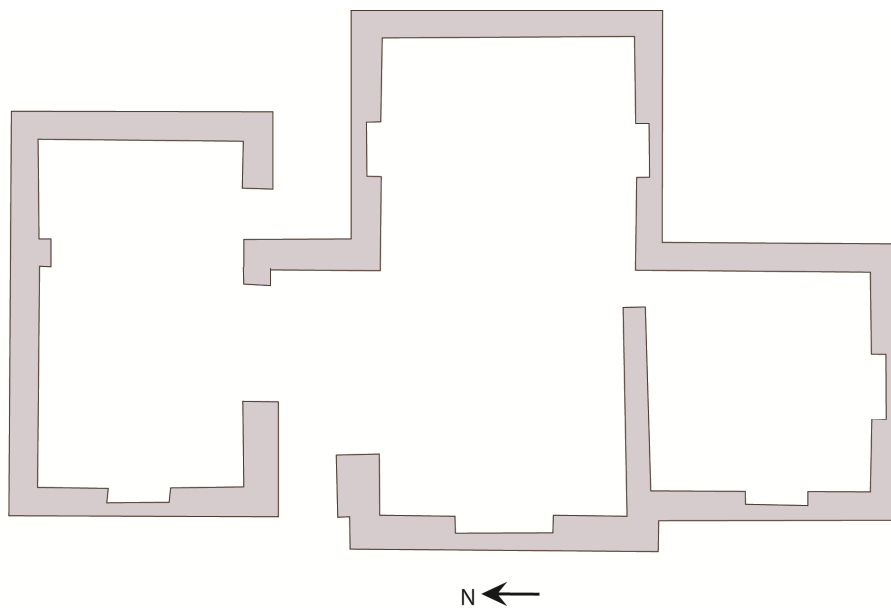
Figure 7b - sketch floor plan (as existing)

The structure that is depicted in the location of the current farmhouse could be an earlier building or it could be the first phase of Glenhead Farm House (Figure 19b). By the time of the 2nd edition, in the late nineteenth century, the current farmhouse is mapped in its current form (Figures 4d & 7b).

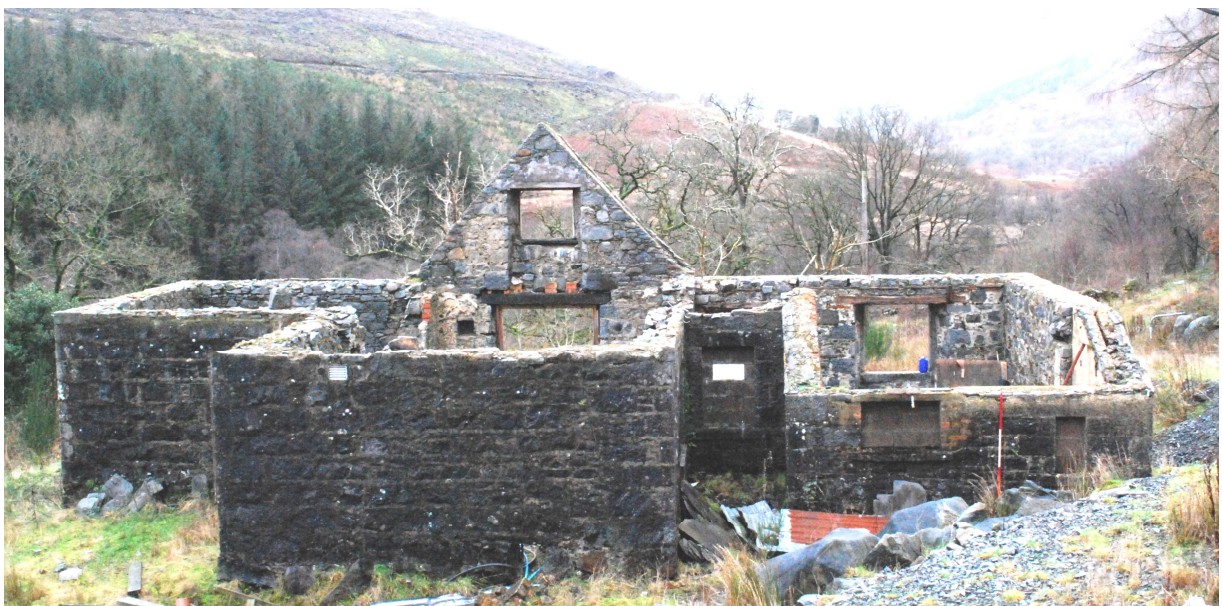
Figure 7c - rear elevation (from E)

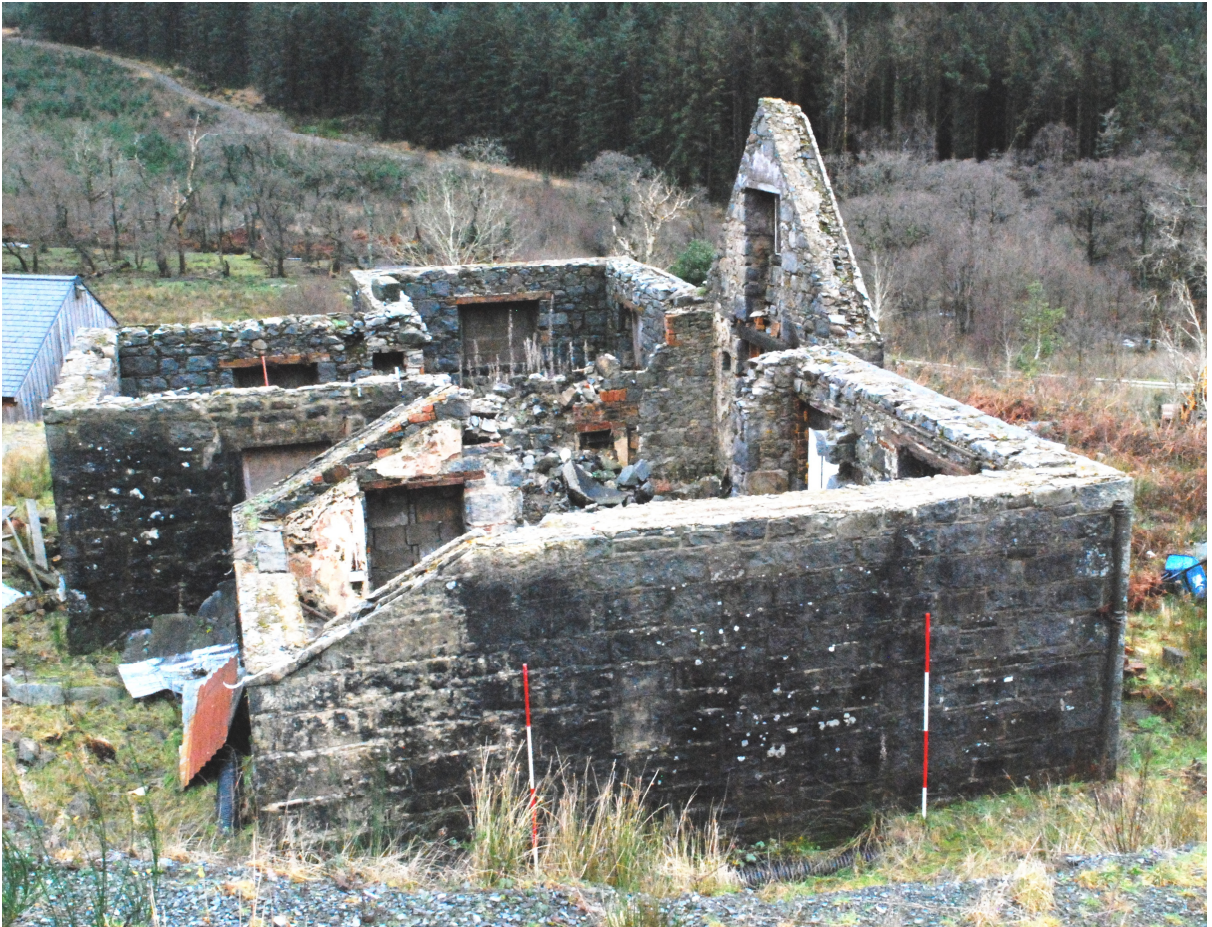
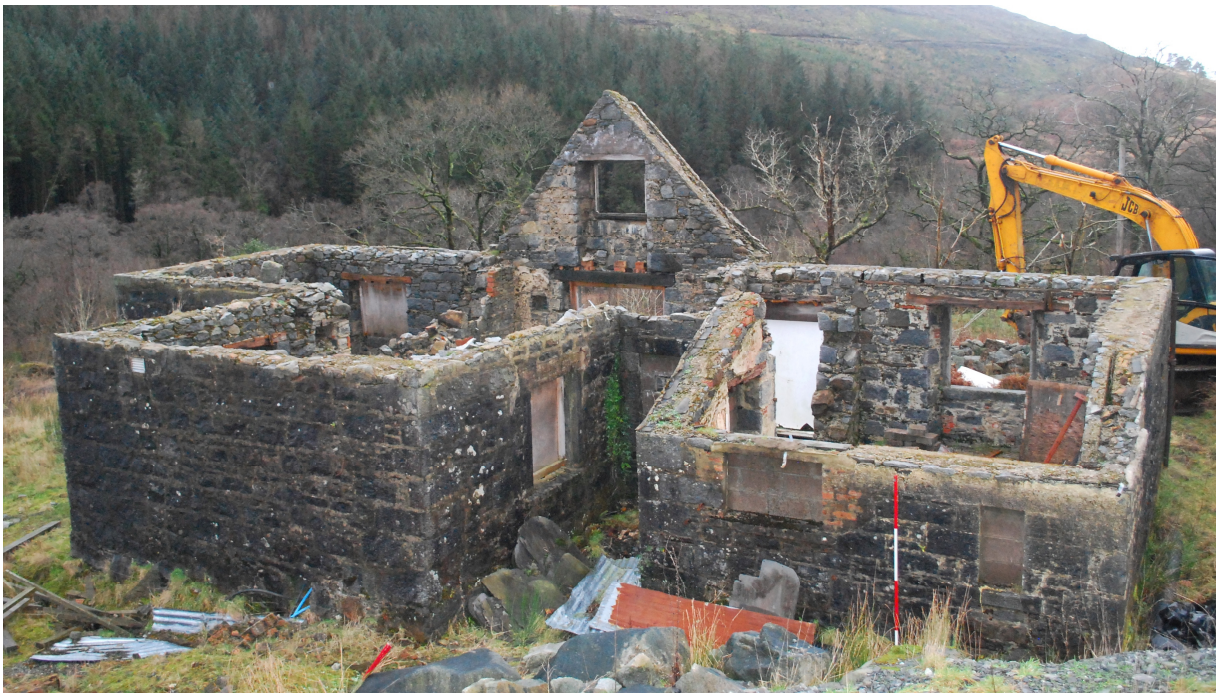
The western (front) elevation comprised three windows and an entrance on the ground floor with a single window on the upper gabled section (Figures 14b & 15a-b). There was a dividing wall, located between the two windows in the southern half, which was attached to the W wall and extended to the E. This wall containing two fireplaces (one in either face - Figures 16a-b) and allowed access via a doorway (at the eastern end) into a small room. There were two further small protrusions of walling located either side of the (main) entrance both of which were attached to the W wall and extended slightly to the E (Figure 8a). The eastern (rear) elevation contained two blocked in windows in the small extension (Figure 11a) and a further blocked in later window (Figure 12b) between the small extension and larger extension. The slight recess for a narrow dividing wall was apparent between the two windows in the small extension (Figure 8a).

Figure 8a - general of Glenhead farm house (from NE)

Figure 8b - general of Glenhead farm house (from ENE)

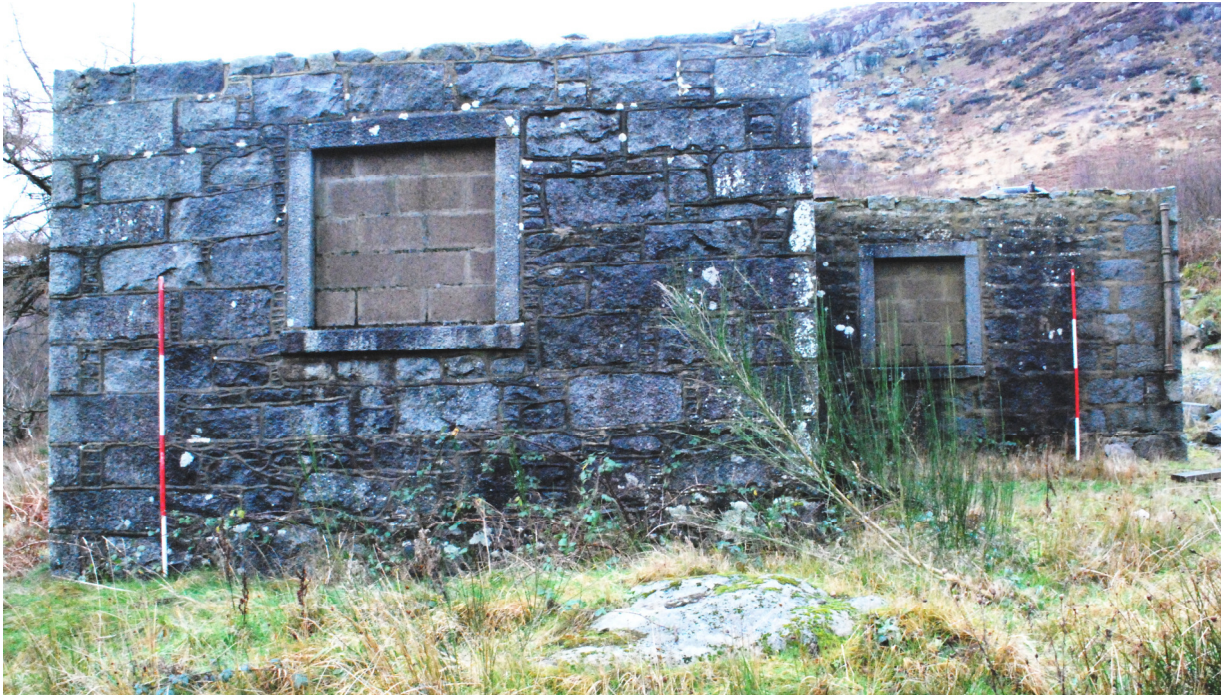
The newer looking stonework (Figure 9a) (and slightly differing roof slates - Figure 21a) observable on the exterior of the structure indicate that the E / W section of the T shaped plan was added as a later extension (Figure 19a) to the N / S cross section. This theory is supported by the scars visible within the interior where it appears that a larger external wall (rather than a thinner partition wall) has been removed (Figures 13-b). As there was a window in the northern wall of the later extension this suggests that this extension pre-dates the smaller extension (Figure 19a) as it is unlikely a window would have been put in this wall to overlook another wall (Figures 8b & 17c). It can therefore be concluded that the small extension was the last phase of the current farmhouse building.

Figure 9a – southern end of Glenhead Farm House (from S)

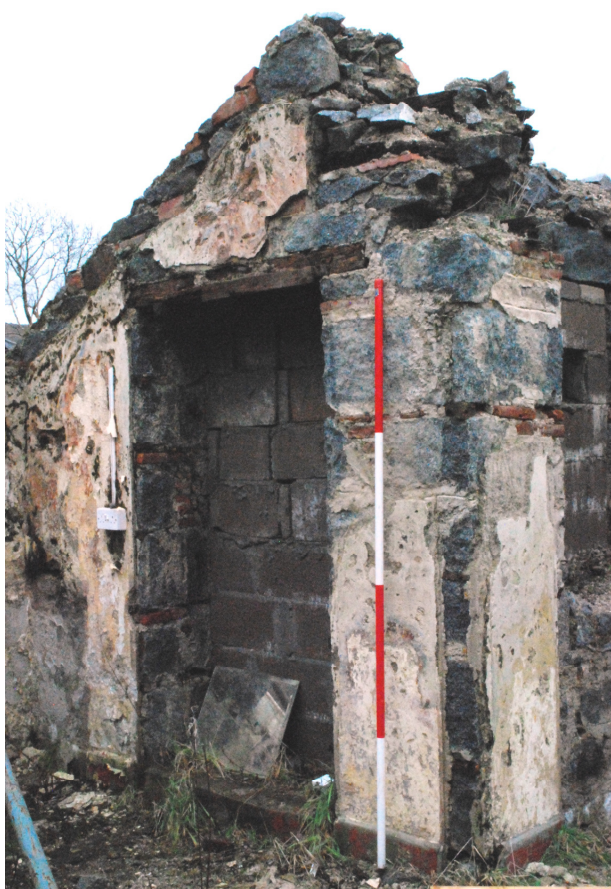
The southern end wall(s) contained two blocked in windows, one in the main cross section of the T (Figure 14a) and one in the extended area (Figure 13b). The later mortar infill at the western end (corner) of the southern wall in the extended area suggests that a section of walling may have been removed (Figure 13b). On the northern end wall it was noticeable where the later small extension had been attached to the main structure (Figure 10a) and a narrow slot in the floor indicated where a dividing wall had stood. In the northern wall of the extended area there is a boarded up window (Figure 13a). The later mortar infill at the western end (corner) of the northern wall of the extended area suggests that a section of walling may have been removed (Figure 13a). In the southern wall of the small extension there was a blocked in doorway (Figure 11b).

Figure 11b - S-wall of small extension showing blocked in doorway (interior) (from NNW)

On the assumption that there was always a back doorway, this was presumably located within the wall that was removed for the small extension, which then necessitated the adding of a new back doorway (Figures 11b-c). Although the blocked in window between the two extensions (Figure 12b-c) may have been where the original back door was, the flare on the interior suggests this was always a window and there are no visible signs on the exterior to indicate a former doorway. The lack of facings on this window suggests that this window may have been forced though at a later date.

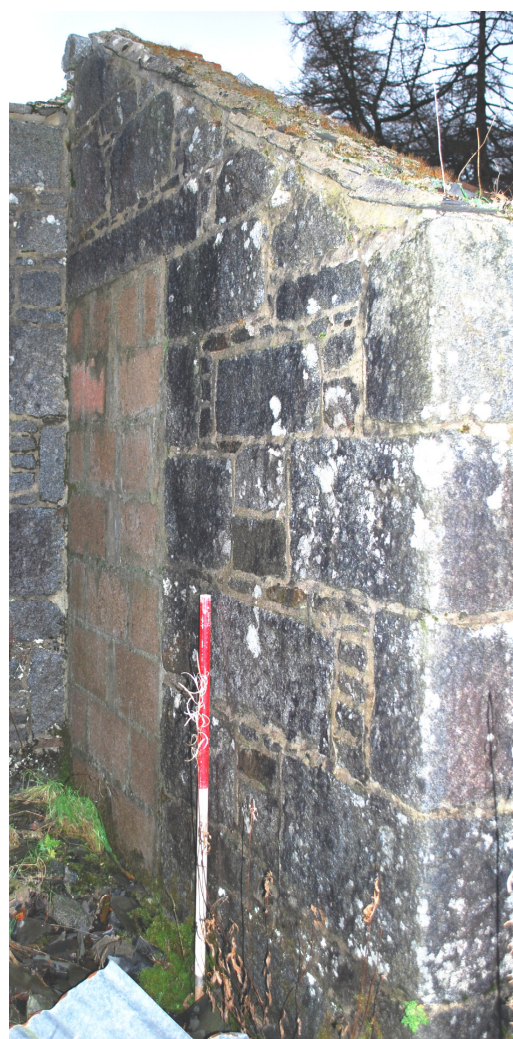
Figure 11c - S-wall of small extension showing blocked-in doorway (from ESE)

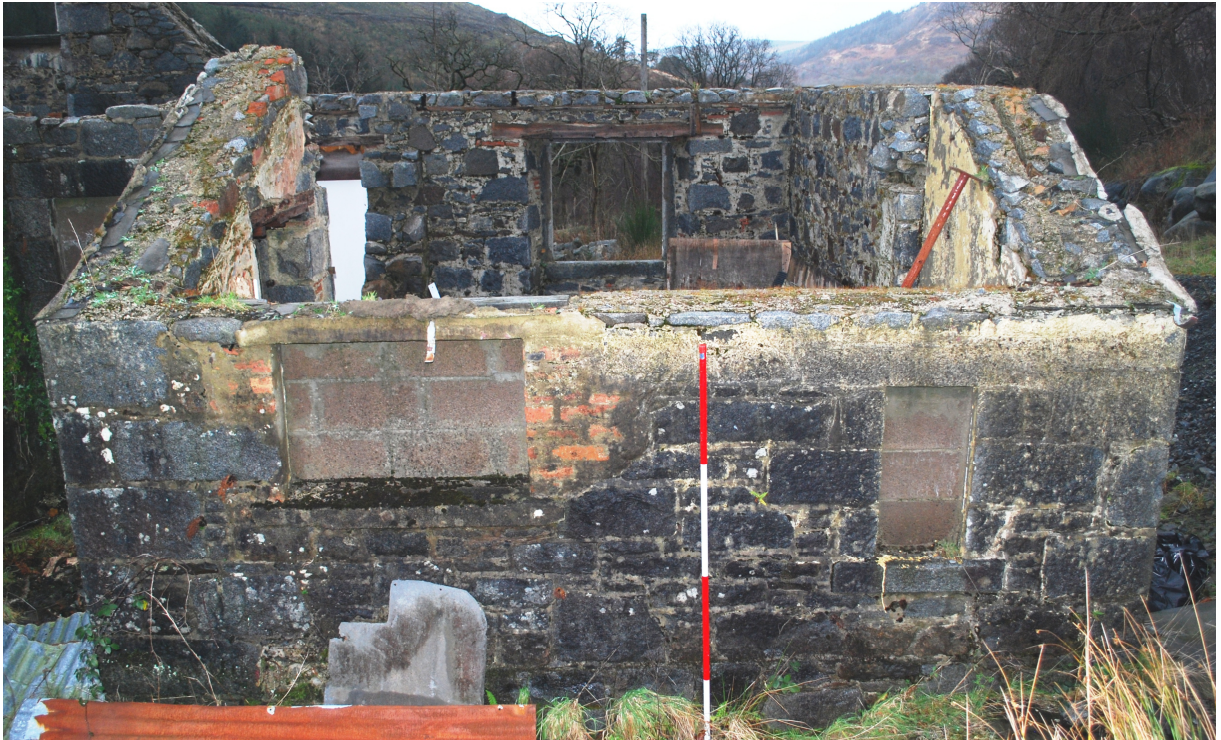
Figure 12a - small extension showing block in windows (from E & above)

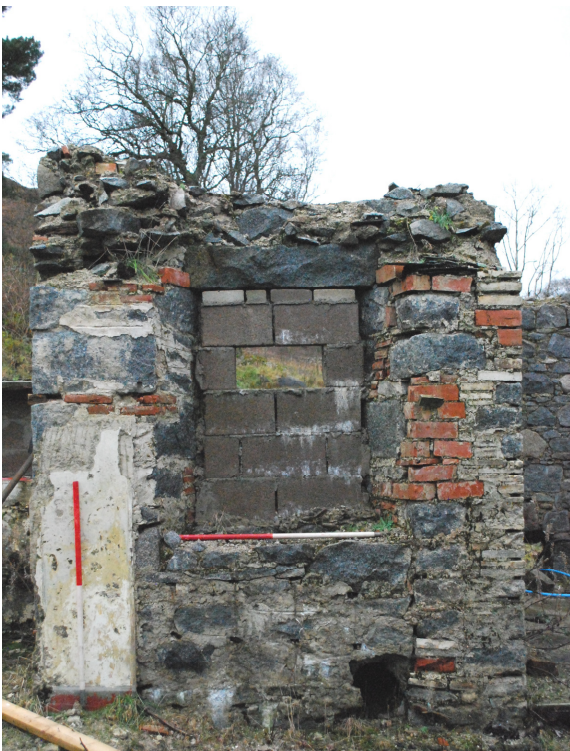
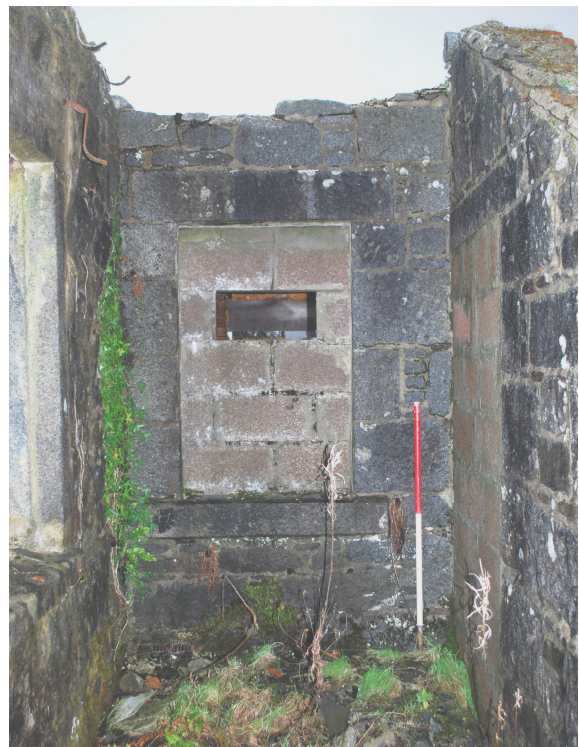
Figure 12b - later blocked-in window in E-elevation (interior) (from W)

Figure 12c - later blocked-in window in E-elevation (exterior) (from E)

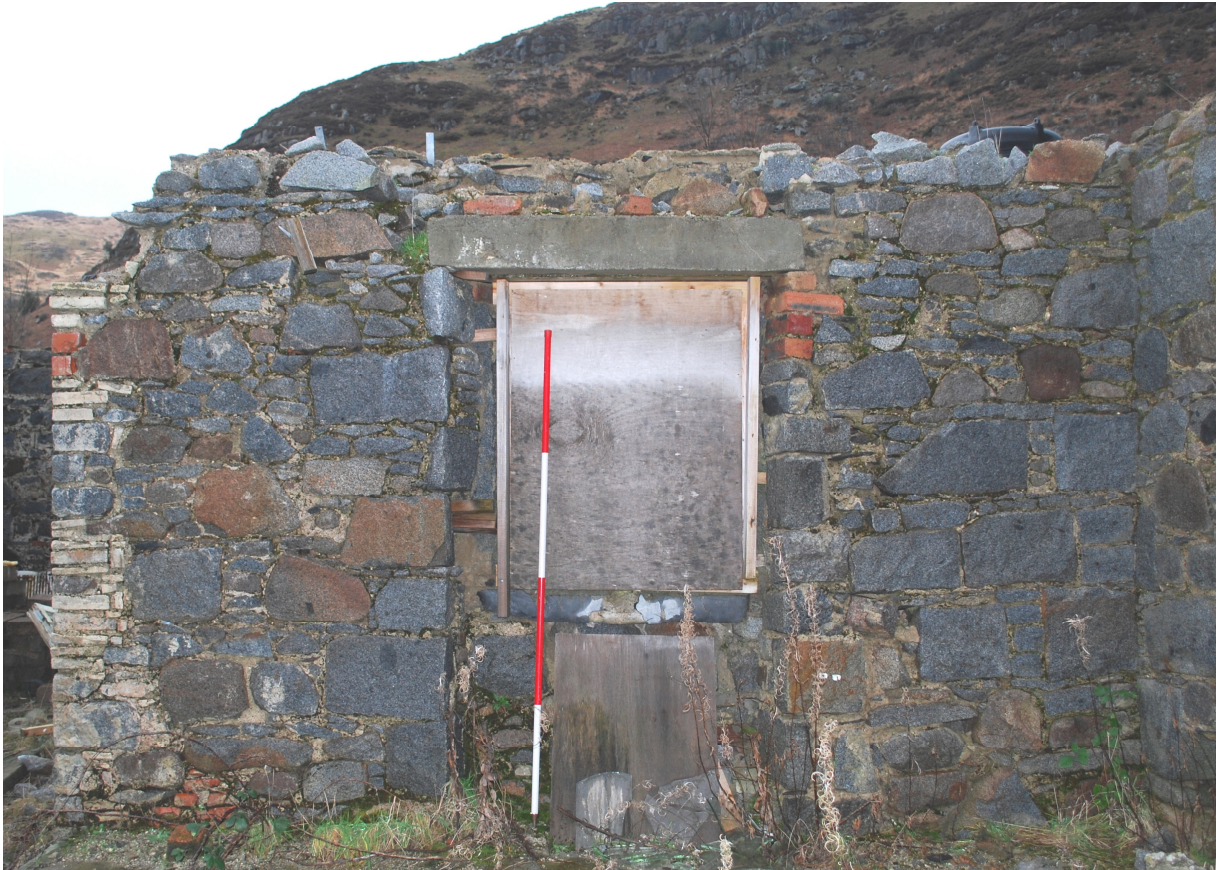
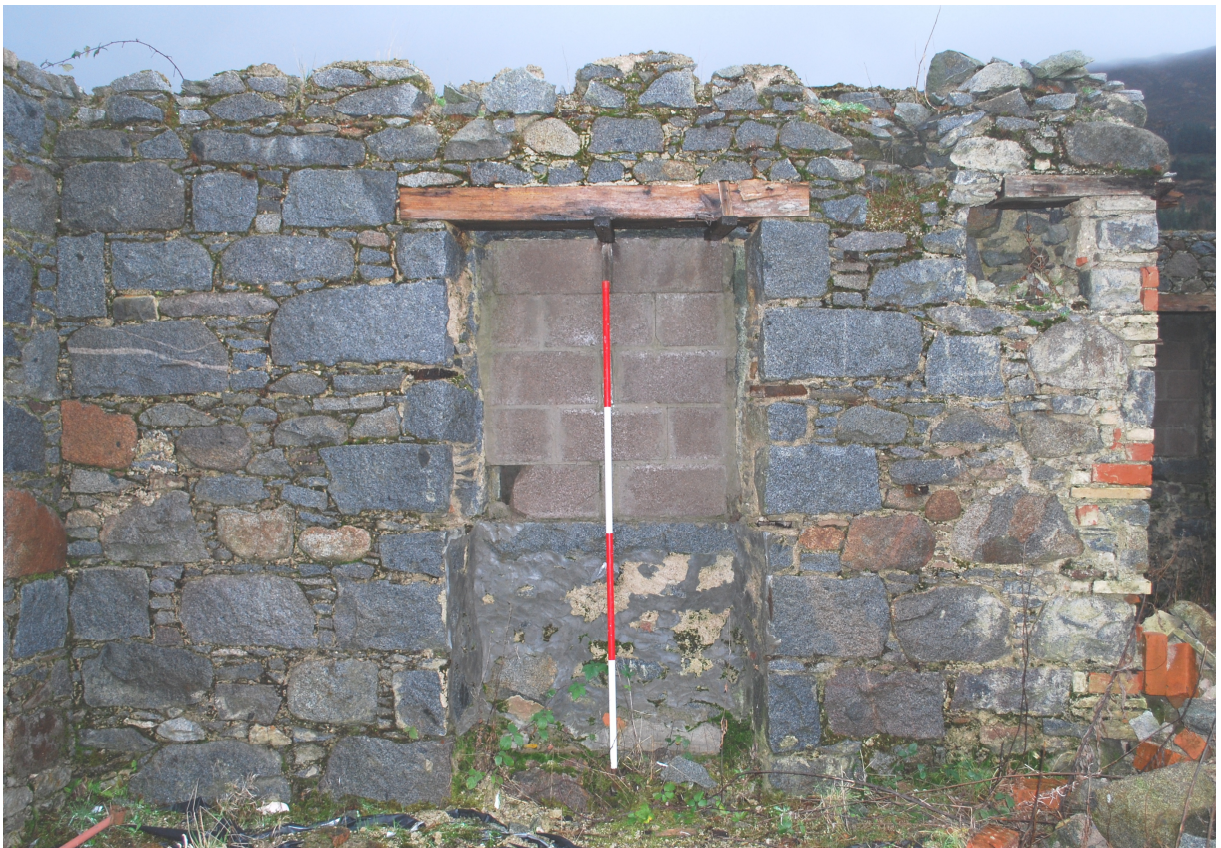
Figure 13a – N-wall of later extension (see Figures 19-b) (from S)

Figure 13b – S-wall of later extension (see Figure 19a-b) (from N)

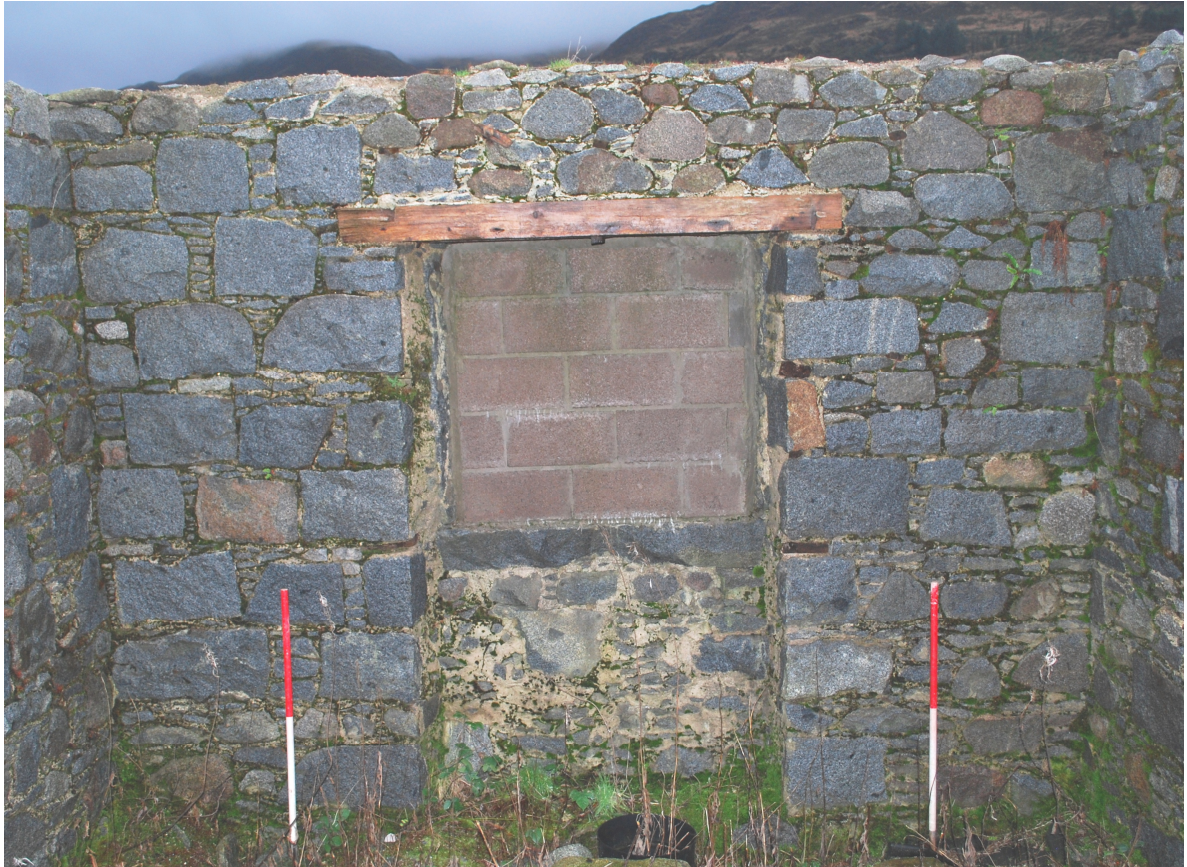
Figure 14a – southern end wall (interior) (from N)

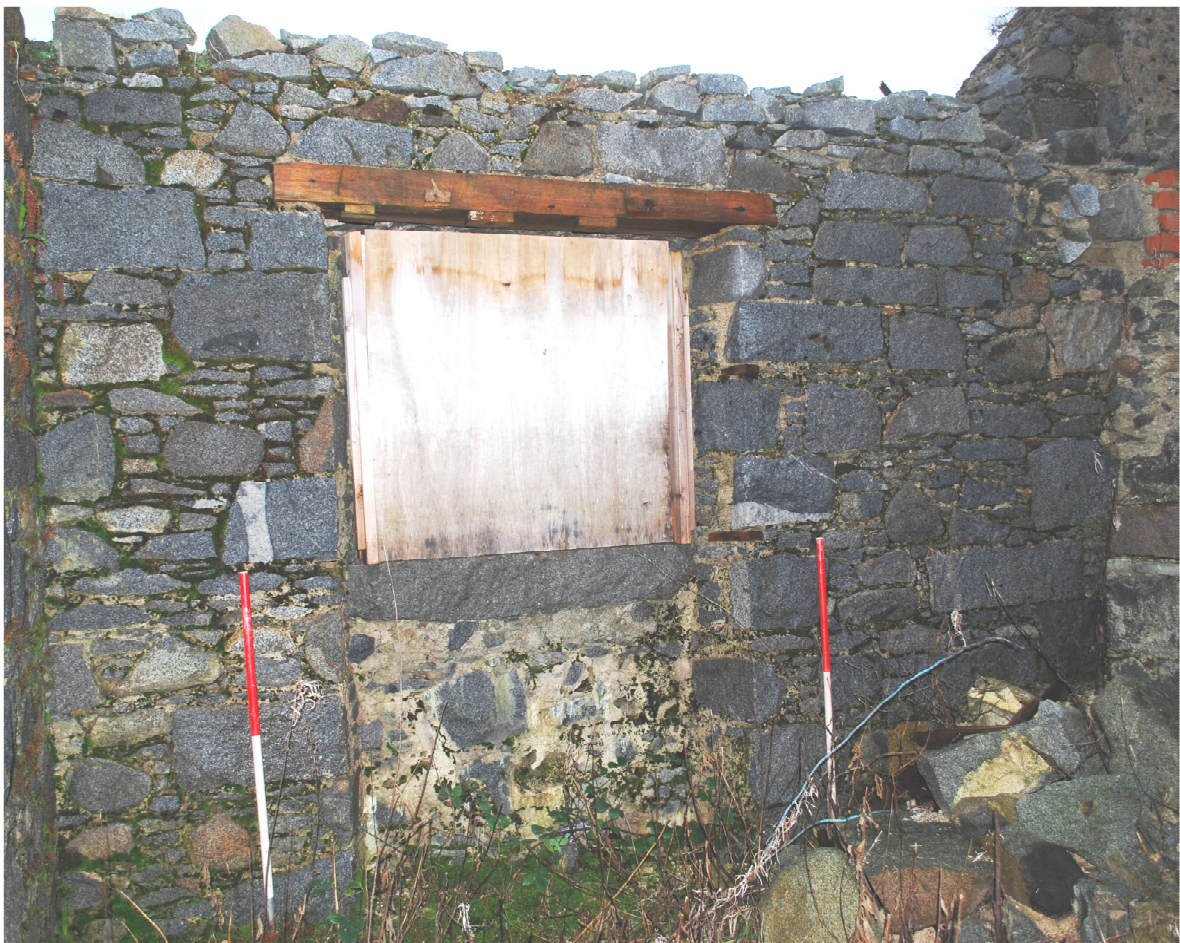
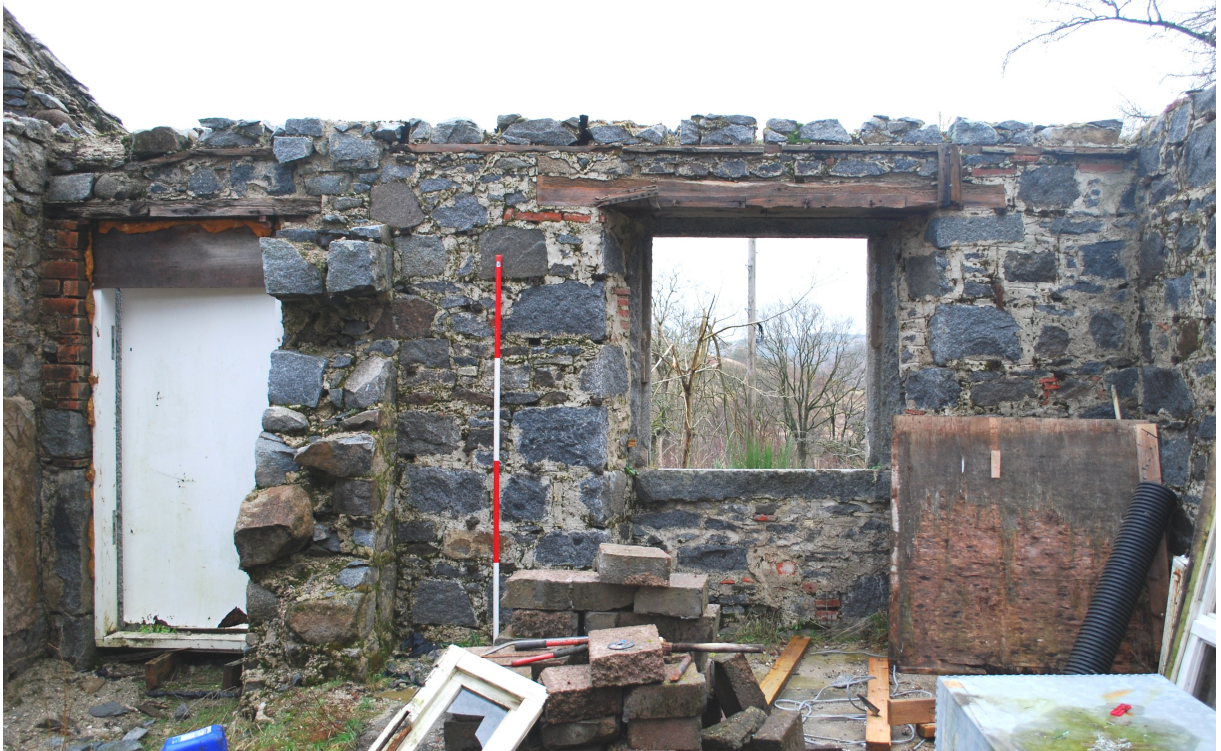
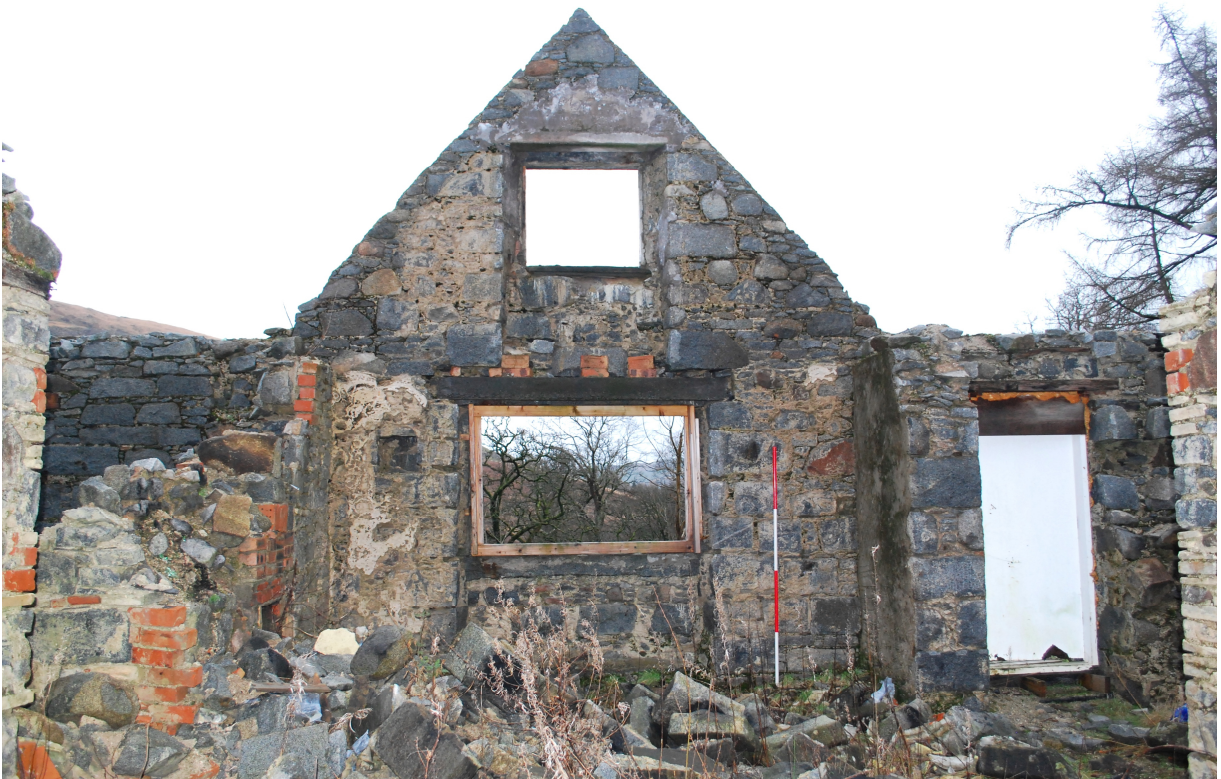
Figure 14b – southern end of western (front) elevation (interior) (from E)

Figure 15a – western (front) elevation (northern end) (interior) (from E)

Figure 15b – western (front) elevation (central area) (interior) (from E)

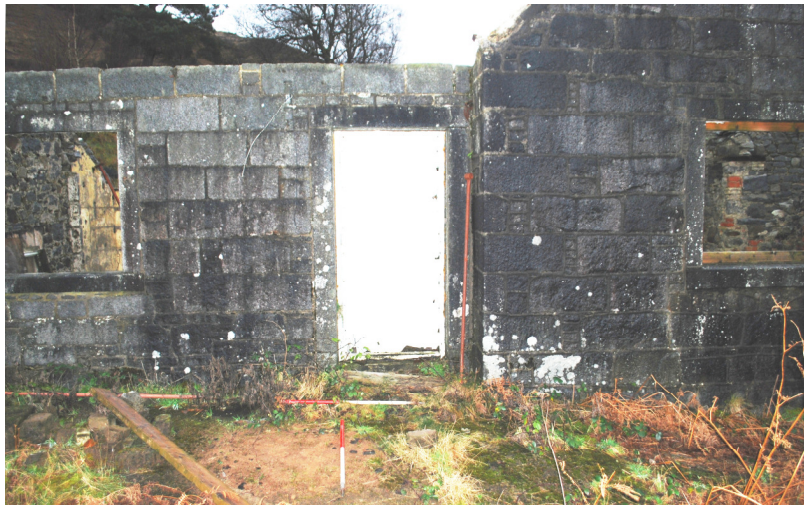
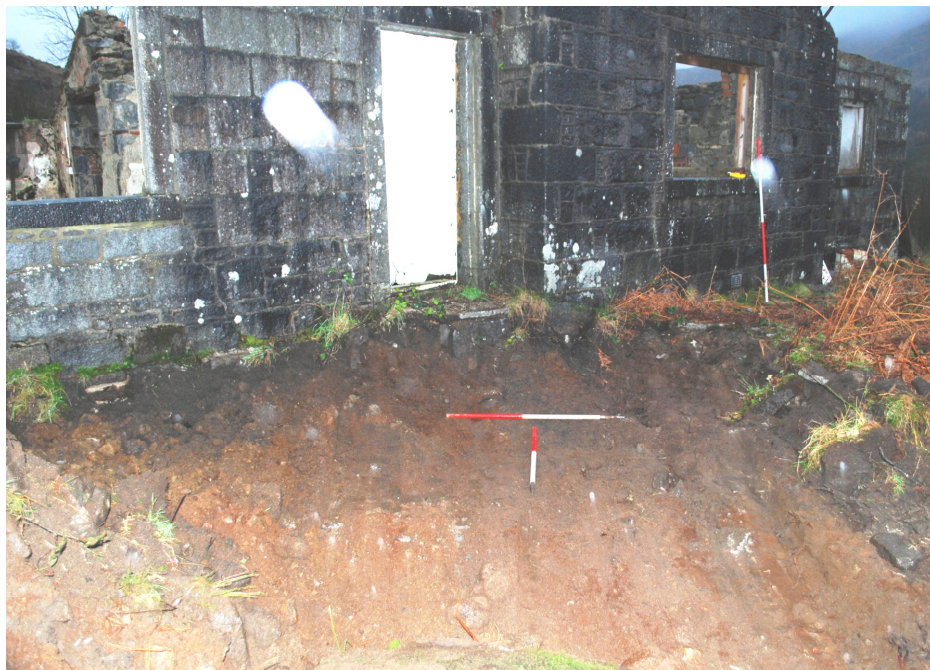
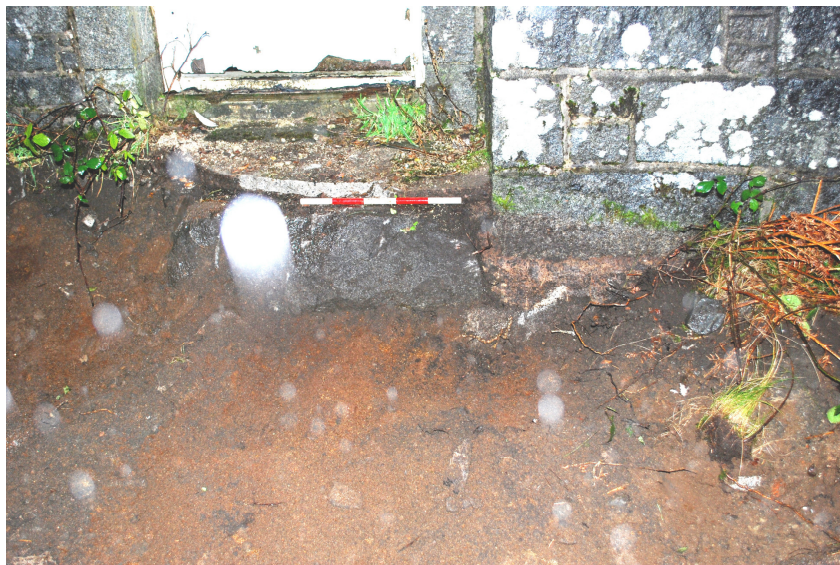
The monitoring works that were undertaken for the proposed new extension to the western (front) elevation (Figure 18a) revealed a brownish black gritty silt [101] 60mm to 150mm in

depth above a brown gritty silt containing a moderate amount of stones [102] (Figure 18b) (100mm approx). The natural comprised orange sands & gravels [103] - bedrock was noted almost immediately below the slabbed surface outside the front entrance (Figure 18c).

Figure 18a - pre-ex of proposed extension area (from W)

Figure 18b - post-ex of proposed extension area (from NW)

Figure 18c - bedrock outside existing entrance (from W)

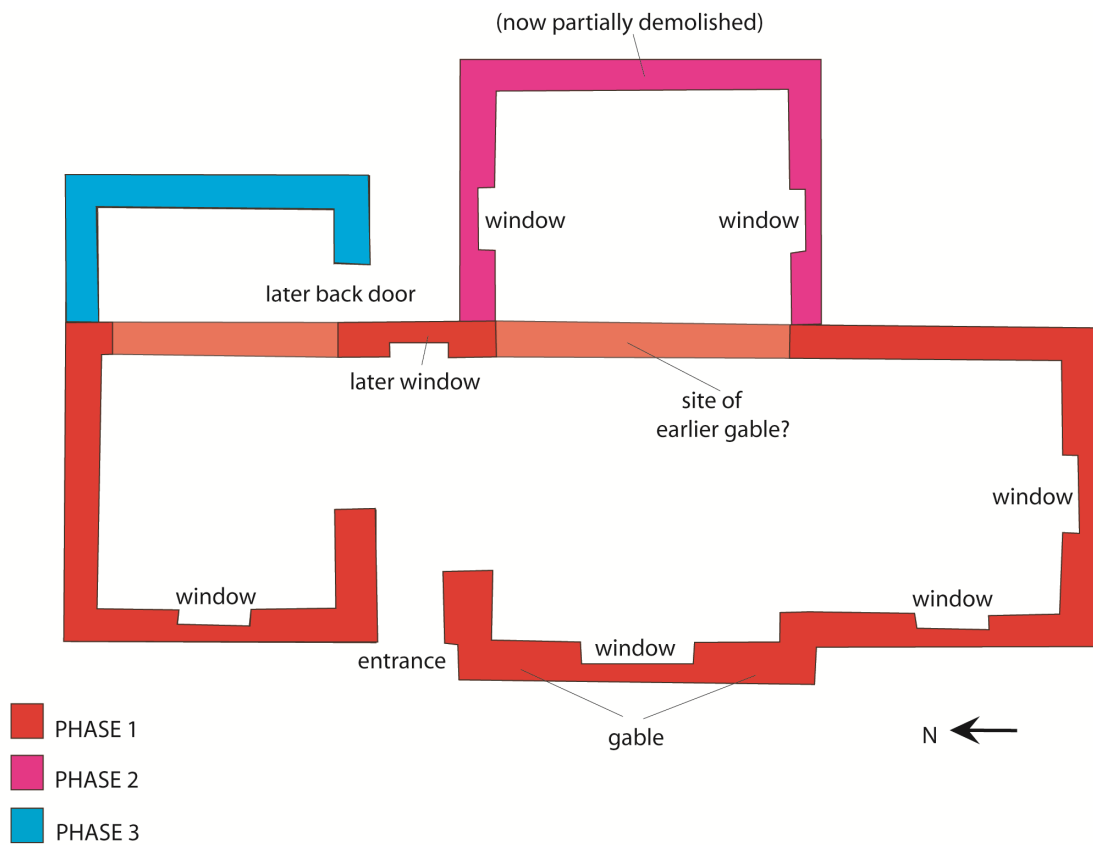
Figure 19a – plan / montage

Figure 19b - phasing plan
