Rebecca Shaw Archaeological Services

Glenhead Farm, Glentroll, Wigtownshire Dumfries & Galloway: Archaeological Works

by Rebecca Shaw
24th January 2019

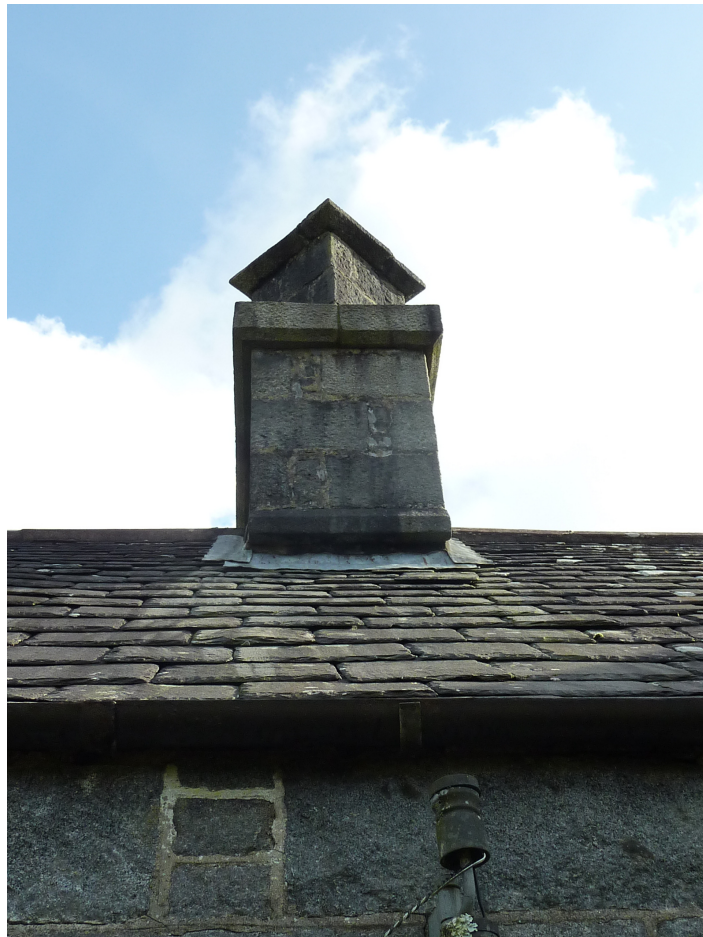
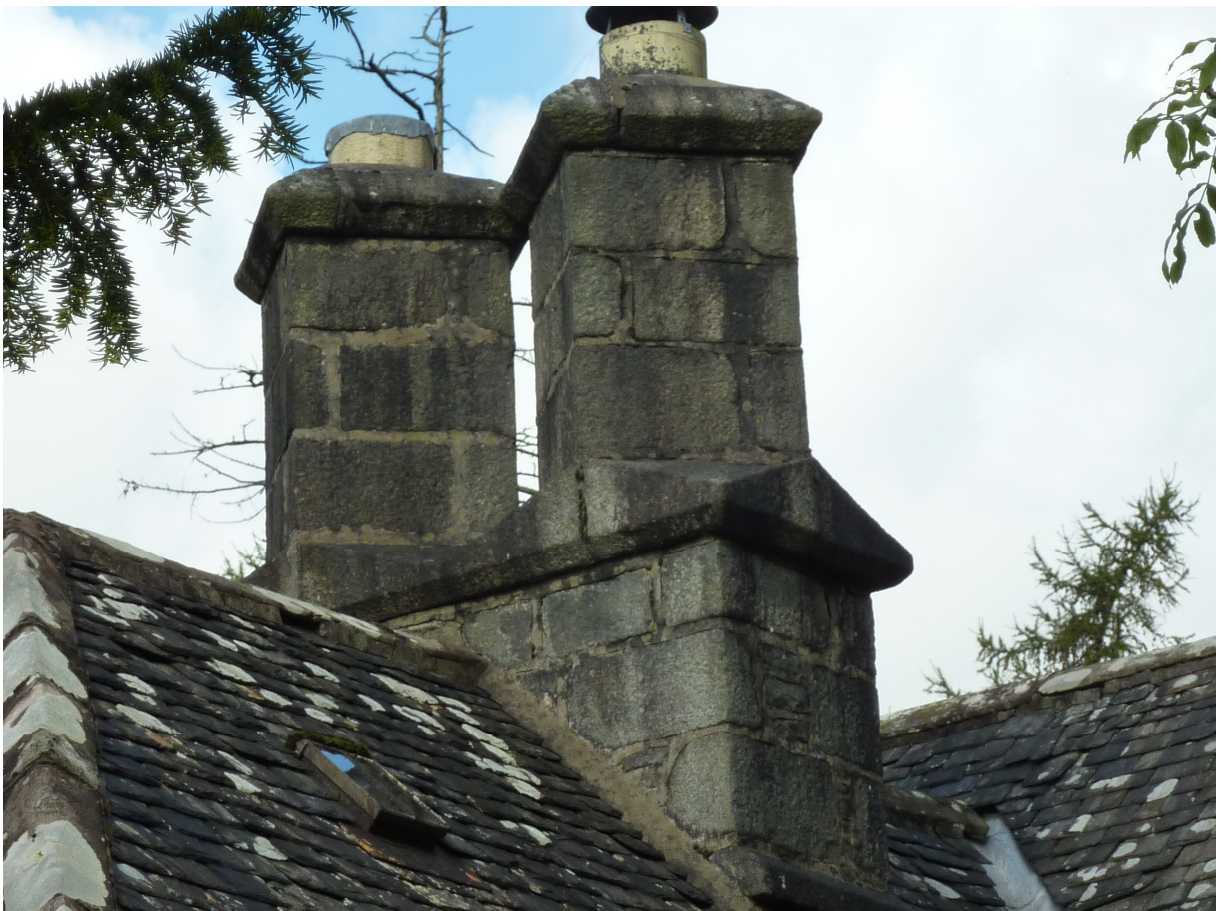
Figure 20 - chimneys in-situ (c) Andy Nicholson

The house formerly had granite chimneys (Figures 20a-b) which were removed fairly recently (at the same time as the roof (Figure 21a) - the current owner has retained the granite chimney blocks and hopes to re-use them - Eric Baird pers. comm).

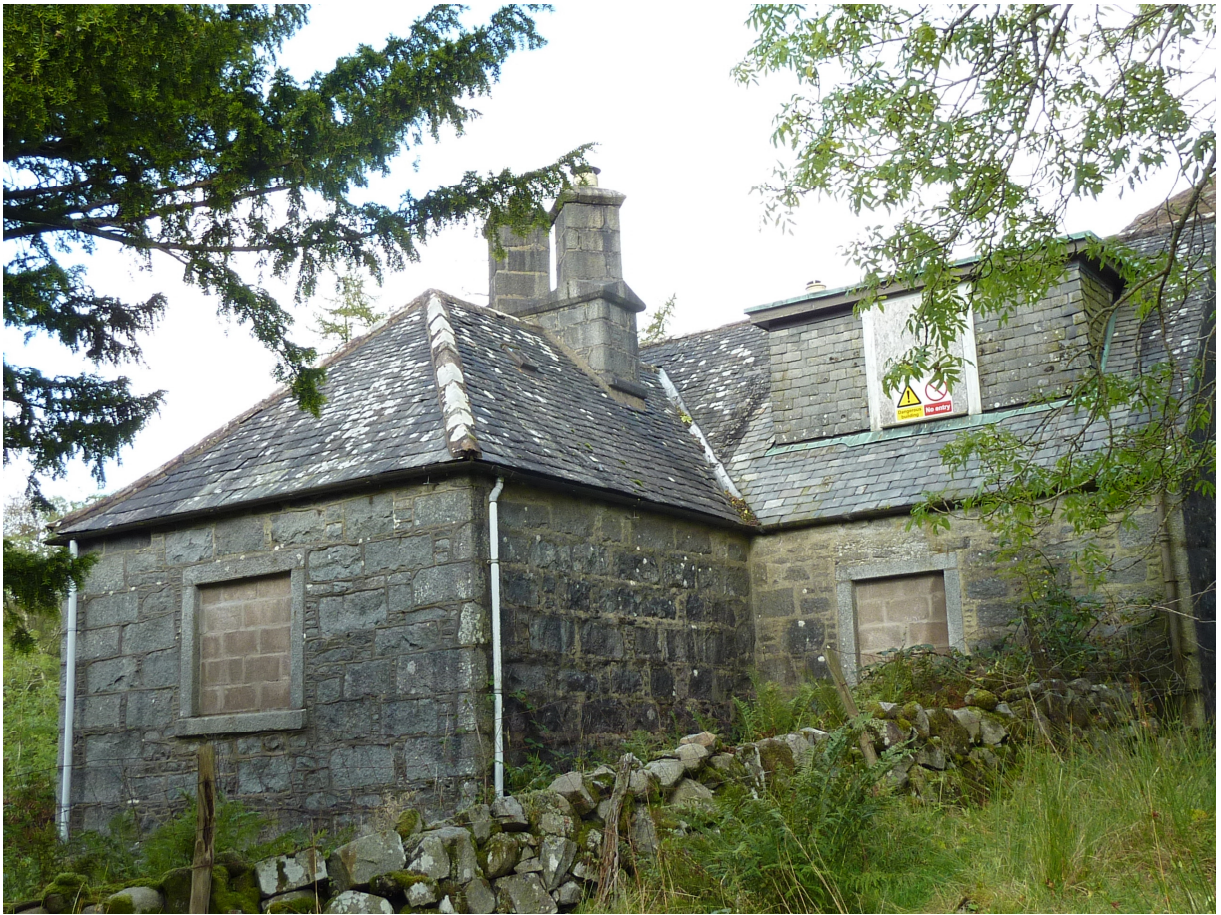
The newer looking stonework (Figure 9a) (and slightly differing roof slates - Figure 21a) observable on the exterior of the structure indicate that the E / W section of the T shaped plan was added as a later extension (Figure 19a) to the N / S cross section. This theory is supported by the scars visible within the interior where it appears that a larger external wall (rather than a thinner partition wall) has been removed (Figures 13-b). As there was a window in the northern wall of the later extension this suggests that this extension pre-dates the smaller extension (Figure 19a) as it is unlikely a window would have been put in this wall to overlook another wall (Figures 8b & 17c). It can therefore be concluded that the small extension was the last phase of the current farmhouse building.

Figure 21a - Glenhead Farm House prior to removal of roof & chimneys (c) Andy Nicholson

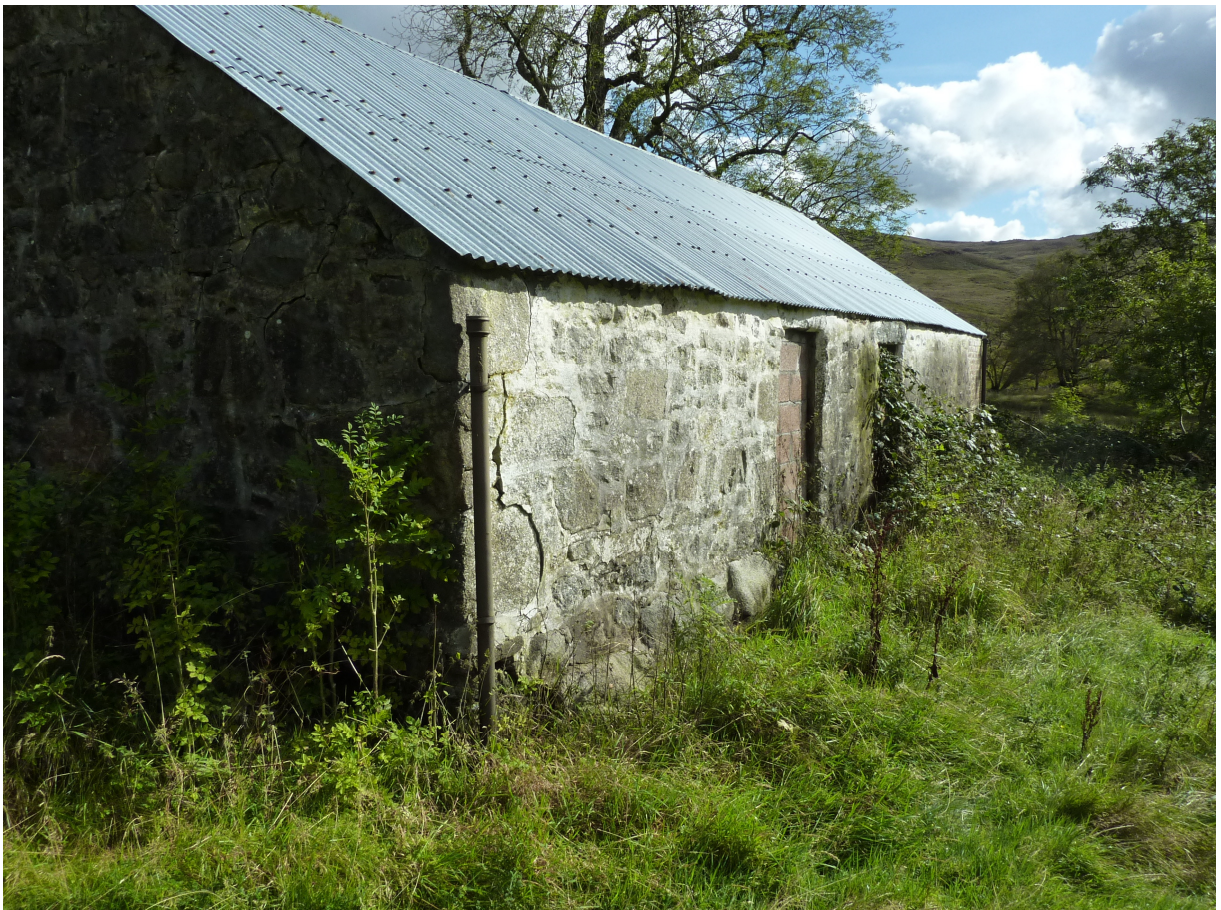
The first sound mapping we have for the proposed development area is the 1st edition ordnance survey map (1852) which depicts Glenhead as a farmstead comprising two roofed buildings with a number of enclosures / pens and a sheep rees (Figure 4c). There is what appears to be a small roofed rectangular structure in the location of the current Glenhead farm house with a larger roofed rectangular structure to the SSE. Although the southernmost structure has now been demolished, earlier photographic evidence suggests that this building was the original farmhouse (Figure 21b).

Figure 21b - original farmstead prior to demolition (c) Andy Nicholson
