**Glen Tarras Remediation Works,
Langholm, Dumfries & Galloway:
Archaeological Monitoring Works**

**by Rebecca Shaw
4th April 2019**

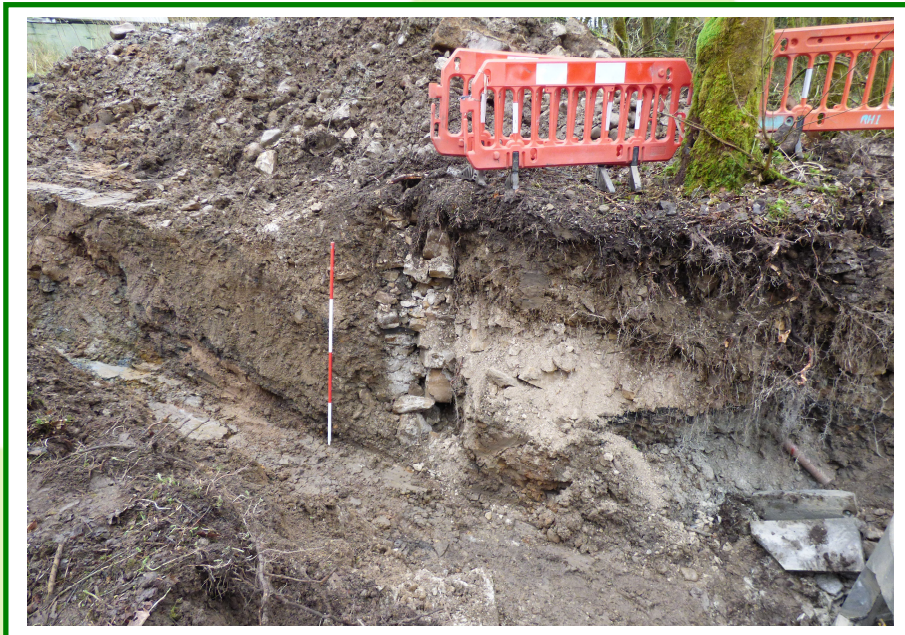
The remains of a section of an in-situ wall (I) [107], aligned SSW / NNE, was observed (Figures 7b-c). The walling, which was located at a depth of 200mm (approx), comprised large blocks of blonde sandstone and measured 0.70m in width (Figure 8a and front cover). To the NW of the wall there was an infill [104] comprising a mixed deposit with re-deposited subsoil which averaged 1.4m in depth. Below [104] was a grey clinker-type deposit 150mm in depth, which was above natural orange sands & gravels [105] (Figure 9a-c).

The monitored excavations indicated that although some of the foundations of the larger load bearing walls - such as wall (I) (Figures 7b-8a) may still exist below ground, in general it appears that the floors and internal walls have been extensively cleared. Wall (I) (front cover) in fact appears to be in the location of an external elevation wall depicted on late nineteenth century mapping (Figure 3b). The other two section of walling: (II) (Figure 8b) and (III) (Figure 8c) are more than likely related to the distillery but they appear to be fairly ephemeral and do not relate to walls depicted on early mapping (Figure 3a-b).

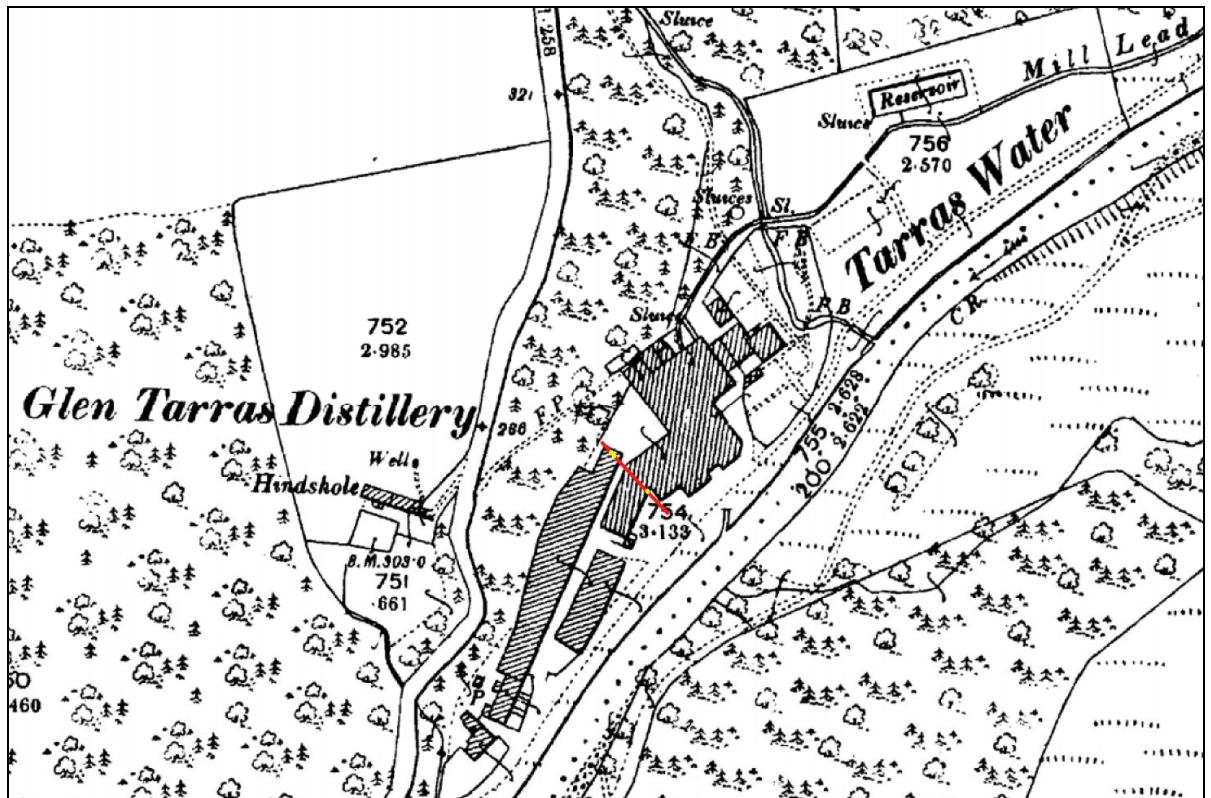
Figure 3b – 2nd Edition Ordnance Survey Map 1:2500 (1899) © Crown Copyright and Landmark Information Group – not to be reproduced without permission (428237352)

Historical archives record that Glen Tarras Distillery was built in 1839 and stopped production in 1905 before finally closing in 1914. Early sound cartographic sources indicate that in the mid nineteenth century (1859) the distillery comprised a small collection of buildings located towards the NNE end of the site (Figure 3a). By the end of the nineteenth century (1899) the distillery had become vast in size (Figure 3b) and it was presumably after the substantial extension that 75,000 gallons per annum of malt whisky were produced.

The monitored excavations revealed the foundation of one large wall which is in alignment with an elevation depicted on late nineteenth century mapping. In general however, very little structural remains or demolition debris / infill was observed and no finds were recovered.

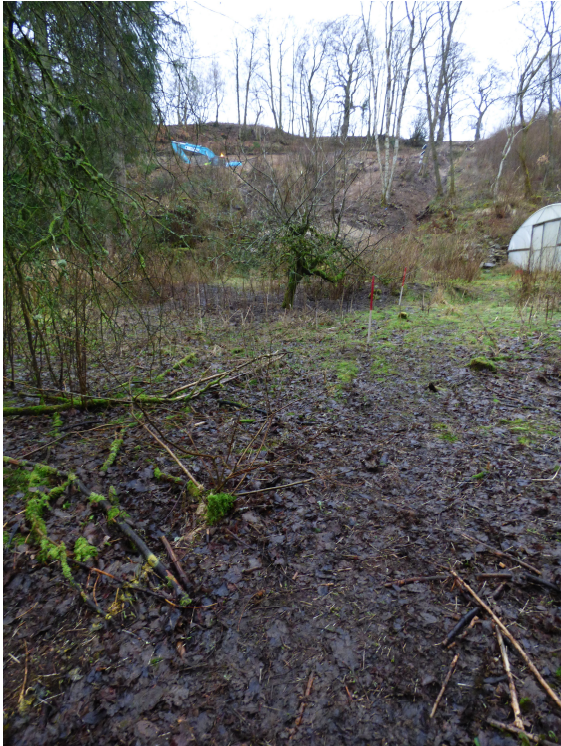
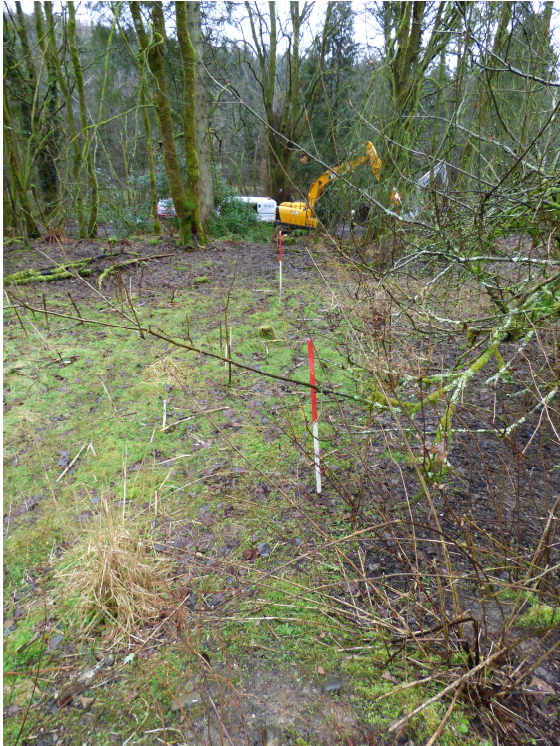
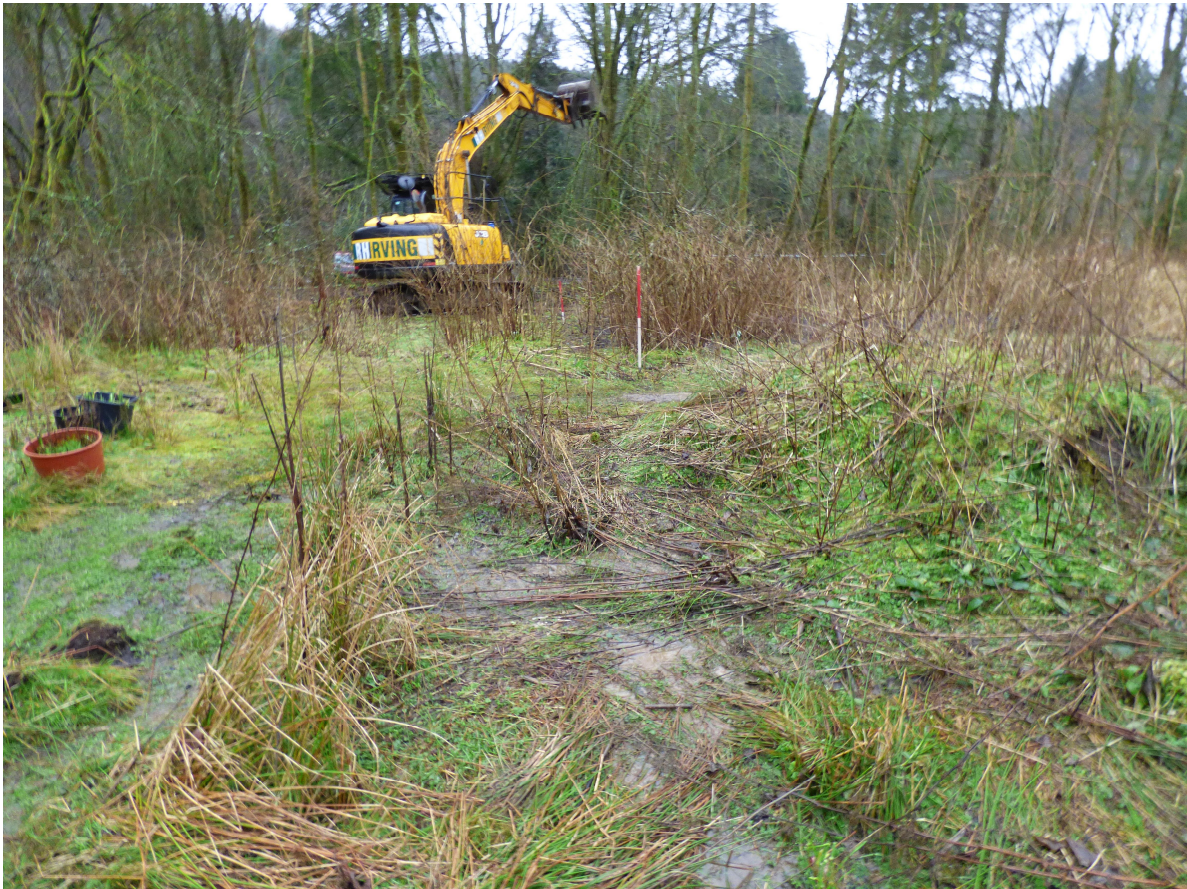
The monitored section of the outfall trench measured 37m in length (approx) (Figures 4 and 5a-c). At the immediate SE end the topsoil comprised a greyish brown gritty silt [101] above a fairly coarse brown sand with frequent stones [102] - the stones / rocks became larger as the depth progressed (Figures 6a-c). As the ground progressed upslope (where the distillery building(s) were located) a layer of demolition debris / infill [103] was noted above deposit [102] (Figure 7a).

Figure 5a - general pre-ex image - NNW end (from SSE)

Figure 5b - general pre-ex image - middle section (from NNW)

Figure 5c - general pre-ex image - SE end (from NNW)

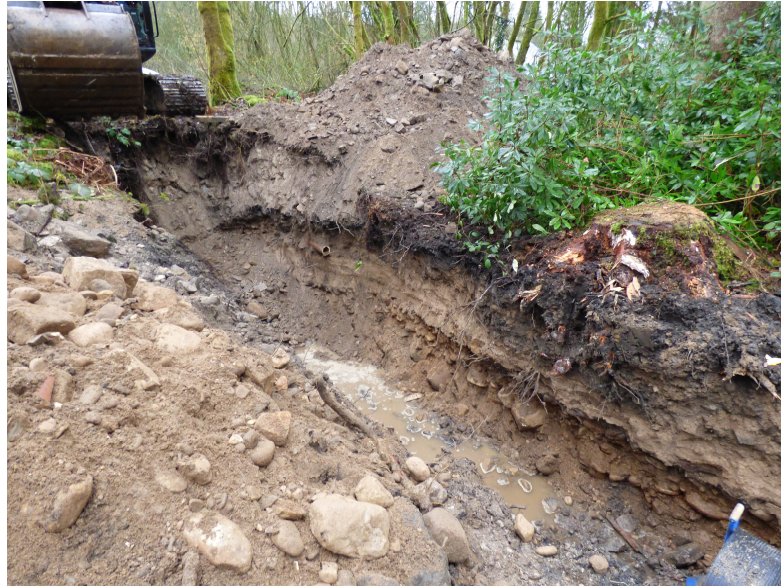
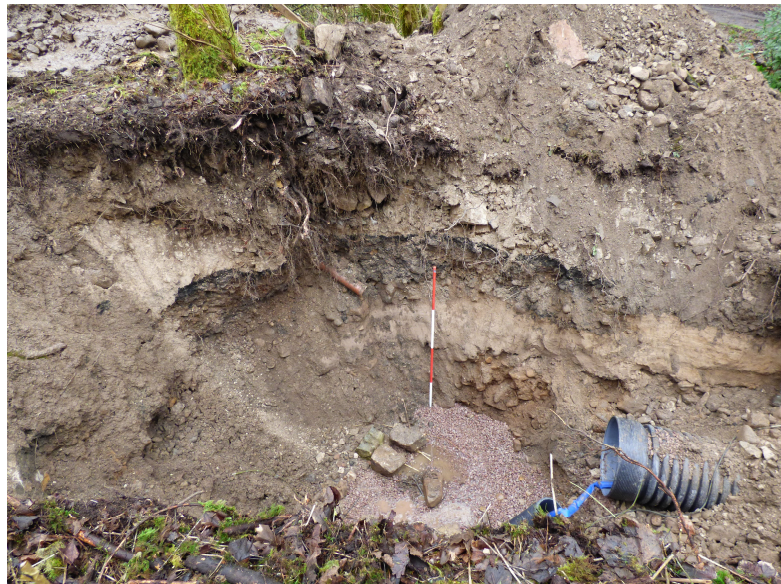
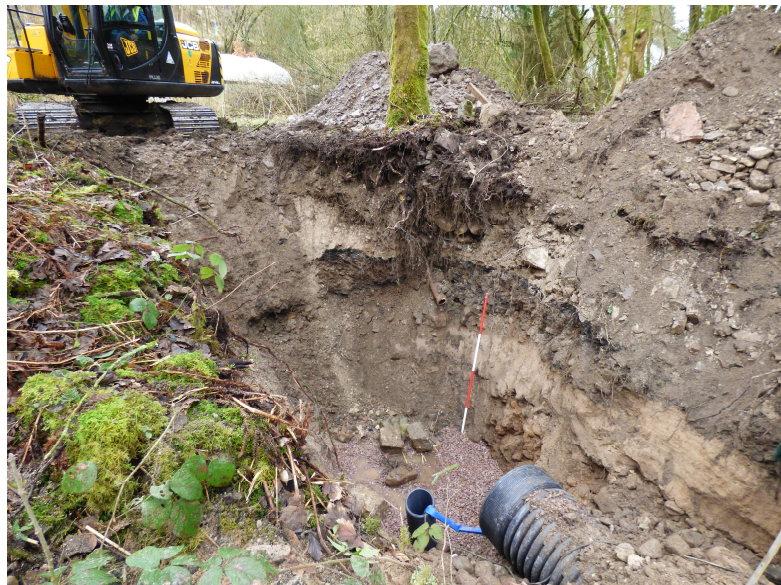
Figure 6a - SE end of monitored section (from S)

Figure 6b – manhole 1 at SE end (s-facing section) (from S)

Figure 6c - general of manhole 1 (from SSW)

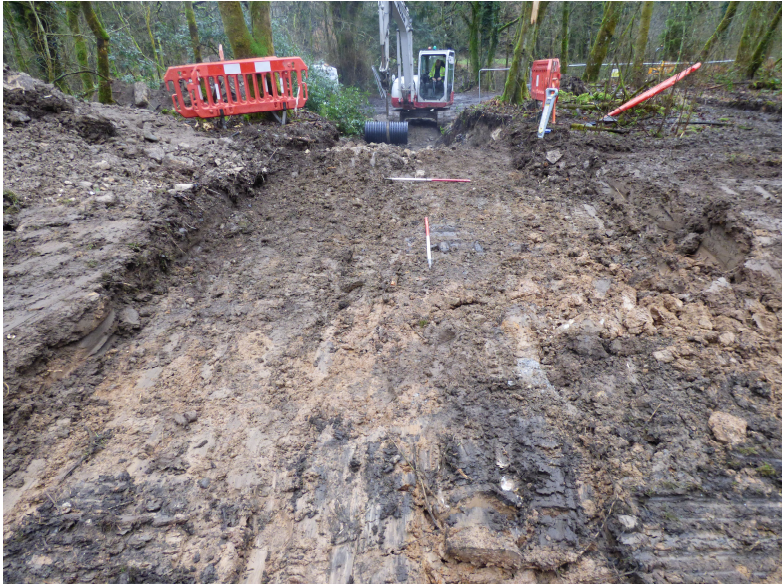
Although there was some demolition debris / infill [103], it was not as dense as expected, which suggest that a lot of material may have been removed from site. No finds were recovered during the monitoring works.

Figure 7a - top of slope after removal of topsoil (from NNW)

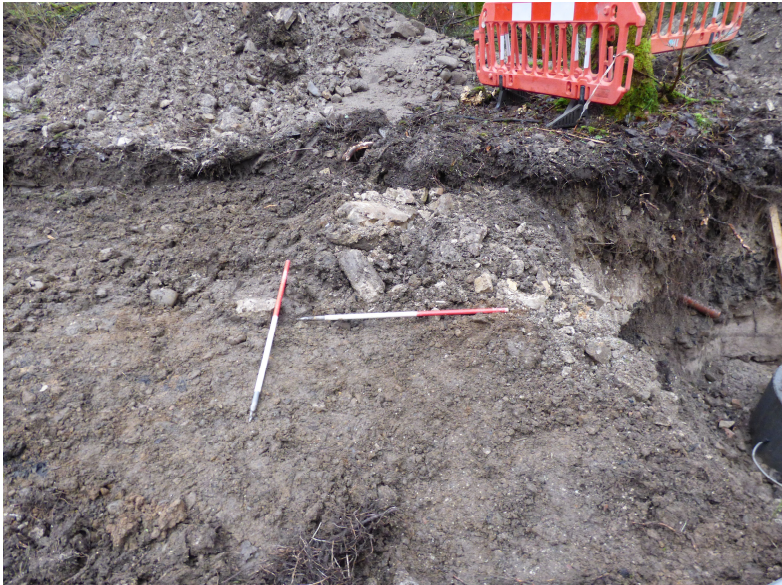
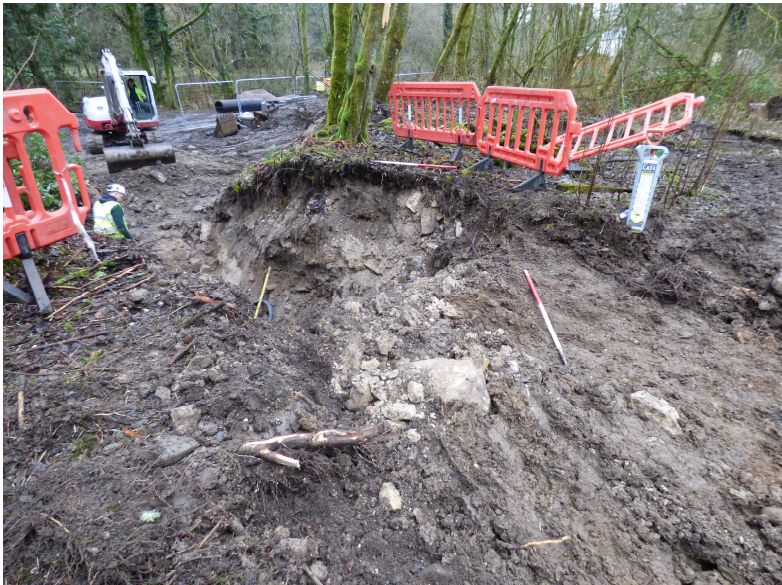
Figure 7b - remains of wall (I) in-situ (from SSW)

Figure 7c - remains of wall (I) in-situ (from NNE)

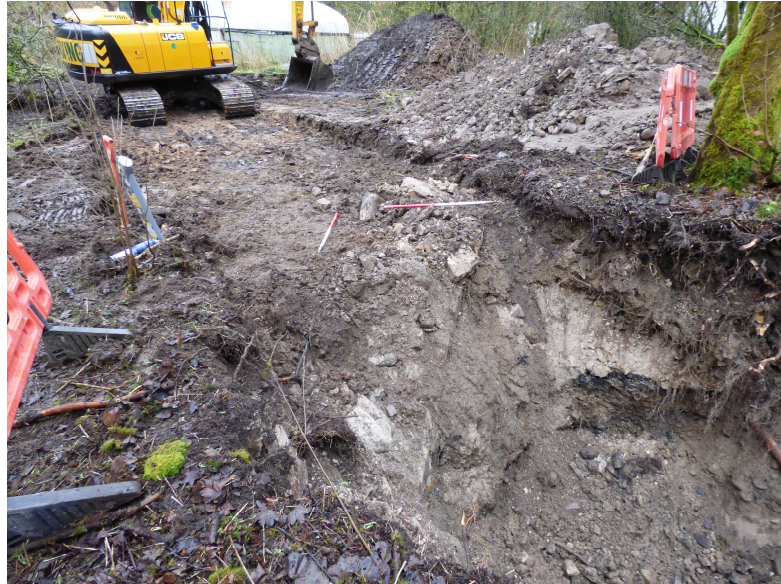
Figure 8a - remains of wall (I) in-situ (from NNE)

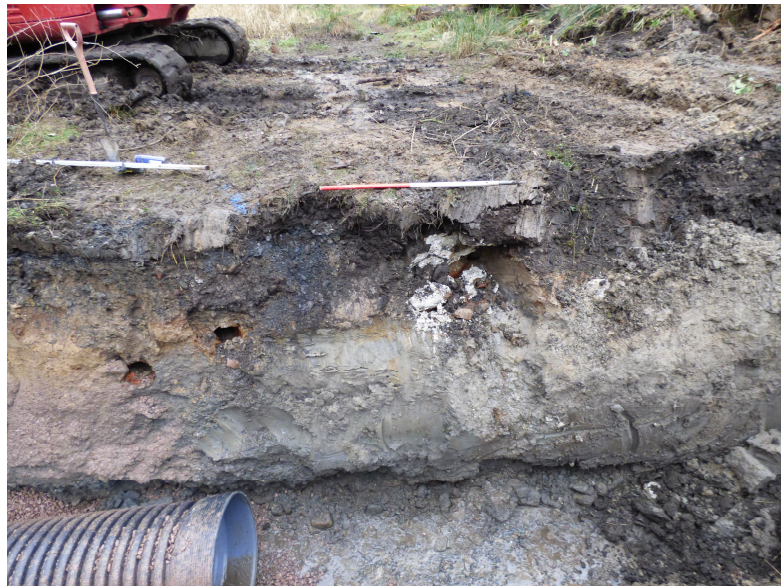
Towards the NNW end of the trench the ground mostly comprised deposit [105] with a grey sandy clay [106] at the very NW end. Within this section a disused cast iron water pipe (200mm in depth) and two clay pipes (water & foul) (600mm / 700mm in depth) were noted. Ephemeral bits of walling (II) [108] (Figures 4 & 8b) and (III) (Figures 4 & 8c) were also observed within this section. Walling (II) [108] measured 0.50m in height and 0.60m in width and walling (III) [109] was located 300mm (approx) below the current ground level.

Figure 8b - remains of ephemeral walling (II) in-situ (from NE)

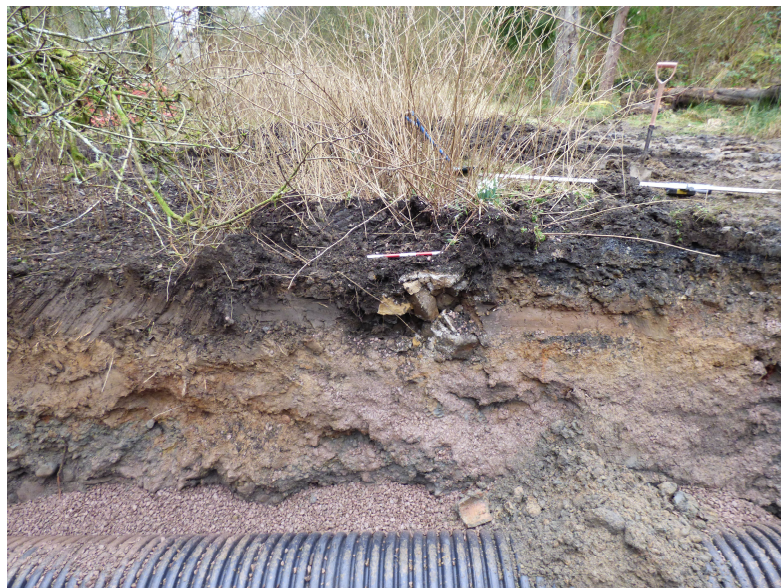
Figure 1 - remains of ephemeral walling (III) in-situ (from NE)

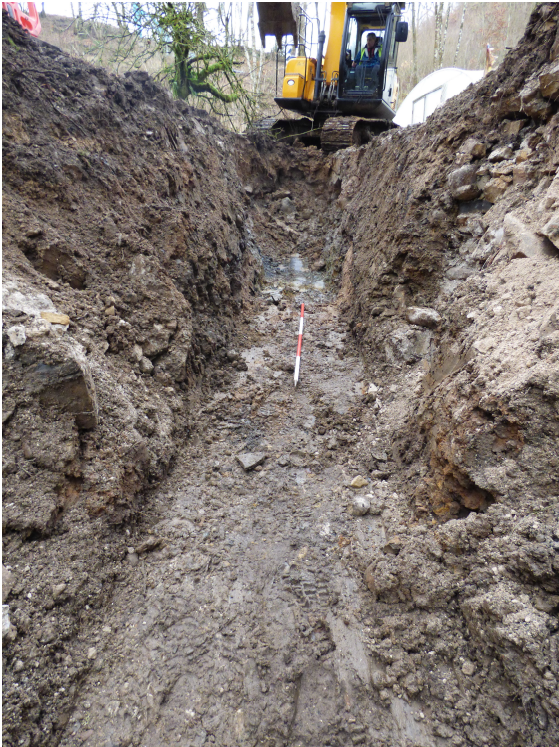
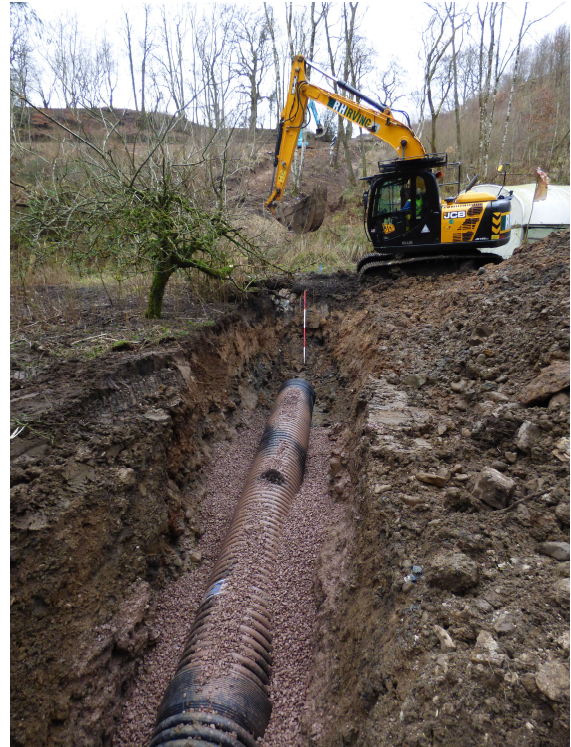
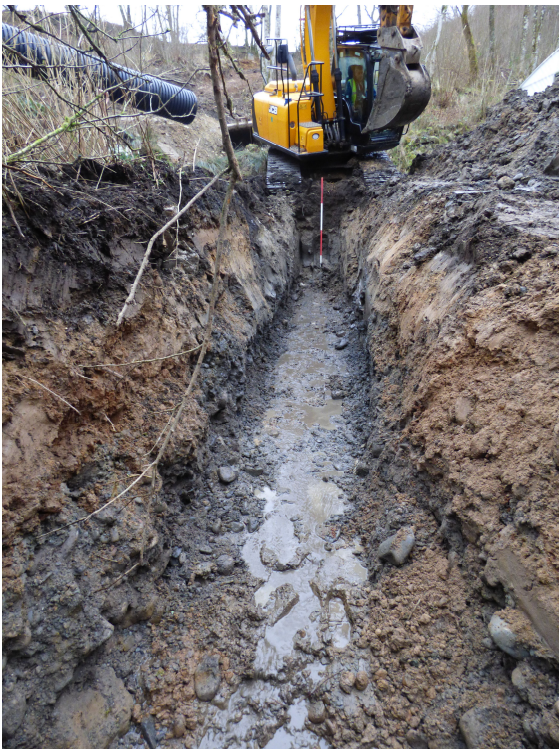
Figure 9a - general of central section of outfall pipe (I) (from SE)

Figure 9b - general of central section of outfall pipe (II) (from SE)

Figure 9c - general of central section of outfall pipe (I) (from SE)

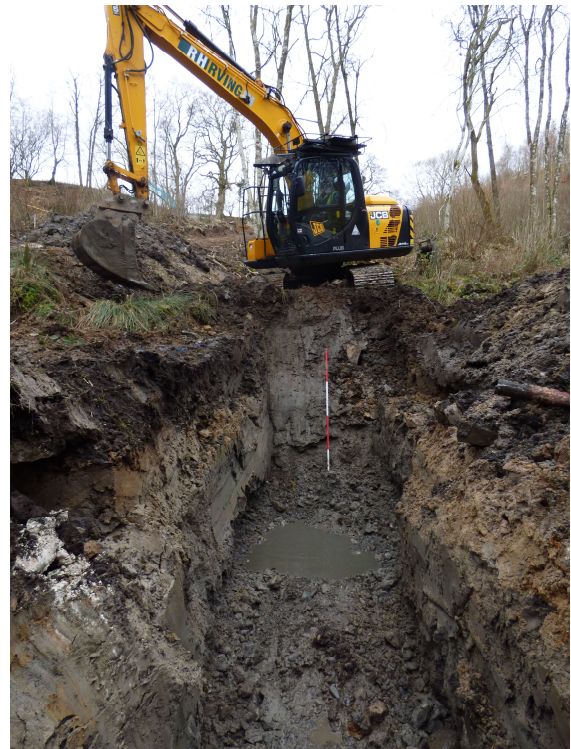
At the end of the monitored area, the topsoil averaged 250mm in depth and was above subsoil [105] which measured between 300mm to 400mm in depth, then natural [106] (Figure 9d).

Figure 9d - NNW end of outfall pipe and manhole 2 (from SE)
