**Old Mill Grain Store, Millburn Street  
Kirkcudbright, Dumfries & Galloway:  
Archaeological Works**

**Data Structure Report  
by Rebecca Shaw  
27<sup>th</sup> October 2019**

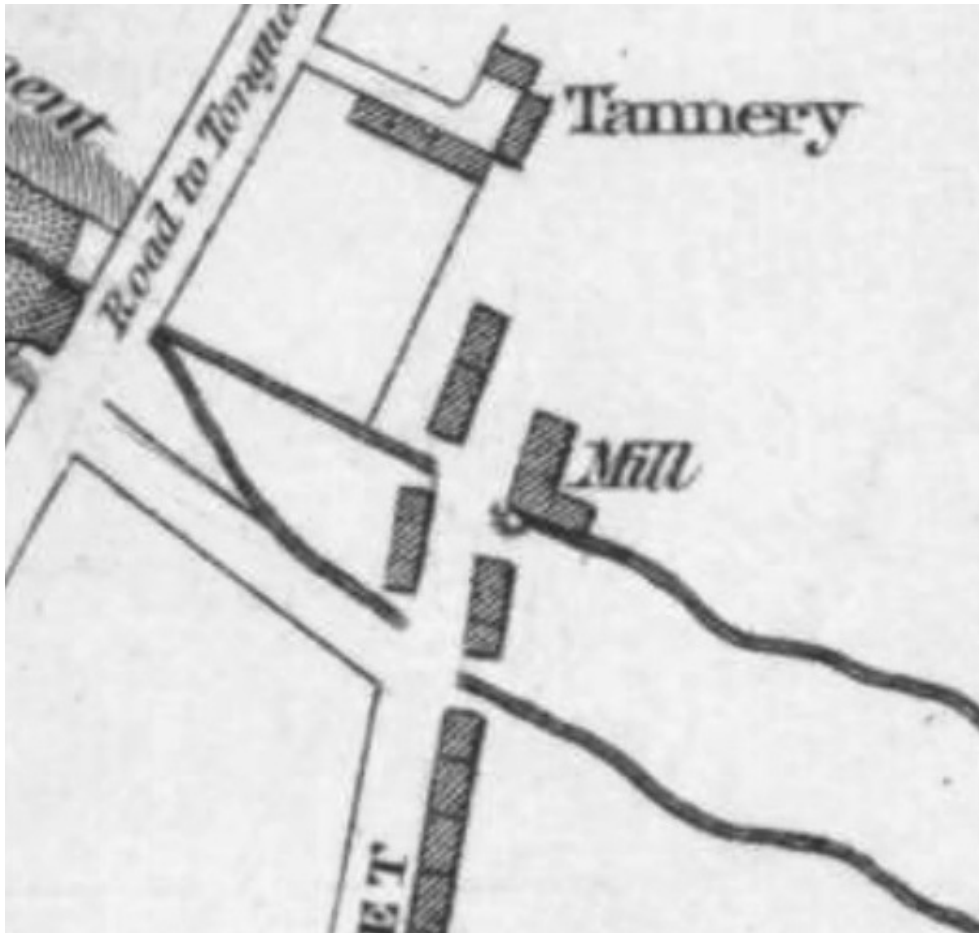
**1832** (Thompson) - the grain store is depicted as a sub-divided rectangular structure, aligned roughly NNE / SSW (with a square shaped compartment in the south and a rectangular shaped compartment in the north). There are no features / structures depicted in the area to the rear - the mill wheel on the adjacent Kirkcudbright Mill is annotated on the map and there are water courses running both the NNE and SSW edges of the proposed planning application area (Figure 4a).

Figure 4a - John Thompson (1832) (c) National Map Library of Scotland

Early cartographic sources indicate there has been a structure in the location of the current old mill grain store since at least 1832 (Figure 4a). This earlier mapping, along with the slightly later map from 1843 (Figure 4b), suggesting that the SSW half of the existing store structure is probably earlier in date than the NNE half, as it is not mapped until the early 1850's (Figure 4c). On this mid 19th century mapping the length of the store structure seems comparable with the current building, although the width appears consistent rather than the NNE half being wider (Figure 2a). However, the detailed 1852 map does indicate that the structure is either two buildings or sub-divided internally - there is a further narrow sub-divided compartment / building attached to the NNE end.

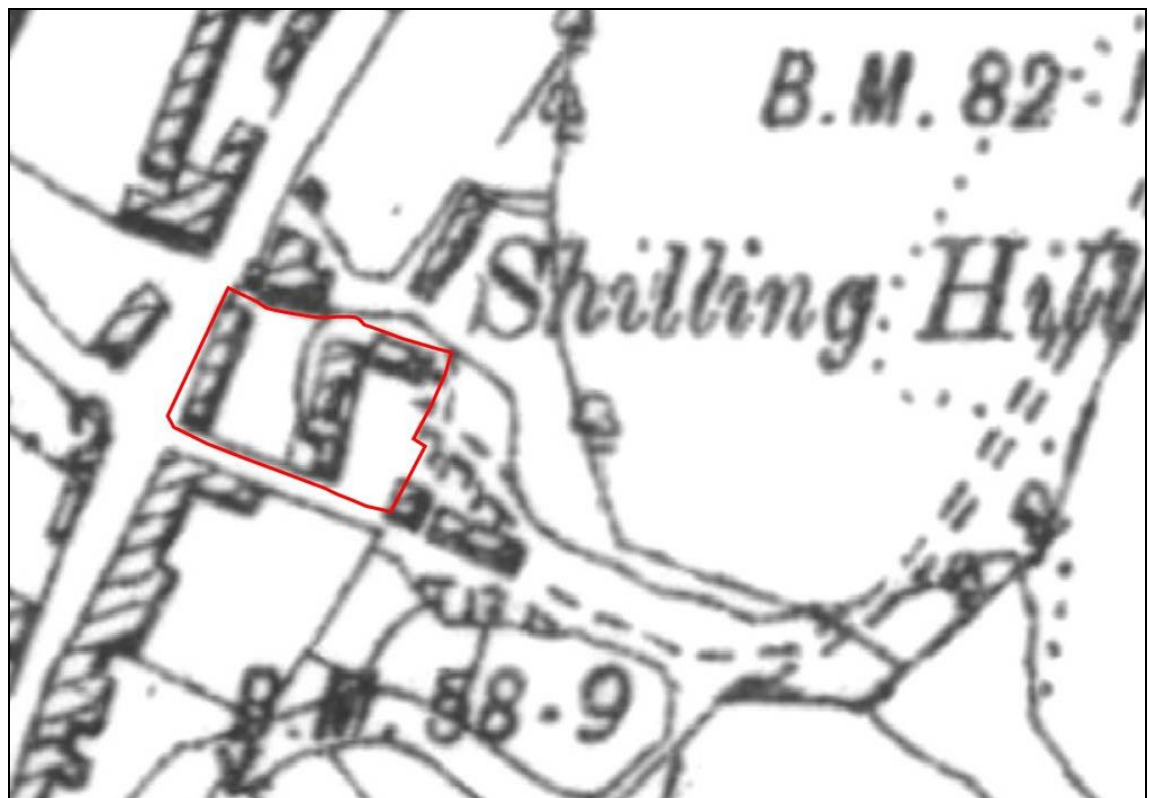
**1895** (Ordnance Survey Map - 2nd Edition) - the grain store is depicted as a long rectangular structure, aligned NNE / SSW. The small sub-divided structure / compartment attached to the NNE end of the building is no longer mapped. Within the area to the rear there are now numerous roofed structures mostly located roughly halfway (and NE corner) - the water course still appears to run into the lade but the burn no longer appears to be mapped (Figure 4d).

Figure 4d – 2nd Edition OS Map 1:2500 (town plan) (1895) © Crown Copyright and Landmark Information Group 2018 – not to be reproduced without permission (883930254)

By the late nineteenth century (Figure 4d) there is little or no change to the structure mapped on the previous edition although the attachment at the NNE end is no longer depicted. By the late 1960's the brick lean to has been added to the NNE end (Figure 4f). Varying numbers of structures are depicted to the rear from 1843 with there being progressively more, until the current Ordnance Survey map, where there are none (Figure 2a).

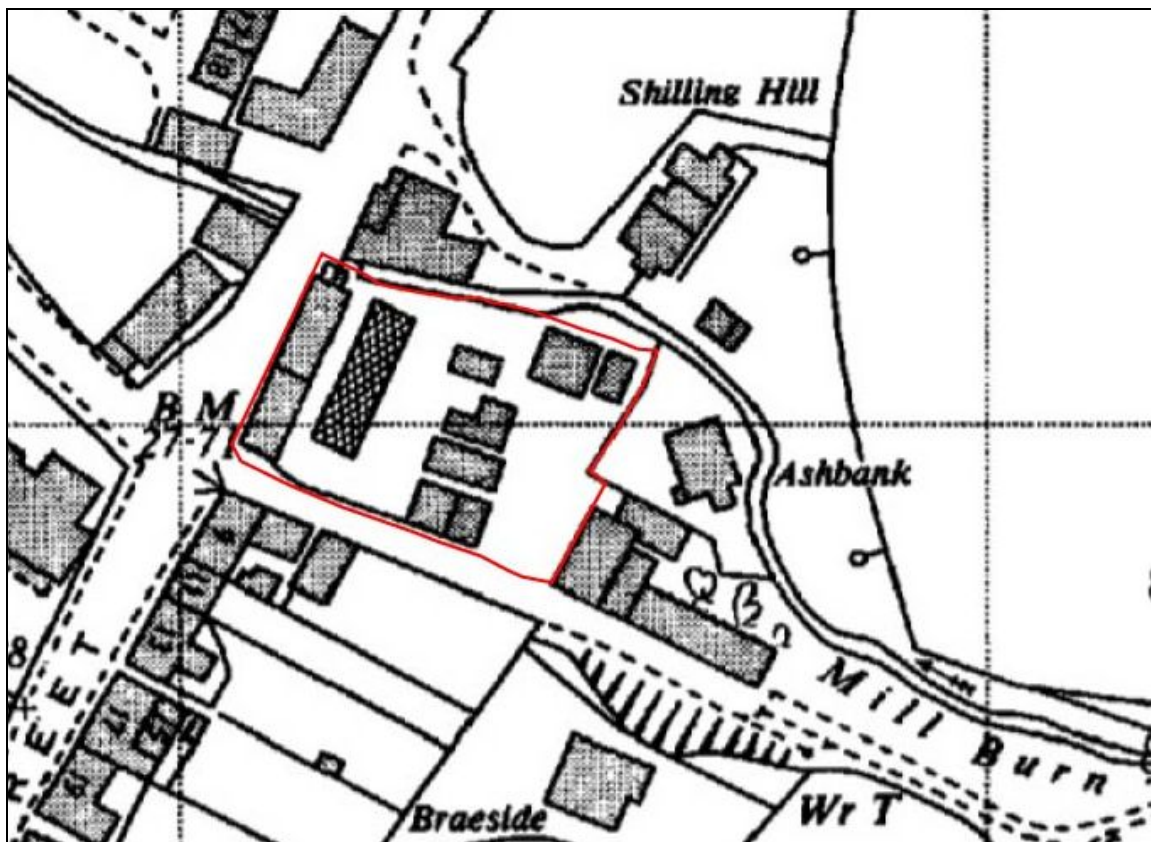
**1967** (Ordnance Survey Map) - the grain store is depicted as a long rectangular sub-divided structure, aligned NNE / SSW - a small building has been attached to the NNE end (Figure 4f). Within the area to the rear there are still numerous structures (halfway and NE corner) and a new long rectangular structure has been constructed in the WNW half (Figure 4f). The water course is no longer mapped.

Figure 4f – OS Map, Kirkcudbright 1: 2500 (1967) © Crown Copyright and Landmark Information Group 2018 – not to be reproduced without permission (883930254)

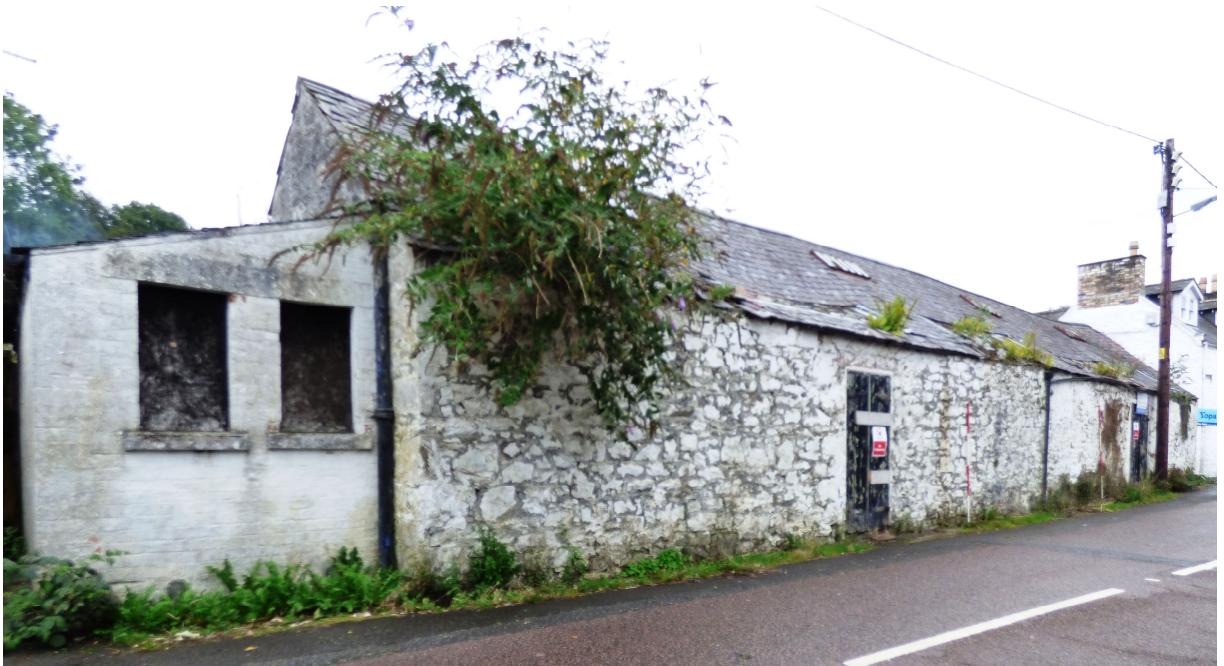
The current store comprised a very long mainly stone built rectangular structure, aligned NNE / SSW with a pitched slate roof and a later brick lean-to / attachment at the NNE end (Figures 5a; 6b and 8a-c).

Figure 5a – WNW (front) elevation (from NW)

The entrances that are visible in both the NNE and SSW halves of the WNW (front) elevation (Figures 5a-c), like the mapping, also suggest two possible buildings or at least two compartments. The upper section of the SSW half of the ESE (rear) elevation is brickwork, (possibly of more than one phase) and the lower half stone (Figure 7 & 13c). This difference is also noticeable within the interior (Figures 10b & 12) although the wall within the interior appears much higher (2m approx) than the stone wall that is visible at the rear. The slope at the back may account for this difference. A possible theory is that when the building was extended to the SSW (between 1832 - Figure 4a and 1843 - Figure 4b) it was also heightened. Prior to being heightened the building was probably a thatched low rubble structure. The adding of a new gable to the SSW would negate any visible heightening at this end (Figure 9a).

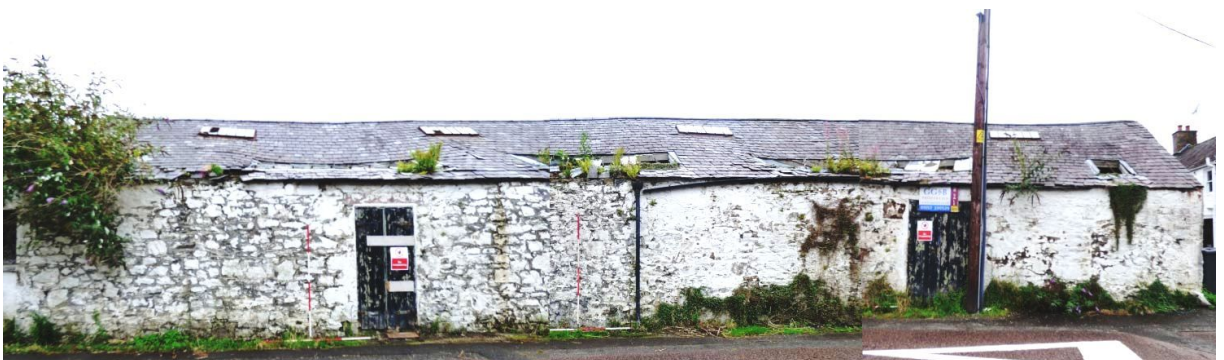
The WNW (front) elevation comprised two fairly large entrances (one in the NNE half and one in the SSW half) (Figure 5b). Towards the SSW end there is a very slight line (Figure 5c), possibly from an abutment when the building was extended. In the SSW half of the ESE (rear) elevation the lower section of walling was stone built while the upper section was entirely brick built (Figures 7 & 13c). Visible at the rear it was noted that the NNE half of the structure was slightly wider than the SSW half (Figure 13a). At the point where the NNE half became wider there was what appeared to be a half height buttress with a corner stone at its base (Figure 13b). However, the corner above this buttress looks to have been rebuilt as some point as there are bricks within it (Figures 13a-b).

Two rows of rooflights visible on both pitches: one row located close to the ridge and one located at the base of the pitch (Figures 5b; 6b & 7).

Figure 5b - WNW (front) elevation (from WNW)

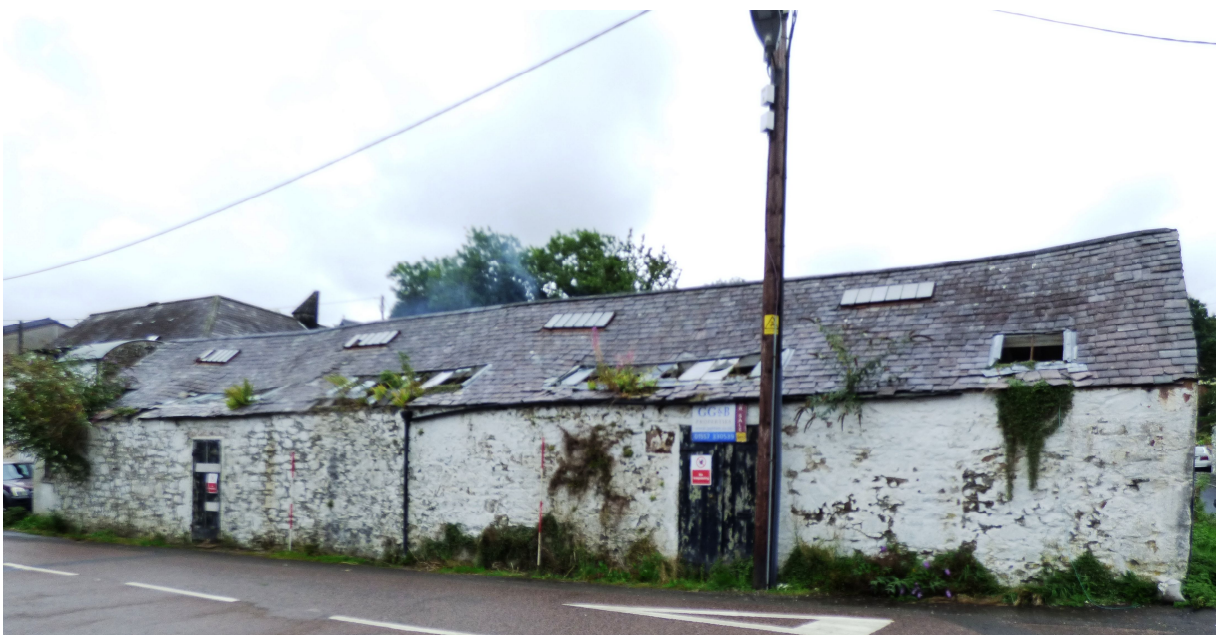
Figure 5c - WNW (front) elevation (from SW)

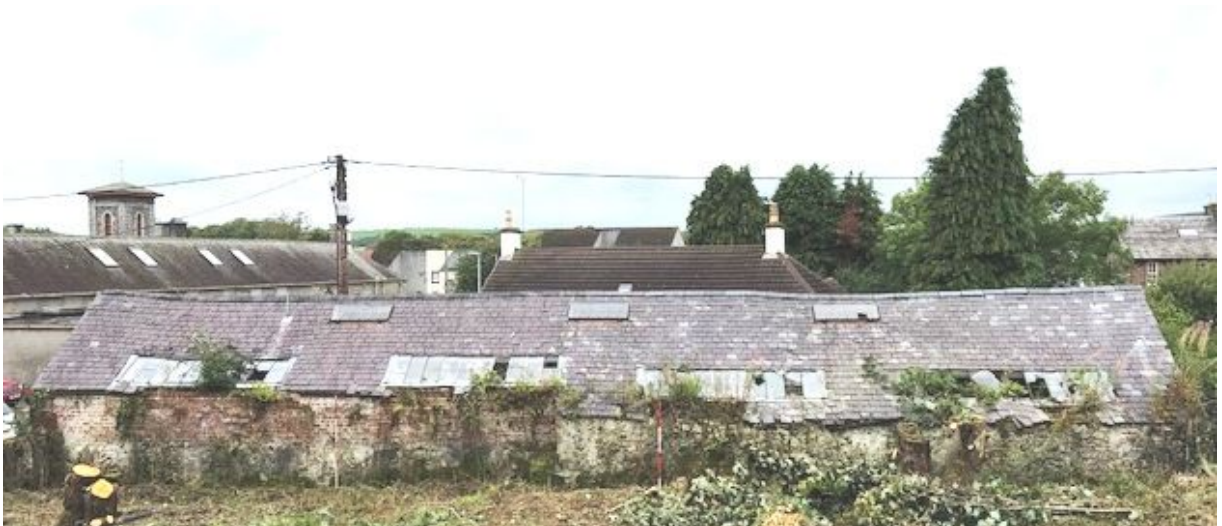
Figure 6b - ESE (rear) elevation (from ESE)

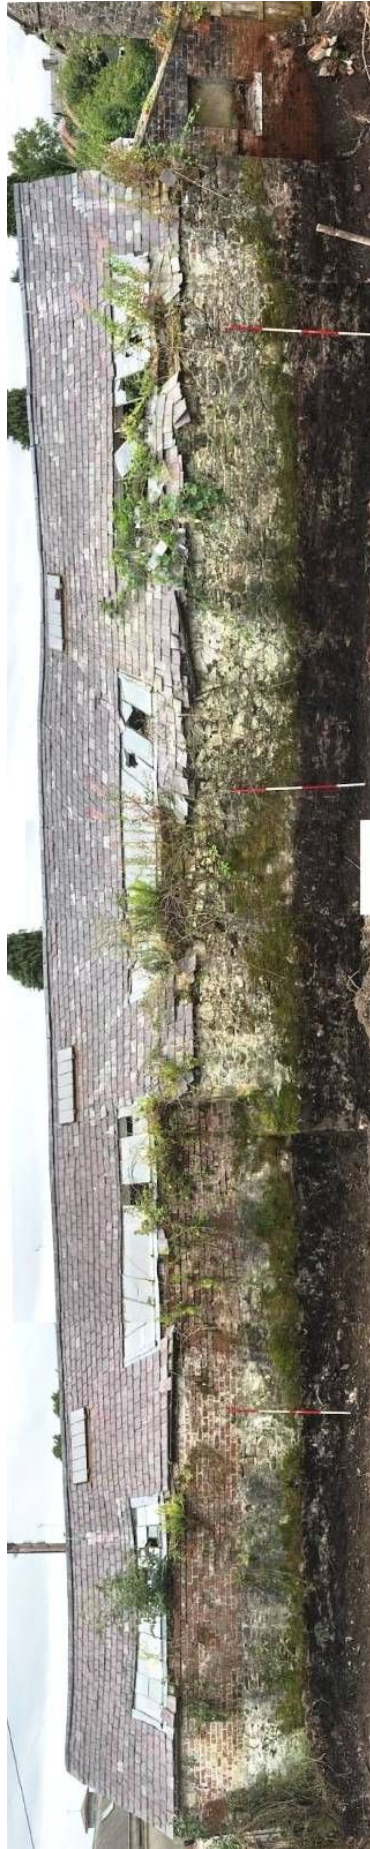
Figure 7 - ESE (rear) elevation (from ESE)

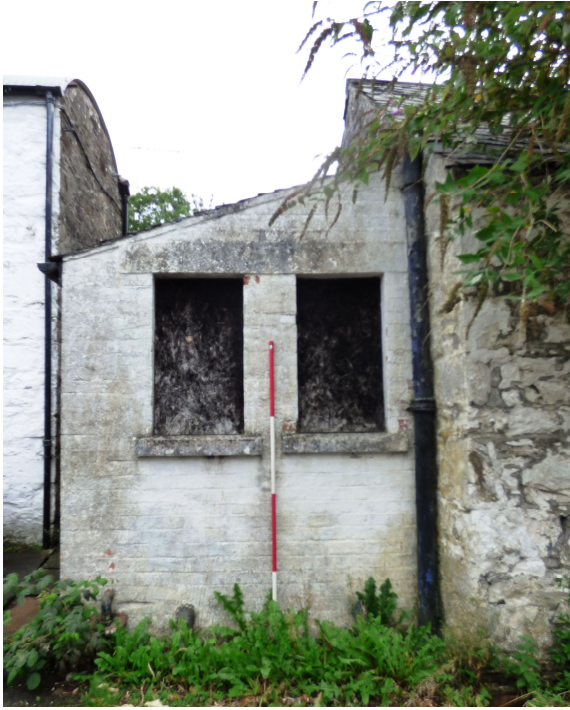
Figure 8a - WNW (front) elevation of brick lean-to (from WNW)

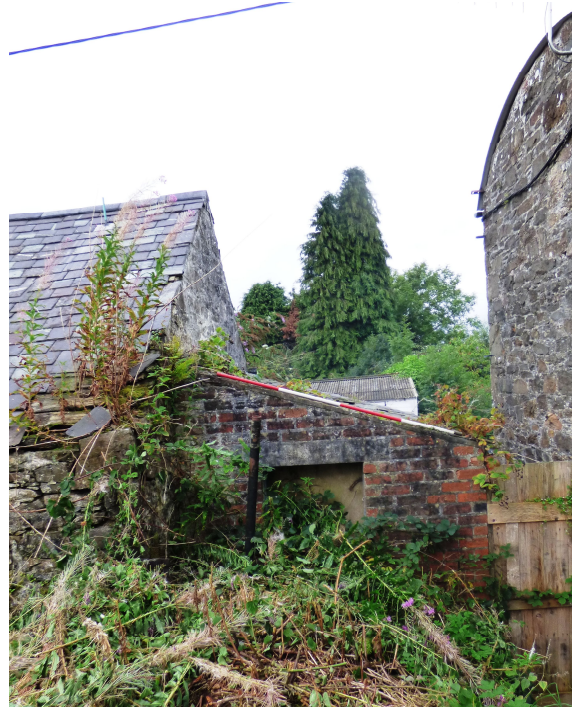
Figure 8b - ESE (rear) elevation of brick lean-to (from ESE)

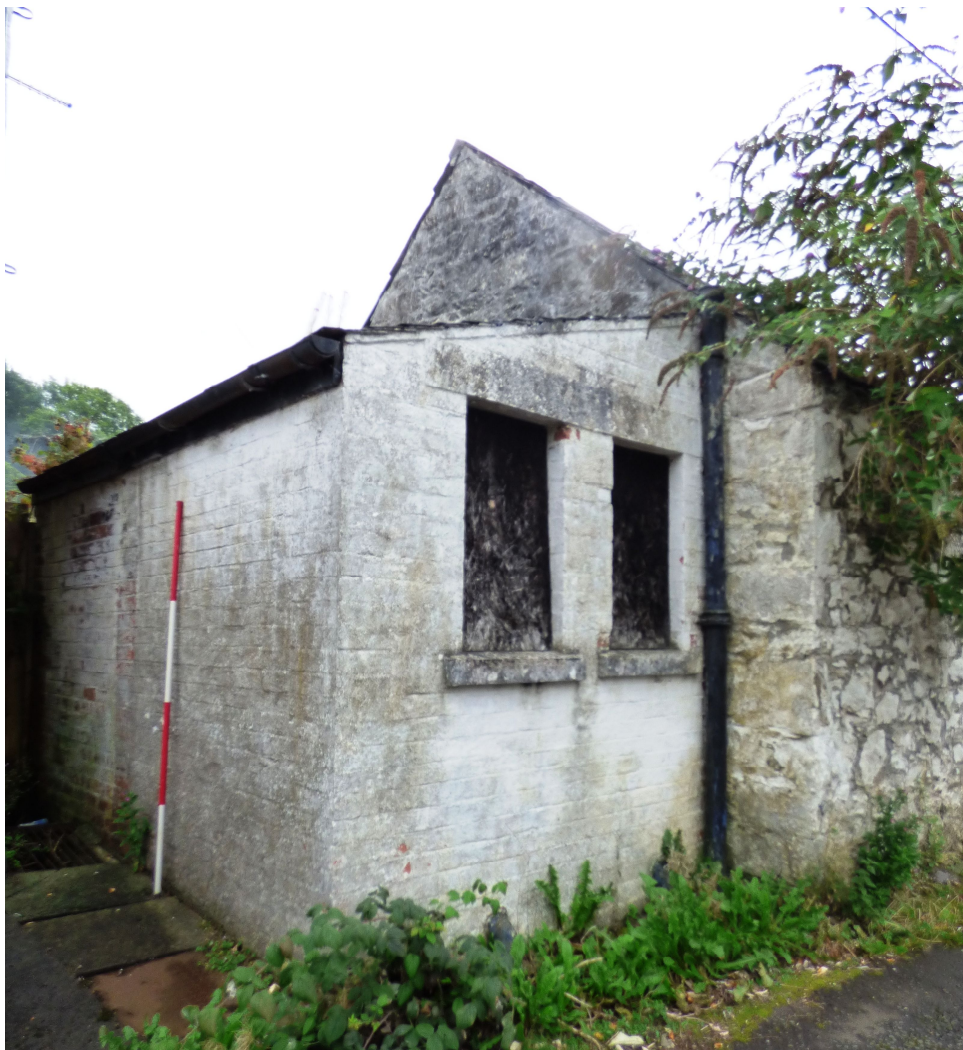
Figure 8c - NNE wall of brick lean-to & part of NNE gable of grain store (from NW)

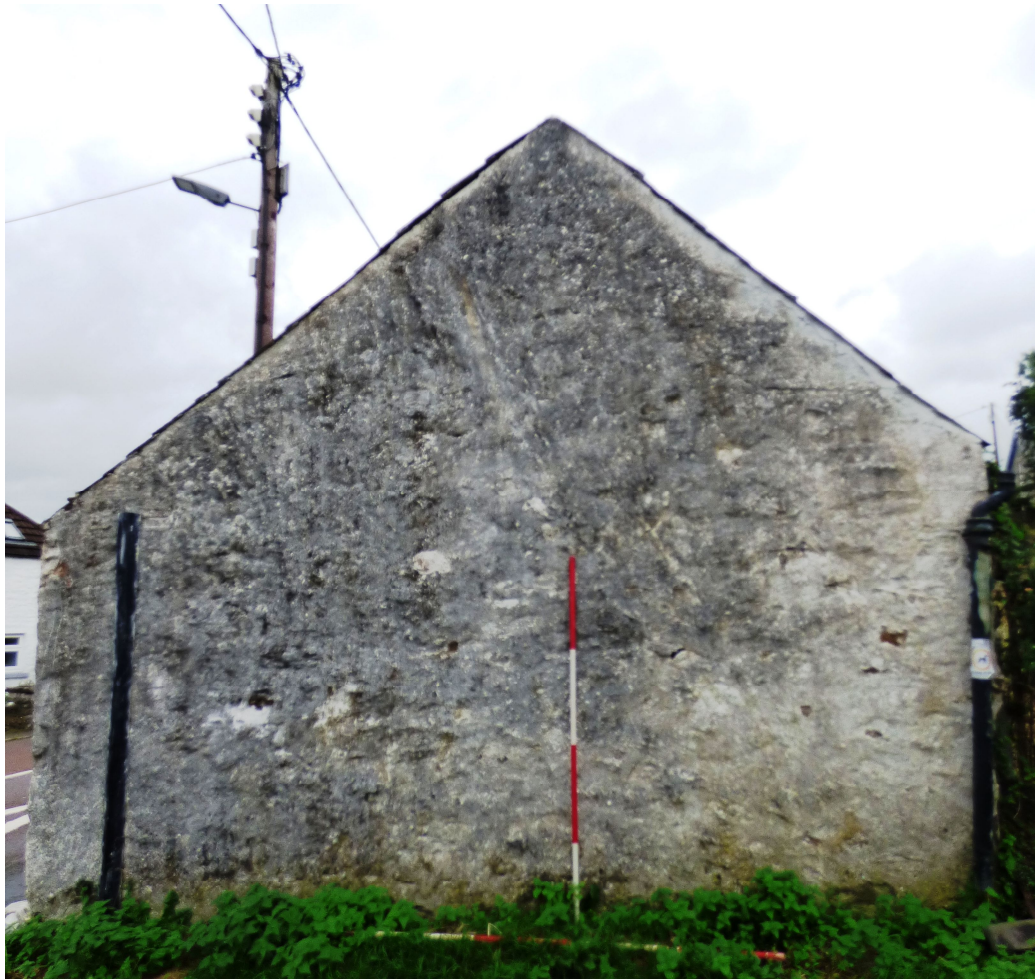
Figure 9a – SSW gable (from SSW)

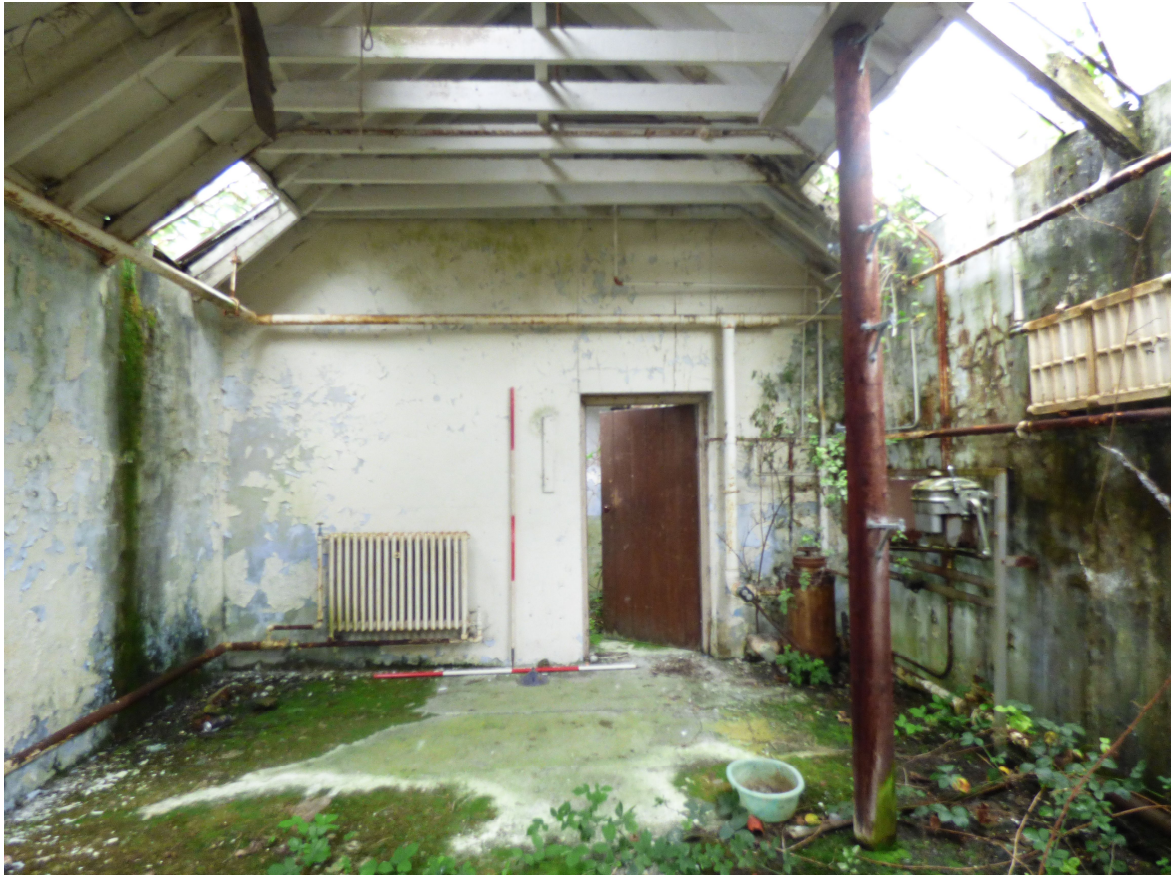
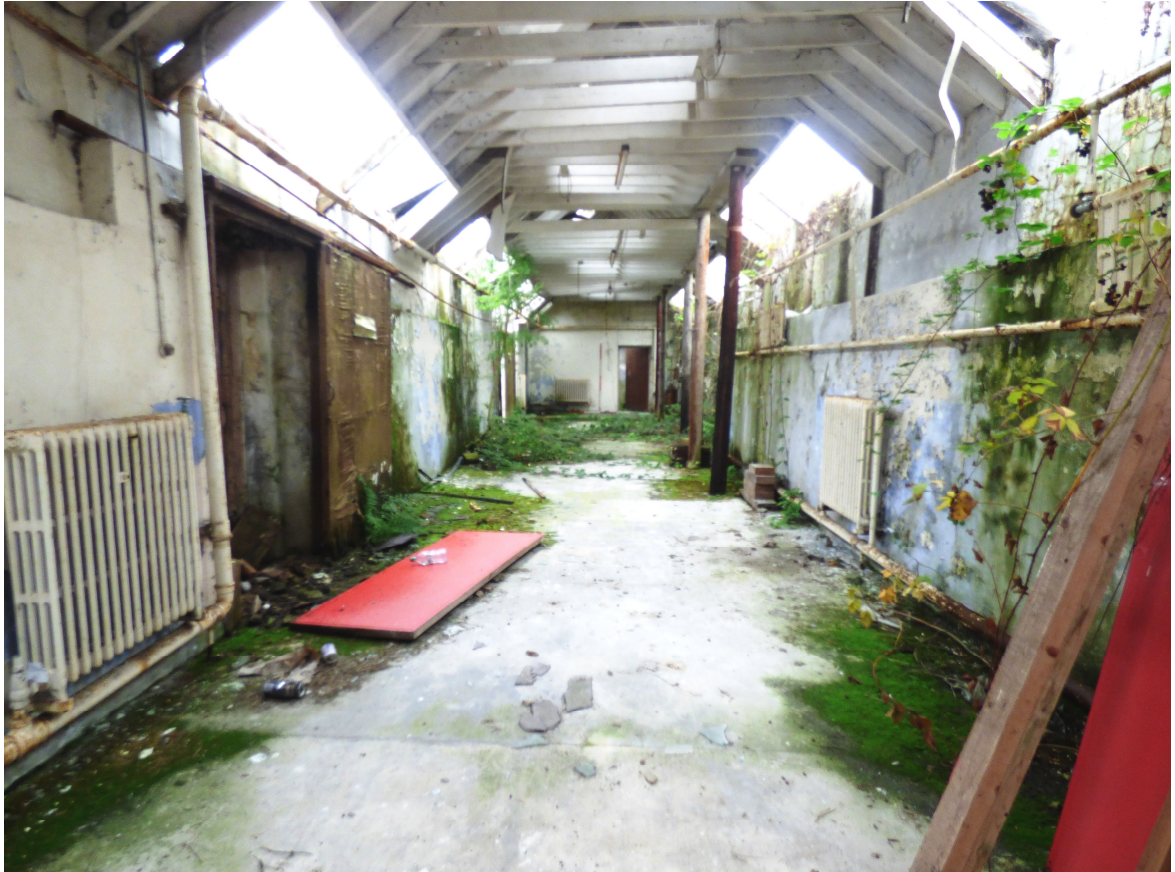
The interior of the building had been entirely modernised by later uses and comprised a concrete floor with plastered walls and wall mounted radiators (Figures 10a-b & 11a-b). The roof is shored with steel props (Figures 10a-b & 11a-b).

Figure 10a - NNE gable (interior) (from SSW)

Figure 10b – general of interior from SSW

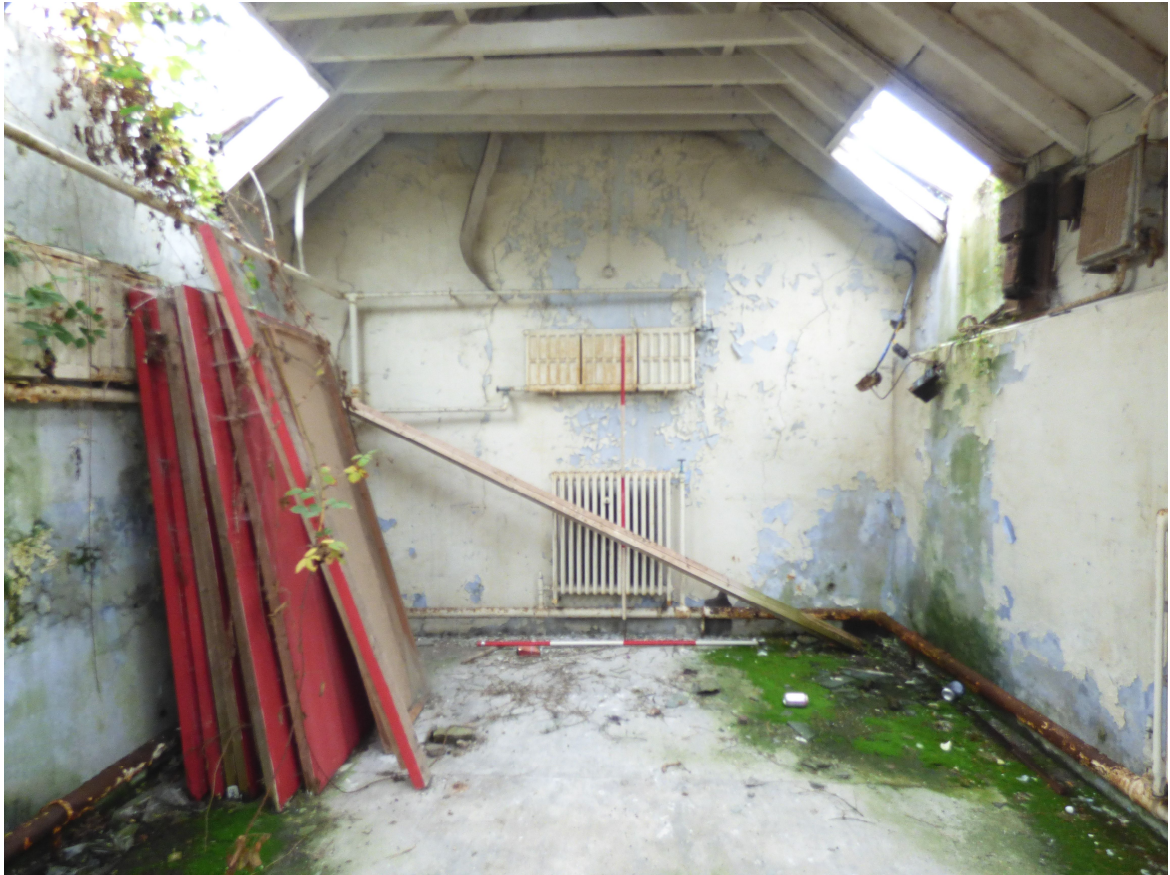
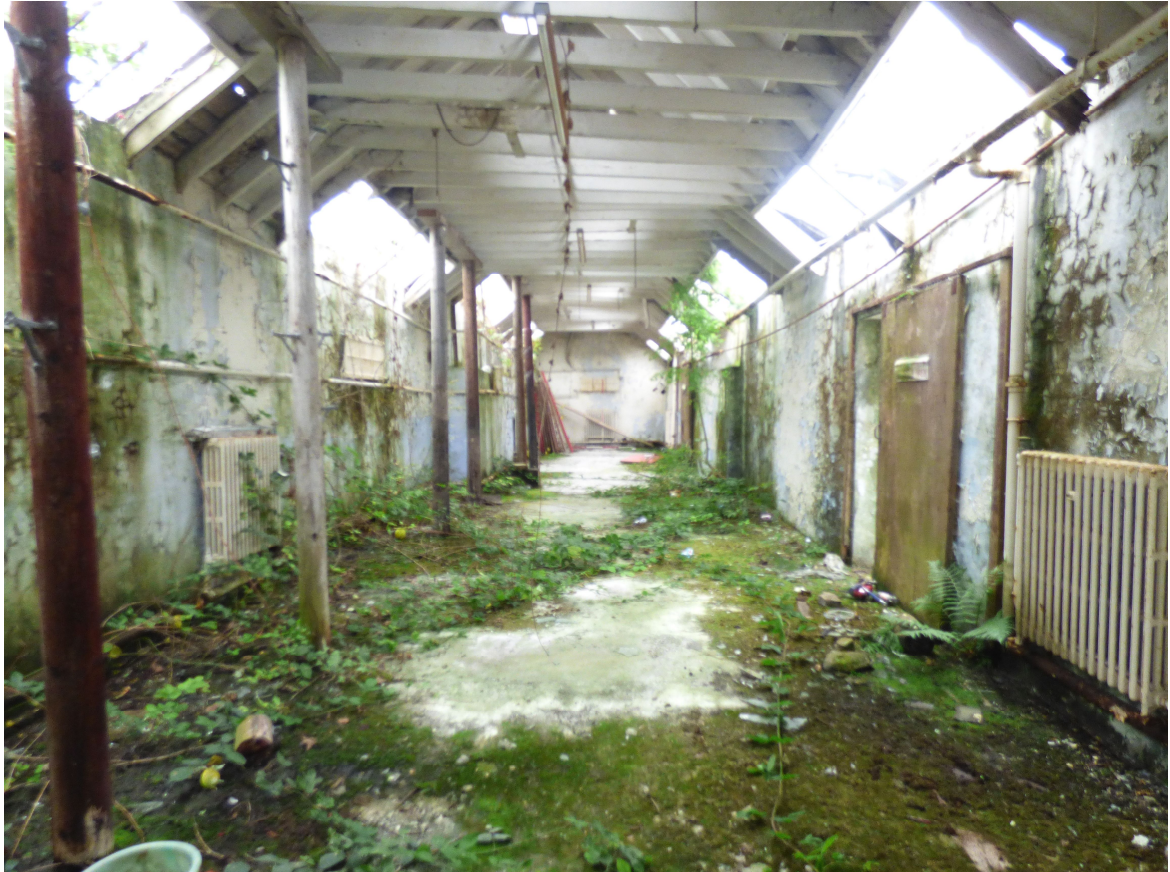
Figure 11a – SSW gable (interior) (from NNE)

Figure 11b – general of interior from NNE

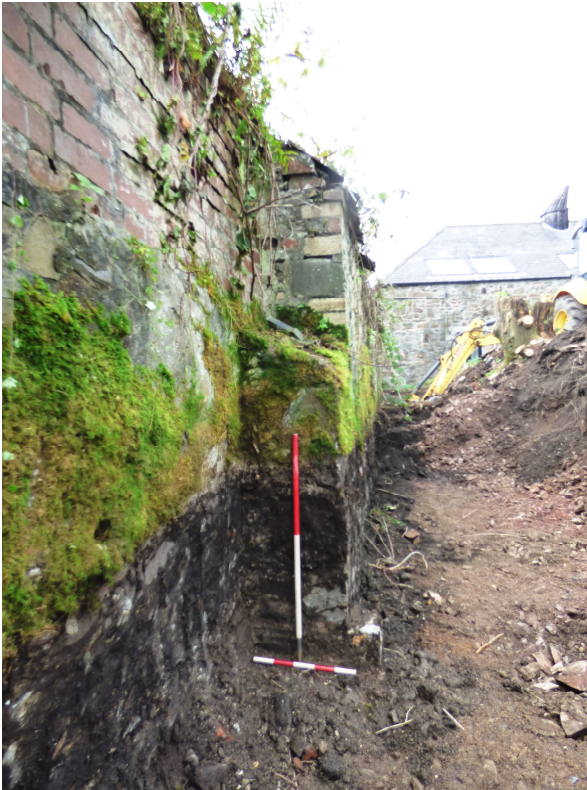
In the SSW half the construction trench averaged 0.70m in width and the infill comprised a dirty greyish brown gritty silt containing fragments of sandstone & stones [104] the subsoil mostly comprised orangey brown gravels & sub-angular stones [105] (Figure 13a & 13c).

Figure 13a - corner stone / buttress in ESE (rear) elevation (from S)

The ground reduction works suggested that towards the NNE end the natural subsoil had been excavated out to allow the construction of the NNE half of the building - this was observable in how steeply the ground sloped upwards immediately adjacent to the construction trench (Figures 13a & 13d).

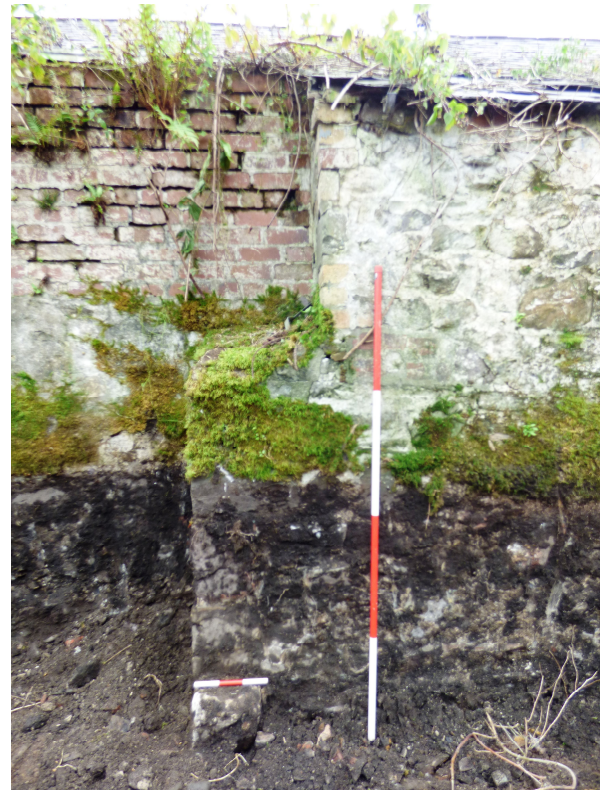
Figure 13b - corner stone / buttress in ESE (rear) elevation (from ESE)

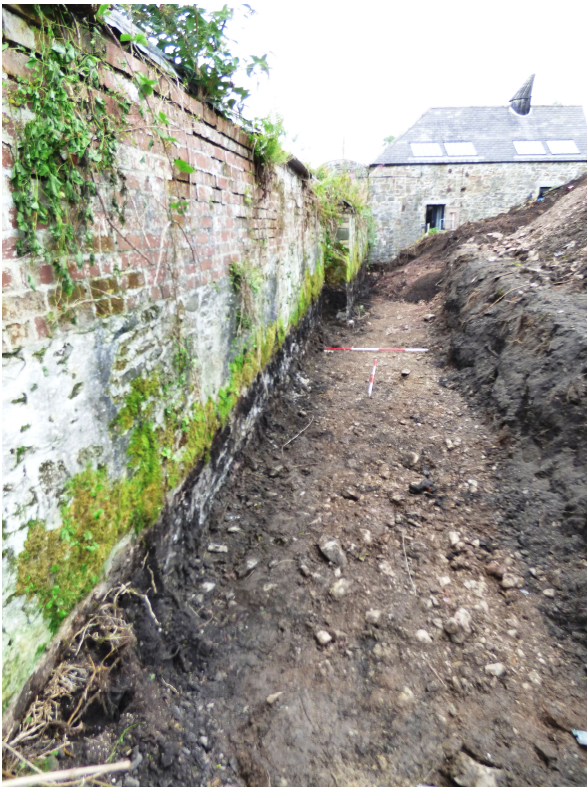
Ground reduction works that were undertaken immediately adjacent to the rear elevation of the existing structure (store) (Figure 14) measured 2.9m at the NNE end and 2.8m at the SSW end and measured 25m in length (approx) (Figures 13c-d). In the area immediately adjacent to the existing structure were the remains of the original construction trench.

Figure 13c - excavated area adjacent to rear elevation (from SSW)

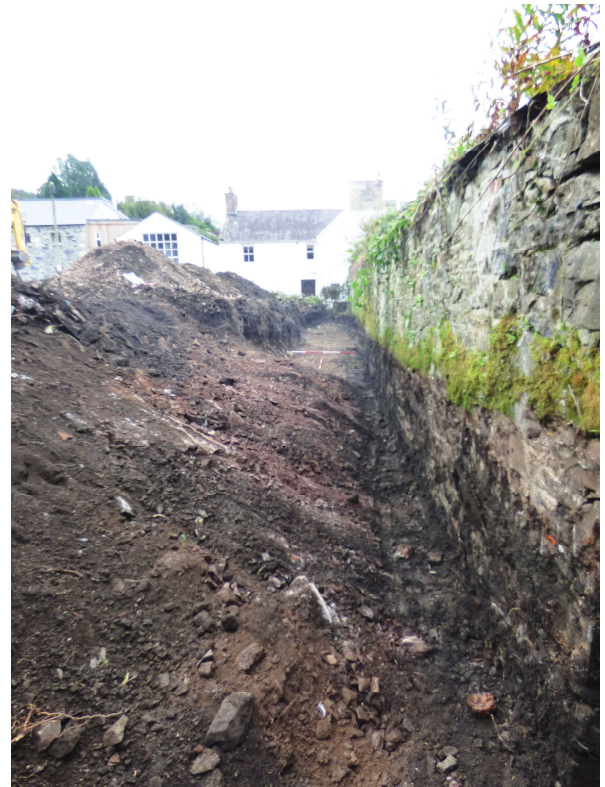
In the NNE half the construction trench averaged 0.50m in width and the infill comprised blackish brown fairly fine silt (200mm in depth) [102] containing a moderate amount of small stones, the subsoil mostly comprised reddish pink shattered rock & rock [103] - the subsoil rises sharply to the ESE (Figure 13d).

Figure 13d - excavated area adjacent to rear elevation (from NNE)
