## Rebecca Shaw Archaeological Services

### Former Workers Club, St John Street, Stranraer, Wigtownshire, Dumfries & Galloway: Archaeological Monitoring Works

by Rebecca Shaw  
15<sup>th</sup> April 2019

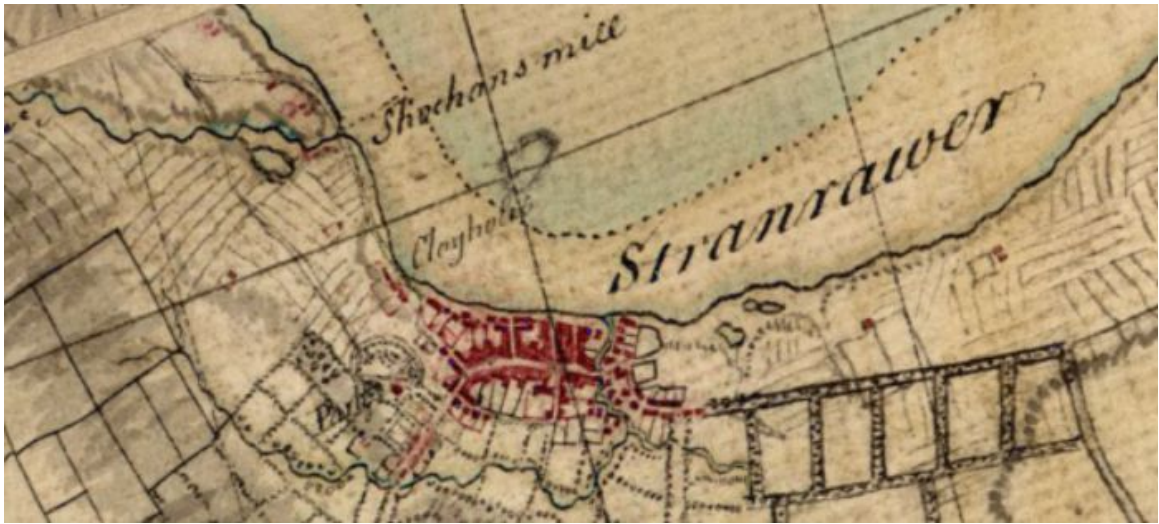
Figure 3a - Roys Military Survey Map of Scotland (1747-55)

Early sound cartographic sources indicate that there has been probably been structures on the site of the Formers Workers Club on St Johns Street since at least the mid eighteenth century (Figure 3a). Detailed sound mapping dating to the mid nineteenth century depicts structures fronting onto both St John Street and St Andrews Street (Figures 3b-c). There is a slight extension / protrusion to the rear of the St Johns Street frontage but apart from that the areas to the rear of the frontages appear undeveloped and are most likely still in use as backlands / gardens. By the late nineteenth century structures still front onto both St Johns Street and St Andrews Street but structures now also exist at the far end of the St Johns Street plot (Figures 3d-e).

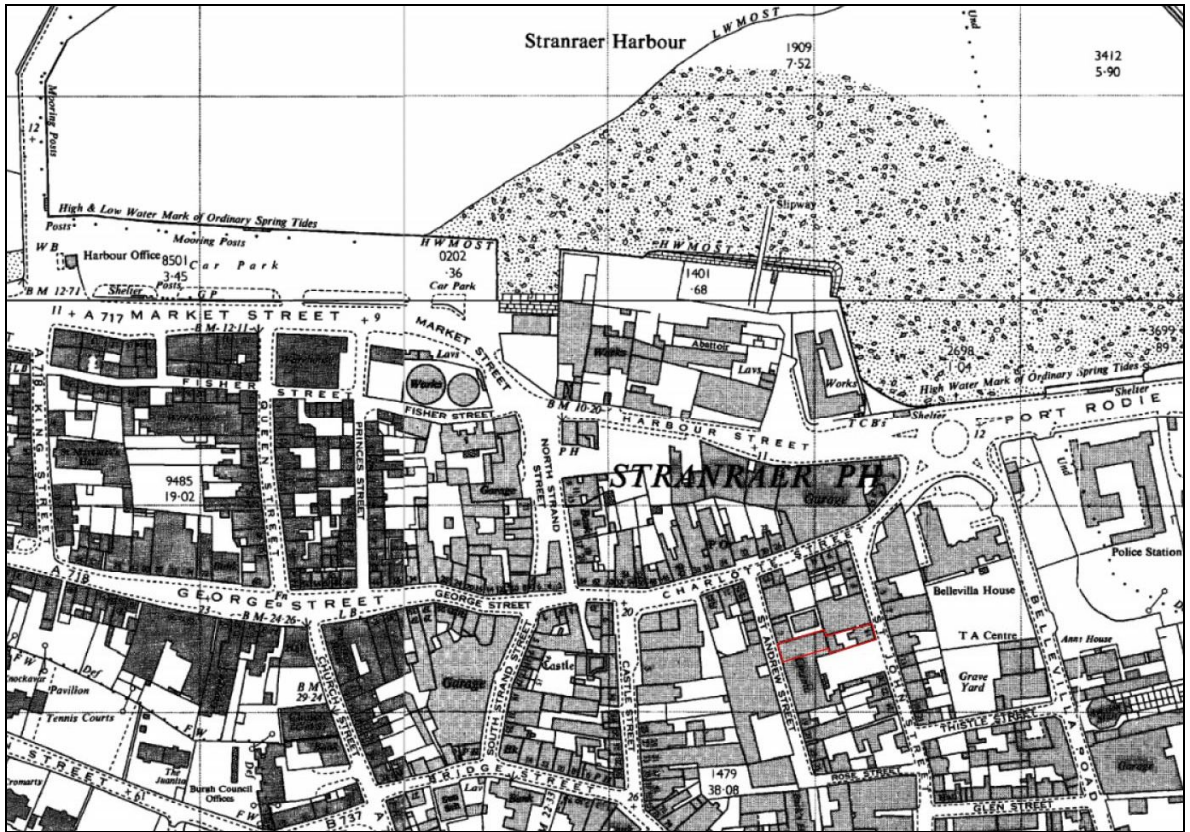
Figure 3f - Ordnance Survey Map 1:2500 (1965) © Crown Copyright and Landmark Information Group – not to be reproduced without permission (86384374)

By the mid 1960's the structures within the St Johns Street plot have been extended / altered which has left very little open space between the two and the entire St Andrews Street plot is now developed into one large building (Former Workers Club / Empire Kinema) (Figures 3f-g).

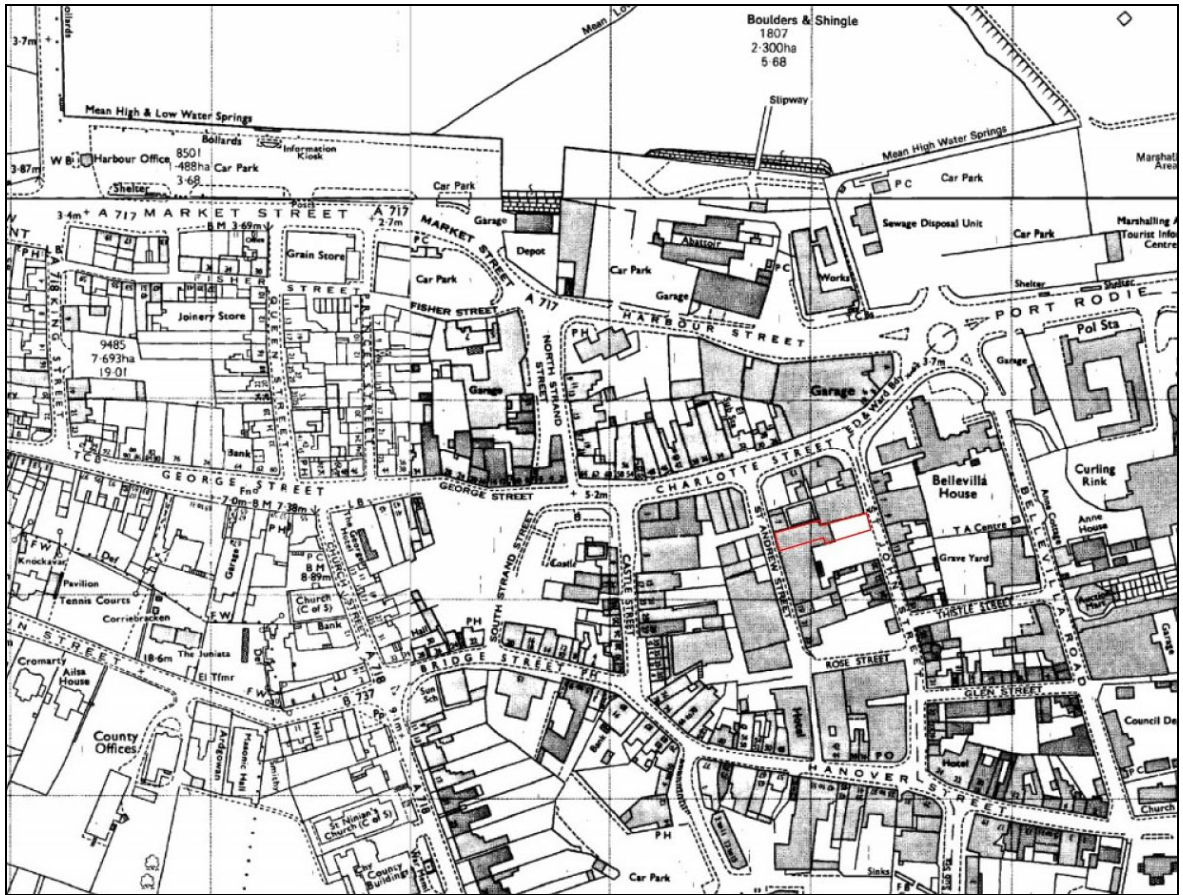
Figure 3h - Ordnance Survey Map 1:2500 (1974-86) © Crown Copyright and Landmark Information Group – not to be reproduced without permission (86384374)

By the mid 1970's / mid 80's mapping there is little or no change to the St Andrews Street plot, while the majority of the St Andrews Street plot is empty with structures only mapped at the rear (WSW end) (Figures 3h-i).

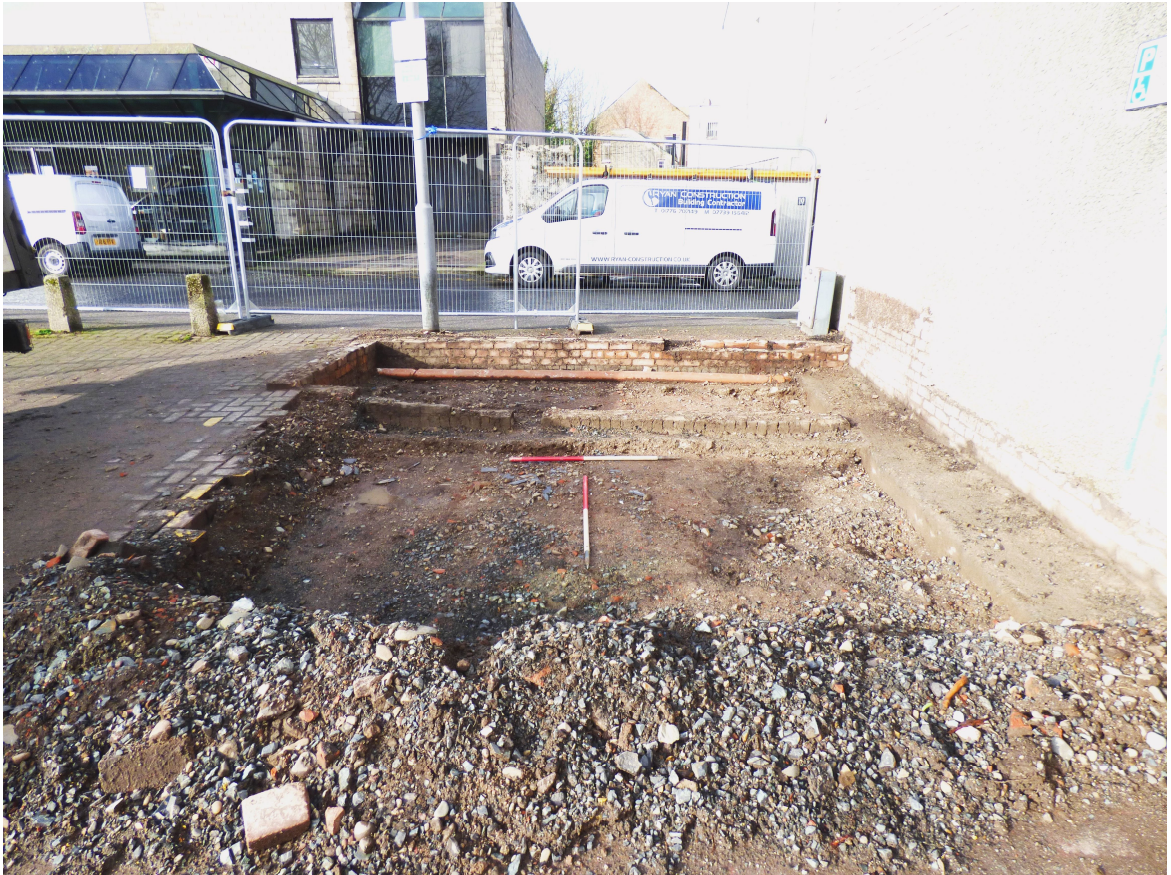
The upper concrete sets were removed from this area prior to the attendance of the archaeologist on-site (Figure 4a & 7). The opened area measured 4.55m x 3.55m (approx). Below the concrete sets was an infill / levelling deposit [107] comprising sand (coarse); gravel; small stones and brick & tile fragments - this deposit was excavated for a depth 300mm (approx) but was not bottomed.

The archaeological monitoring works for the proposed extension (B) (Figures 2 & 7) mainly indicated disturbed ground (Figures 4a) which is consistent with the large cinema structure that previously stood there. No great depth was excavated as existing finds were uncovered that could be utilised for the new extension.

Figure 4a – area (B) (from ENE)

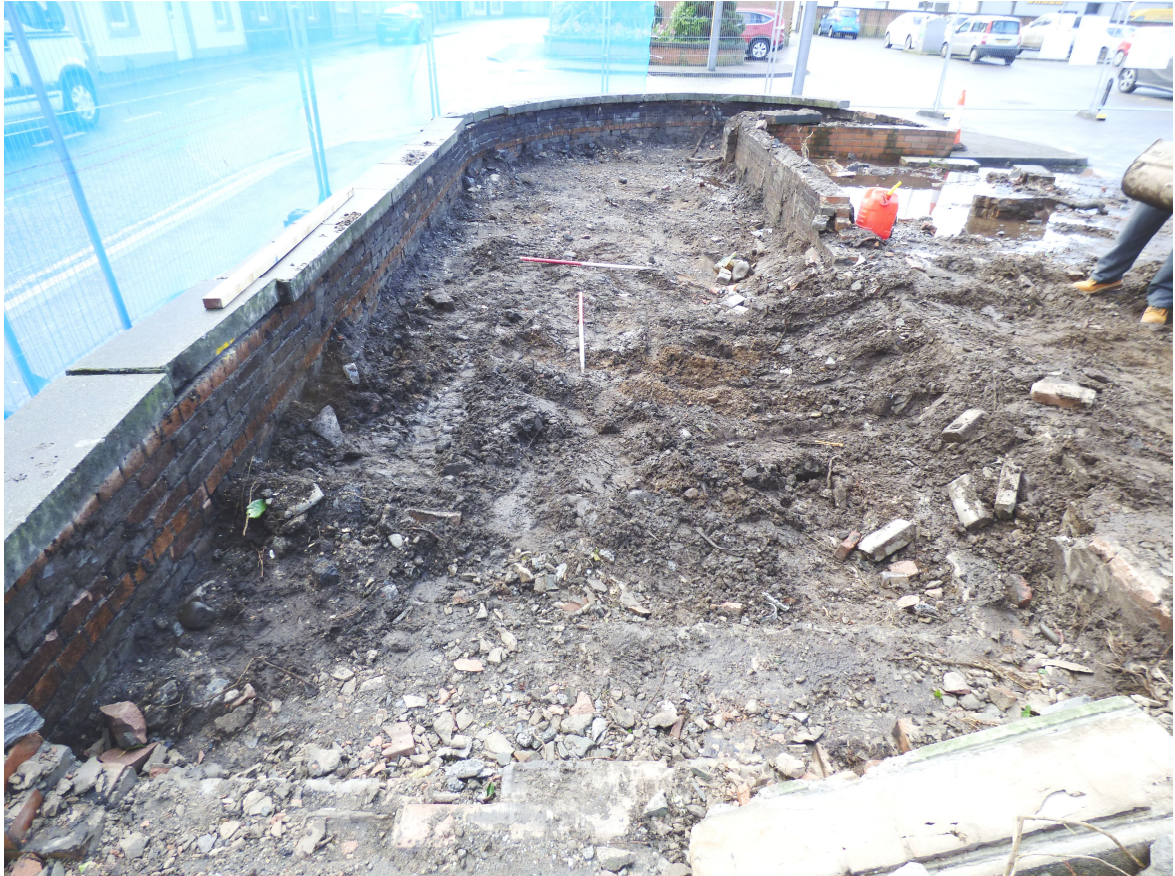
In total three foundation trenches were exacted in area (A) (Figures 4b & 7). Foundation trench A measured 3.1m x 0.9m and was excavated to a total depth of 900mm (Figures 5b-c). The upper fill comprised a mid brown gritty silt containing frequent stones [101] which averaged 300mm (approx) in depth. Deposit [101] was above a brown beach sand [102]. A plastic pipe / duct (for 2 cables) was observed within this trench - there was 200mm of concrete above the pipe. Existing walls with concrete founds were located at both the WSW and ENE ends of this trench.

Figure 4b - area (A) (from NNW)

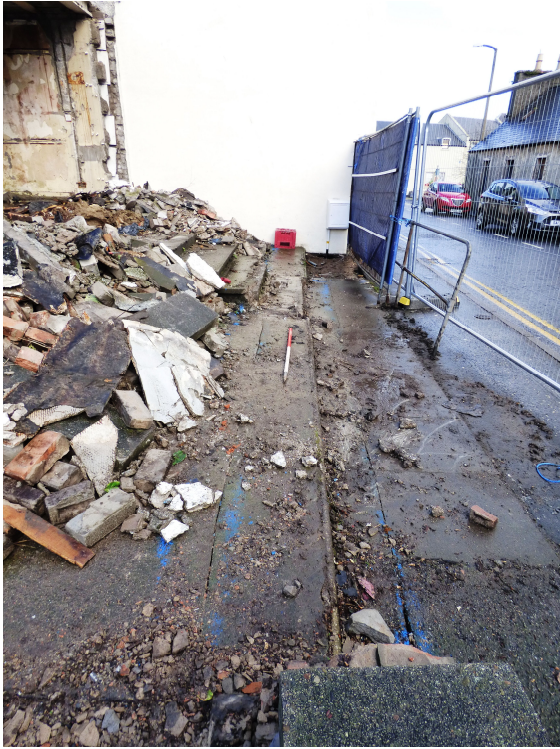
Figure 5a - pre-ex of foundation trench A (from SSE)

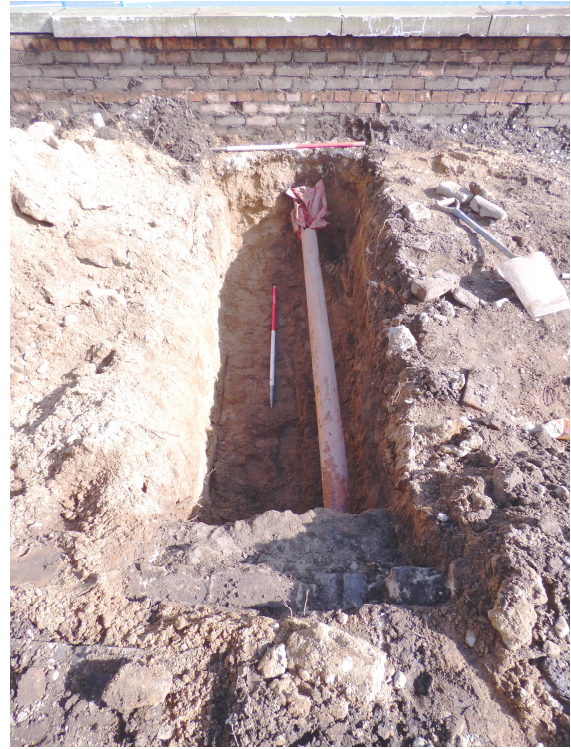
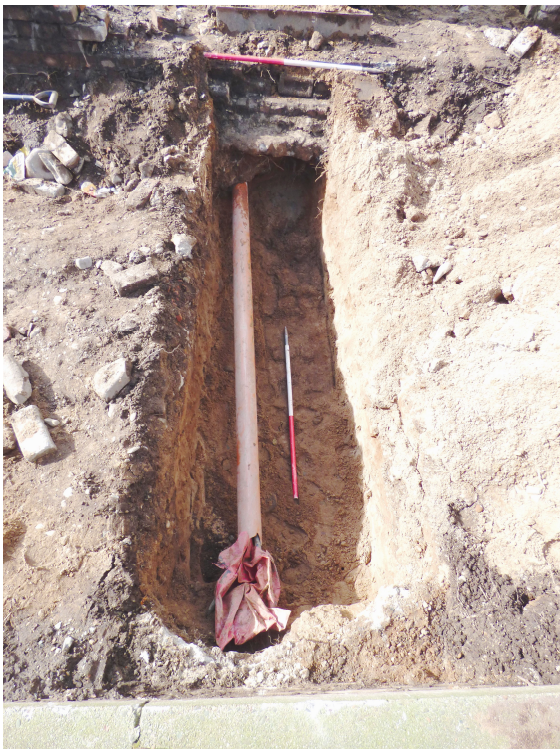
The archaeological monitoring works for proposed extension (A) (Figures 2 & 7) essentially indicated that that this area had been previously cleared down to the natural sandy subsoil, (Figures 5b-d) probably when the structures that previously fronted onto St Johns Street were cleared. At the NNW end of trench B the foundation stones of the gable of the adjacent building were noted (Figure 6a) while the extent of the width of trench C contained large stones (Figure 6b) which also appeared to be foundation stones. In general the foundation stones in trench C appeared more stable than those located at the NNW end of trench B (set mortar rather than sandy mortar) and it is possible the foundation stones in trench C are slightly later in date.

Figure 5b - post-ex of foundation trench A (from WSW)

Figure 5c - post-ex of foundation trench A (from ENE)

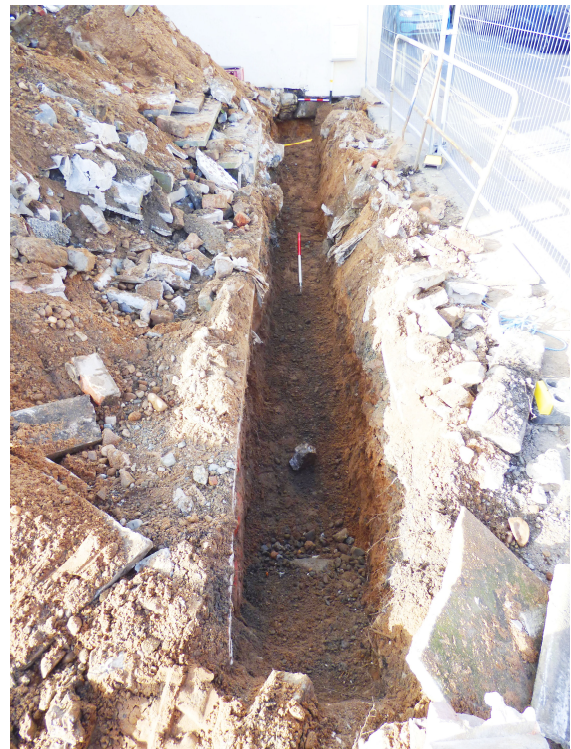
Foundation trench B measured 8.2m x 0.5m and was excavated to a total depth of 800mm

(Figure 5d). The upper surface comprised concrete with bedding [103] above a fairly fine orange sand [104] below which was a dark brown sands & gravels [105]. The remains of a red brick wall was observed in the WSW section of this trench and large rounded foundation stones for the existing (large) wall were uncovered at the NNW end (Figure 6a).

Figure 5d - post-ex of foundation trench B (from SSE)

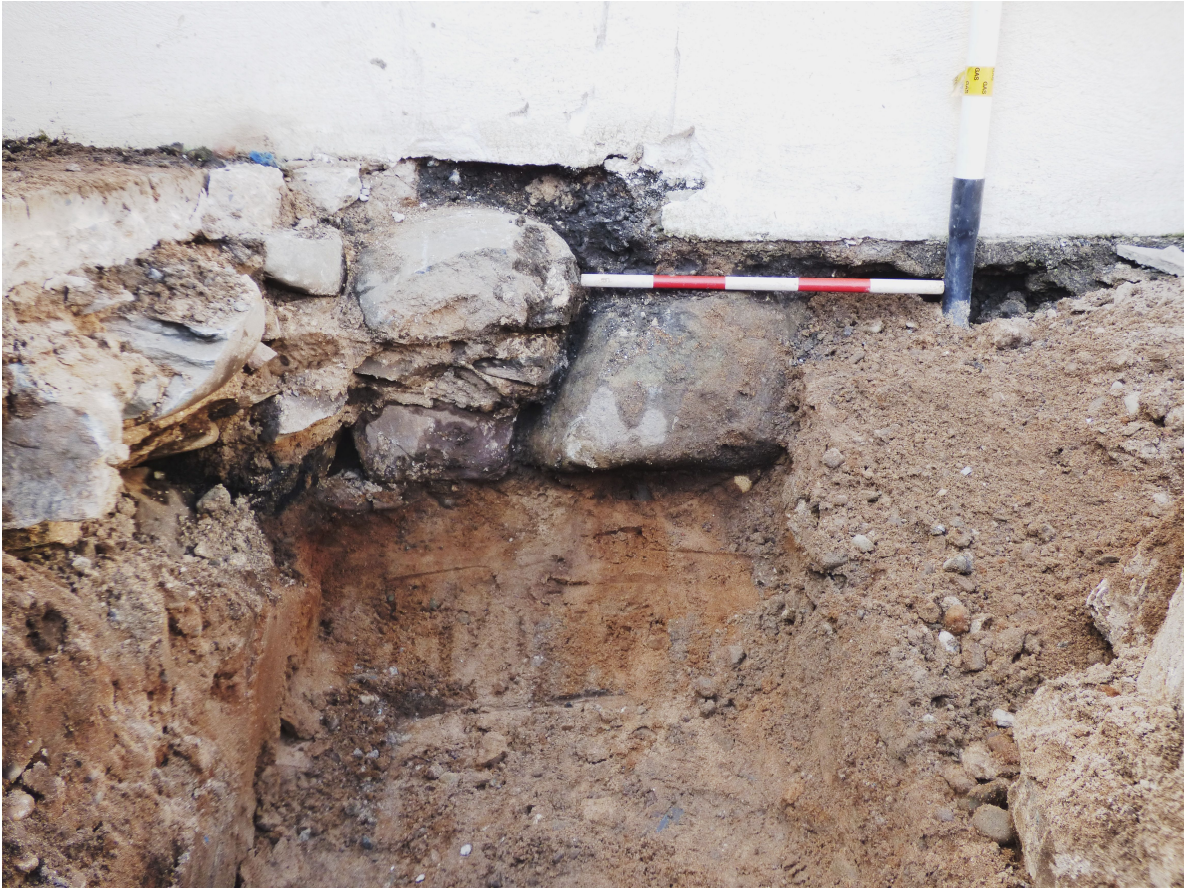
Figure 6a - detail of finds at NNW end of foundation trench B (from SSE)

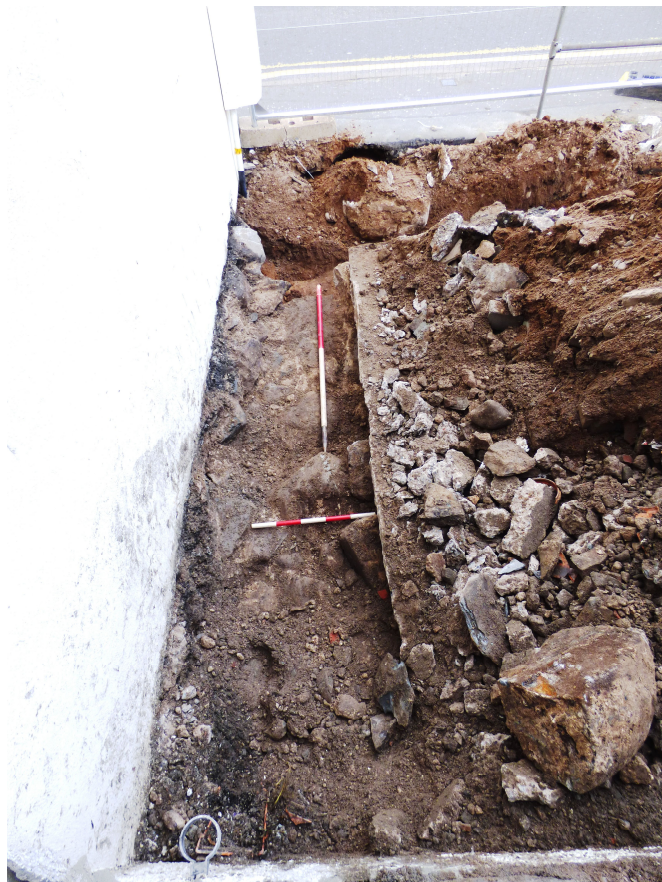
Foundation trench C measured 2.8m x 0.65m (approx) and was excavated to a total depth of 400mm (at most) (Figure 6b). Located almost immediately below the existing concrete surface were fairly large stones (mostly rounded) which were bonded with lime mortar [106] - exploration below the remaining concrete surface indicated these stones measured 0.76m in width.

Figure 6b – post-ex of foundation trench C (from ENE)
