Paradise Walk, Priory Gardens, Christchurch, Dorset Archaeological Observations and Recording during Installation of New Fencing

Report No. 53545/3/1

Archaeological Observations and Recording during Installation of New Fencing, October 2022

Scheduled Monument: 1018277 Pre-Conquest monastery, early Christian cemetery, Augustinian priory and a motte and bailey castle at Christchurch

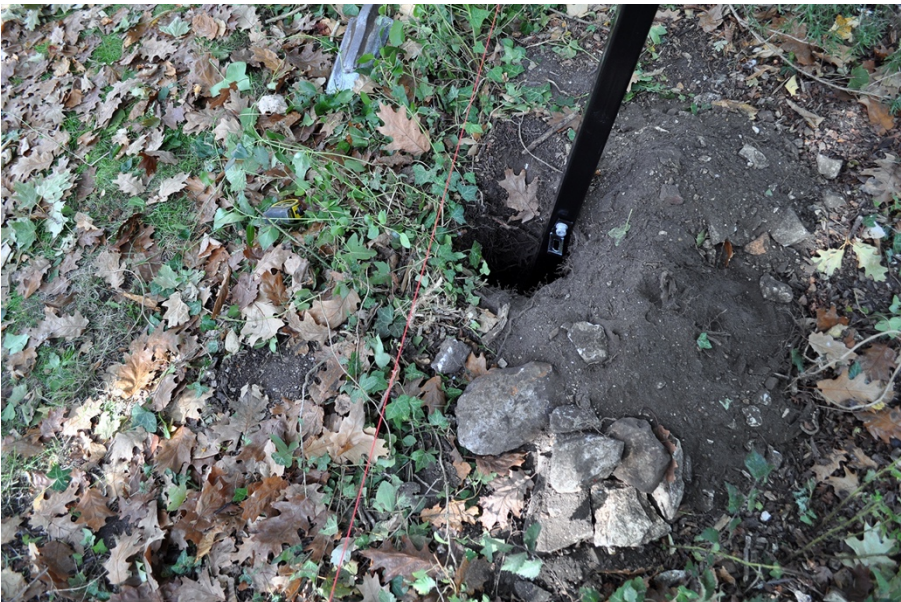
Plate 5: Detail of Hole 107, showing stone rubble.

Along the whole length of the new fence line, there was a mid greyish-brown sand layer with flint gravel, over 0.3 m thick, directly beneath the modern topsoil. In holes 107–110 and 118 quantities of small stone rubble were found within this soil and some tile and slate rubble in hole 108 (Plates 5–6). Quantities of small chalk rubble was found in Holes 116, 119, and 120.

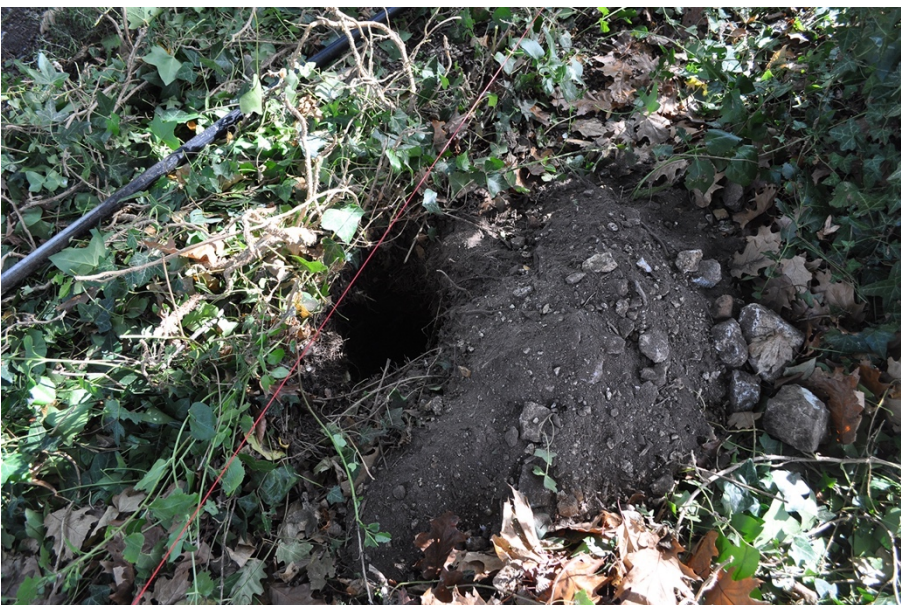
Plate 6: Detail of Hole 108, showing stone rubble.

No finds were retained from the observations. A small quantity of clay roof tile and slate roof tile was noted in Hole 108 and a small fragment of dressed limestone in Hole 118, but these were not collected or quantified.

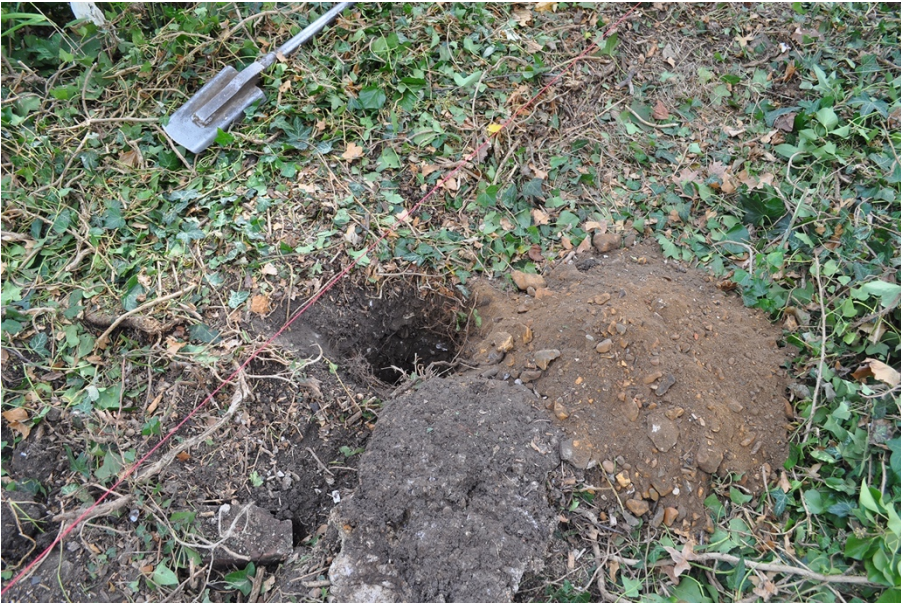
Plate 7: Detail of Hole 115, showing sand and gravel from base of hole.

In Holes 114 and 115, an orange-brown sand and gravel was exposed at a depth of 0.5–0.6m below ground level, below the made ground deposit described above (Plate 7). This is likely to be a localised layer of redeposited sand and gravel.

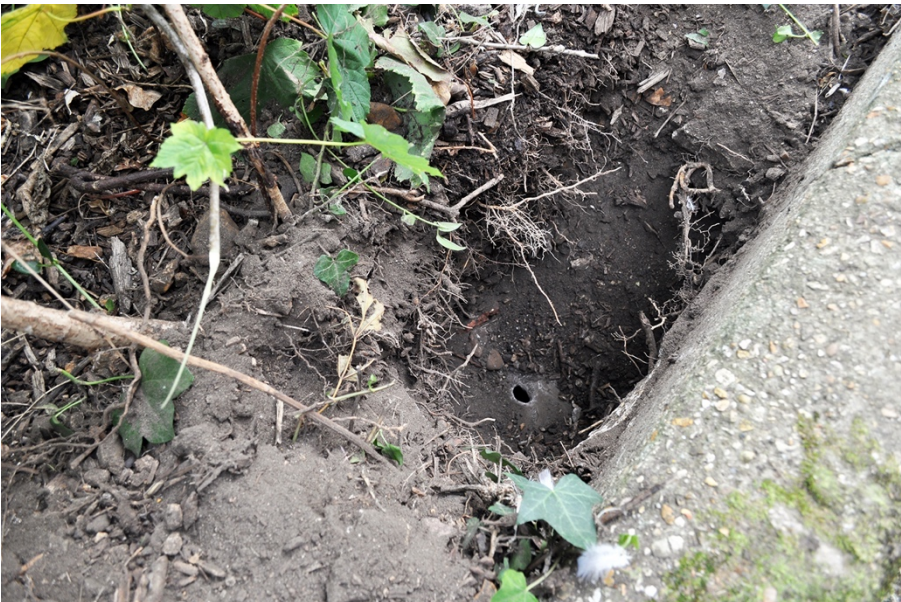
Plate 8: Detail of Hole 124, showing stone slab at base with hole pierced through it by fencing contractors.

A single archaeological feature was observed. In Hole 124 at a depth of 0.25m was a finely worked flat limestone slab 25mm thick (Figure 2; Plate 8). A small hole was knocked through this stone, but further damage was halted, and new fence post was concreted over the top of the slab with a membrane protecting the slab. The hole knocked through the stone revealed a void about 1.6 m deep below. An attempt to probe to find the extent of the slab was unsuccessful on account of the amount of rubble and roots in the soil.

The single archaeological feature discovered immediately south of the east end of the Lady Chapel (in Hole 124) is poorly understood, as its full extent and character was not determined. The presence of a substantial void below the stone slab could suggest that it was the remains of a stone coffin or vault. Not enough of the stone slab was exposed to determine whether it was plain or was decorated or inscribed. The slab was found at a very shallow depth, much shallower than the stone-lined graves found by Wessex Archaeology to the west behind Priory House (Wessex Archaeology 2020). Stone-lined graves were found in 1939 to the south of the Lady Chapel (immediately north of the new fence line) at a depth of about 1.0 m below ground level, but this is likely to be the depth at which the burial was encountered rather than the top of the grave. Nevertheless, the discrepancy in depth between the earlier graves and the stone slab do not allow it to be readily interpreted as part of a grave and its precise interpretation remains in doubt.
