St Andrew's Church, Preston, Weymouth, Dorset

Report No. 53355/3/1

March 2012

Archaeological Observations and Recording During New Gas
Supply and Other Services, September-October 2011

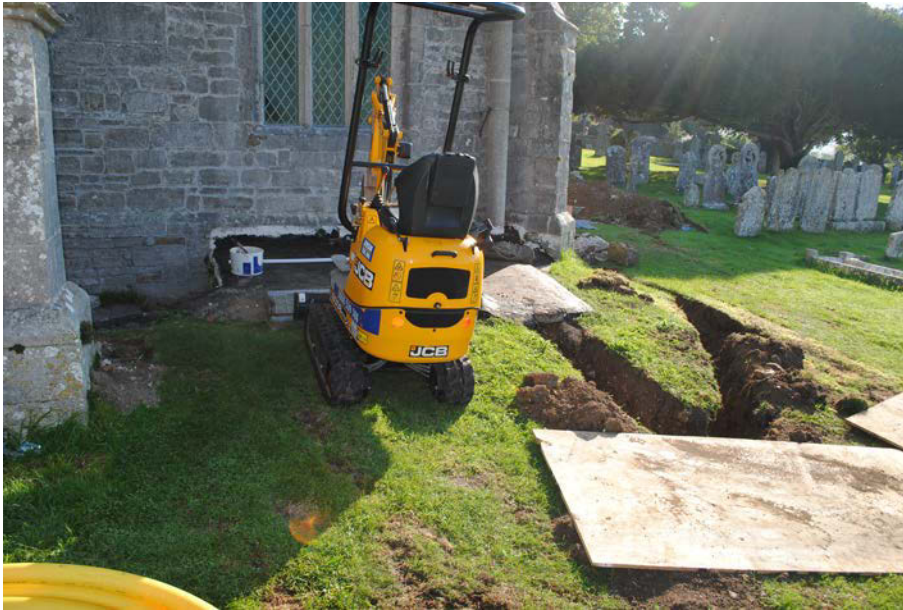
Plate 1: Trenching works adjacent to the West Tower and South Aisle. View from the west.

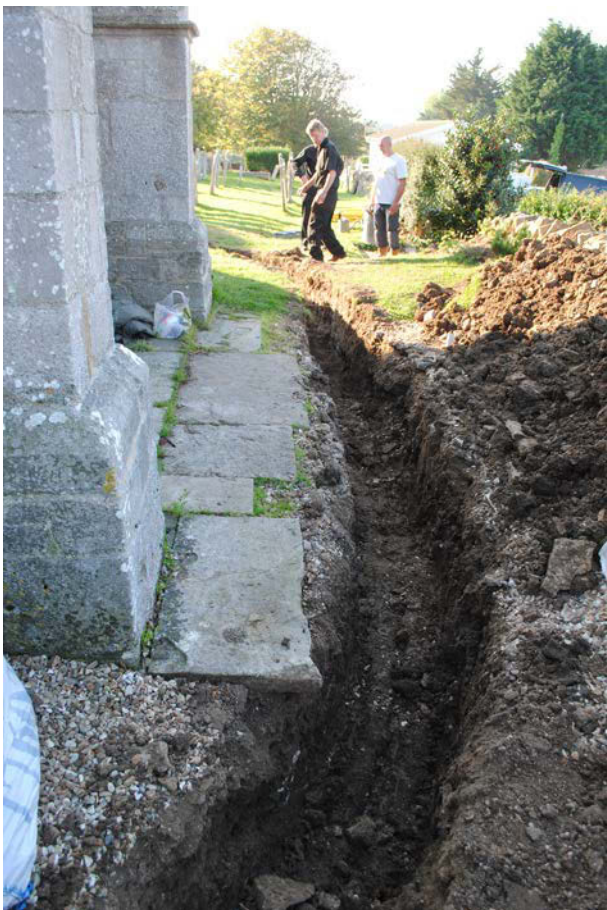
Plate 2: Trenching works west of the West Tower. View from the north.

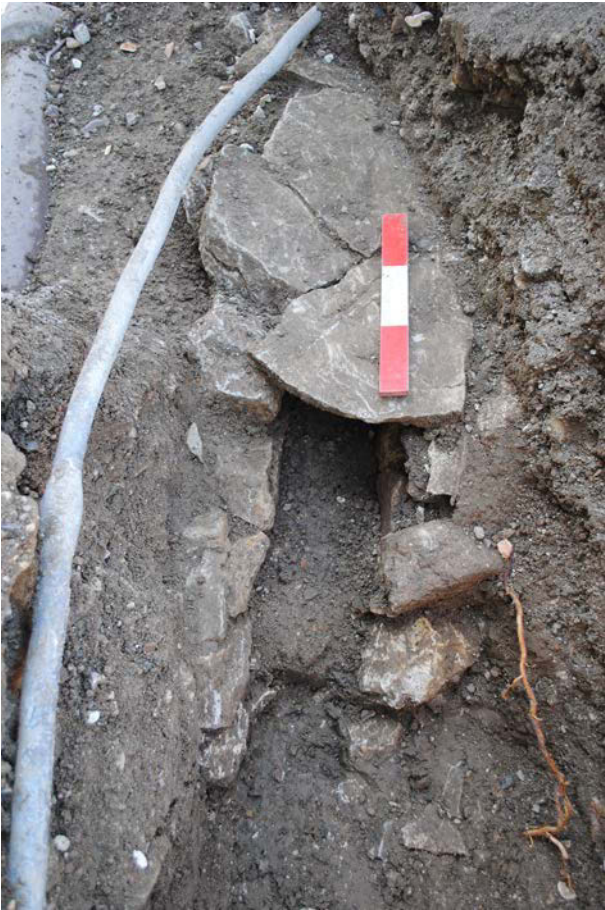
Part of an ENE-WSW aligned drain (109, Figure 3, Plate 4) was seen near the northwest corner of the West Tower. The drain is assumed to have lain within a construction cut (108), although the possibility that its creation was contemporary with deposition of layer 103/107 cannot be ruled out. The drain structure comprised two parallel rows of three to four courses of unmortared limestone rubble forming a central channel c. 0.15 m wide. No base stones were present, but the drain was capped (at c. 0.35 m BGL) with undressed and unmortared tabular limestone pieces up to 0.35 m across, and presumably intended to lie below the contemporary ground level.

The drain continued westward beyond the observed area, but appeared to originate within the trench. The drain is not closely datable but must be contemporary with, or later than, layer 103/107 (see below), and pre-date the construction of the existing church path (102).

Plate 4: Drain 109. View from the east: 0.3m scale.

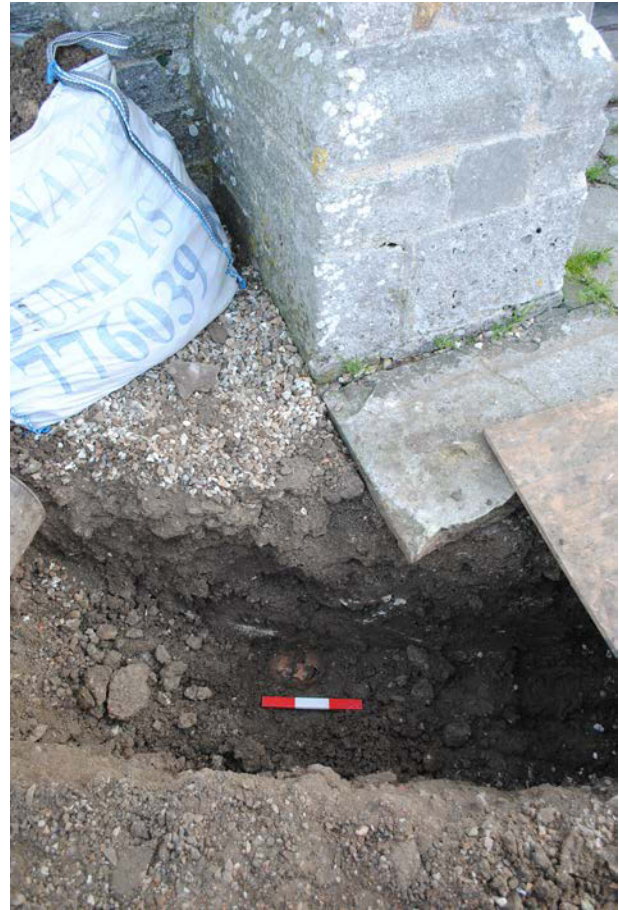
Grave 104 (Plate 5) was recorded immediately northwest of the north buttress of the West Tower's west wall. No grave cut was seen, and the extents of the grave remain unknown. Trenching exposed a cranial vault (106) within the

grave (0.6 m BGL), indicating interment of an adult or sub-adult, supine and extended, and uncoffined. The grave fill (150) remained largely unexcavated and comprised firm, semi-plastic mid dark grey-brown clay-loam.

There seems insufficient room between the skull and tower footing to permit insertion of a full-length adult inhumation, and the burial may pre-date at least the 16th century rebuilding of the tower (and potentially its original construction). The skull was re-interred at slightly greater depth in order to accommodate the new pipework.

Plate 5: Skull 106 (Grave 104) adjacent to the West Tower. View from the west: 0.3m scale

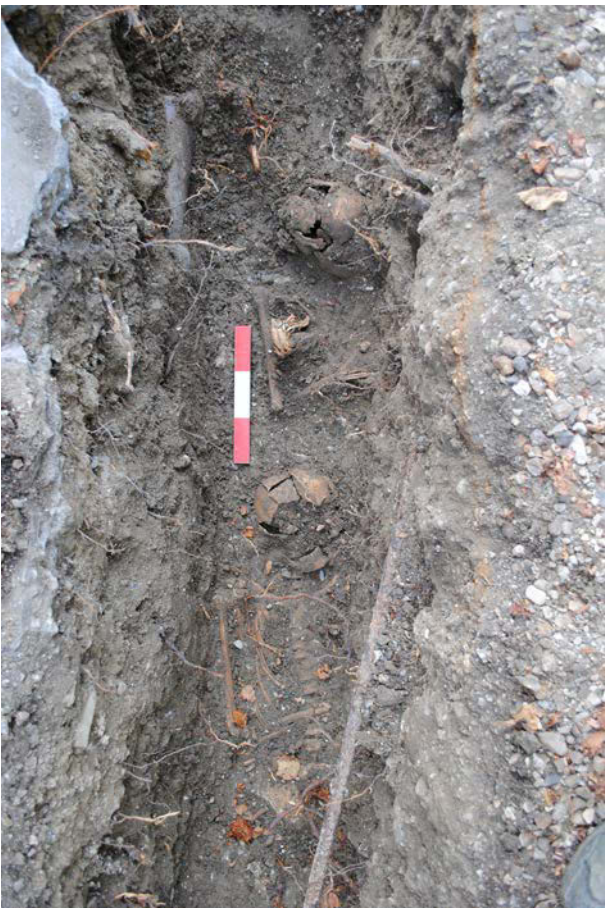
Grave 113 (Plate 6) was situated just north east of the north porch. No grave cut was seen and the extents of the grave remain unknown. Trenching exposed the cranium (0.6 m BGL) and upper torso of a moderately-proportioned adult or sub-adult (114), supine and extended with forearms crossed over abdomen, uncoffined. The grave backfill (115) was indistinguishable from the undifferentiated graveyard soil 110. The lower abdomen appeared to have been destroyed or truncated by digging of adjacent grave 116. The skull was re-interred at slightly greater depth in order to accommodate the new pipework.

Grave 116 (see also Plate 6) was located just east of grave 113. No clear grave cut was seen and the extents of the grave remain largely unknown. Trenching exposed the cranium (0.6m BGL), upper torso, right pelvis and leg (117) of an adult, supine and extended with forearms crossed slightly up over abdomen, uncoffined. The grave backfill (118) was indistinguishable from the undifferentiated graveyard soil 110. The skull was re-interred in the same position but at slightly greater depth in order to accommodate the new pipework.

Plate 6: Skeletons 114 (grave 113) and 117 (grave 116). View from the east: 0.3m scale.
