# St Mary's Church, Glanvilles Wootton, Dorset

## Observations and Recording

Report No. 53342/3/1

Archaeological Observations and Recording During Provision of  
New Electricity Supply, November 2011

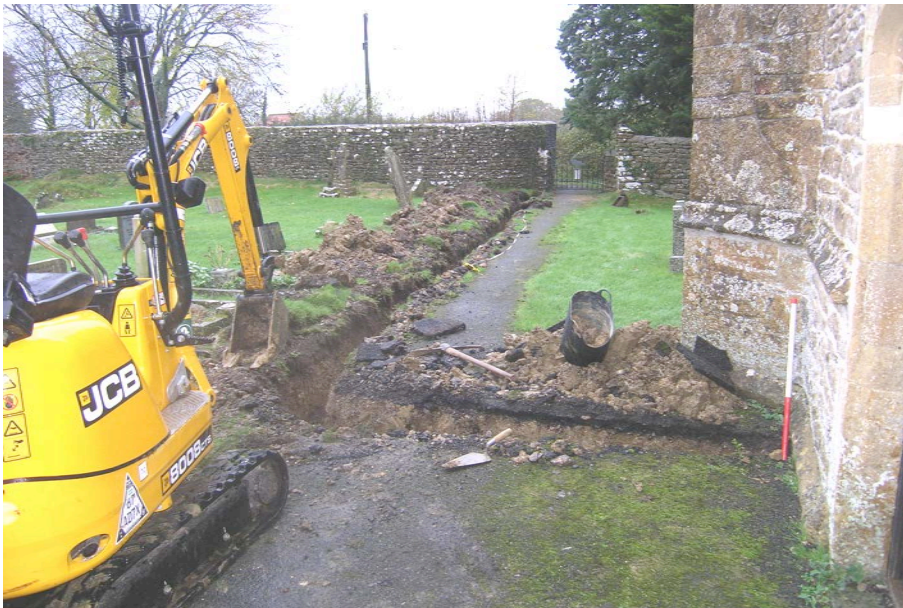
A trench measuring 0.35 m wide and 0.5 m deep was dug by machine along the western side of the footpath entering the northern side of the churchyard as far as the west face of the West Tower (Figure 2; Plate 1). This work was carried out under archaeological supervision.

*Plate 1: Overview of electricity cable trench, viewed from South. 1m scale.*

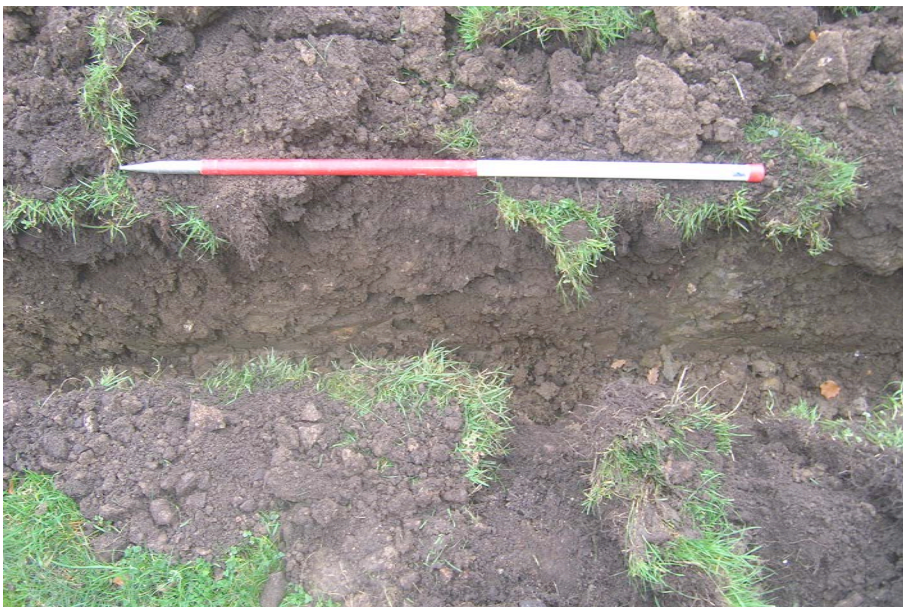
The remains of a single possible grave were identified (Figure 2; Plate 2). This comprised of an E-W aligned, straight-sided vertical cut 0.7 m wide (103) filled with dark yellowish-brown clay with moderate small stone pieces (102).

*Plate 2: Probable Grave 103, viewed from East. 1m scale.*

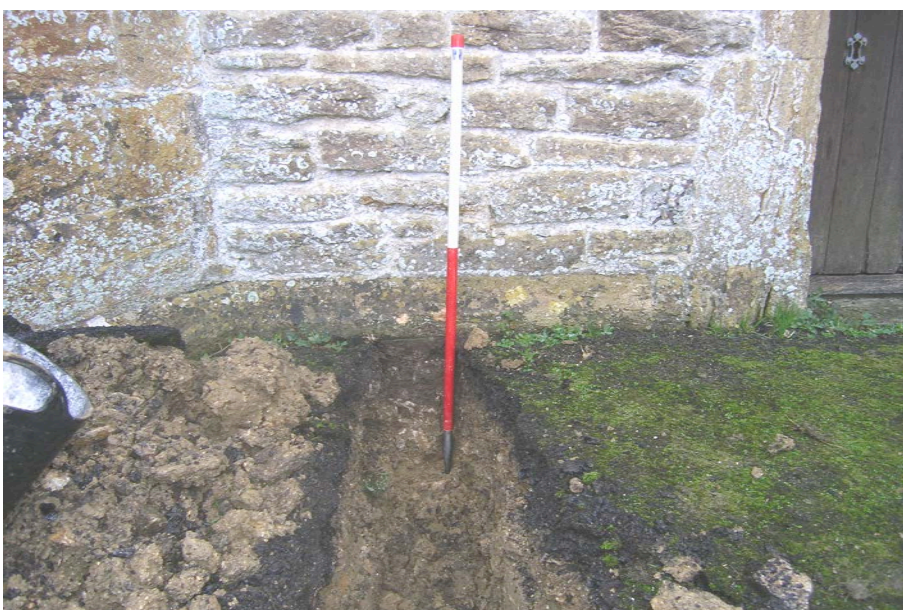
A small section of the footings of the west face of the West Tower was exposed at the end of the trench (Plate 3). The base of the footings was not exposed. The top of the chamfered plinth lay at ground level and a single course of ashlar 0.25 m high lay buried below ground. This was founded on rubble footings with a 0.15 m external offset visible at a depth of 0.39 m.

*Plate 3: West Tower footings exposed in trench. 1m scale.*
