# Sea Wall, Kimmeridge Bay, Dorset

## Assessment of Heritage Impact of Proposed Works

Report No. 53382/1/1

September 2012

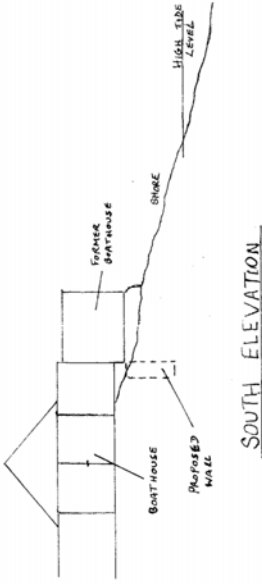
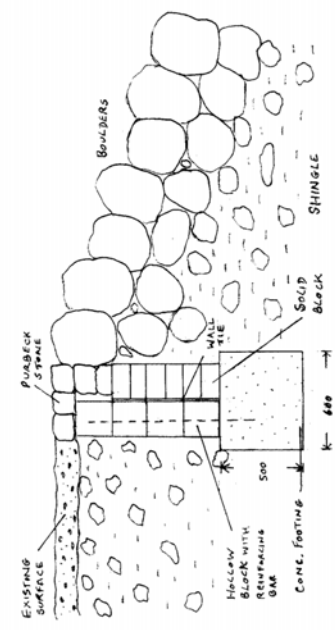
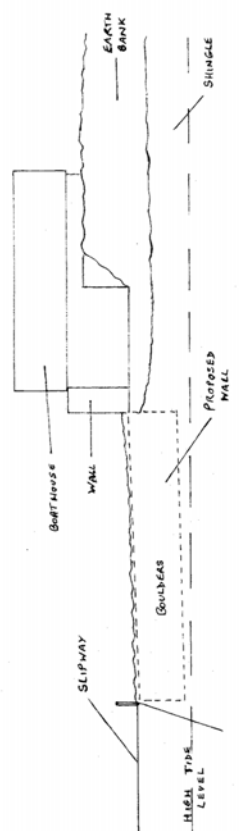
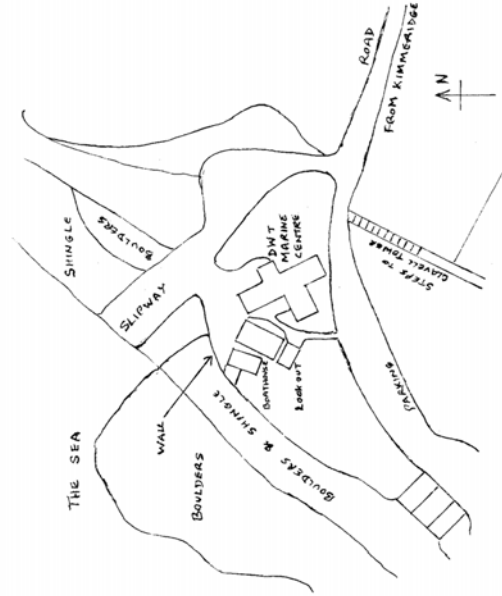
Figure 2: Details of proposed Sea Wall (not to scale).

The proposed development is to reinstate a sea wall in front of a boathouse that collapsed in bad weather in 1989/1990. A nine metre length of wall will be constructed of concrete blocks faced in Purbeck stone to about one metre height on a foundation 600 mm wide and 500 mm deep. Boulders will be placed in front of the wall to form a slope from the boathouse access to the sea. (Figure 2)

The proposed sea wall will be nine metres long and will be built in a 600 mm wide footing, 500 mm deep. This footing will be constructed at a depth of over one metre below the existing ground levels to the east of the proposed

course of the wall, so that the top of the sea wall is at existing ground level. At this depth it will penetrate through any surviving archaeological deposits and into any surviving stream deposits or beach deposits below. The course of the proposed wall is partly across an area that has been scoured by the sea and is about 0.75 m lower than the ground levels outside the boat house. The southern end of the new wall could potentially disturb the remains of the stone wall of the hard that underlies the boathouse. It is also likely to disturb any surviving industrial deposits relating to the earliest alum works and/or glassworks.

The proposed construction using concrete block with Purbeck stone cladding is in contrast to the other structures, which are of timber and/or dolomite block construction. However, in its finished form the new sea wall will be largely hidden by dolomite boulders, so will look only a little different to the current arrangement of hard standing outside the boathouse with dolomite boulders in front. Hence the impact of the construction of the new sea wall is assessed as a **Negligible Effect**.

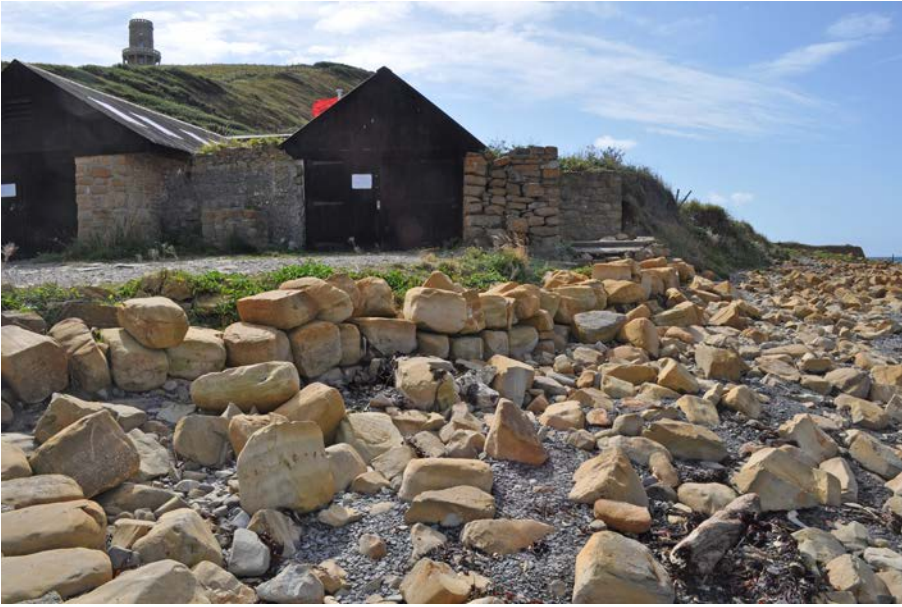
*Plate 1: View of area of new sea wall looking south to boat house.*

The boathouse sits behind a thick stone wall forming the seaward side of the structure (Plate 1). This wall is in fact two walls butting each other, one forming part of the boathouse and the other part of a now ruined structure on the edge of the shore (Plate 3). There are the remains of a stone alignment running out into the bay below this wall (Plate 2). The area in front of the boathouse appears built up to form a roughly level metalled surface and the seaward side is protected by a line of large dolomite boulders (Plate 1).

The proposed development is to reinstate a sea wall in front of a boathouse that collapsed in bad weather in 1989/1990. However, there is no surface trace of the wall visible at the present day (Plate 1) and it is not shown on any maps, so its precise course and nature is not clear. Therefore, it is not possible to determine whether, and to what degree, there has been previous disturbance of this area as a result of an earlier wall. The site lies immediately north of the area of built up ground formed by dumps of burnt shale waste (Plate 2). It abuts the edge of an earlier hard, the remains of which underlie the boathouse and the bounding wall can be traced running across the foreshore (Plates 2-3). The shape of the land suggests there has been some erosion of deposits in this area by storm action but the current ground levels suggest that it is possible that the remains of the earliest industrial waste deposits may still survive in this area.

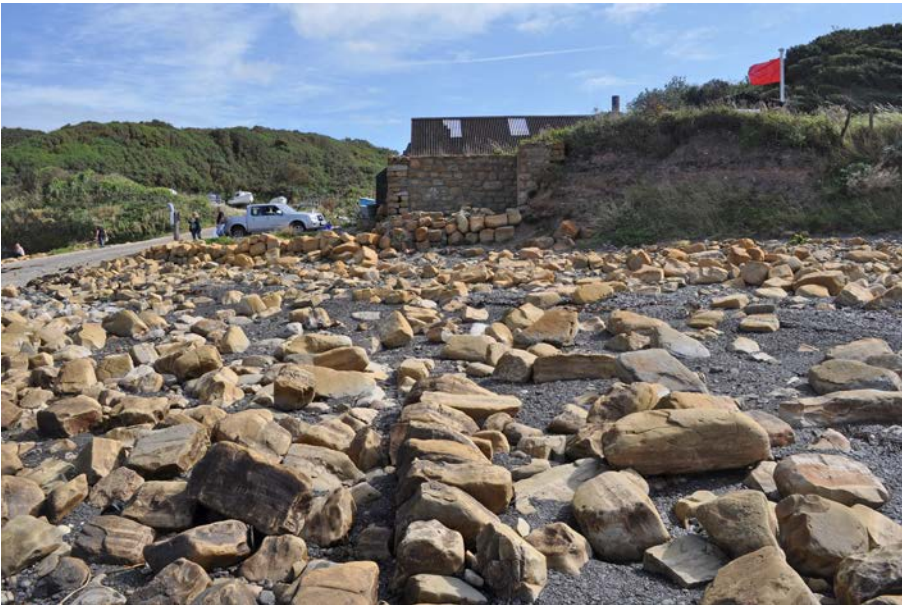
*Plate 2: View from foreshore towards boathouse with alignment of former hard wall in foreground.*

The location of the proposed sea wall lies immediately to the north of an earlier hard, possibly of early post-medieval date. The stone wall of this hard is still visible running across the foreshore and continues inland beneath the boathouse, where at least two courses still survive (Plates 2-3). It is in the area of the outflow of the original course of the stream, which may have been used by the first alum works at Kimmeridge before later being diverted to flow further to the north. The evidence from the sea cliff exposure just to the south suggests that the remains of the stream bed was sealed by layers industrial waste probably relating to the first phase of alum production or the first phase of glass making at Kimmeridge in the late 16th century.

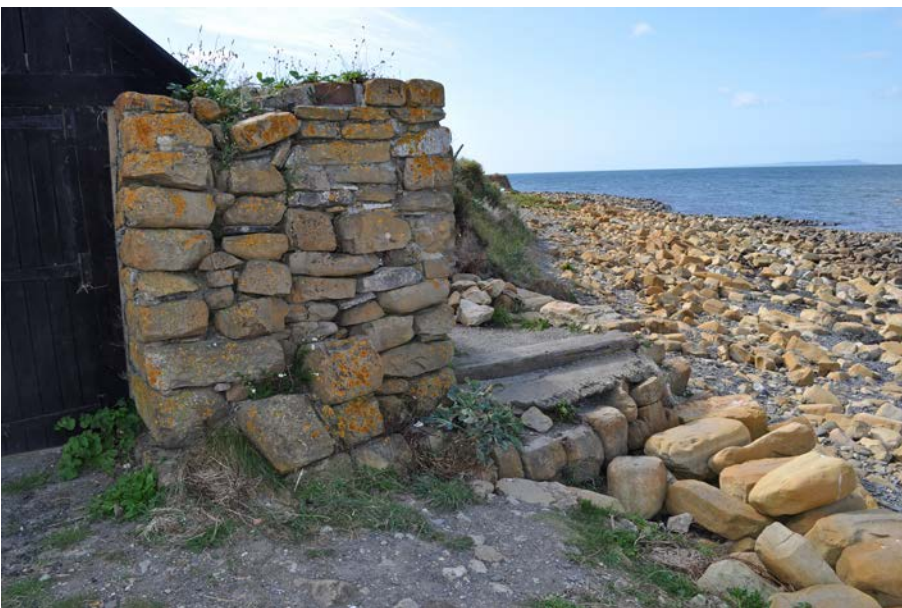
*Plate 3: View of stone wall of boathouse and the remains of the former hard wall below to the right.*
