Maumbury Rings, Dorchester

Observations and Recording during new fencing and retaining wall construction

Archaeological Observations and Recording during new fencing and retaining wall construction, June–September 2012

Report No. 53331/3/1

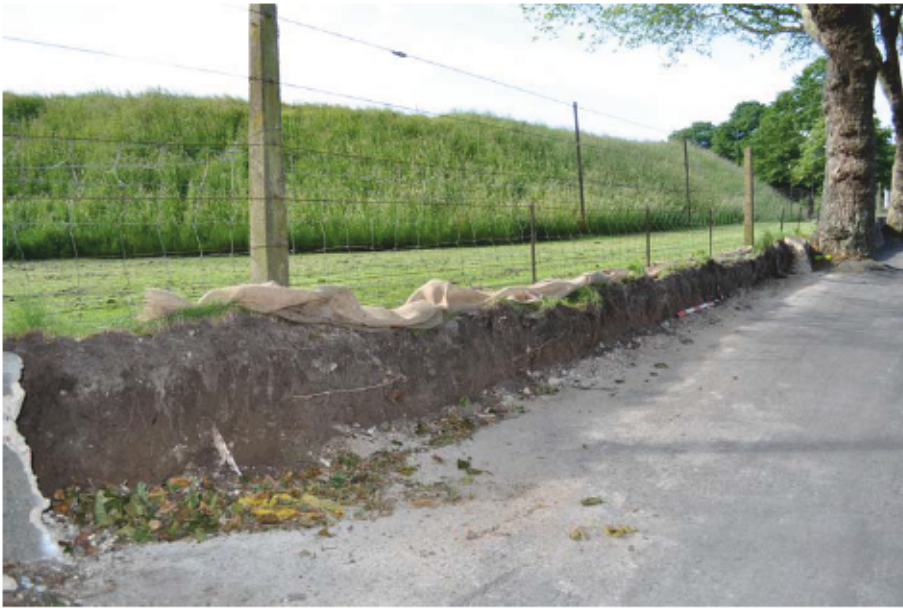
Plate 1: View of soil profile after removal of retaining wall along Weymouth Avenue.

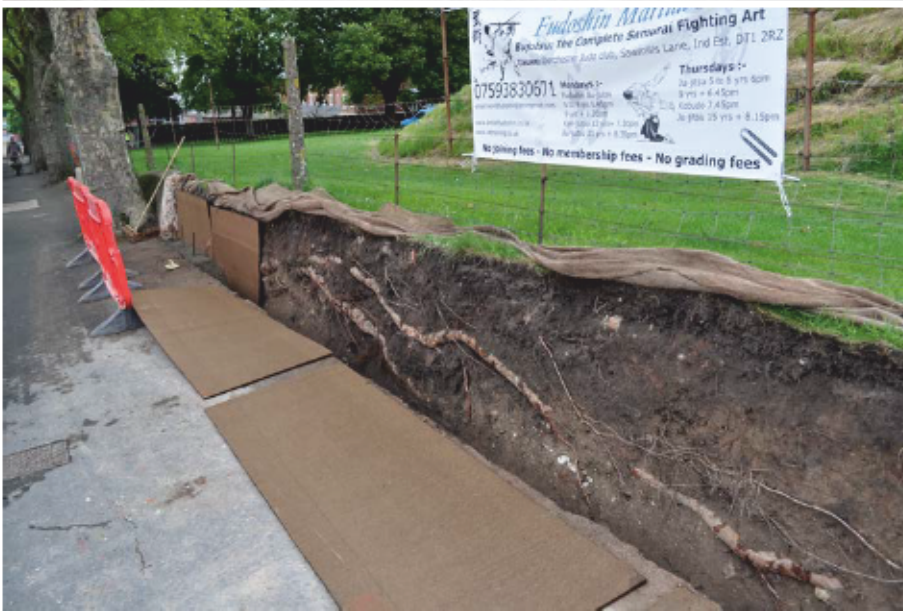
Only one archaeological feature, a ditch (102) was found along the Weymouth Avenue frontage (Figure 3). This ditch is undated and its full extent is unknown. However, it appears to coincide with an earthwork feature running WNW-ESE towards the monument, which appears to be of relatively recent origin. The stratigraphic position of the ditch within the sequence of soil layers is uncertain, but the overall character of its fill does not suggest it is an ancient feature. Its function remains unknown.

Plate 2: Ditch 102 after removal of retaining wall along Weymouth Avenue.

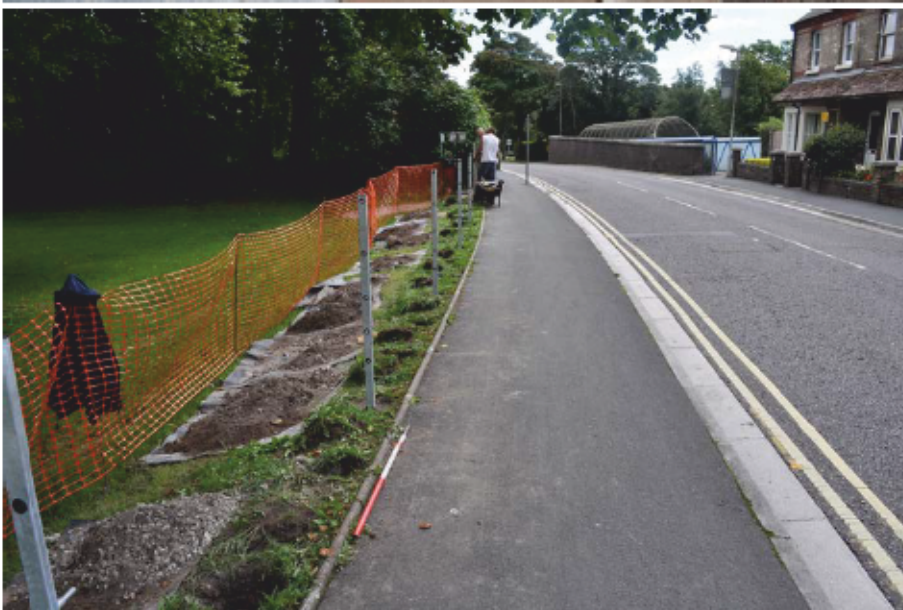
One hundred and twenty seven postholes (87-208) were dug along Maumbury Road for the new fencing and kissing gate. The sequence revealed was different to that on Weymouth Avenue and was almost completely composed of modern disturbance. It was clear that the ground level had been built up significantly next to Maumbury Road as there is a bank about 2-3 m wide and between about 0.6-0.8m high ramping up to pavement level inside the scheduled area, suggesting that the original ground level lay at or below the base of the post holes. A layer of concrete up to 0.5 m deep was recorded in the upper part of many of the postholes. It appears to be associated with the pavement and services beneath the pavement along Maumbury Road. Beneath this concrete a disturbed layer of chalk rubble and soil containing fragments of tarmac was observed, particularly in the area up to about 46 m from the junction. Further to the southeast, the lower part of the sequence comprised a silty loam similar to context 101 recorded along Weymouth Avenue. This layer contained post-medieval pottery, clay tobacco pipe, bottle glass and brick.

Plate 2: General view of new fence along Maumbury Road, showing postholes and retained spoil behind.
