Old Henley Farmhouse, Hilling Lane, Henley, Dorset

Observation and Recording during formation of new parking area and new retaining wall

Report No. 53396/3/1

March 2014

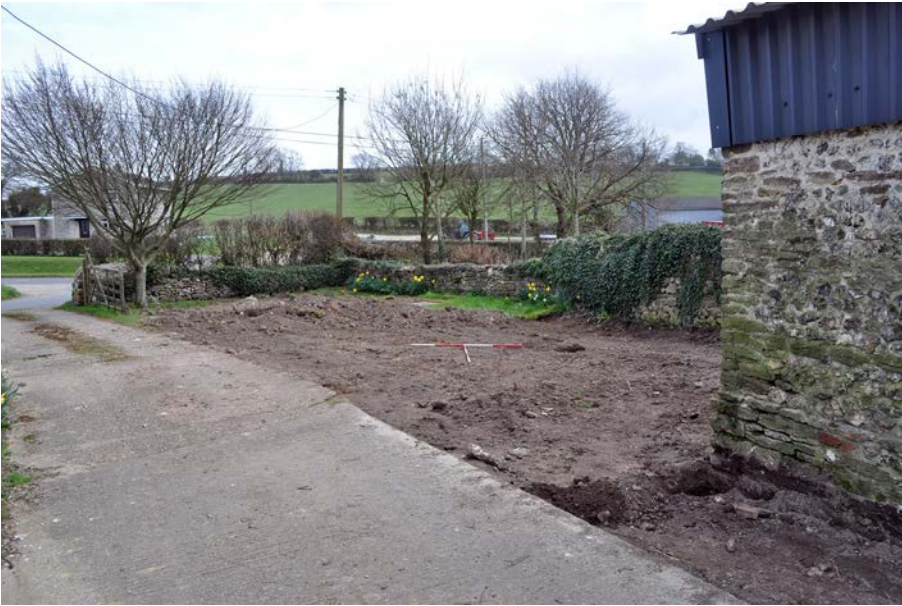
Plate 1: View of new parking area after stripping, looking north east. 2m scales.

The dark yellowish-brown clay loam topsoil (101) had been largely removed by machine across an area of about 7 m by 10 m in the new parking area (Figure 2; Plates 1-2). Natural mid-reddish-brown clay (102) was exposed at a depth of about 0.25 – 0.38 m below ground level, in the base of a small sondage against the north corner of the former stable and at the north east corner of the stripped area.

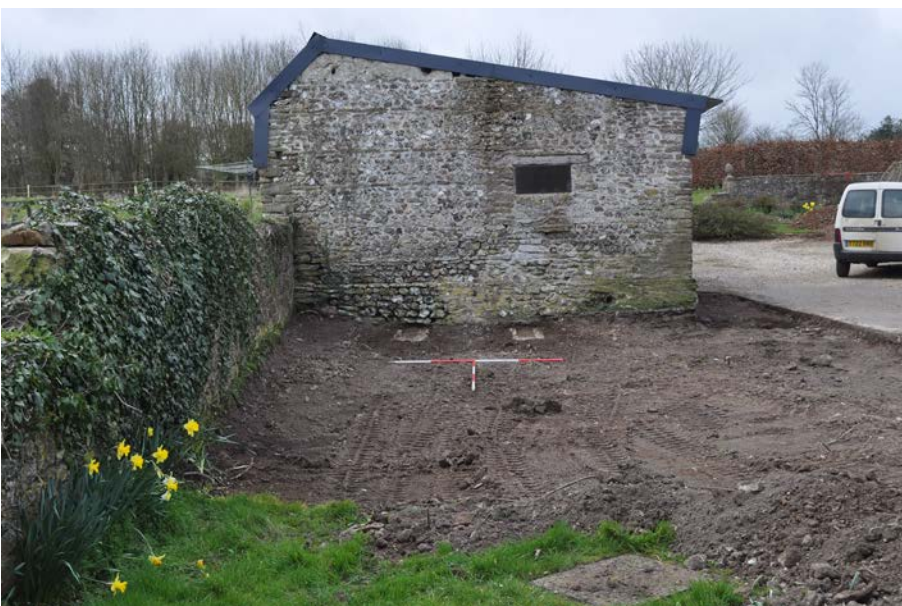
Plate 2: View of new parking area after stripping, looking south west, with concrete base 103 in background. 2m scales.

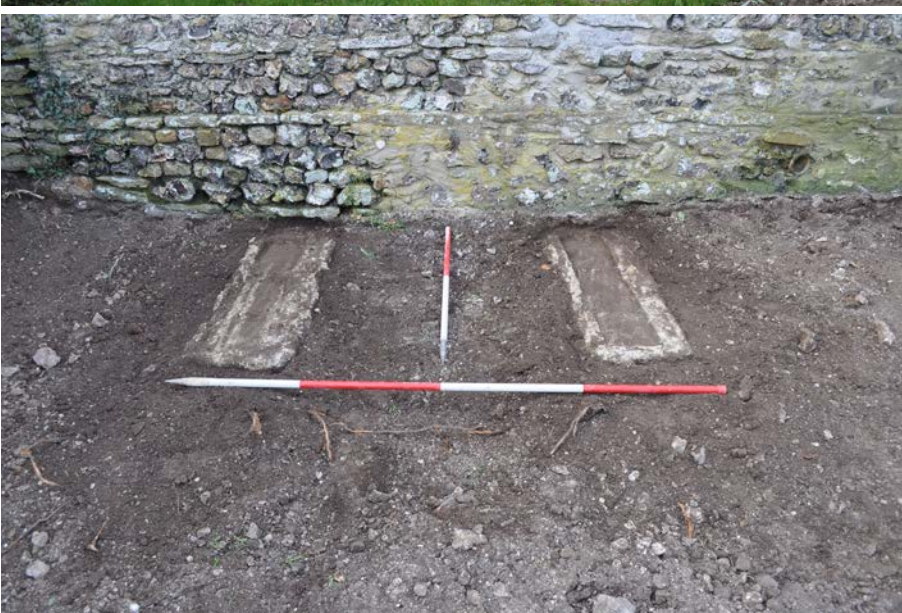
The remains of a concrete footing (103) were exposed within topsoil 101 against the north east wall of the stable (Figure 2). This comprised two linear poured concrete bases, measuring 1.3–1.4 m long and about 0.4 m wide, set about one metre apart. The upper surface of each linear concrete base retained the impression of a line of 2.5 concrete blocks, probably the remains of a built foundation for an oil or diesel tank (Plate 3).

Plate 3: Concrete base 103. 2m scales.

The stripping of the new parking area did not remove the full depth of topsoil, so it is unsurprising that no significant archaeology was recorded. The only feature exposed (103) was clearly modern in date and represents the remains of a probable former oil or diesel tank. Although no archaeological features were recorded in the stripped area, it cannot be determined whether or not features do survive beneath the topsoil here, as the underlying deposits were not exposed.

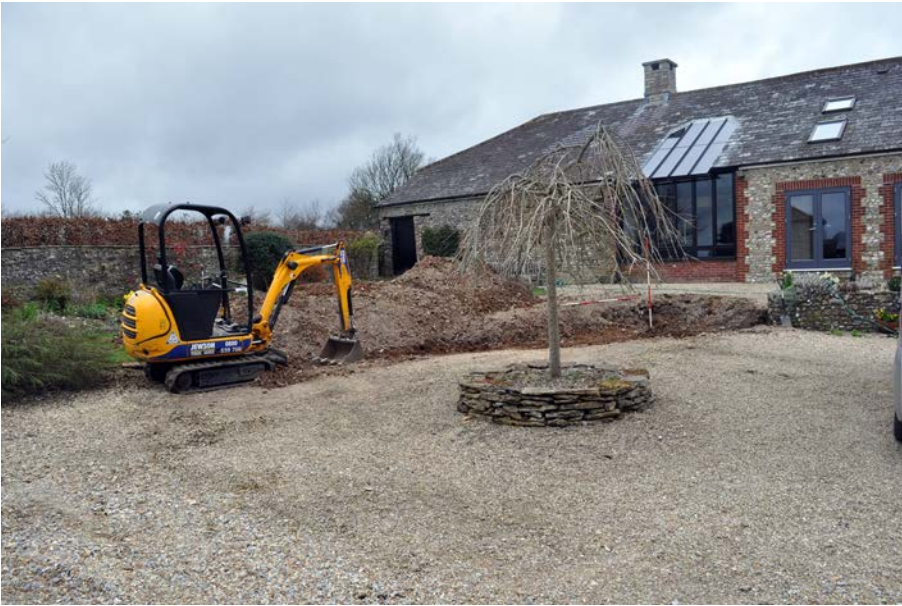
Plate 4: View of new retaining wall trench, looking south west. 2m scales.

The line of the new retaining wall cut across the ramp up to the doors of the former barn and across the south western part of the former farmyard (Figure 2; Plates 4-5). The present courtyard consists of a layer of angular flint metalling, up to 100 mm across, in a dark greyish-brown clay matrix, laid directly on the natural clay 204 and sealed by a 0.05 m thick layer of loose gravel in an orange sand matrix (201), which forms the current surface of the courtyard. In the area of the ramp up to the barn (at the north western end of the trench), the present gravel surface (201) sealed a 0.15 m thick layer of hard-packed reddish-brown clay and angular flint metalling up to 100 mm across (Plate 6). This metalling sealed a 0.2 m thick layer of dark brown silty clay (203) with frequent angular flint and occasional limestone rubble up to 120 mm across, which lay directly on top of the natural clay 204.

Natural reddish-brown clay with shattered flint (204) was exposed at a depth of between 0.2 m and 0.4 m along the length of the new retaining wall. No archaeological features were noted cut into the clay.

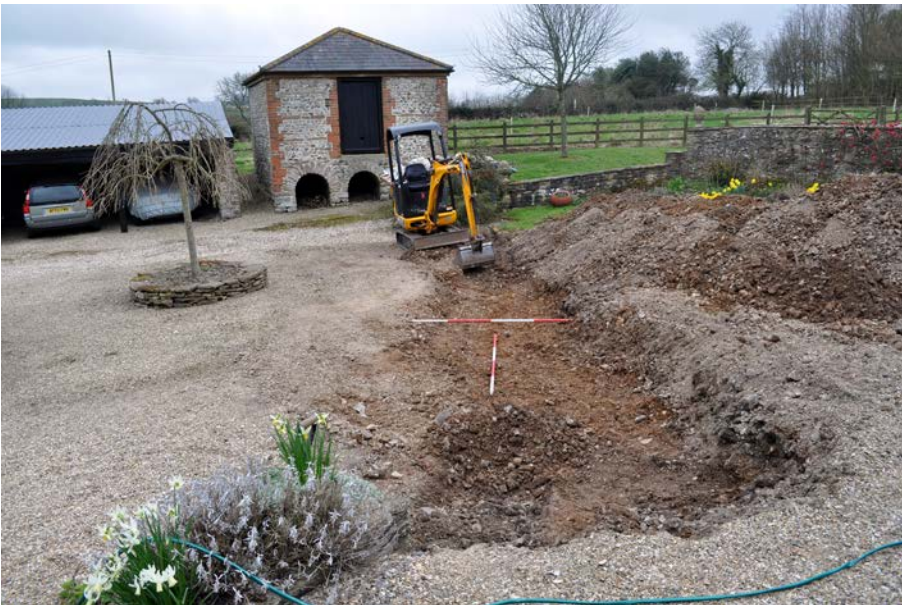
Plate 5: View along line of new retaining wall trench, looking south east. 2m scales.

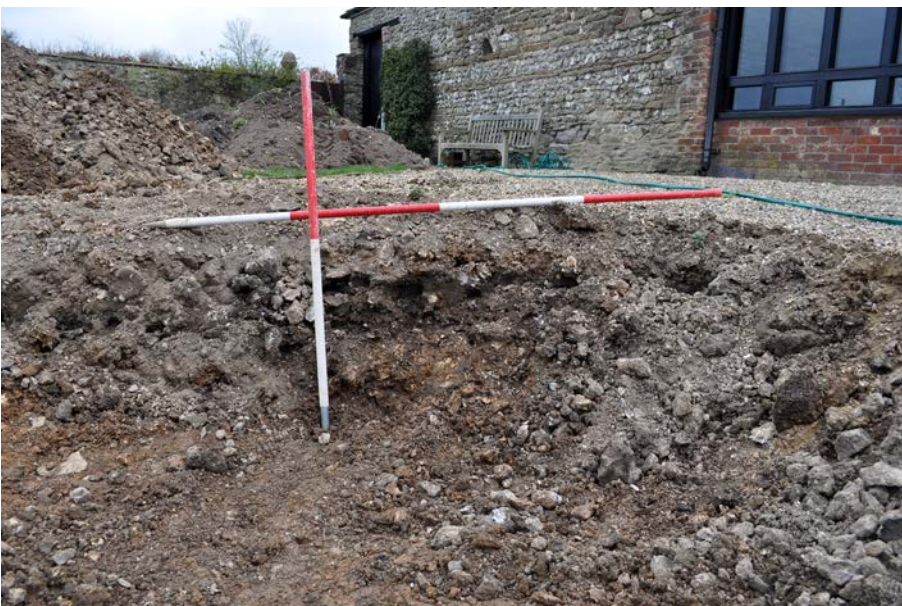
Plate 6: Detail of deposits on former barn ramp, looking west. 1m and 2m scale.

Along the length of the new retaining wall, no archaeological features were visible cut into the underlying natural clay. The trench did expose the metalling of the farmyard and barn ramp. The farm courtyard had a layer of flint metalling (205) laid directly over the natural clay. The character of the flints suggests they are not local and may represent a new yard surface laid at some time during the twentieth century. The barn ramp had a lower deposit of clay flint and stone (203), which may be the remains of the original surface, which was subsequently covered by another layer of flint metalling (202).
