# Hardy's Cottage, Higher Bockhampton, Dorset

Archaeological Observations & Recording during underpinning  
works, January–February 2014

Report No. 53405/3/1

**Client:** The National Trust

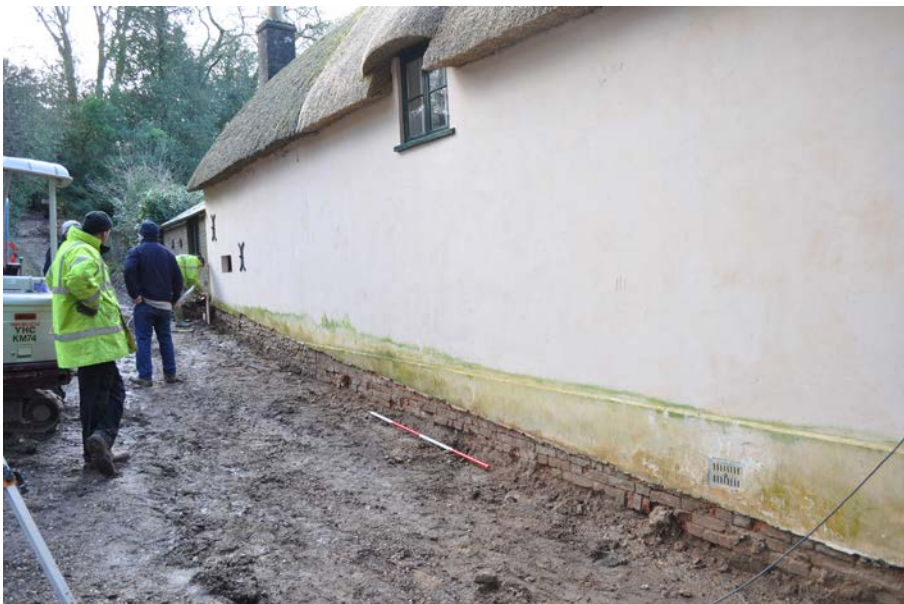
*Plate 2: East wall of cottage showing the brick plinth to the north and flint base to the south, below the level of the render, looking SSW. 2m scale.*

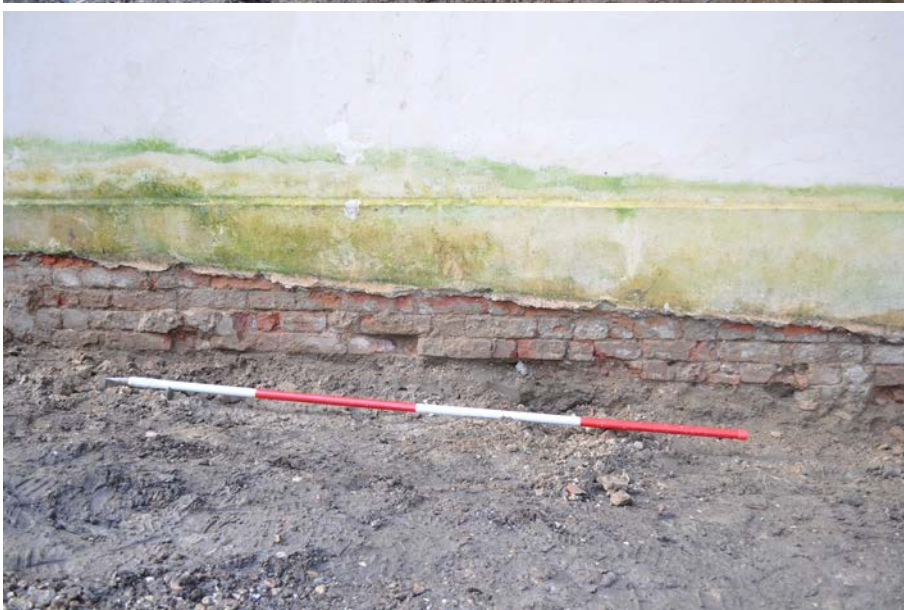
*Plate 3: Detail of brick plinth of original cottage east wall. 2m scale.*

The cob wall of the northern part of the cottage was constructed on a brick footing wall (104). This footing gradually stepped up to the south, following the general topography of the site. This footing wall was at least 0.43 m high (6 courses) and penetrated to a depth between 0.1–0.4 m below present ground level: the full height of the footing was not exposed and was obscured by the existing render, but is likely to be marked by the slight plinth visible in the north end of the east wall and the north wall of the cottage (Plates 2-4). This would indicate the footing wall was about 0.75 m high at the north end. The footing wall was of solid brick construction bonded with yellowish-brown lime mortar and was built in an irregular bond with some bricks set on edge in the lower part of the footing.

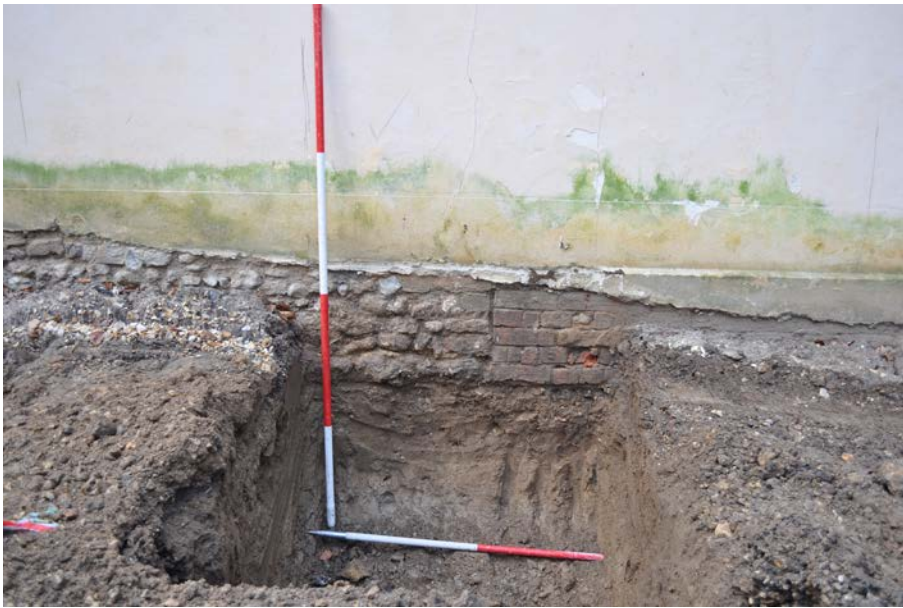
*Plate 4: Junction between base of walls in original cottage (right) and later extension (left) in underpinning pit 9. 2m and 1m scale.*

The footing wall at the southern end of the cottage is of mortared flint construction (105) with a straight joint with the brick footings to the north (Figure 3; Plate 4). The flint nodules are largely undressed but were laid in rough 'courses' with up to five 'courses' recorded. The lowest part (c. 0.15–0.3 m) has more mortar on the face of the footing, while above the flint nodules stand slightly proud of the bonding mortar (Plate 6). A number of large ironstones up to 500 mm across were used in the base of the wall and also at the southern end (Plates 6-7). To the north, there were a number of bricks used in its construction and other brick fragments were present elsewhere in its upper part (Figure 3; Plate 4). The northern end of the flint footings was at the same depth as the original brick footing wall (104) but they are deeper further to the south. At the north end, the base of the footing wall was at about 0.28 m above floor level and at the south end about 0.23 m above floor level.

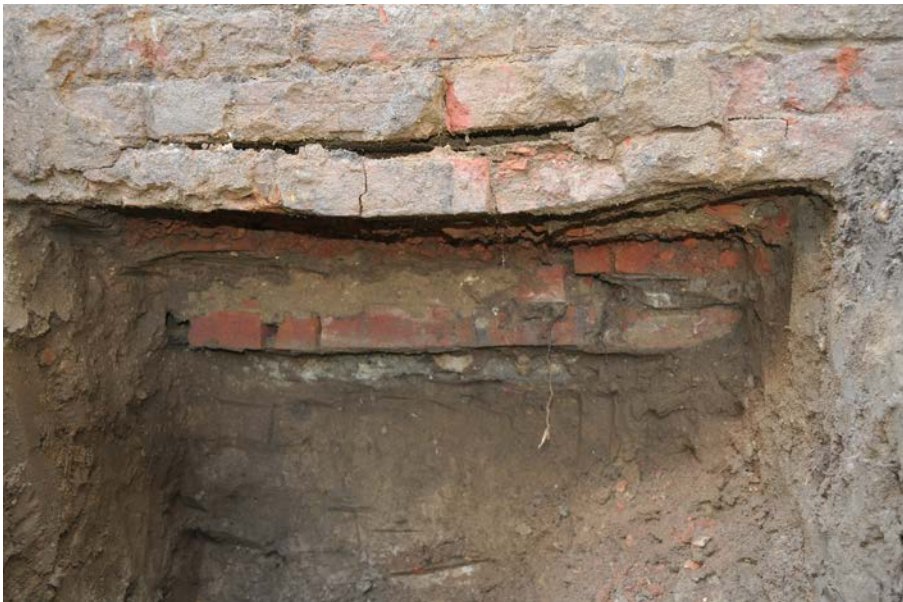
*Plate 5: Detail beneath brick plinth 103 in underpinning pit 7, showing relationship with floor.*

single skin of bricks (106) added flush with the inside face of the wall and bonded with grey lime mortar (Figure 3; Plate 5). There is no deeper inner face of the wall in the area of the fireplace and oven.

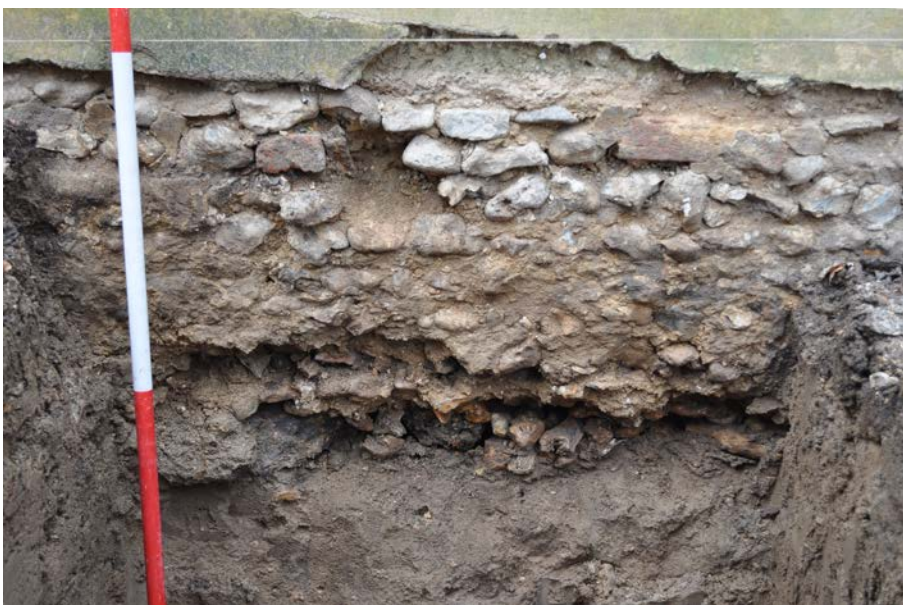
*Plate 6: Detail of flint footings 105 in underpinning pit 12.*

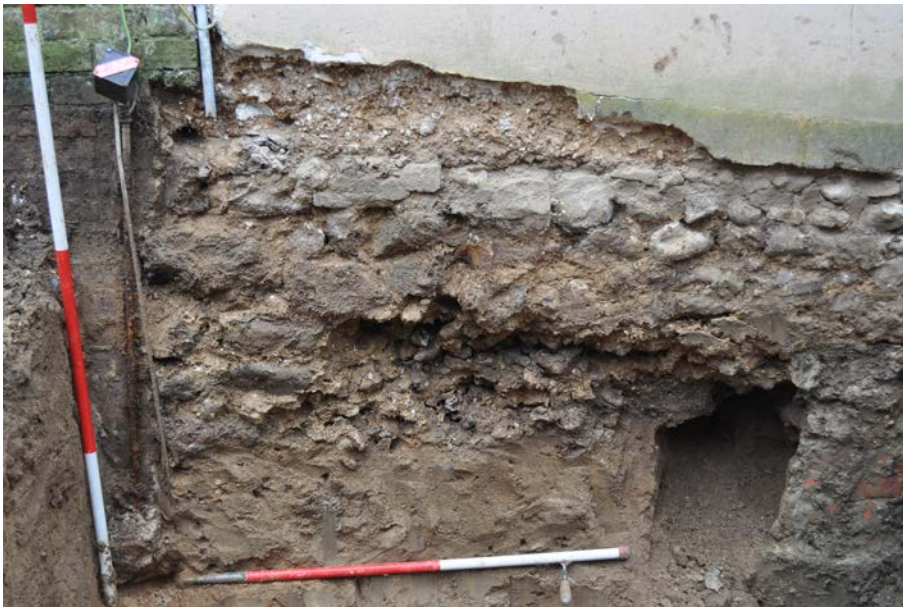
*Plate 7: Footings 105 at south end of cottage and junction with the south extension in underpinning pit 13/14. 2m & 1m scales.*

Only a very small part of the north east corner of the southern extension was observed. This revealed the bricks of the extension continued down to about 0.4 m below present ground level. Below this was modern brick down to 1.2 m below ground level, founded on a poured concrete foundation 0.15 m thick (Figure 3; Plate 7).

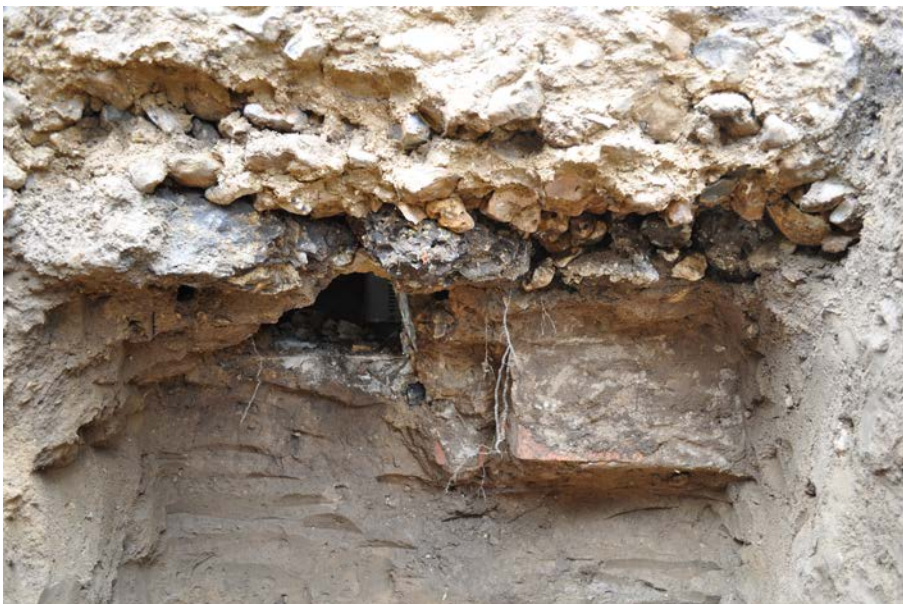
*Plate 8: Detail of base of footing 105, with bricks of structure 109 to right and gap formed by removal of slate (111) to left, exposed in underpinning pit 12.*

The gap between the base of the flint footing wall and the floor of the old kitchen was sealed by a single skin brick construction (109) between 3 – 5 courses of brick laid flush with the inner face of the wall (Figure 3; Plate 8). The exterior face was covered in grey sandy lime mortar 25 mm thick, which covers most of the bricks, suggesting the bricks were laid from inside the building against a vertical edge cut in the natural sand. The southern end of this lower brick structure butted against the footing of the partition wall between the old kitchen and the former pantry (110). To the south of this wall in the area of the pantry, the gap between the base of the wall footing and the floor was sealed by a layer of upright slates (111) set flush with the inner face of the wall and plastered over (Plates 8-9).
